GEOLOGY @ FLOOR OF DRIVE

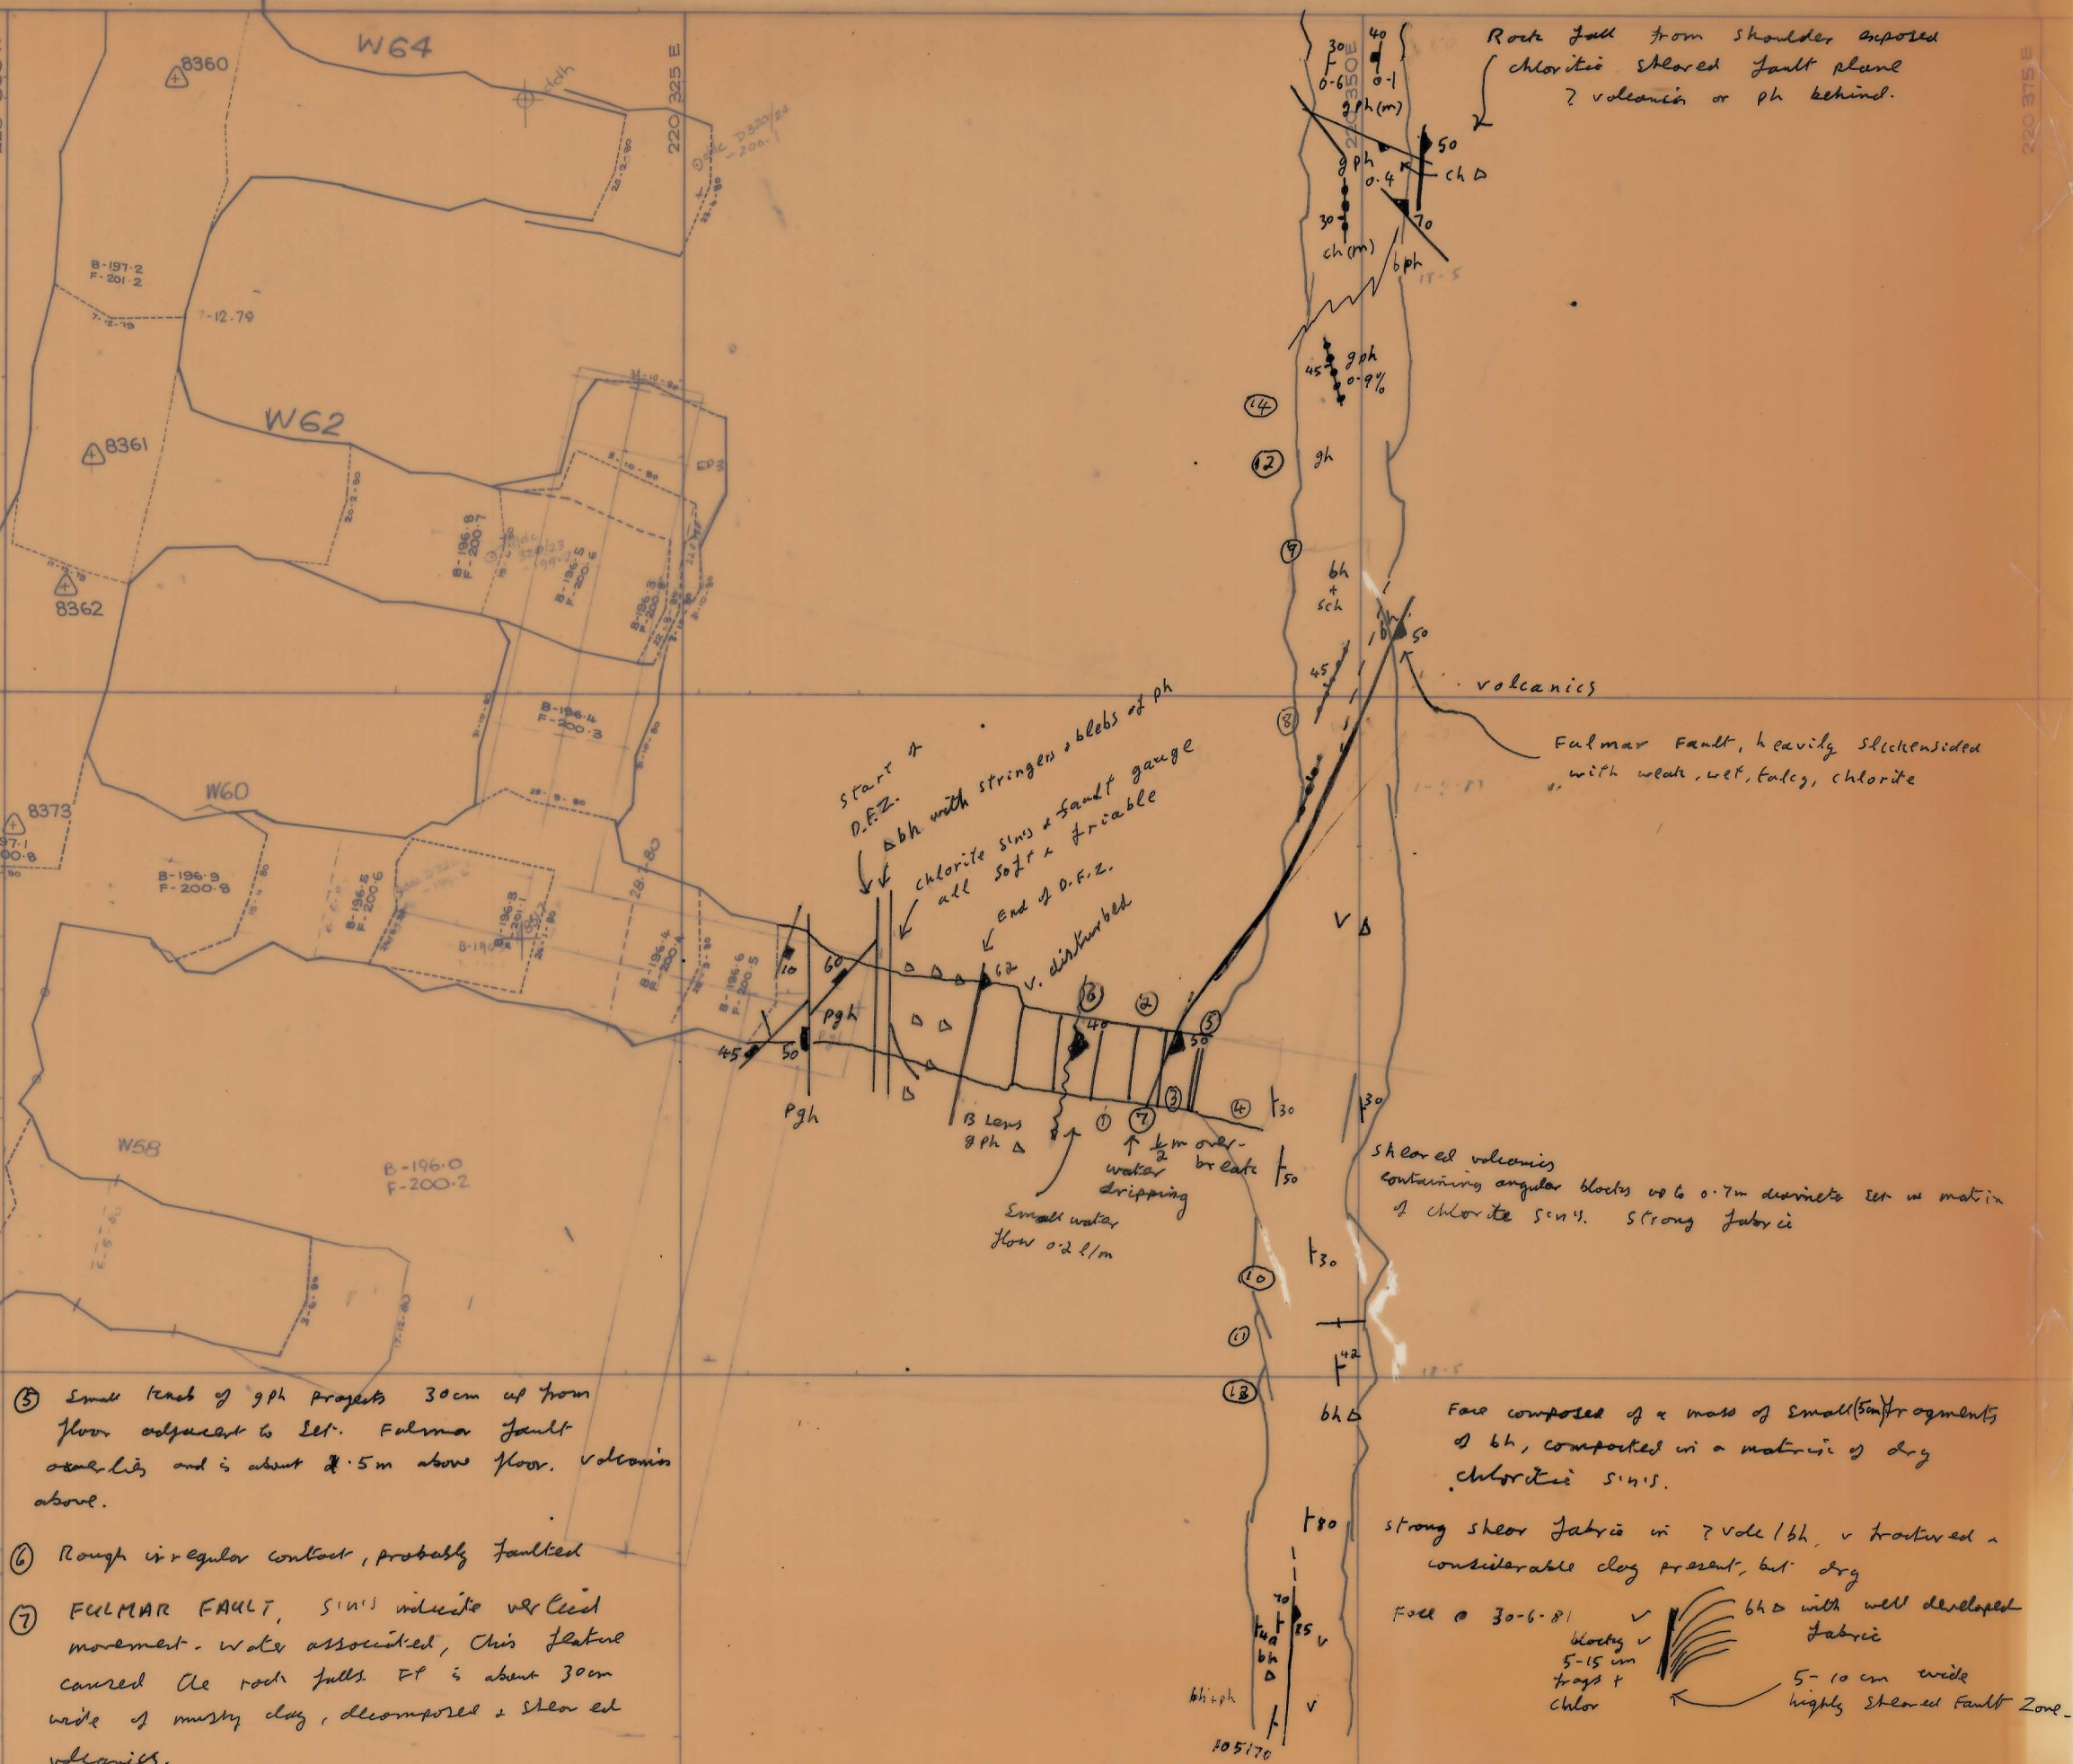
- ① Angular volcanic fragments < 20 cm set in matrix of greenish blue, clay chlorite / talc slickenside
- ② gph in bottom of fault (1 m) highly sheared volcanics above

- ③ 2-3 hrs after firing on 4-2-81 the volcanics along the Fulmar Fault had started to fall in. By 9:00 a.m. on 5-2-81 the fault had risen back 2 m above the old back end the fault (1 m).

- ④ Highly sheared volcanics occasionally containing large (0.7 m) angular blocks. Generally fragments are smaller (0.2 m) & separated by blue chlorite slickensides material which is wet & greasy.

- ⑤ Mostly bh with large (1 cm) scheelite crystals scattered through it. Occasionally they are loosely or isolated on veins 235/40. Some only present with the scheelite. Fault visible in L.H. side of face at mid height. approx 135/40

- ⑥ Sheared volcanics with intercalated bh/ph and rare grossular garnet
- ⑦ Intermixed bh/ph with volcanics. Ground is dry but very chloritic & has a strong fabric

- ⑧ well mineralised gph 0.7% some scheelite veins 268/45 ground moderately fractured features trend E-W
- ⑨ Face @ 12-5-81, highly sheared bh, dry but chloritic blue flower-like scheelite scattered sparsely throughout. Sulphides on joint surfaces, some ph units.

- ⑩ High grade (0.9%) well mineralised gph, sch vein 255/45. Ground blocky, 30 cm blocks, but competent

- (5) Small knob of gph. Projects 30cm up from floor adjacent to let. Fulmar fault stair lies and is about 1.5m above floor. volcanic above.
- (6) Rough irregular contact, probably faulted
- (7) FULMAR FAULT, S.M.S indicate v. E. C. movement. water associated, this feature caused the rock falls. It is about 30cm wide of rusty clay, decomposed & stained volcanic.
- (8) B Lens hangingwall. 6h below Fulmar Fault, 4m below. Majority  $WO_3$  is in veins approx 1m apart dipping 290/45
