0374_1669

SCALE 1:500	<p>north</p>	LOCATION DOLPHIN MINE	<p>KING ISLAND</p>
		SUBJECT 260m LEVEL GEOLOGY PLAN.

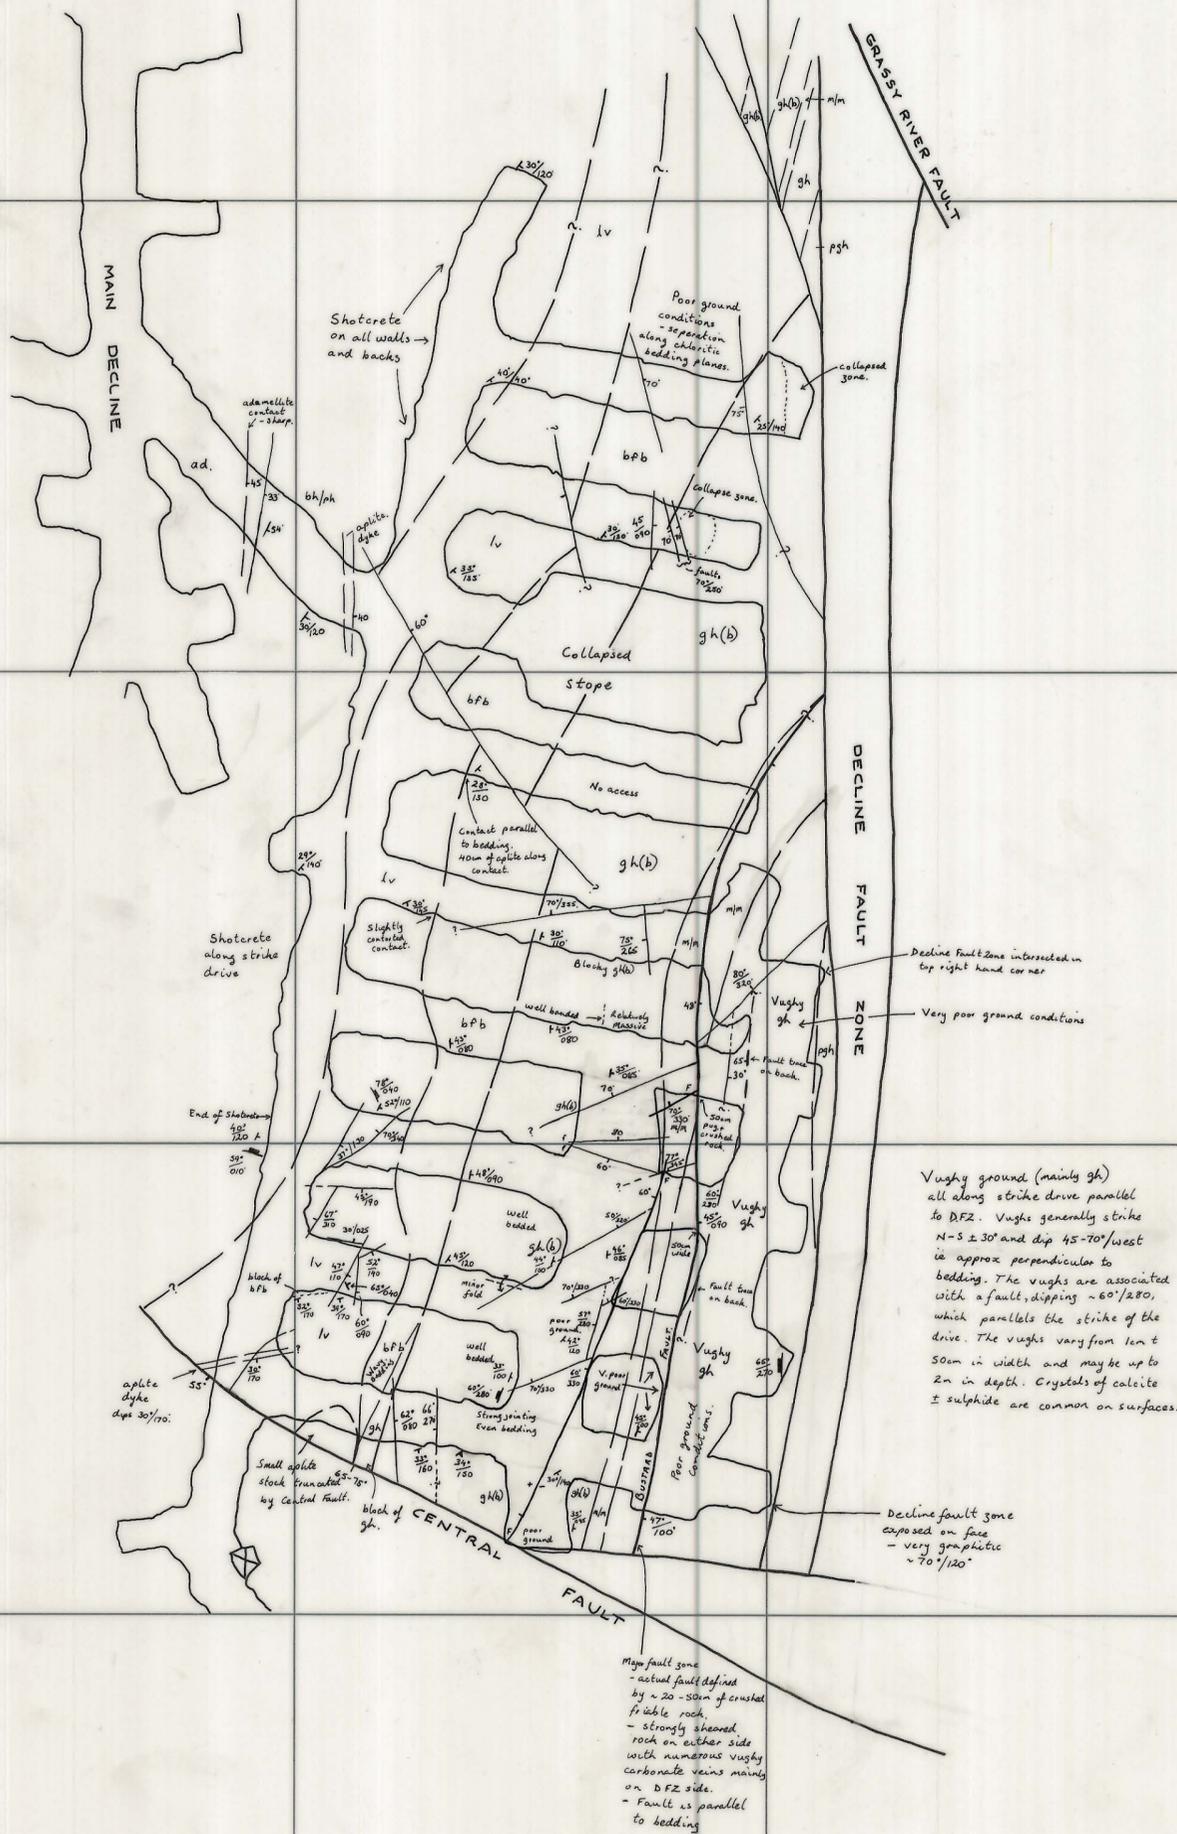
Vughy ground (mainly gh) all along strike drive parallel to DF2. Vughs generally strike $N-S \pm 30^\circ$ and dip $45-70^\circ$ west i.e. approx perpendicular to bedding. The vughs are associated with a fault, dipping $\sim 60^\circ/280^\circ$, which parallels the strike of the drive. The vughs vary from 1m to 50m in width and may be up to 2m in depth. Crystals of calcite \pm sulphide are common on surfaces.

Decline fault zone exposed on face - very graphic - $\sim 70^\circ/120^\circ$

Major fault zone - actual fault defined by $\sim 20-50m$ of crushed friable rock - strongly sheared rock on either side with numerous vughy carbonate veins mainly on DF2 side. - Fault is parallel to bedding
