**Archaeological reconnaissance of Storeys Creek and Aberfoyle mines
Rossarden, Tasmania**

Mine site rehabilitation: phase 1

**Report to Industry Safety and Mines Division,
Tasmania Development and Resources**

**Archaeological Survey
Report 1995/01**

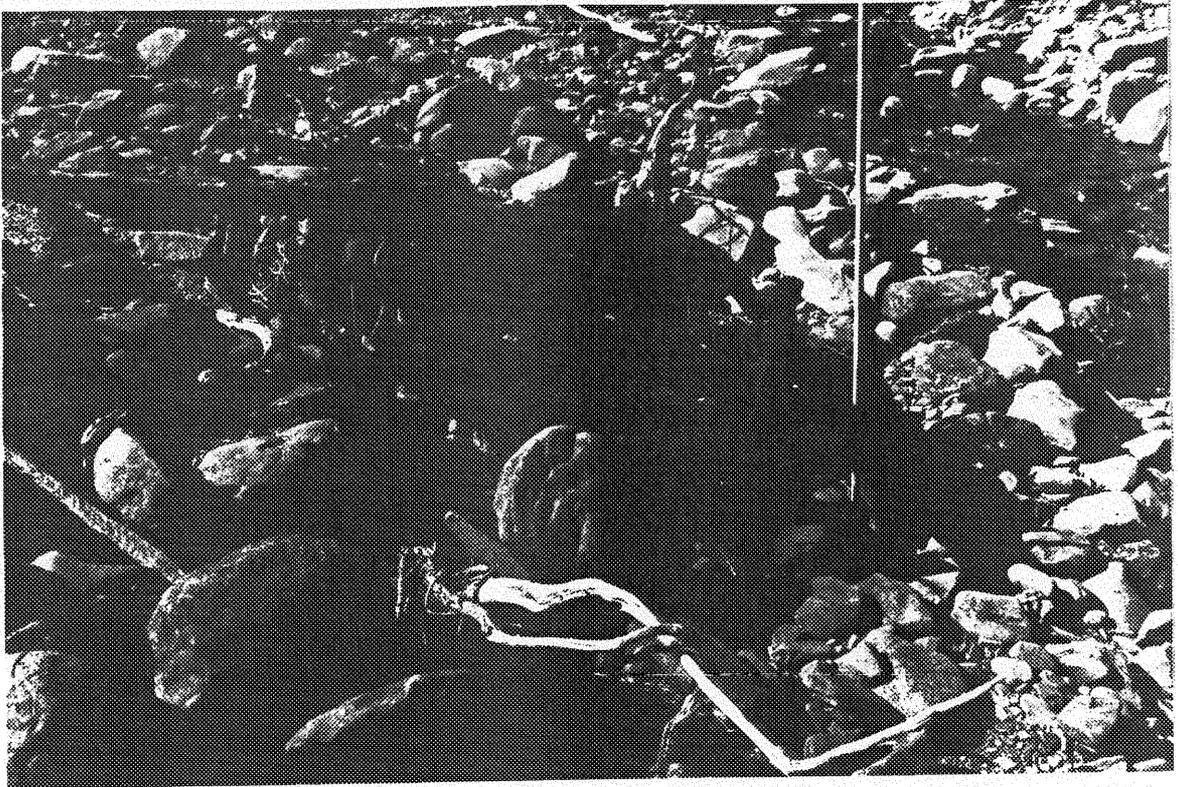
The artefacts scattered along the creek bed below the tailings dump are derived from the plant, structures and services that were utilised and discarded around the mine site, typically over the later years of milling and mining operations. In theory at least, these objects have the intrinsic potential to illustrate, in part, the large range of equipment used over the life of the mine. In reality however, the majority of the artefact types cannot easily be identified to specific function and/or are also represented in other areas of the site not likely to be affected by the proposed rehabilitation works. The sole exceptions to this rule are the remains of two ore trolley frames, lying in the creek bed near the entrance of Side Creek.

Figure 4: Trolley car frame in Storeys Creek

- * The remains of the two trolley cars in the bed of Storeys Creek should be relocated at a safe distance from the edge of the creek.
- * The tramway, machinery site remains and artefact scatter should be recorded in detail prior to the commencement of site remediation. Disturbance to these sites should be avoided in any drainage and bank stabilisation works.

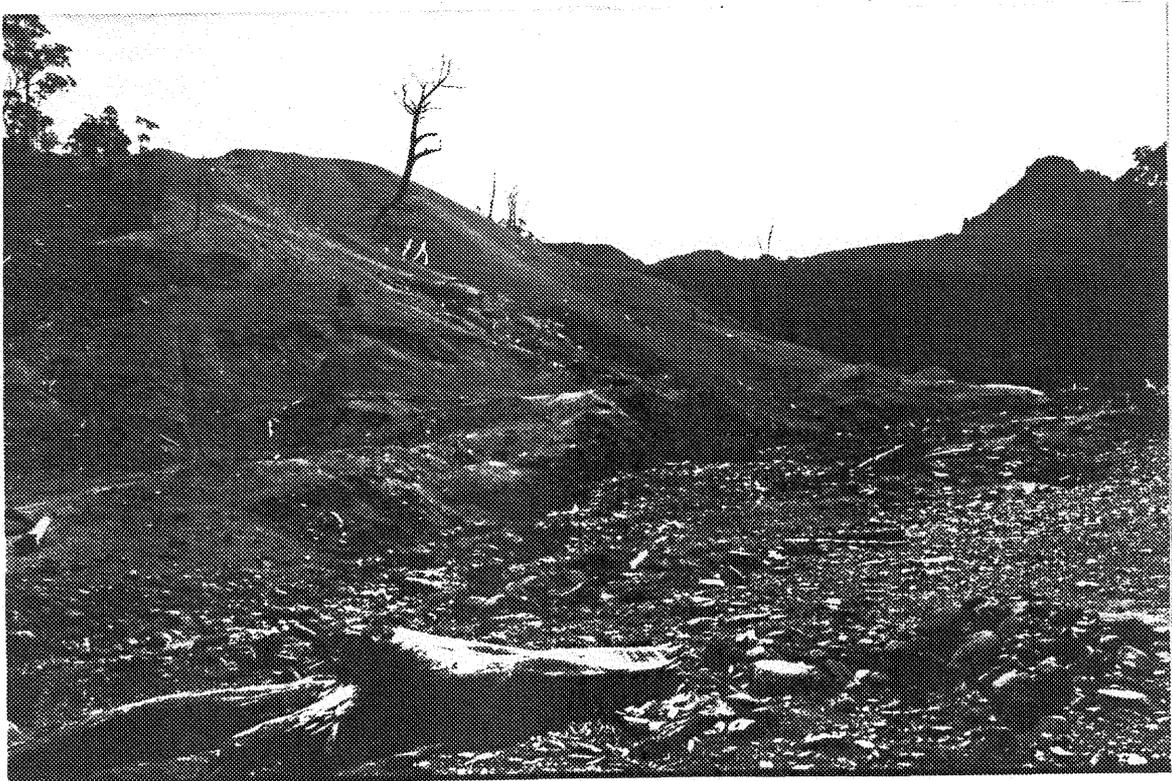
The remains of several mine openings and a machinery site, partially buried in tailings, are situated 20 to 30 metres above the level of the creek near the southern end of the tailings dump. Among the in situ features are concrete machine footings, shaft and flywheel combinations, a second standing gas producer and a large concrete water tank, laid, according to an inscription cut into the lip, in 1938. An extensive scatter of discarded machinery items including ore buckets and pipe and rail segments covers the hillside below. The precise function of the site was not determined at the time of inspection.

The mine openings, machinery site and associated artefact scatter, and tramline section around the northern perimeter of the tailings dump are all sensitive areas and warrant preservation. Further disturbance to the remaining tailings deposits on the west bank of Storeys Creek should be avoided in any creek bank stabilisation and drainage remediation attempts.

Figure 5: Machinery site and jig tailings dump, Storeys Creek mine

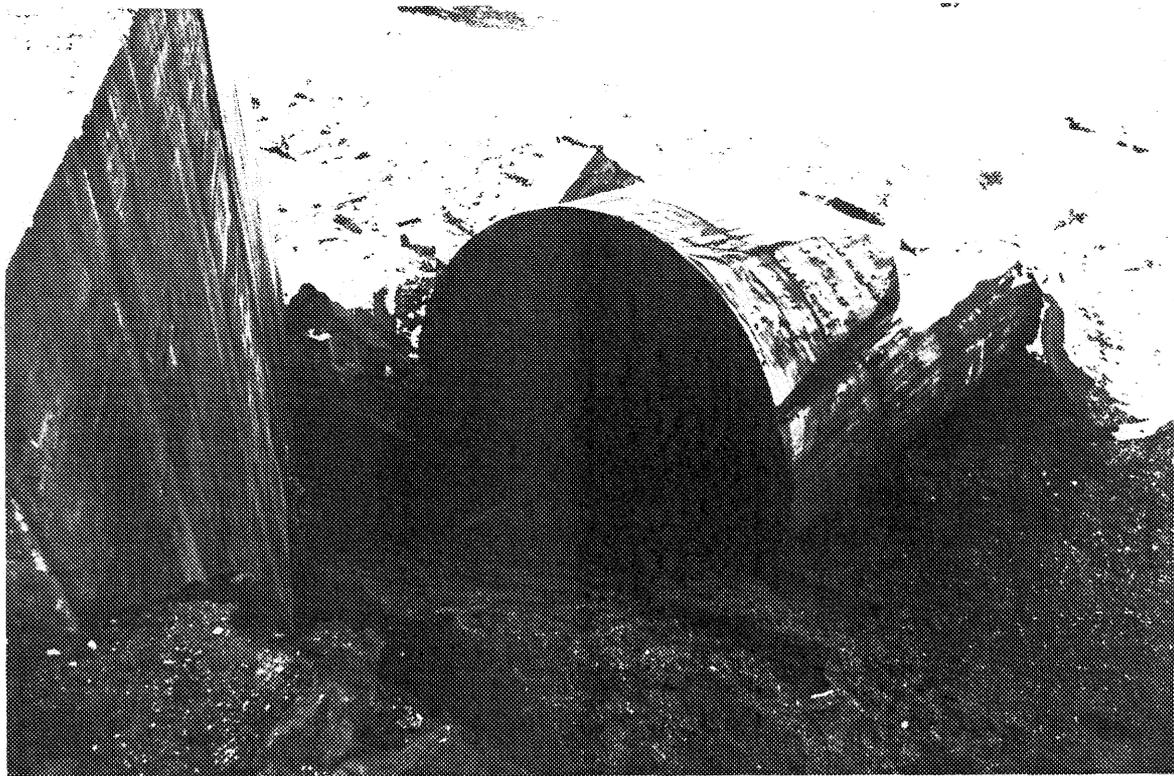
To this end the collapsed ore bin requires consideration. Whilst the structure is of significance in that it further illustrates part of the ore storage and handling process, in its current state it represents something of a hazard. The stability of the feature is not likely to improve with time.

Figure 8: Collapsed ore bin in front of loading bay, Aberfoyle mine, Rossarden

- * The loading ramp should be retained.
- * The chute steelwork in the reclaim tunnel should be repaired and made secure.
- * The excess tailings piled at the entrance to the reclaim tunnel should be removed and protective mesh fencing place at the tunnel openings to prevent access.
- * The gravel piles beneath the ore chutes should be left in their current form.
- * Protective fencing may be installed at the top of the loading ramp.
- * The collapsed ore bin may be removed.

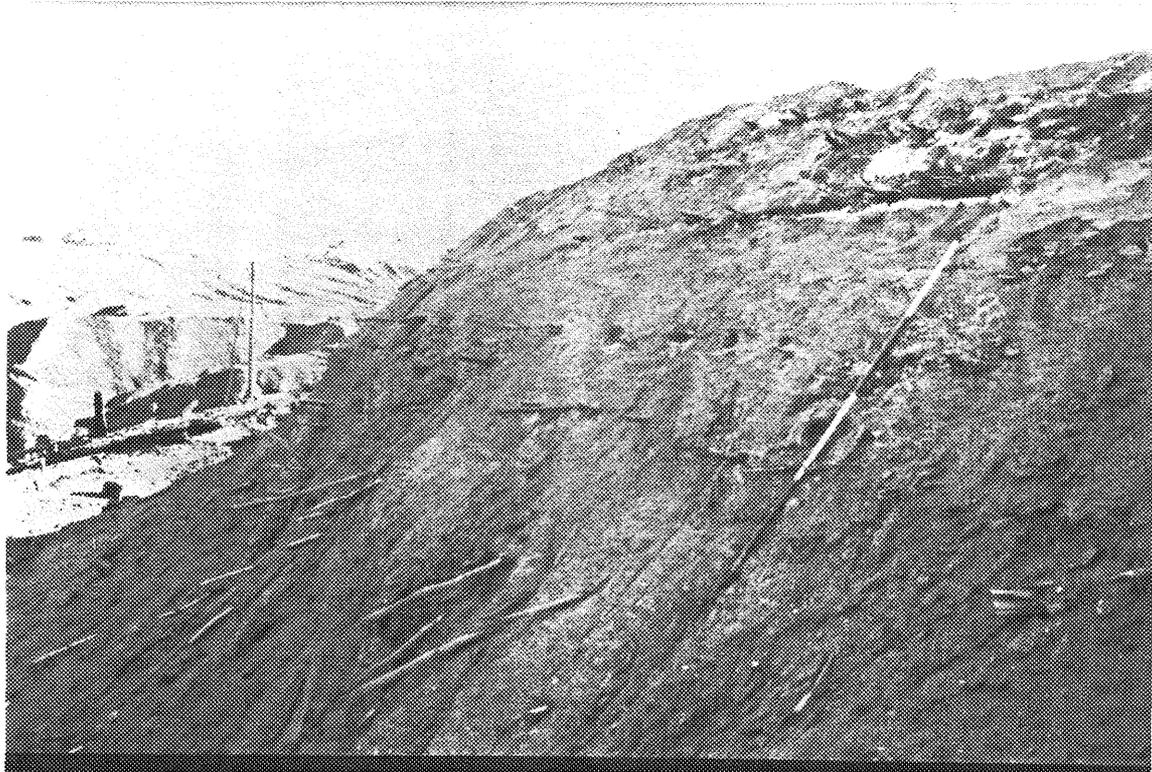
The dam is an extensive elongate area of impounded tailings, built around the contour of a steep gully above Aberfoyle Creek, and consists of at least two separate ponds of different age. The older southern pond, covering 1 ha, is constructed with a tea tree reinforced earth bund. The south, east and north walls have been formed from earth and clay, reinforced every half metre or so with mats of cut tea tree saplings. The wall is eroding badly with the loss of large amounts of tailings to the creek below. A drain has been installed running around the south and east sides however this is only a temporary measure and largely ineffectual in limiting slimes dispersal. Immediately to the west of the slimes pond, adjacent to the drain lie several sections of bucket conveyor, partially concealed by slimes. Most of the other moveable objects relating to mine operations have been collected up and deposited in scrap piles around the mine site.

Figure 9: Tea tree reinforcing in south face of No.4 slimes dam, Aberfoyle mine

- Slimes dams are a common feature on mining fields.
- The dam in question is a significant source of environmental pollution, both as a result of leaching toxins into the local waterways and through covering nearby vegetation by wind blown fines.
- Due to the low shear strength of slimes when wet, slimes deposits are extremely unstable features which have been known to collapse with tragic consequences.

For these reasons, and despite the nominal heritage value of the site, it is considered inappropriate to leave the dam in its current condition.

- * Stabilisation of the number 4 slimes dam may proceed as proposed.
- * The bucket conveyor may be extracted from its current position and replaced at an appropriate location subsequent to site rehabilitation.
