**Archaeological Survey Report
2004/01**

**An archaeological inspection
of the Silver King main shaft
area at Zeehan**

By A. E. Webster

November 2004

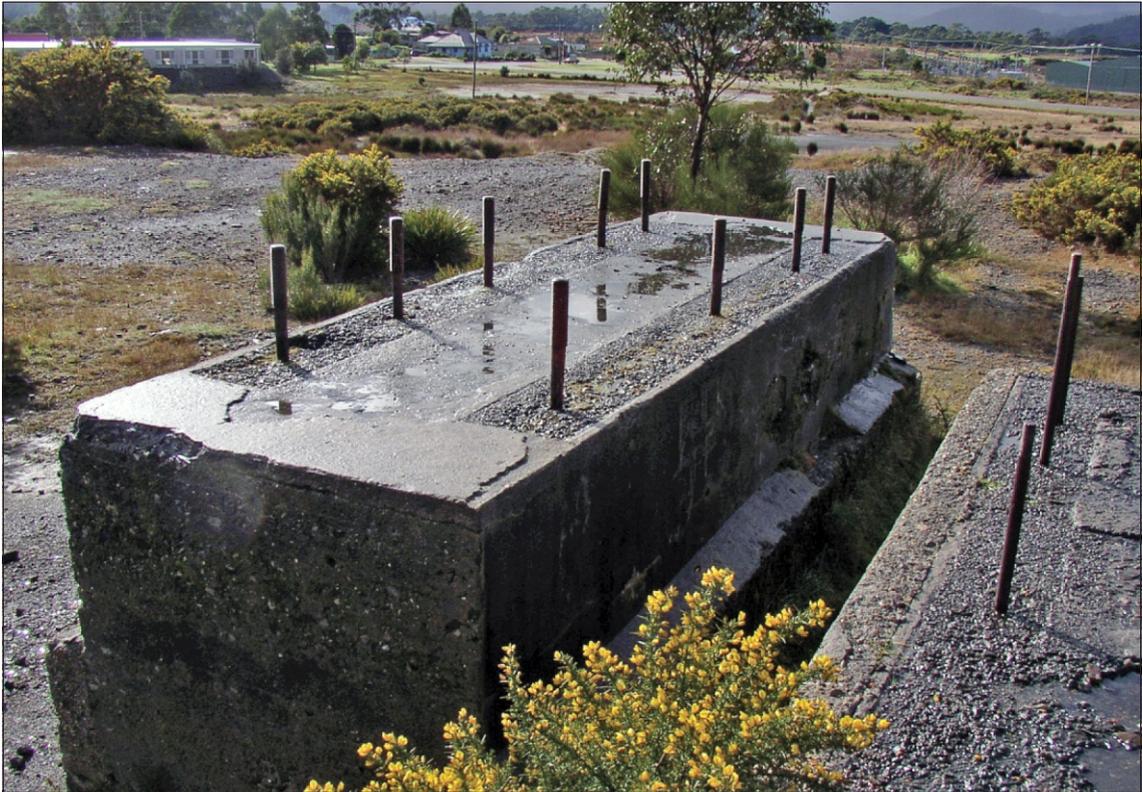
Plate 1

View of the top of the main (northern) concrete engine bed at the Silver King main shaft site. It is uncertain whether this bed mounted an engine, part of the engine, or a component of the pumping mechanism. The latter is considered most likely. Heemskirk Motel in background.

The engine beds are in very good condition and are extremely robust structures. They will require very little management. Clearing of any superficial debris in the vicinity of the engine beds, pressure receiver brick footings, concentrator footing, shaft or pump pit should be done with extreme care so that none of the remaining infrastructure is damaged.

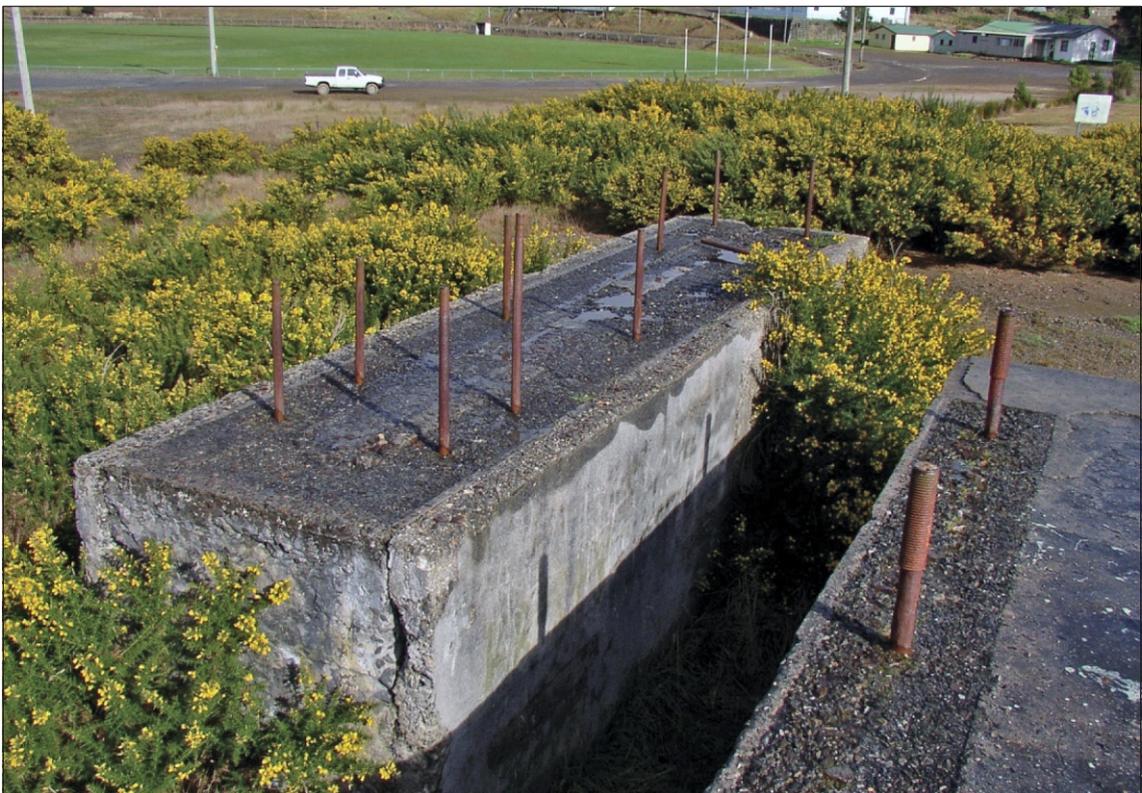
Plate 2

View of the top of the smaller (southern) concrete engine bed at the Silver King main shaft site. This bed probably formed the mounting for a single cylinder horizontal steam engine, which powered the pumping mechanism. There does not seem to be any provision for winding gear on these beds and it is possible that the shaft was used only for mine pumping in the final stages of its life.

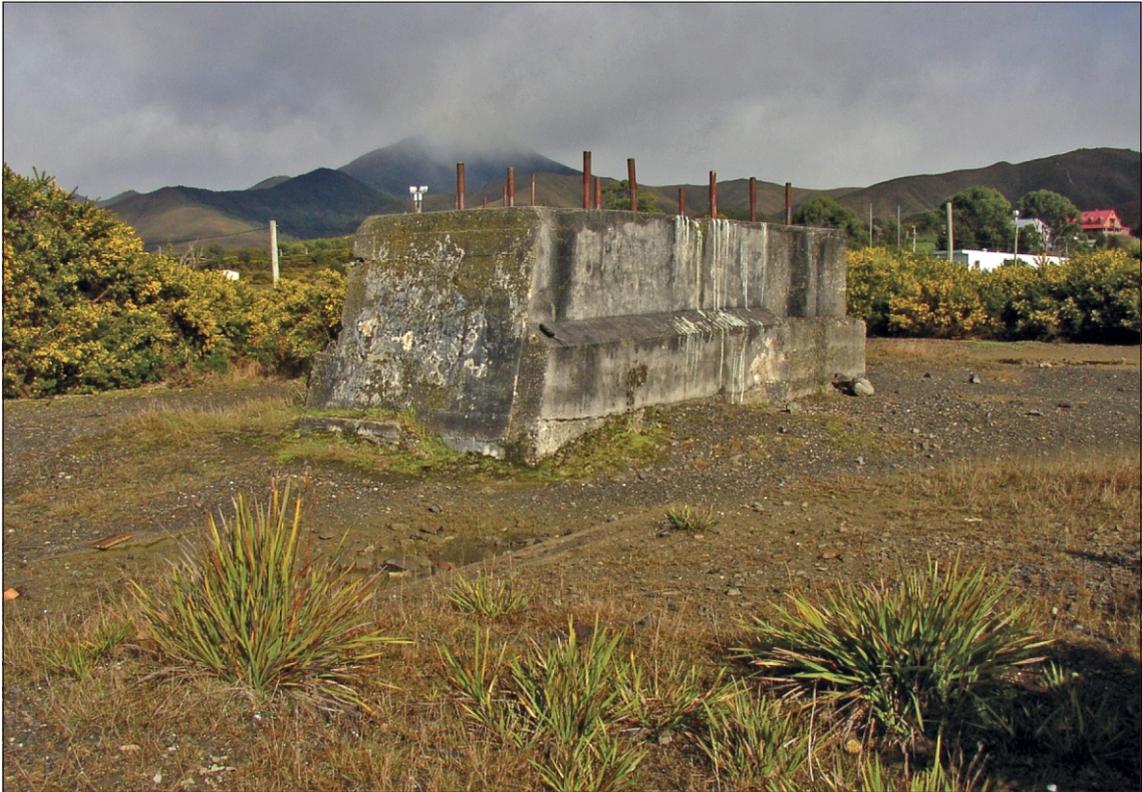
Plate 3

*The main concrete engine bed at the Silver King main shaft. The backfilled, concrete-lined balance beam pit is immediately in front of the bed. The shaft collar is to the left of view.
Note the engine mounting bolts in the top of the bed.*

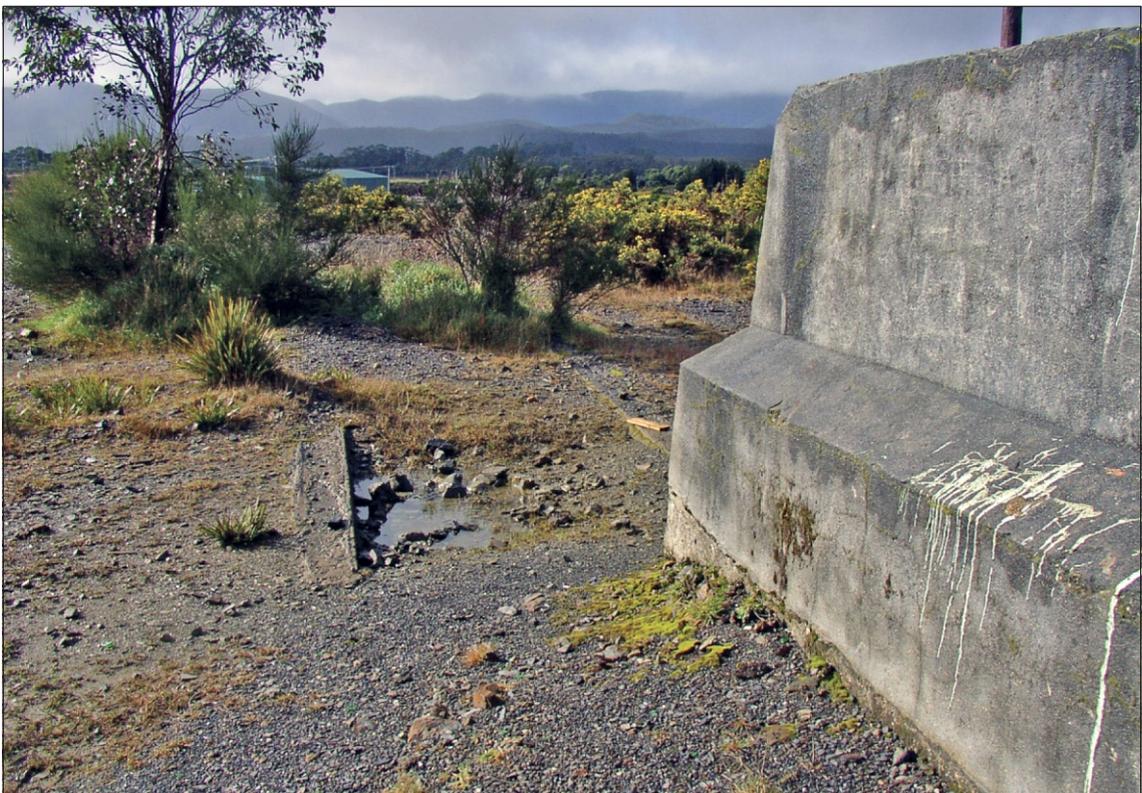
Plate 4

The shaft collar is located in the clump of scrub in the middle ground. The backfilled, concrete-lined balance beam pit is immediately in front of the engine bed.

The shaft is back filled, through slumping, and may not be secure at depth. Fencing should be considered.

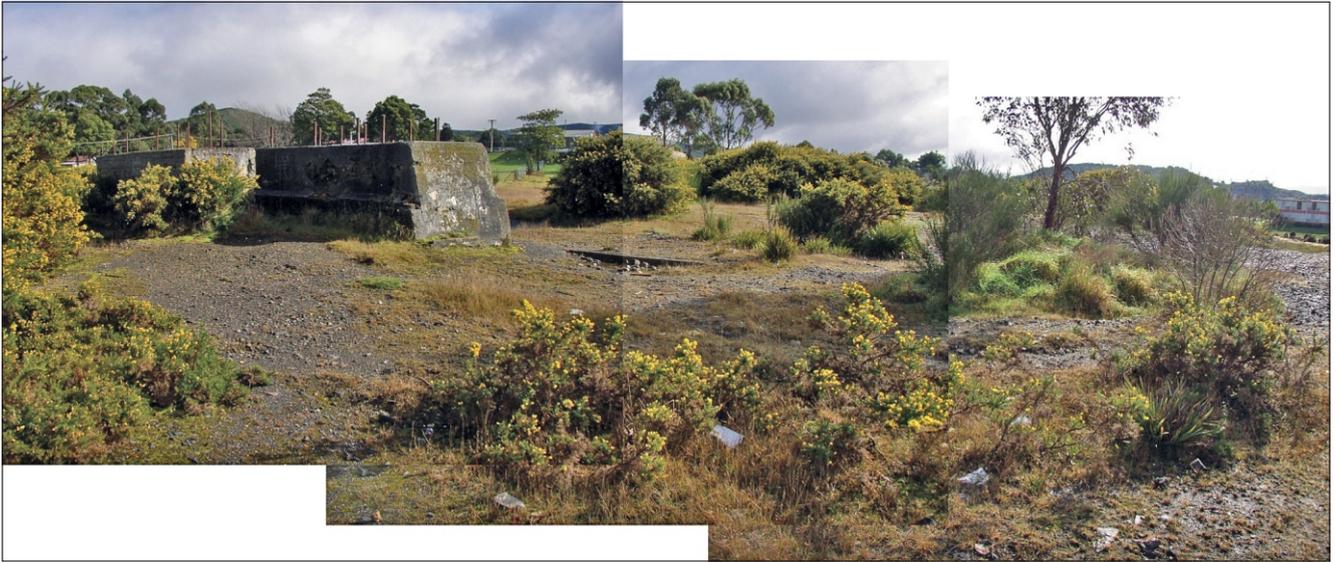
Plate 5

Panorama view of the Silver King main shaft site from the southeast, showing the engine beds (left), backfilled pump beam pit (centre) and the shaft collar (shallow scrubby depression on right). The concentrator site is located in the patchy gorse in the right rear.

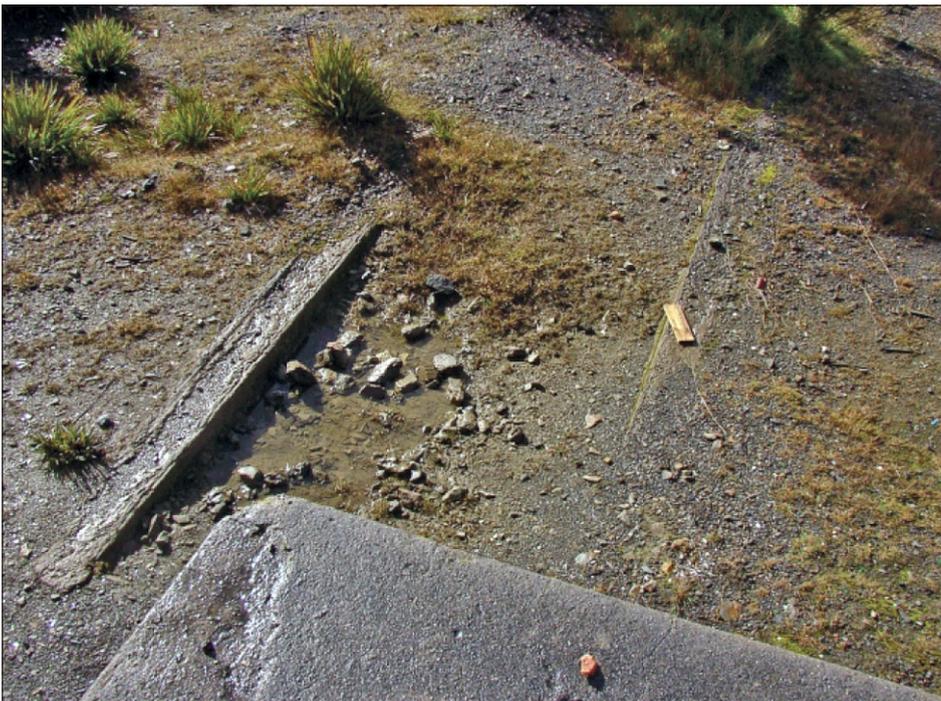
Plate 6

The backfilled, concrete-lined balance beam pit immediately in front of the northern engine bed. This view is taken from on top of the engine bed, looking down.

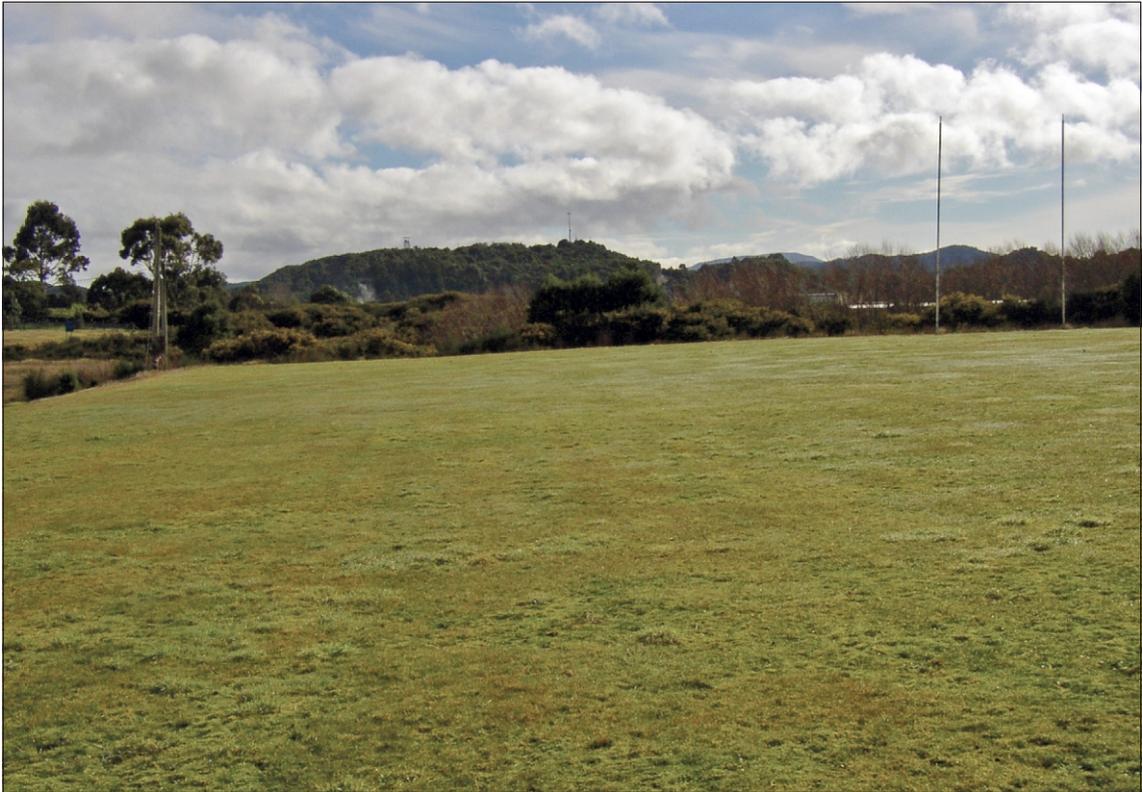
Plate 7

Despite these impacts, there are still enough remnants of the historic infrastructure to relate the current landforms to that of the original mining landscape when the mine was operating (fig. 2; plates 7-10). The removal of the waste dump and tailings material has returned the site to a condition that differs little from that seen in photographs held by the Zeehan Museum depicting the mine in c. 1897 and c. 1900, so the removal of this material has affected the heritage value of the site less than it otherwise may have done (plates 7-10).

View of the Silver King mine site taken from the rugby pitch located to the south of the site (looking approximately north). This view is taken from approximately the same location as Plate 8).

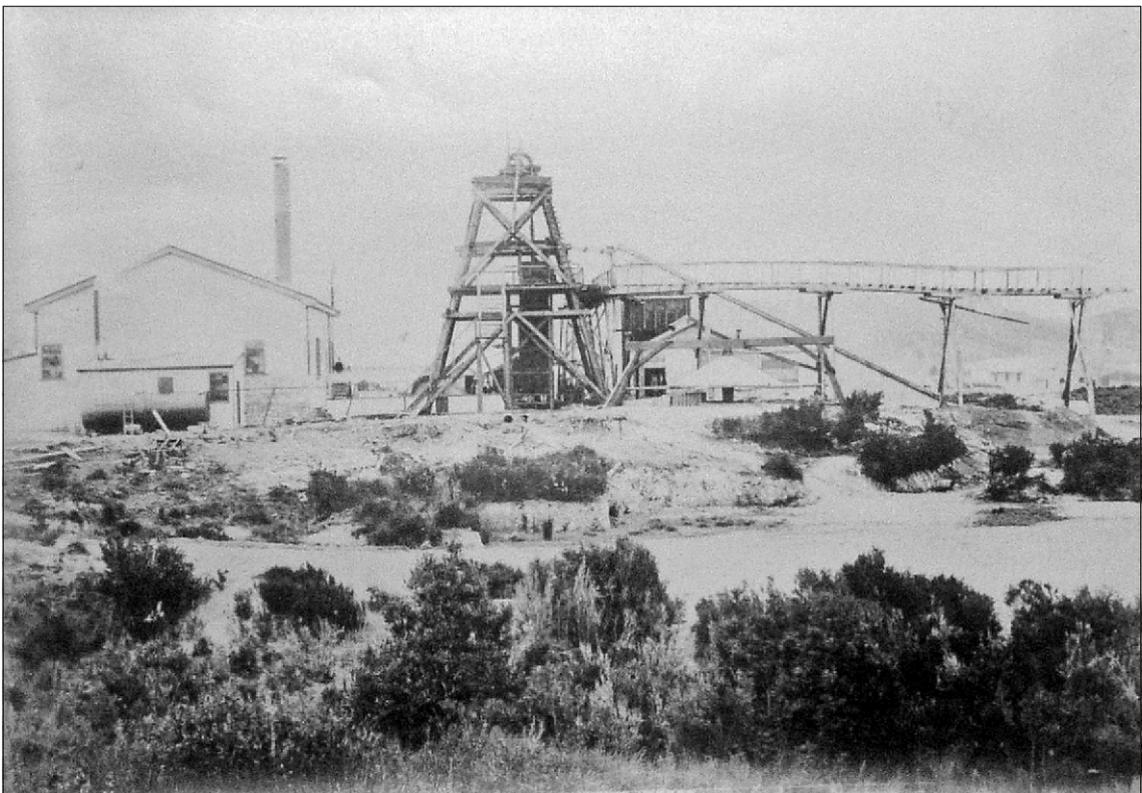
Plate 8

View of the Silver King mine surface infrastructure showing the head frame, mullock tip trestle and winder/boiler house. This view is taken from approximately the same position as Plate 7. Note the concentrator hopper behind the head frame.

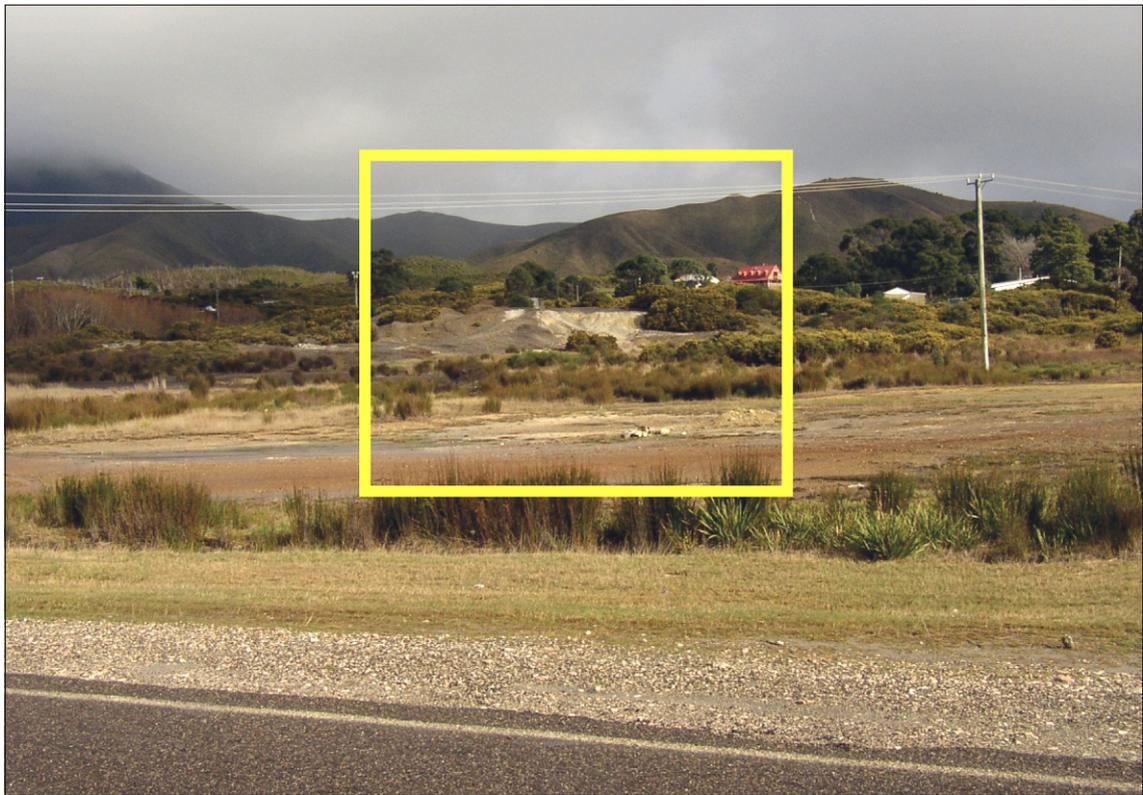
Plate 9

Panorama of the Silver King mine site, taken from near the intersection of the Zeehan Highway and Henty Road. The site lies to the southwest of this intersection. The view approximates that seen in the historic photo shown in Plate 10. The yellow square outlines the approximate location of Plate 10.

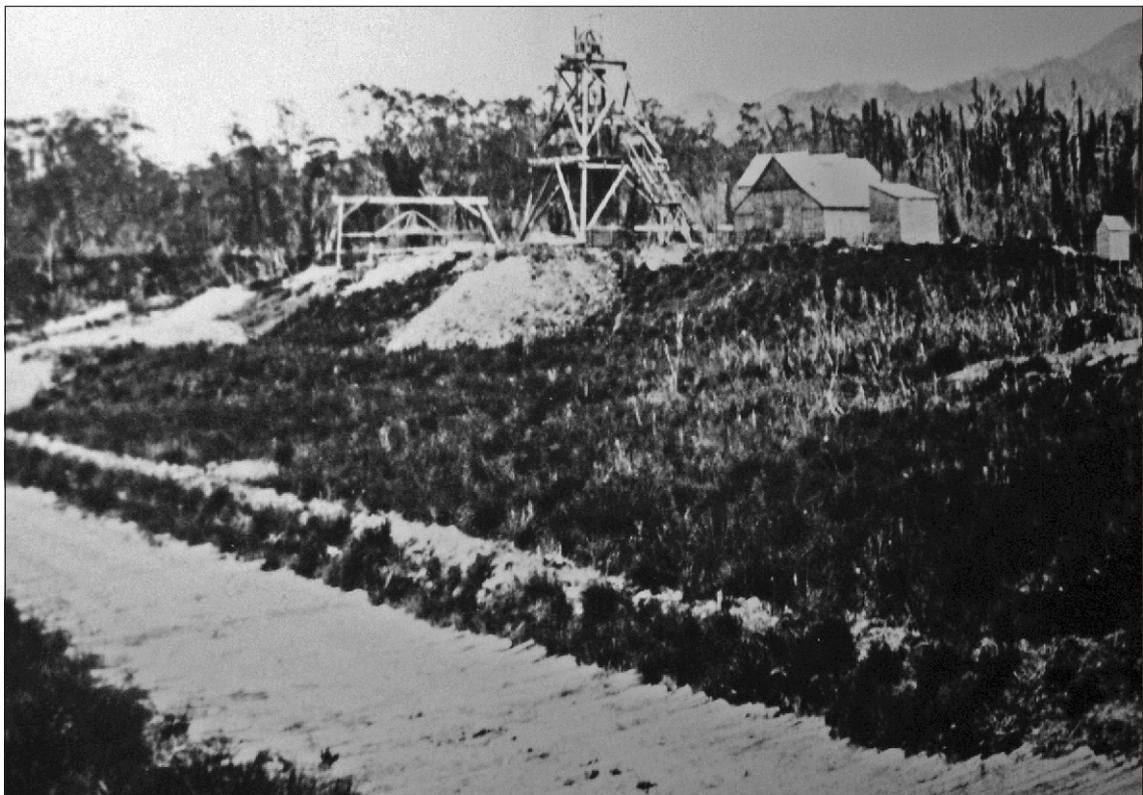
Plate 10

The area of jig tailings in the low wet area on the eastern side of the site has been heavily modified by a number of subsequent developments. A 1960's era football ground was once in place adjacent to the Strahan (Henty) Road (David Lane, pers. comm., July 2003). This is now long gone and there is little evidence remaining. The local council has removed gravel over many years, and there have been various drains and other water management works that have been carried out across the tailings flat. These works were probably to improve the drainage of this low-lying area, which seems to have always been a wet area (there is a corded road to the mine site seen in the 1897 photo, Plate 10).

Historic photo of the Silver King mine, taken from a road located in the low flat and swampy area that is now occupied by jig tailings. Note the corded road. The yellow square on Plate 9 outlines the approximate location of this photo. The face of the low bank has since been modified during mullock dump quarrying.

There is little heritage value remaining in this area and clay capping, drainage works and the development of wetland areas can go ahead. However, wet areas such as this have a high potential to preserve organic materials such as wood, so care should be taken during all excavation works to identify any heritage features (such as remains of the corded road) that may be exposed.

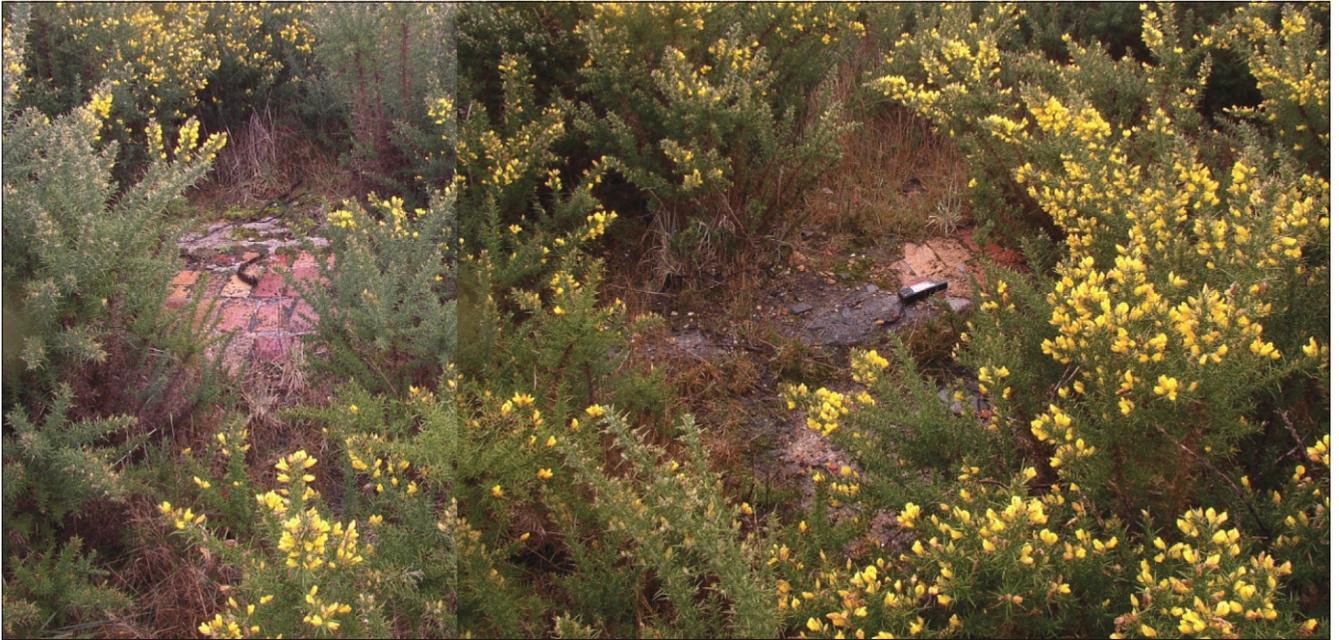
Plate 11

Remains of infrastructure features lie beneath the gorse and broom infestations. The ground-level brick base of at least one boiler (or pressure receiver) lies adjacent to the southern side of the pumping engine beds (almost completely overgrown with gorse). This type of feature, mostly covered in gorse, is likely to be uncovered in any place where weed infestations are removed. Special care must be taken to avoid damage of features that may be exposed as weeds are removed by machinery. All weed removal should be closely supervised by someone with archaeological training.

Brick footings of boiler, or possibly the pressure receiver of the steam plant of the Silver King Main shaft site. The brick footings lie at the base of the southern engine bed and are largely obscured by gorse.

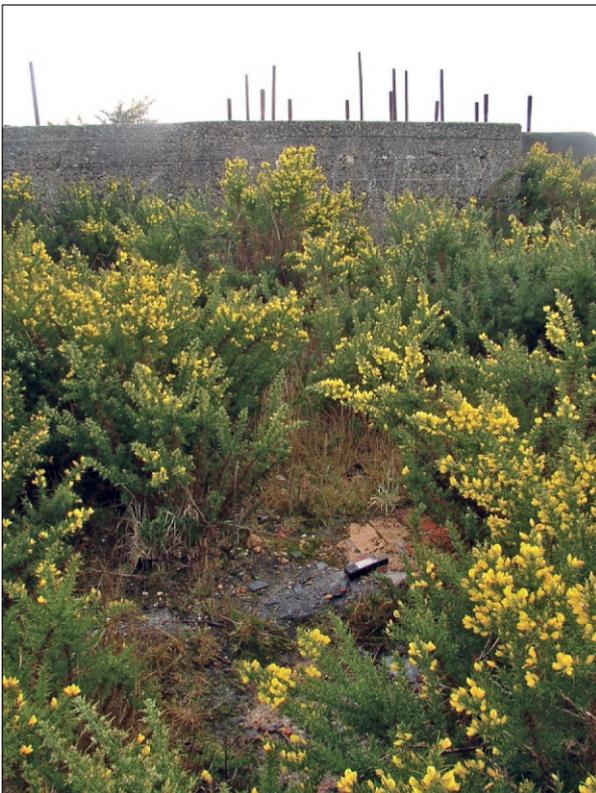
Plate 12

View looking north showing the relationship between the brick footings of a boiler (or possible pressure receiver) of the steam plant of the Silver King Main shaft site. The brick footings lie at the base of the southern engine bed and are largely obscured by gorse. The Magellan GPS receiver in the centre of the view is approximately 170 mm long.
