## **Kingborough Council**

Report for Technical Review for  
Taroona Landslide

Risk Assessment & Mitigation  
Stage 1

March 2012

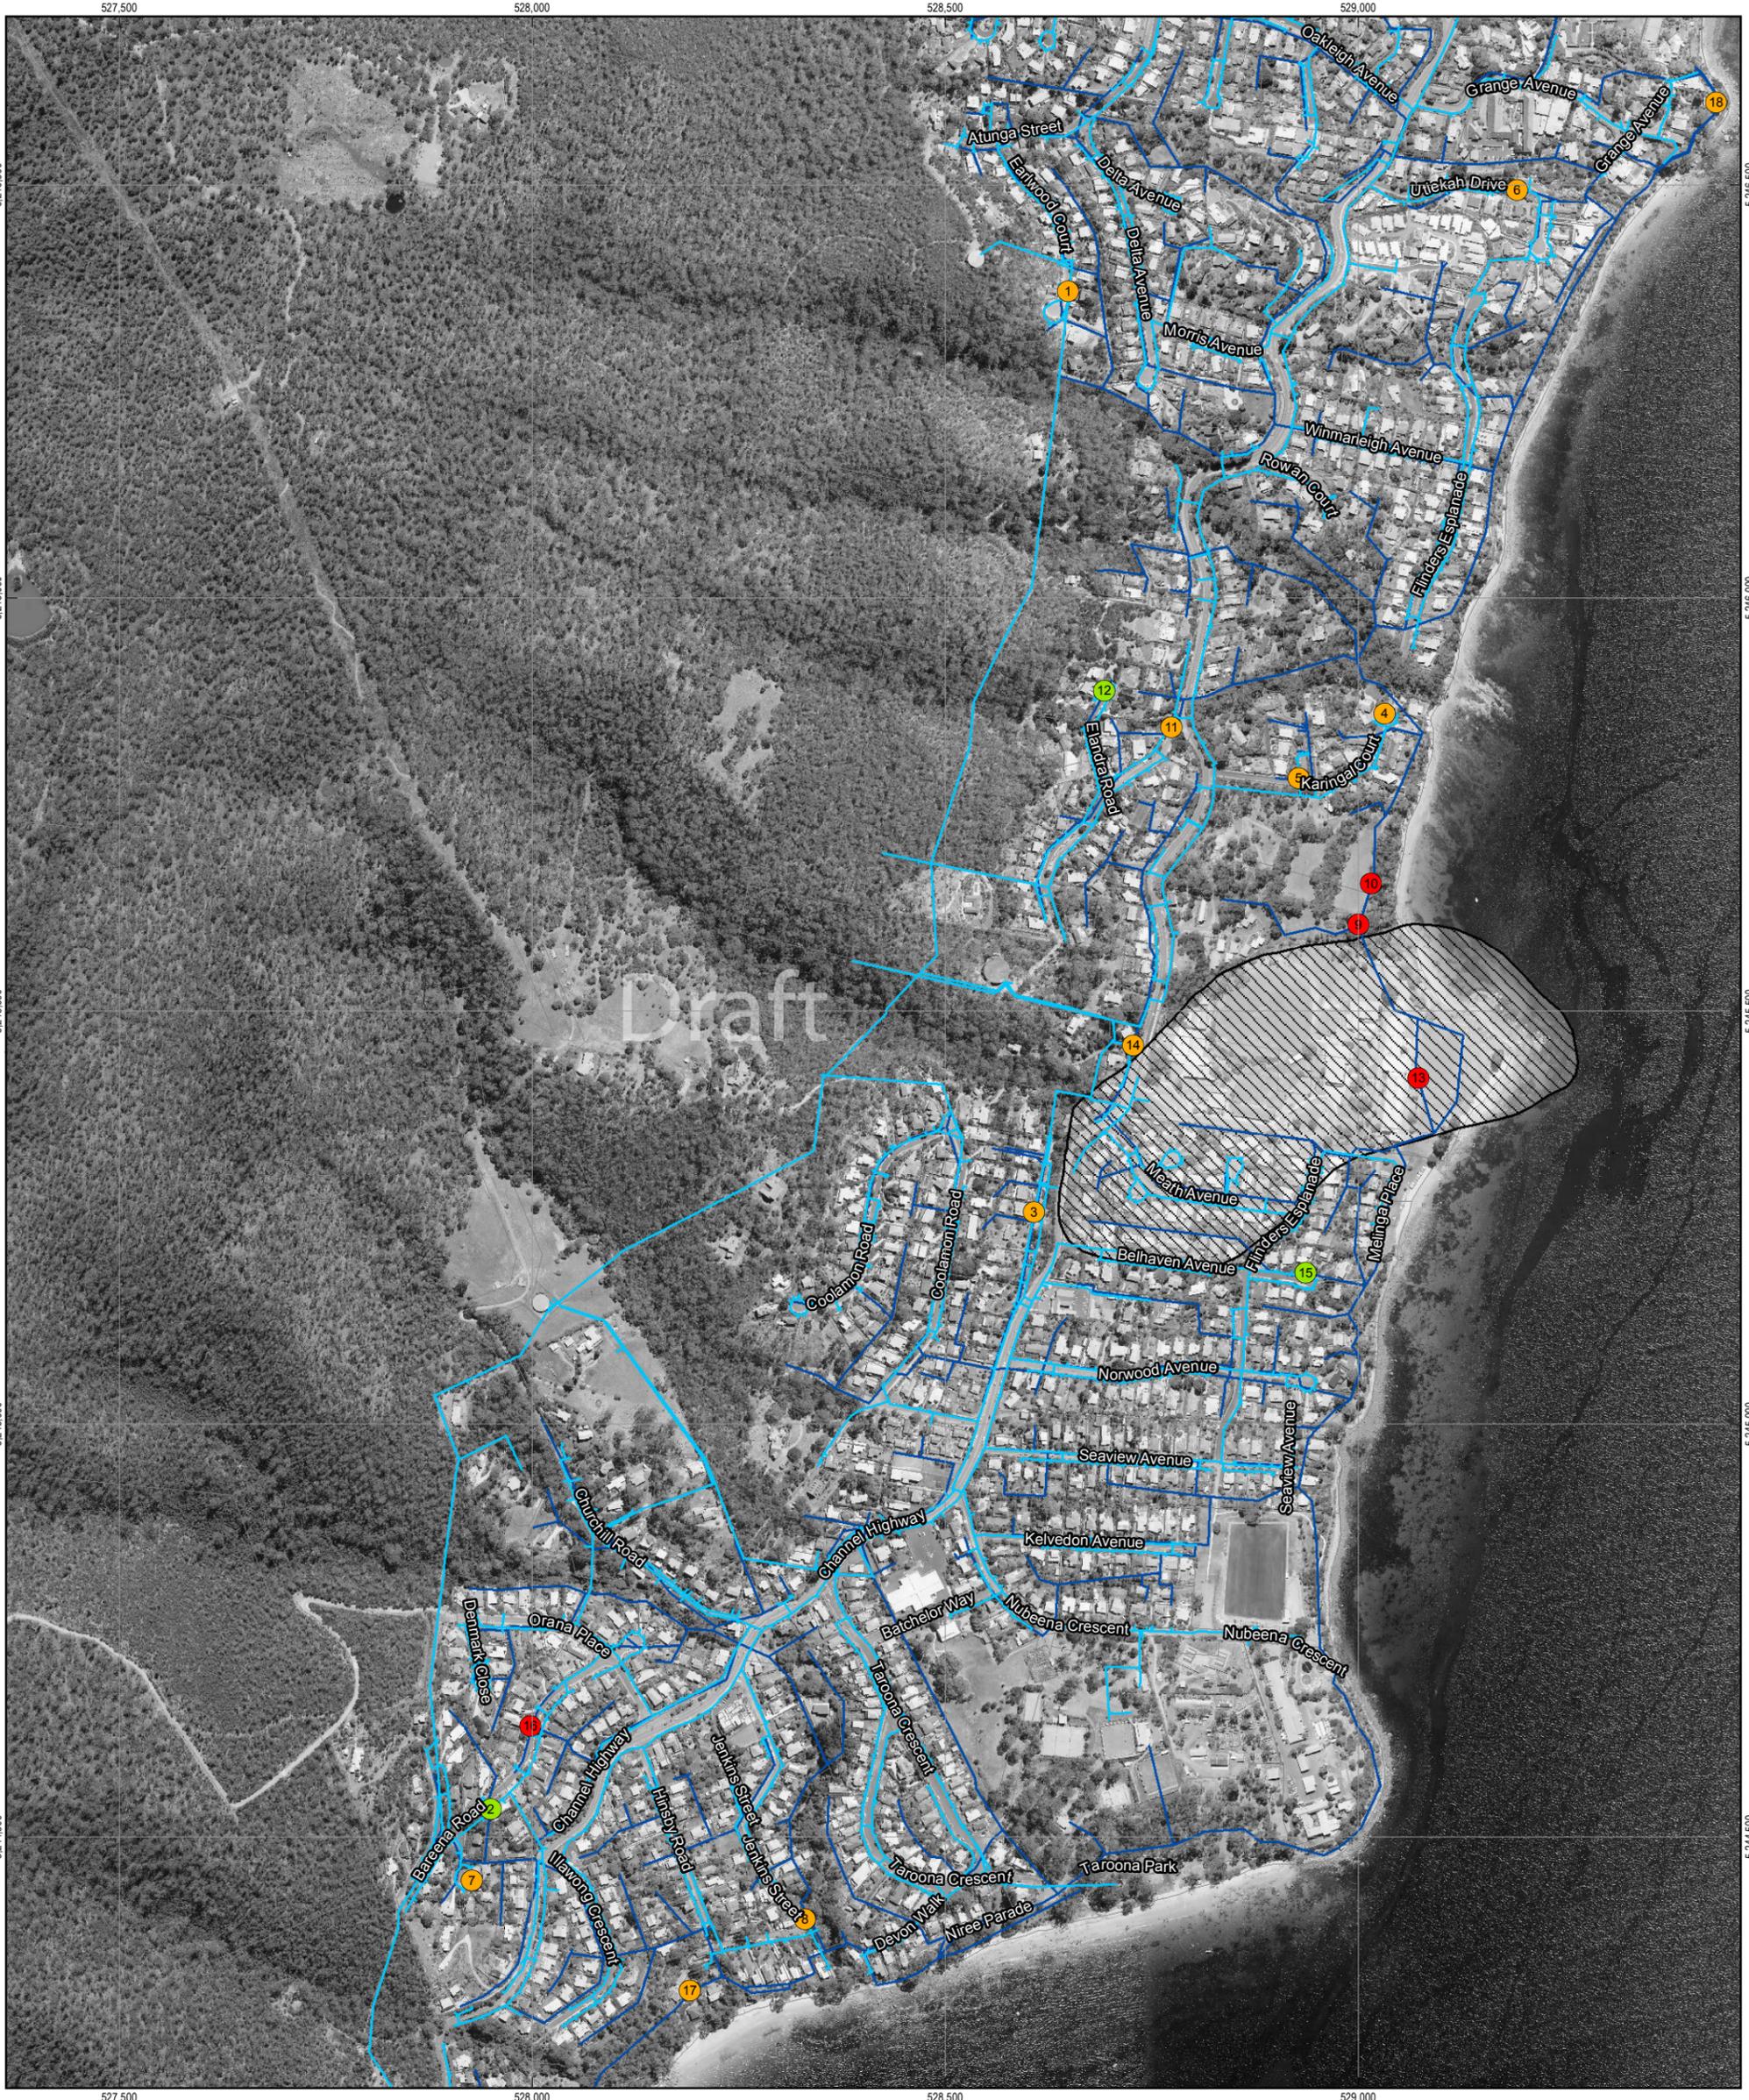
Appendix D  
Damage to Southern Water Assets

Discussions were held with Steve James of Southern Water regarding sewer assets. Steve recalled significant breakages that could be attributed to potential ground movement. Information included approximate location, approximate date, nature of break, composition and diameter of pipe, approximate depth and ground condition. Steve's work extended back to 1980. Significant uncertainty is noted with this anecdotal evidence. This information has been incorporated into the damages database (refer to Appendix D for plot of damage points).

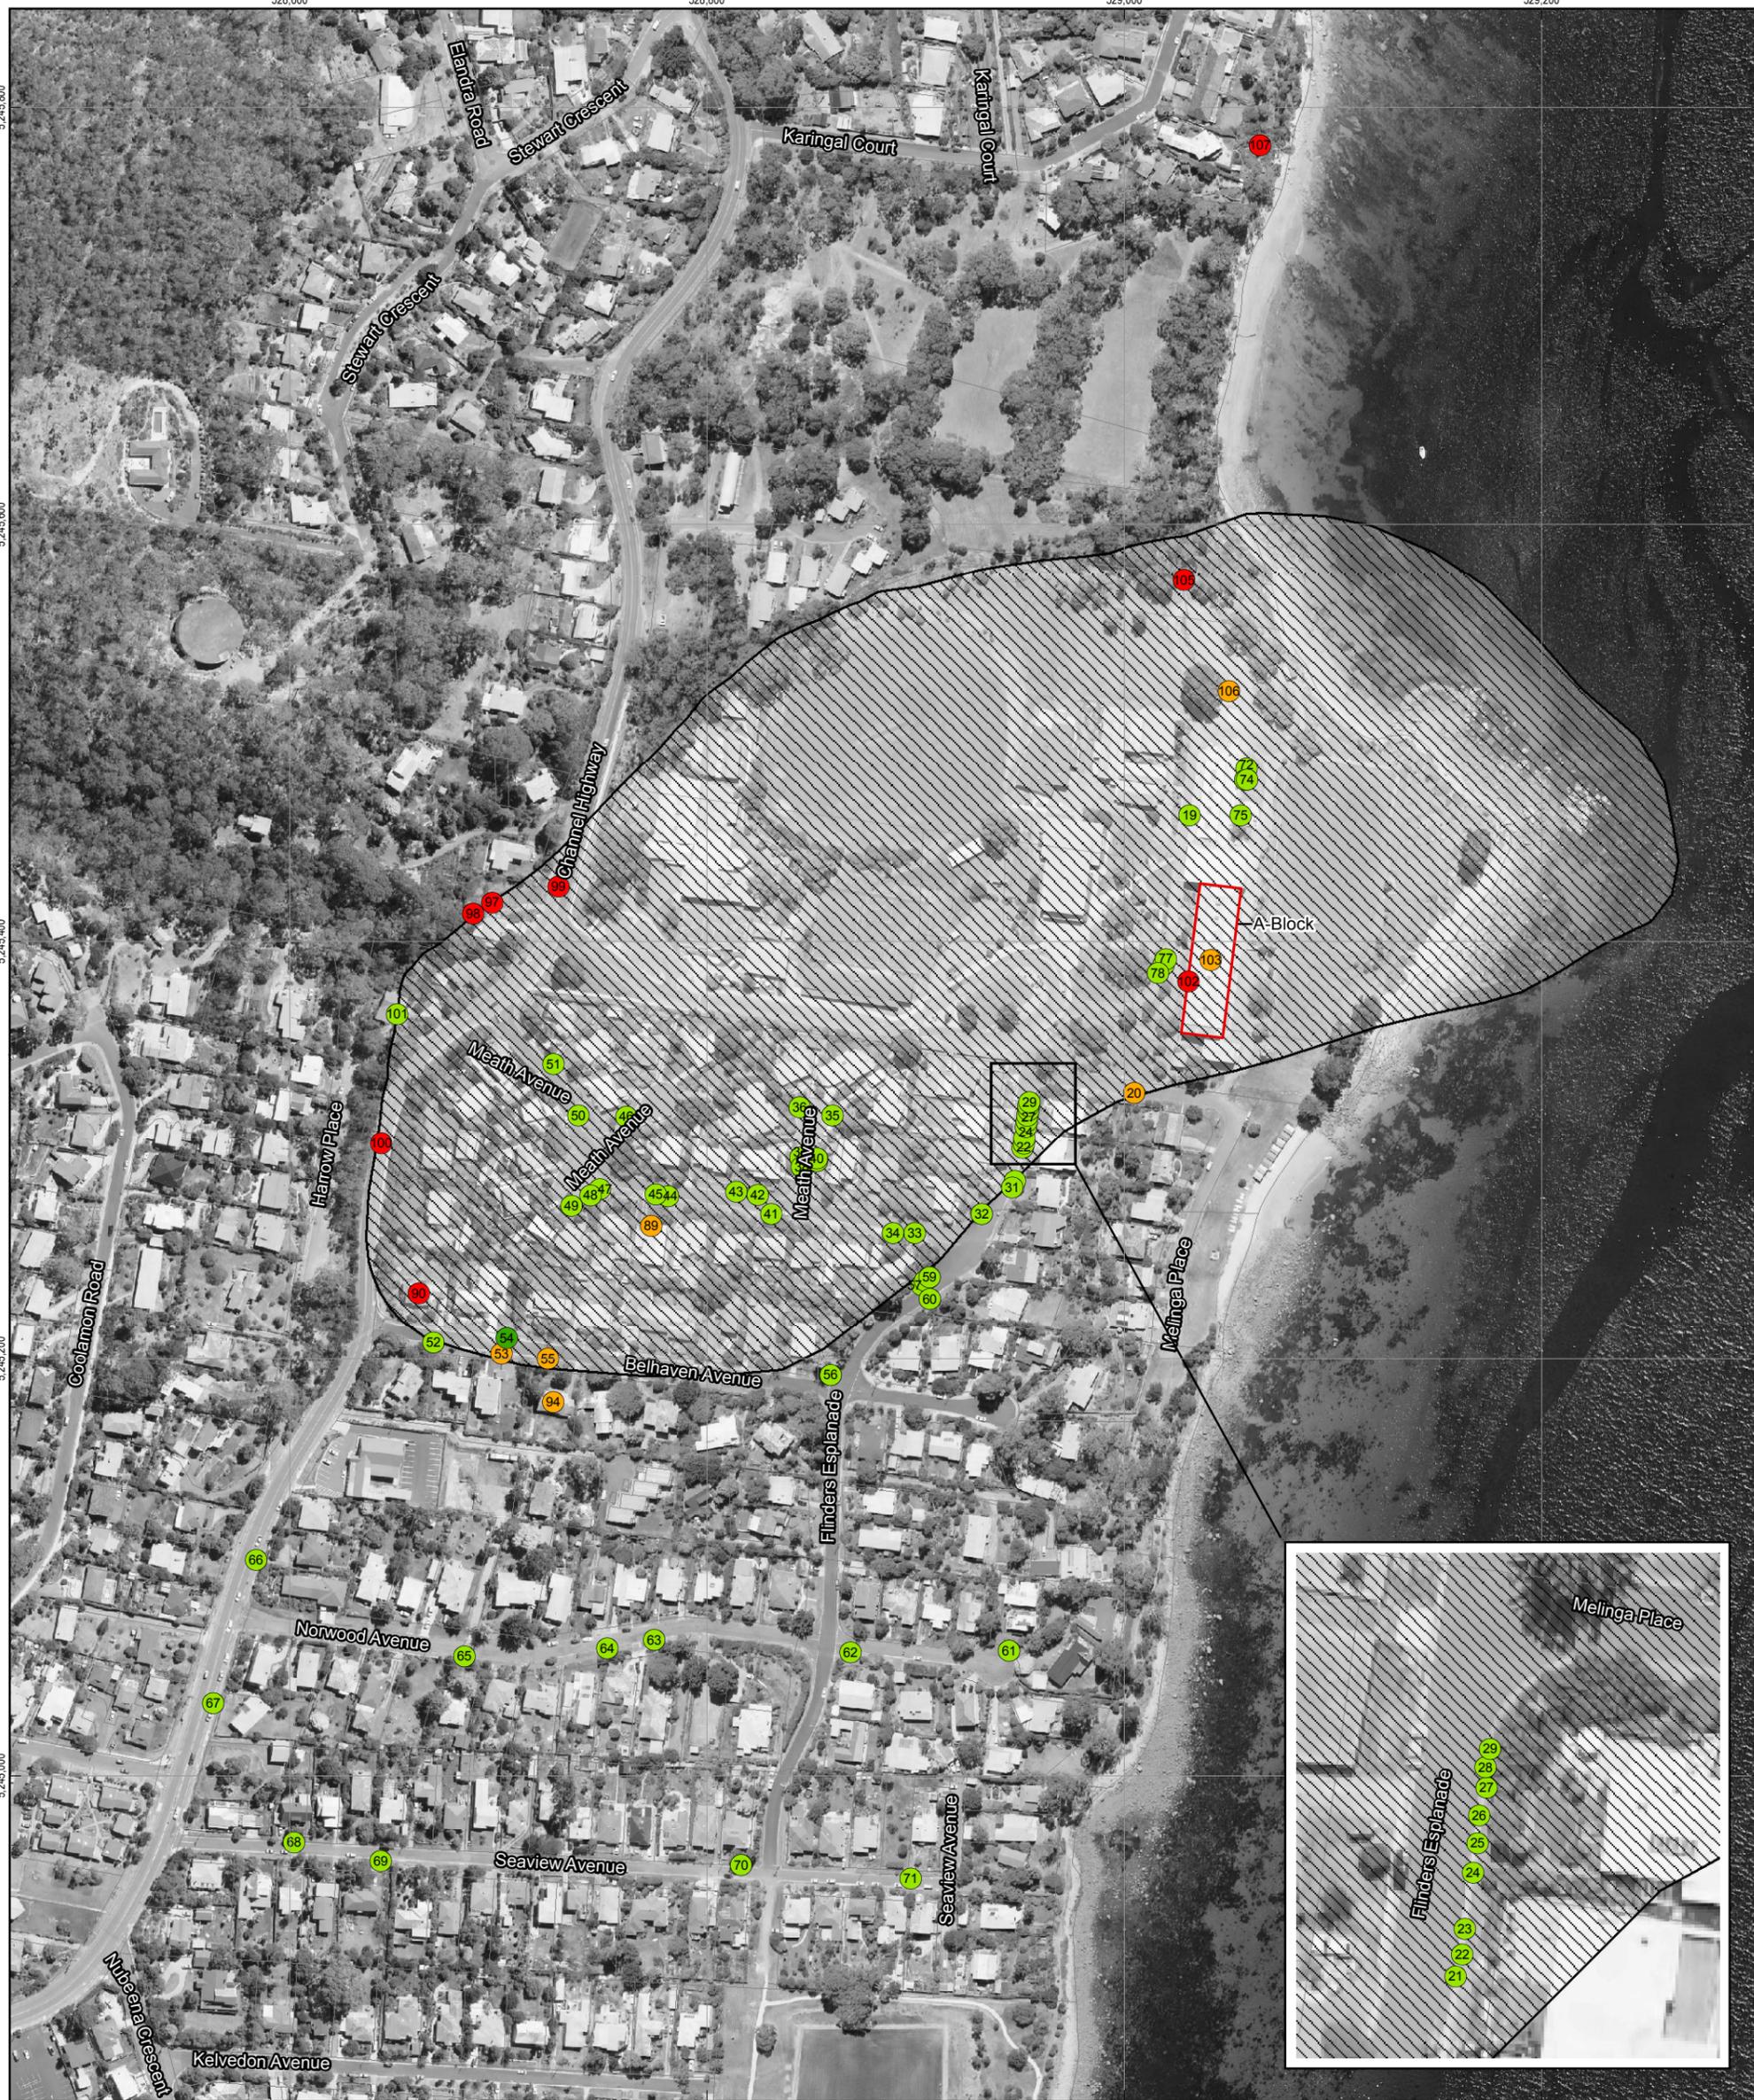
# Damage to Buildings and Surface Structures - North

A survey of surface damage to roads, footpaths and kerbs was conducted within the landslide zone by GHD and MRT on the 14th June 2011 (refer to Appendix F for plot of damage points). This survey identified damage attributed to movement of the underlying ground, although it was not clear whether this was related to landslide movement or reactive soils. Damage included cracking of retaining walls, footpaths, roads, kerbs and gutters, and also displacement in joints between sections of kerb and gutter. The nature and magnitude of the displacement was recorded, along with locations and photographic logs. This information has been incorporated into the damages database. It should be noted that the thresholds established to decide whether surface damage was recorded were subjective.

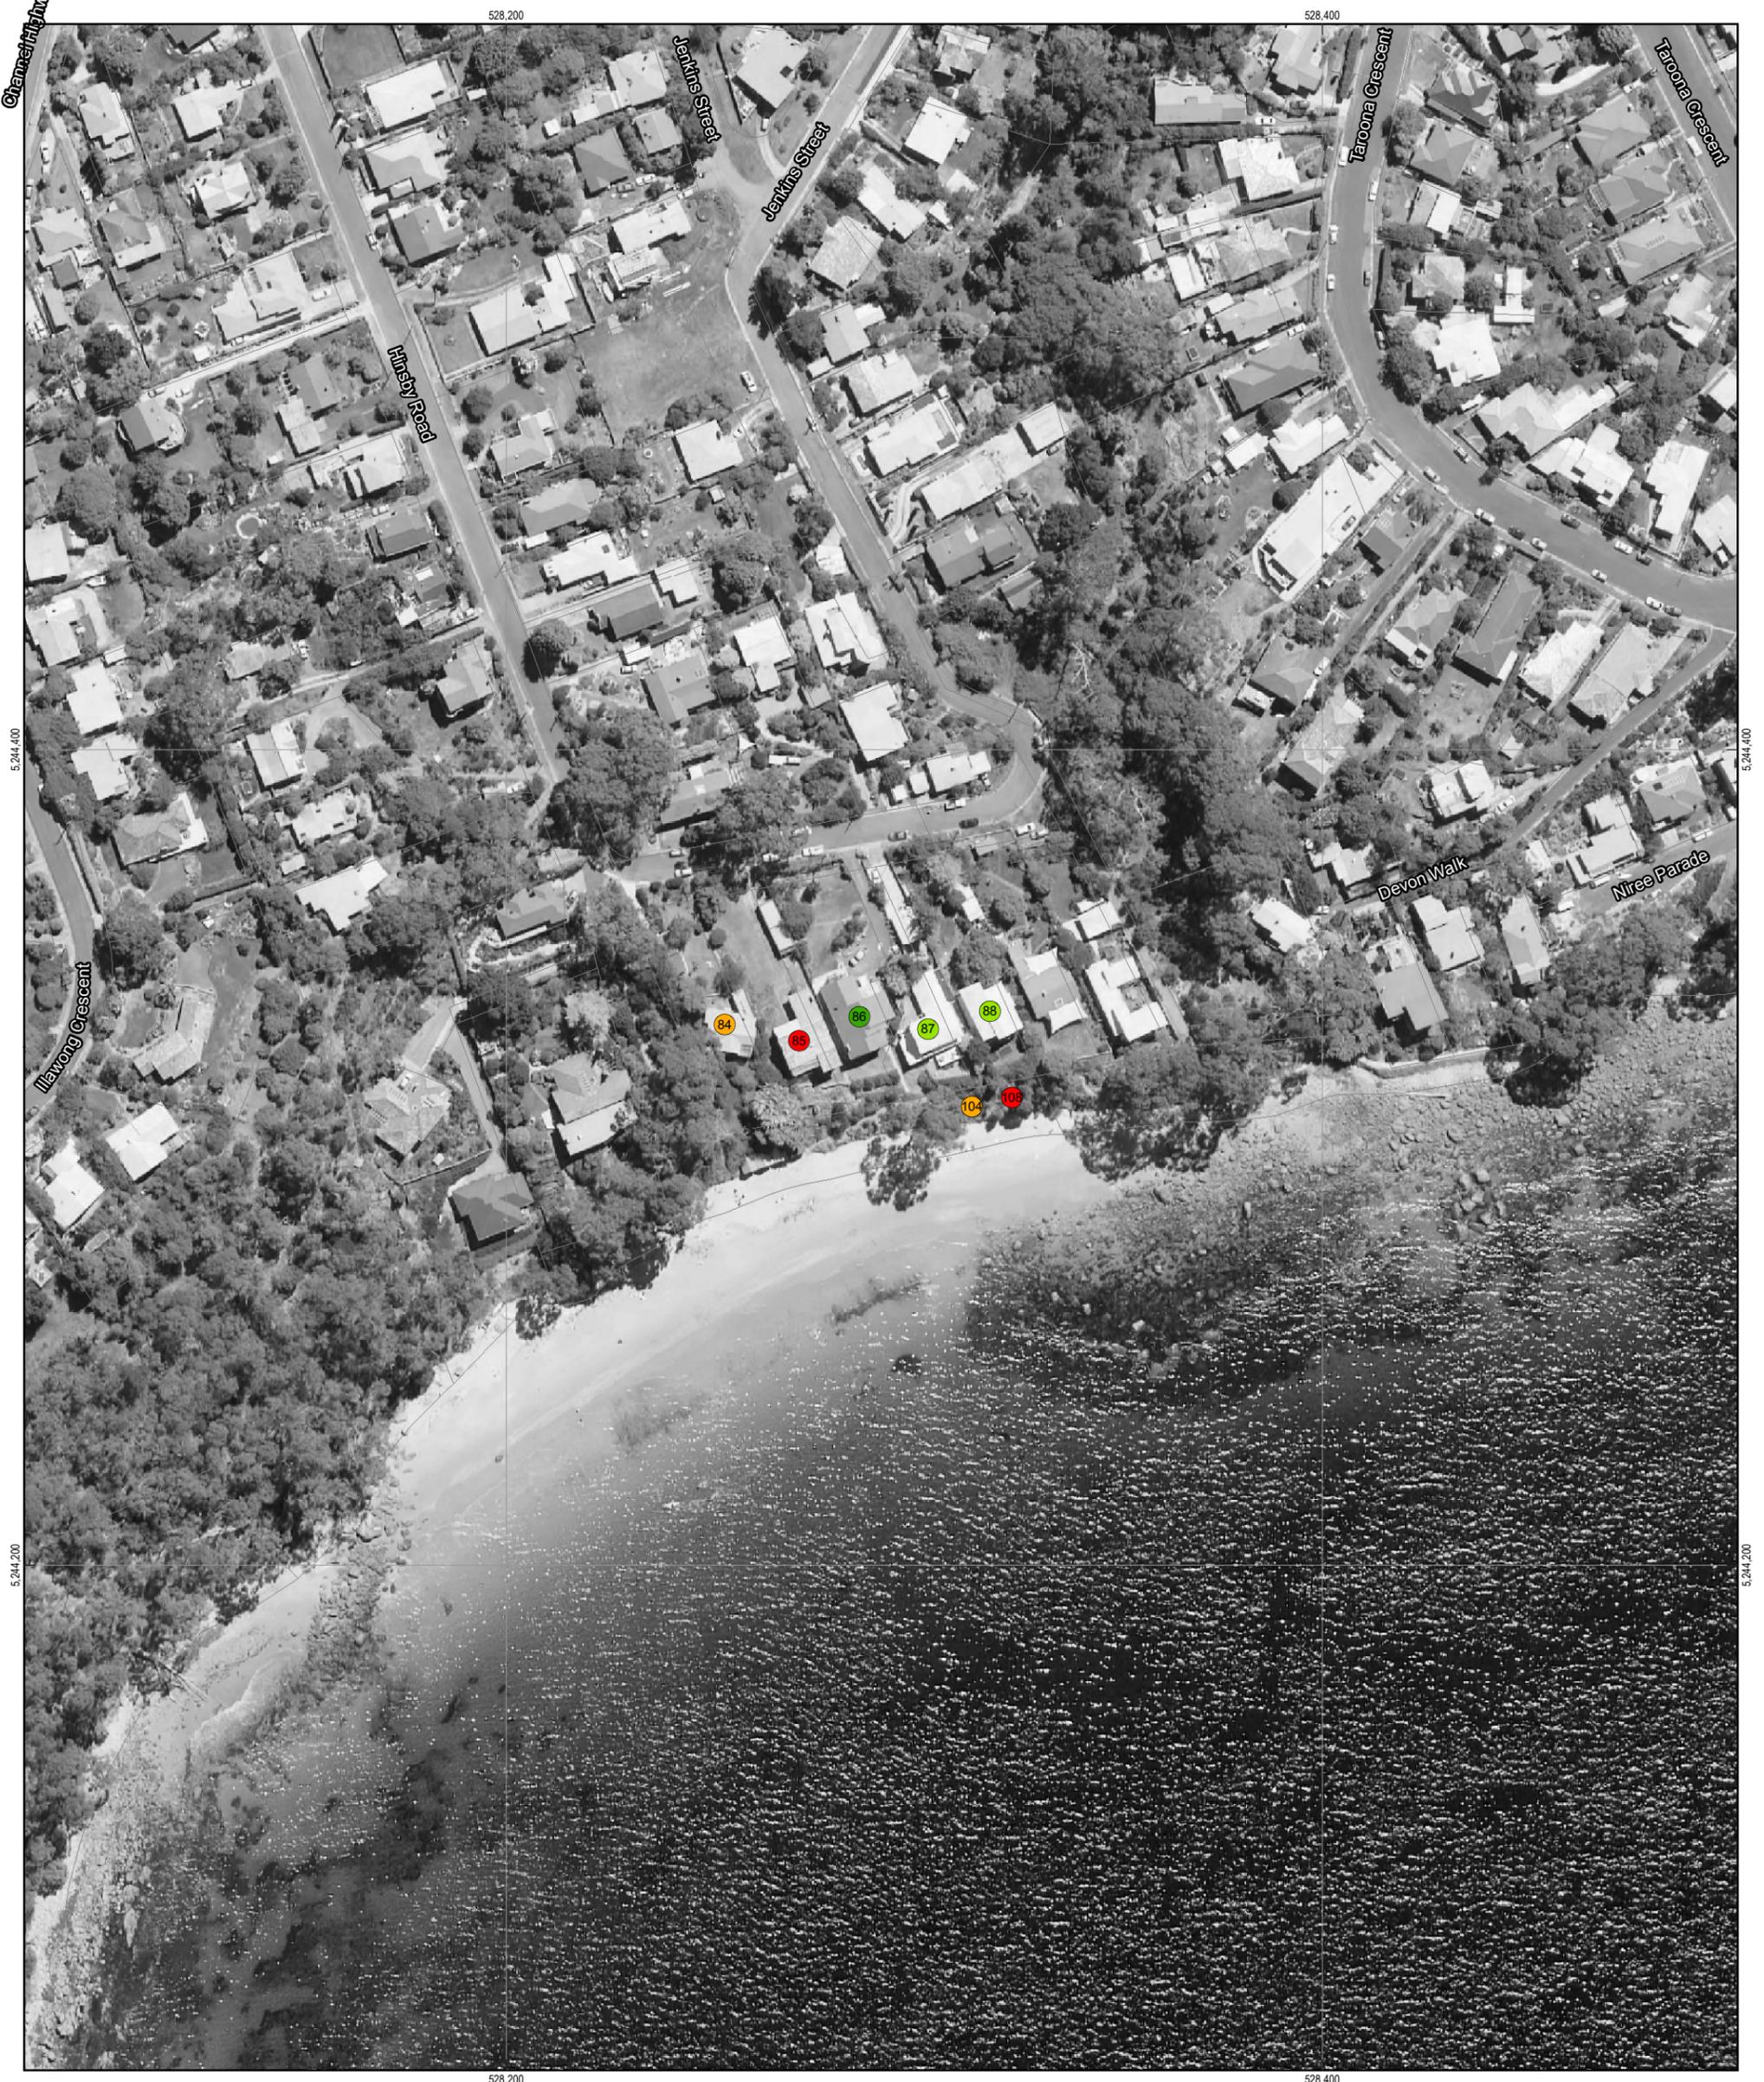
# Damage to Buildings and Surface Structures – South

Documents provided by MRT were reviewed in detail by GHD and all references to damage have been incorporated into the damages database. These primarily revealed damage to residential houses, the Channel Highway and associated underground infrastructure (refer to Appendix E, Appendix F and Appendix G for plot of damage points).
