Kingborough Council

Taroona Landslide Area

"The History, Current Understanding of Risks and Proposed Management of the School Creek Landslide and Surrounds"

September 2014

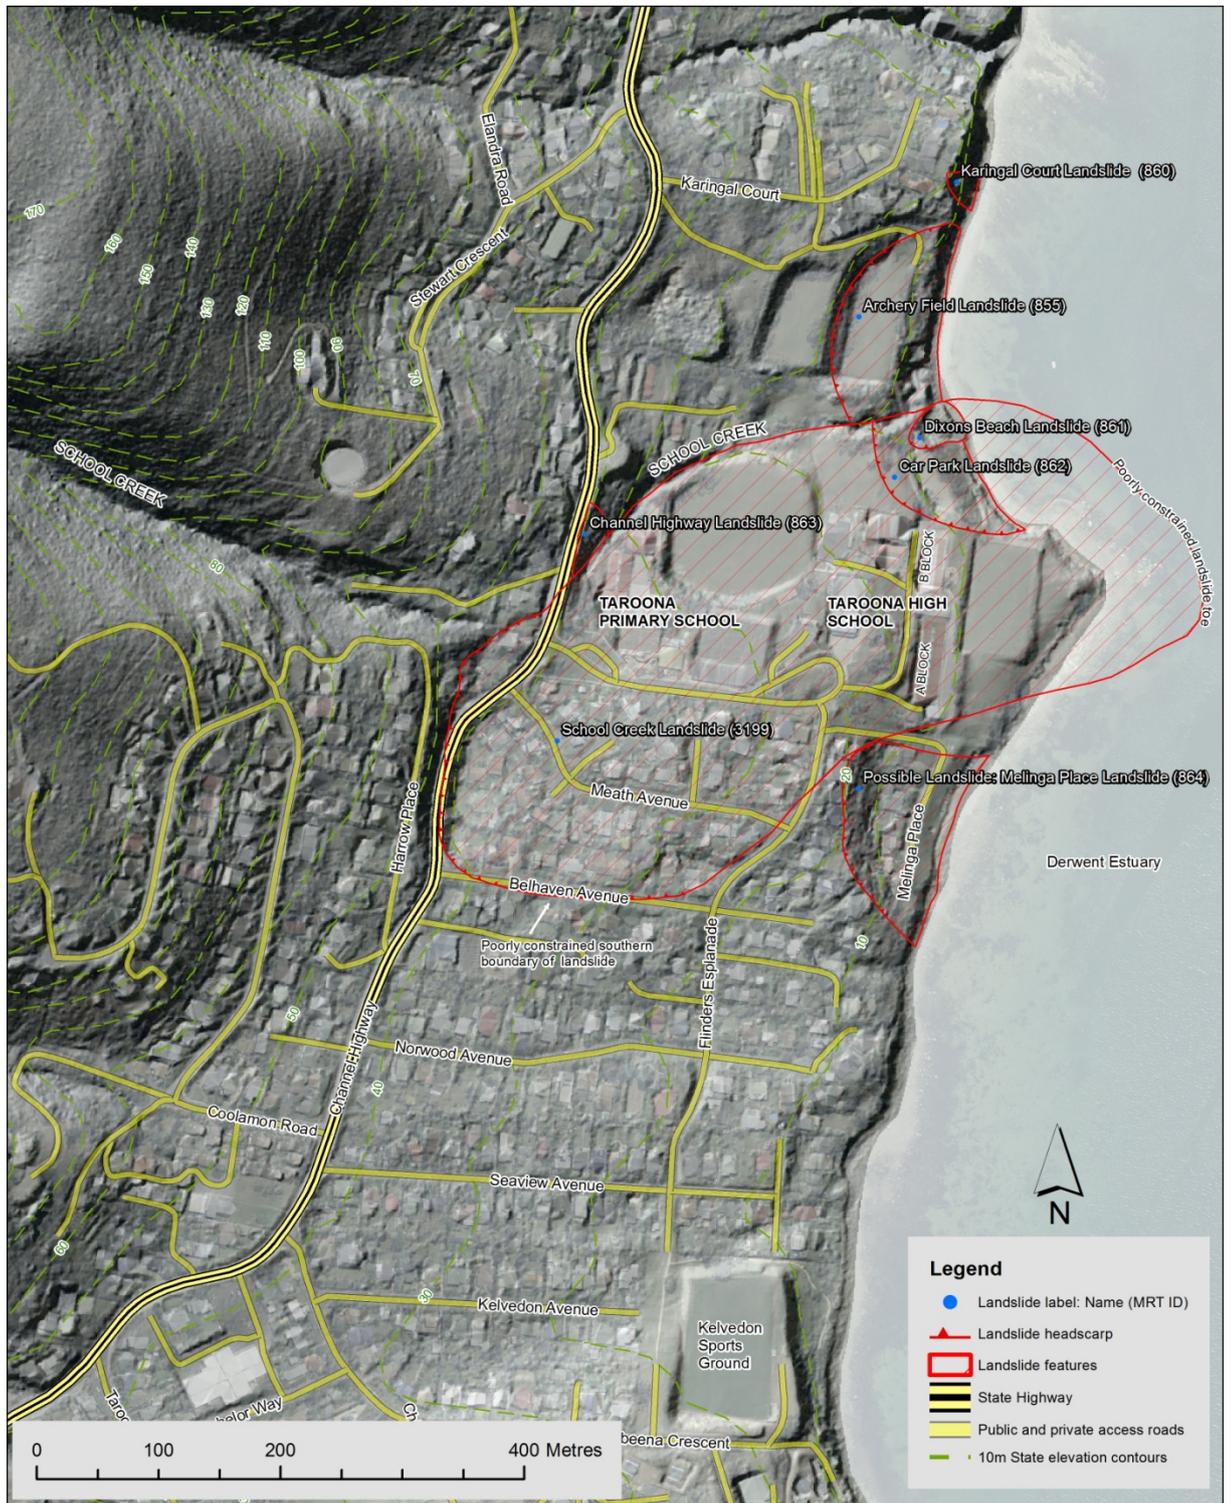
Figure 1 General plan of the landslides at Taroom

There are several relatively small active coastal landslides that have been known since the 1970's (namely the **Archery Field, Car Park and Dixons Beach Landslides**) that have a relatively clear expression on the landscape Figure 1. There are currently no buildings on these features.

Subsidence and damage along the Channel Highway, centred about 100m north of the intersection of the school driveway has been ongoing for several decades. This feature, here named the **Channel Highway Landslide** (Figure 1), is considered to be a small landslide and is probably related to failure of the embankment fill.

There is a much larger feature - the **School Creek Landslide**, in the vicinity of the two schools and south to Belhaven Avenue (Figure 1) which is an active landslide. This feature is not obvious on the landscape. It had been known for many years that buildings in the general area have required periodic structural repairs, much of it attributable to poor foundation construction on highly reactive soil. However, the continuing program of repairs to a section of the Channel Highway adjacent to the Tarooma Primary School appear to have prompted more critical investigation of land instability in the mid 1970's by the then Department of Main Roads. This resulted in a large landslide hypothesis (Moon and McDowell 2002) that has been subsequently refined by various parties. In hindsight direct evidence of contemporary movement of the School Creek Landslide dates back to the beginning of aerial photography in the State (mid 1940's).

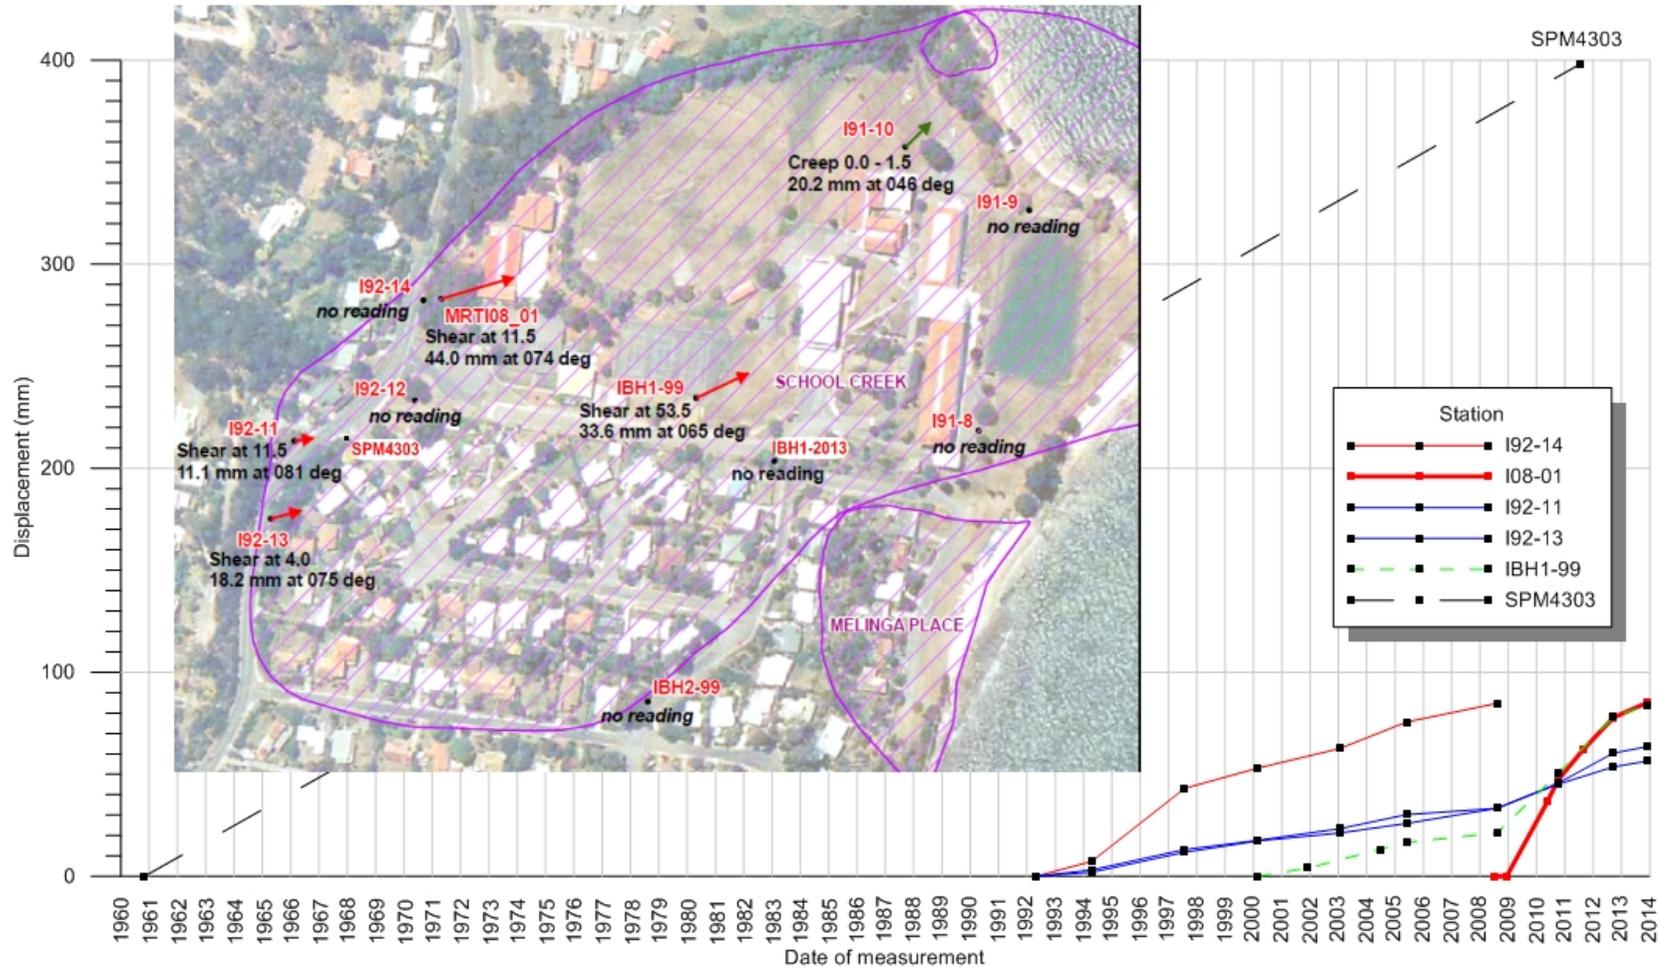
Note: vectors on map are measured from 2010 and are not total displacements (source AS Miner Geotechnical 2013)

Figure 2 Displacement versus time plot of inclinometers and a single survey mark within the School Creek Landslide. The inset plan shows the location of the instruments and movement vectors since 2010.

It is recommended that manual inclinometer readings be carried out annually.

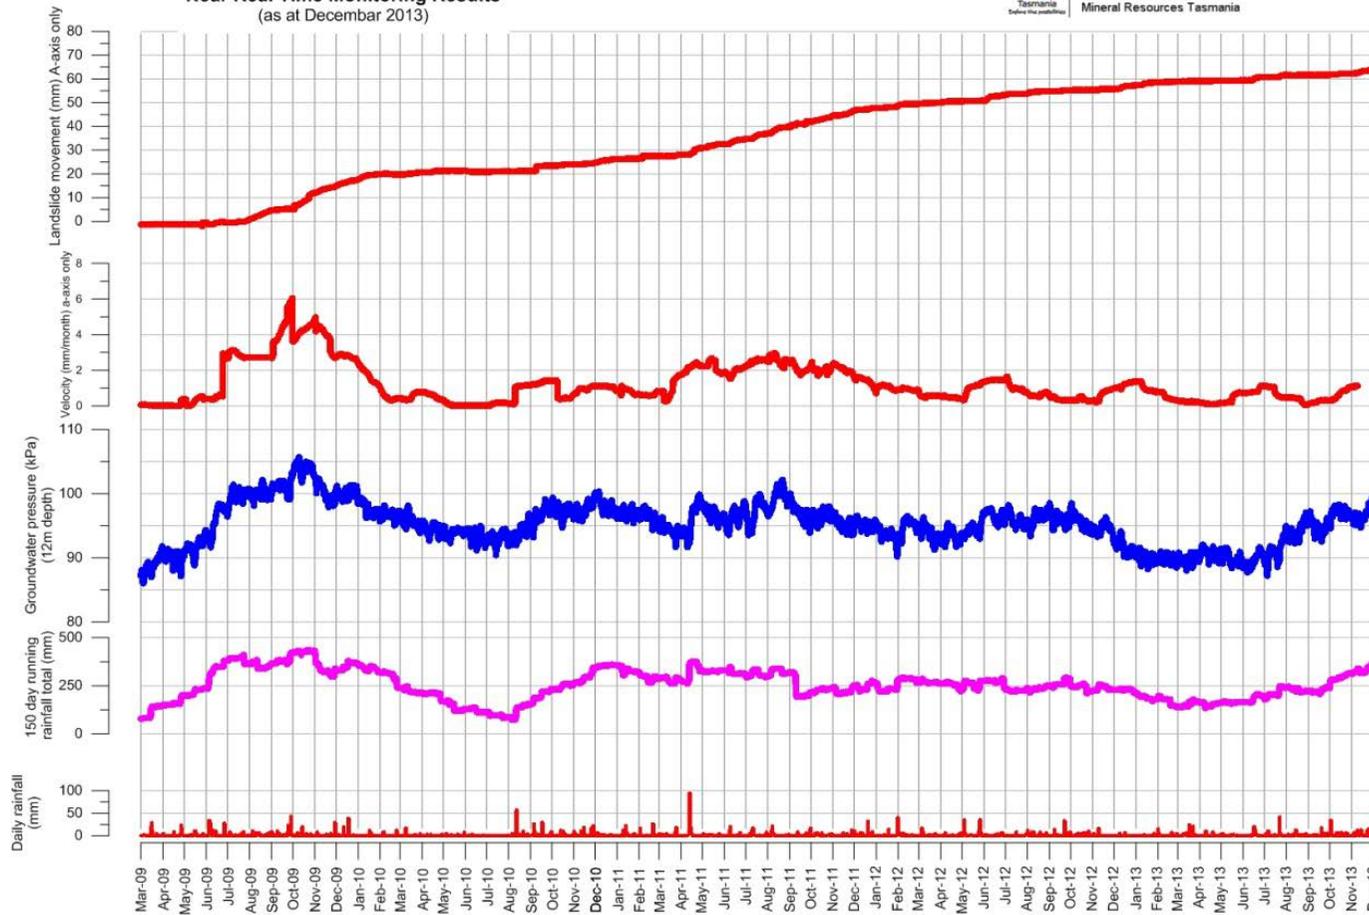
**School Creek Landslide, Taroona,
Near Real Time Monitoring Results**
(as at December 2013)

Figure 3 Time series plot of rainfall/groundwater pressure & near real time inclinometer displacement. Note that groundwater pressure and landslide movement is strongly correlated to long term rainfall

It is recommended that the near-real-time monitoring facility be supported for the length of its useful life and that additional sensors recently installed be integrated with this facility.

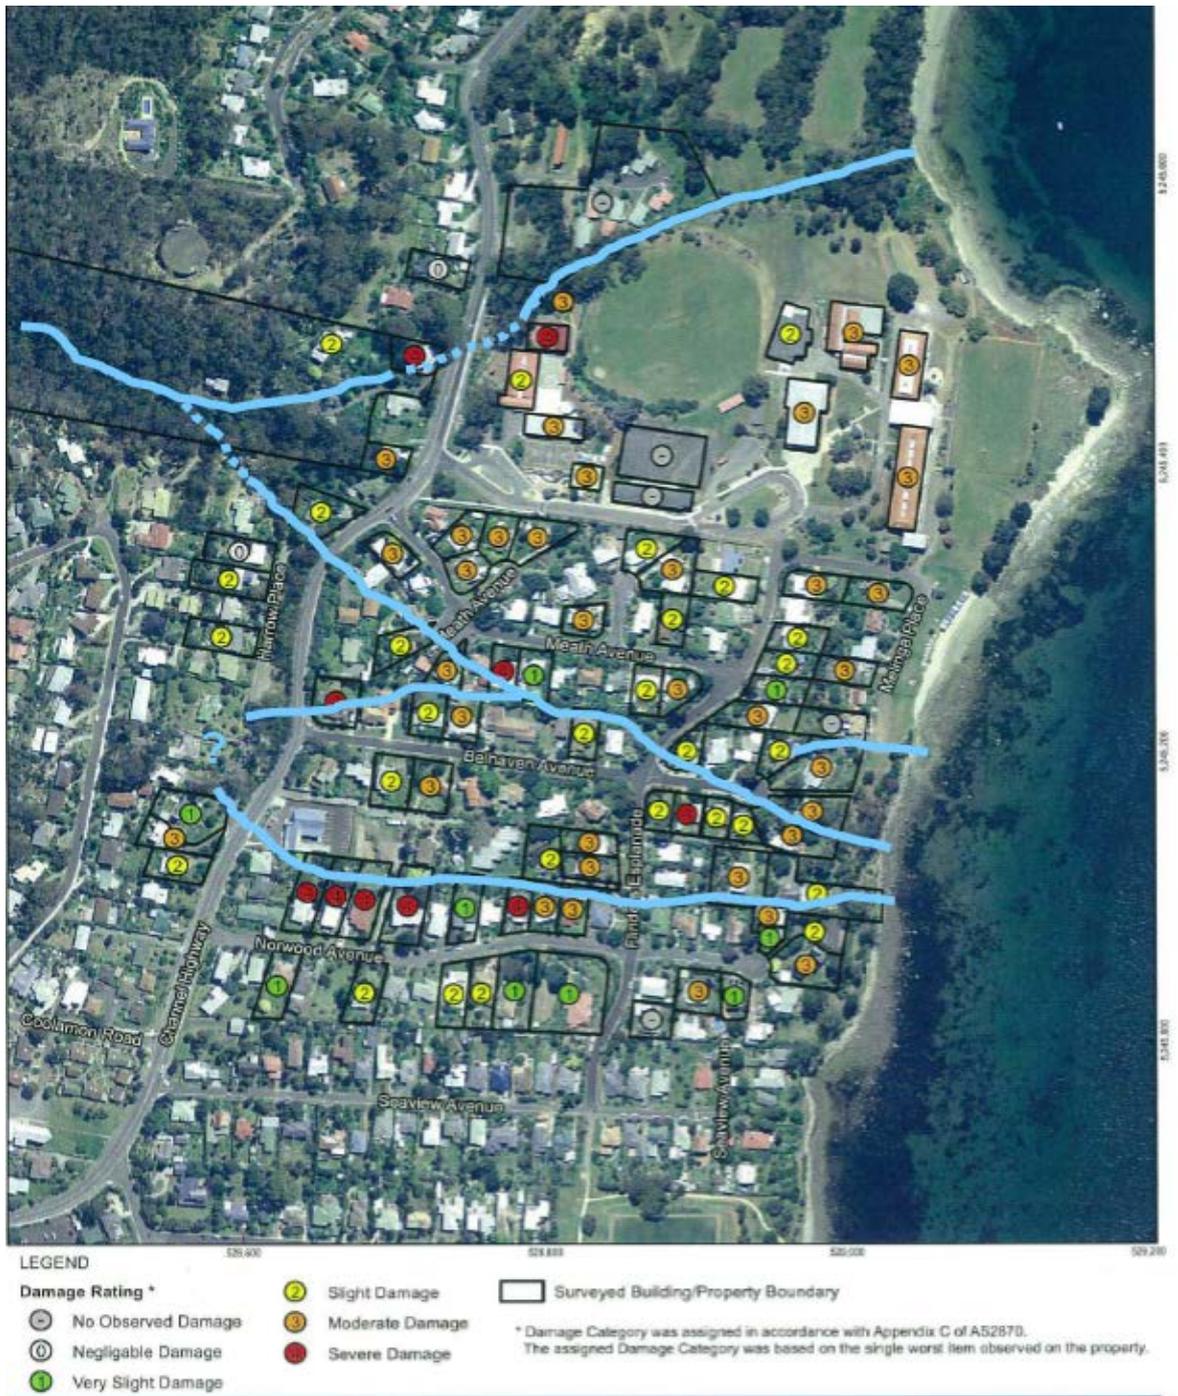
Aerial photographs from the 1940's reveal that prior to this development; several streams crossed the coastal plain below the steeper escarpment slope. In the vicinity of School Creek, these streams originated in the base of the steep gully that descends the escarpment slope immediately west of the point where School Creek crosses beneath the Channel Highway. The aerial photographic record shows that in developing the Tarooma residential area some of these natural stream courses were filled in and residential streets and buildings constructed over the filled stream courses. The recent visual damage survey of buildings in the landslide area (see section 2.2.2 of this report) has assessed the damage of these buildings under five rating classes, from no damage through to severe damage. When the traces of the existing and former natural stream courses are superimposed on the plan of buildings examined, there is a strong correlation of former stream courses with buildings exhibiting severe and moderate damage. This correlation suggests that the observed building damage may in some part be due to ongoing long term settlement of poorly compacted fill within the former stream courses. Confirmation of this causal relationship would require more detailed investigation including sub-surface insitu material testing.

Figure 4 shows the location of the old stream paths overlaid onto the structural damage map.

Figure 4 Plan showing overlay of building damage survey results and infilled stream locations

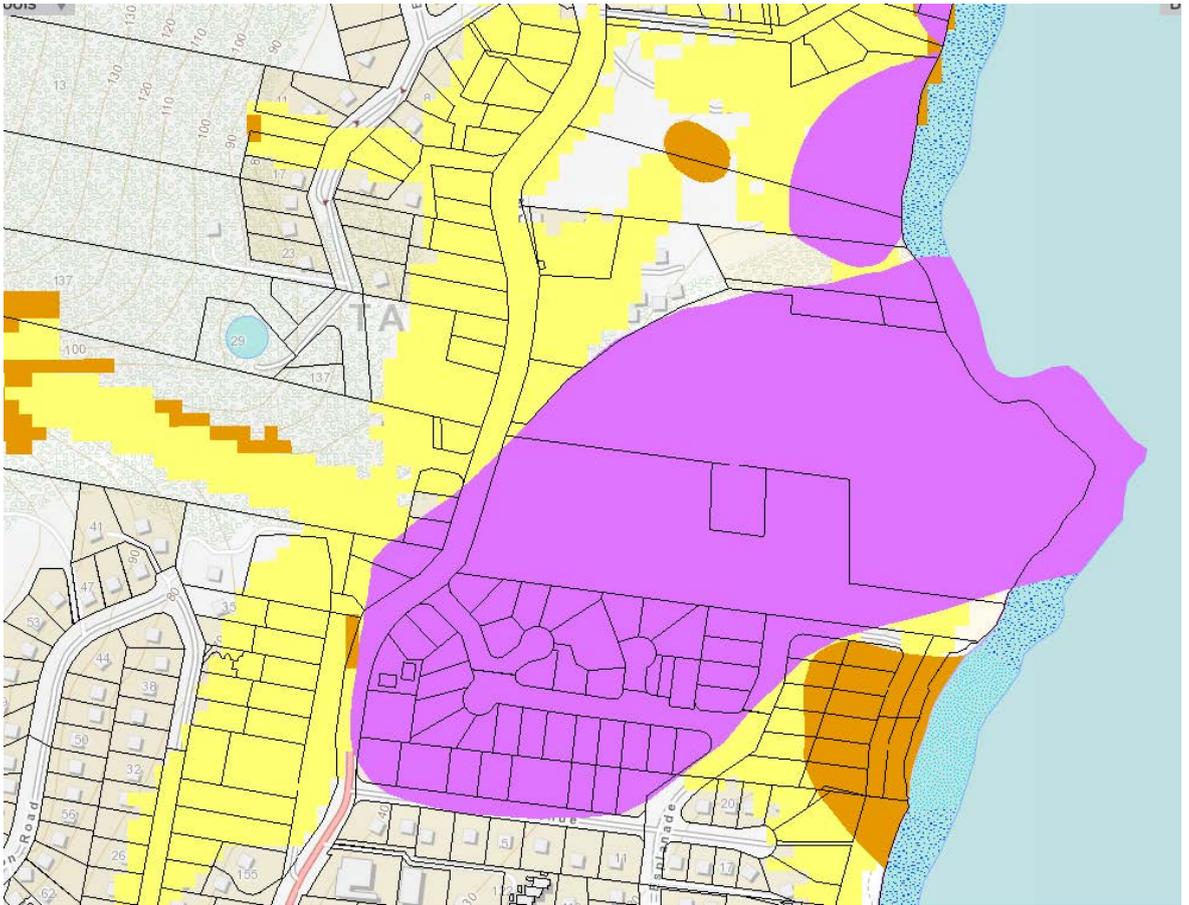
The Tarooma Landslide Area is identified as being within the Medium Active Landslide Hazard Area on the planning scheme maps. Building and works within this area will generally require a landslide risk management report prepared by an suitably qualified person to demonstrate that the landslide risk associated with the buildings and works is either:

Figure 5 Landslide Hazard Bands, Kingborough Interim Planning Scheme 2014 (Source: The LIST)

Stages 2 and 3 of this Project further recommended that the best approach to mitigate the landslide hazard risk through the land use planning process is to introduce local provisions to provide for a specific area plan. Such controls would require an amendment to the Interim Planning Scheme, and would introduce site specific controls that implement the technical recommendations of this Report. Council would be responsible for the implementation of this recommendation.

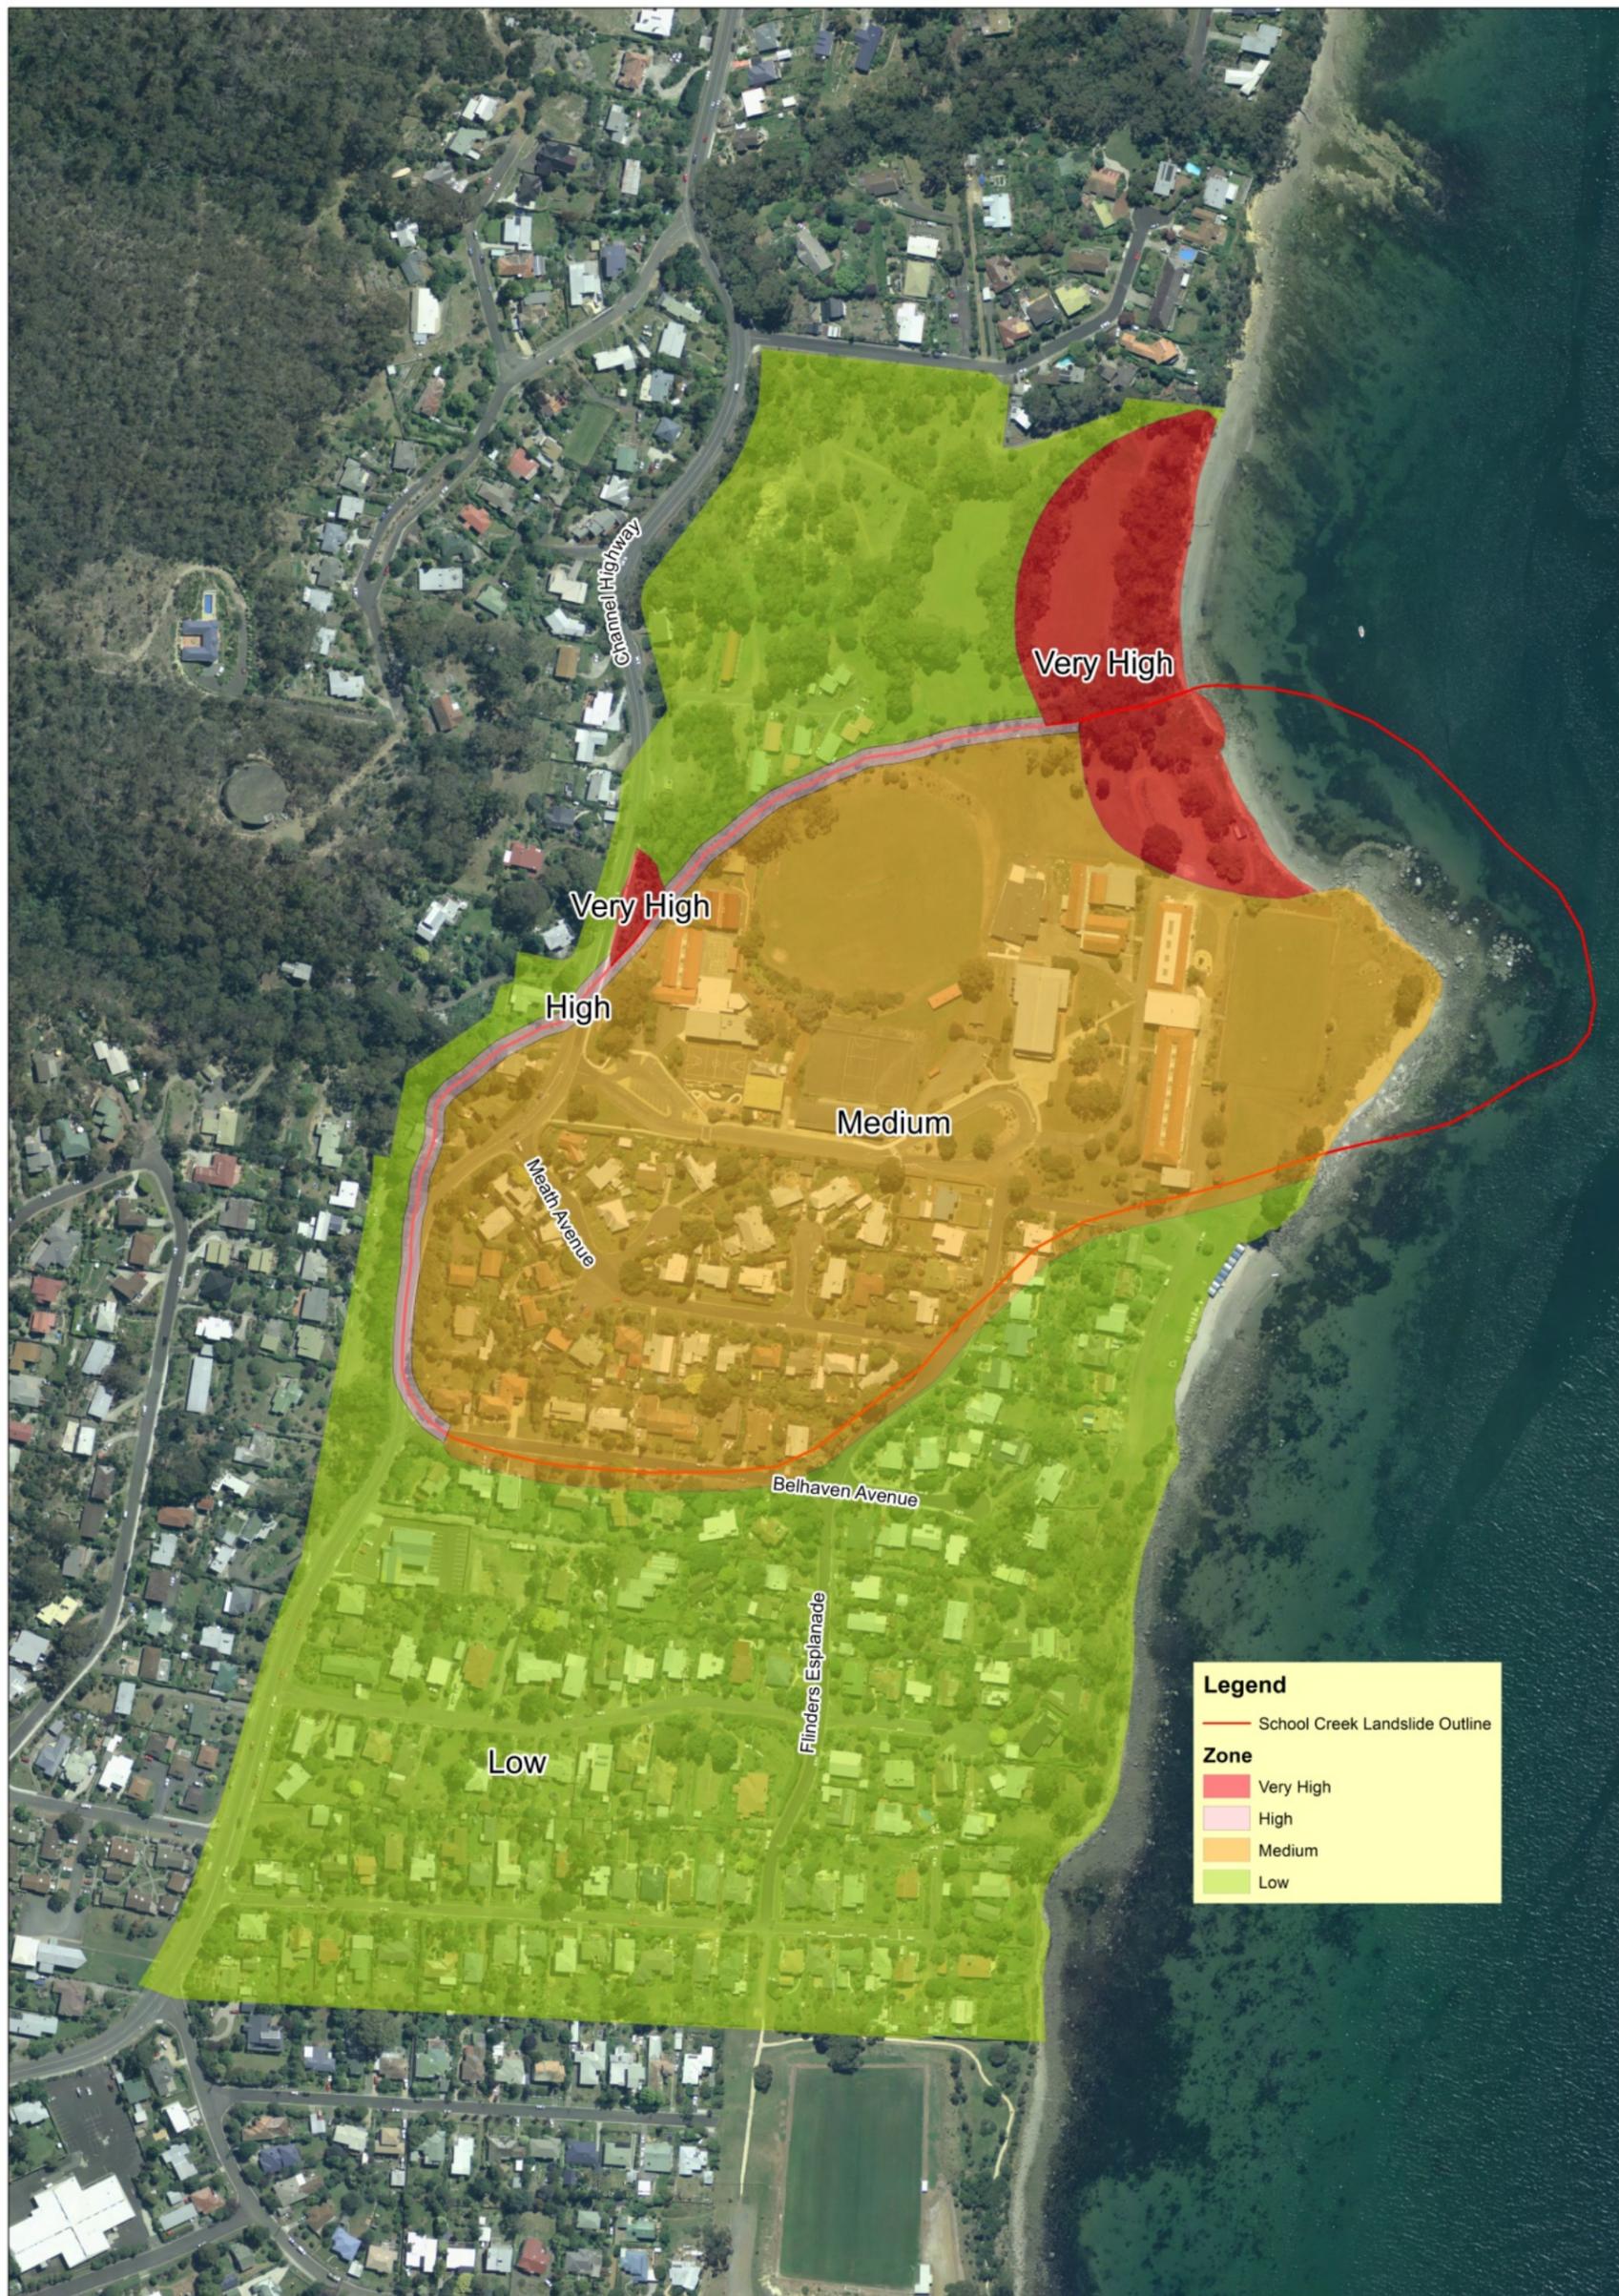
Appendix A - Site Plan showing Hazard areas

The identified hazard zone encompasses the area of the School Creek Landslide and is shown in Appendix A. It is noted that the definition of the area of the School Creek Landslide is based on sometimes widely spaced information and that some aspects of the extent of the landslide are poorly defined (e.g. the southern boundary of the landslide is not well understood).

In general, the higher hazard zones, where differential movements are most noticeable, encompass the boundary zones of the landslide, in particular the headscarp area. The headscarp area (whose boundary with the side scarps is poorly defined and conjectural) is regarded as the most hazardous, as differential movements recorded in this area are regarded as having the highest hazard. The correlation of movement in this area with rainfall, and the significant vertical component of the displacement vectors are typical of a headscarp regression of a landslide. These headscarp displacements are evidenced by the continued deformation of the Channel Highway at this location, and can be expected to continue as long term displacements accumulate.

The main body of the landslide is regarded as a medium level hazard zone where movement of the body of the landslide mass may occur, but differential movements will be less noticeable. The areas outside the main body of the landslide are regarded as forming a lower hazard area where differential movement is less likely.

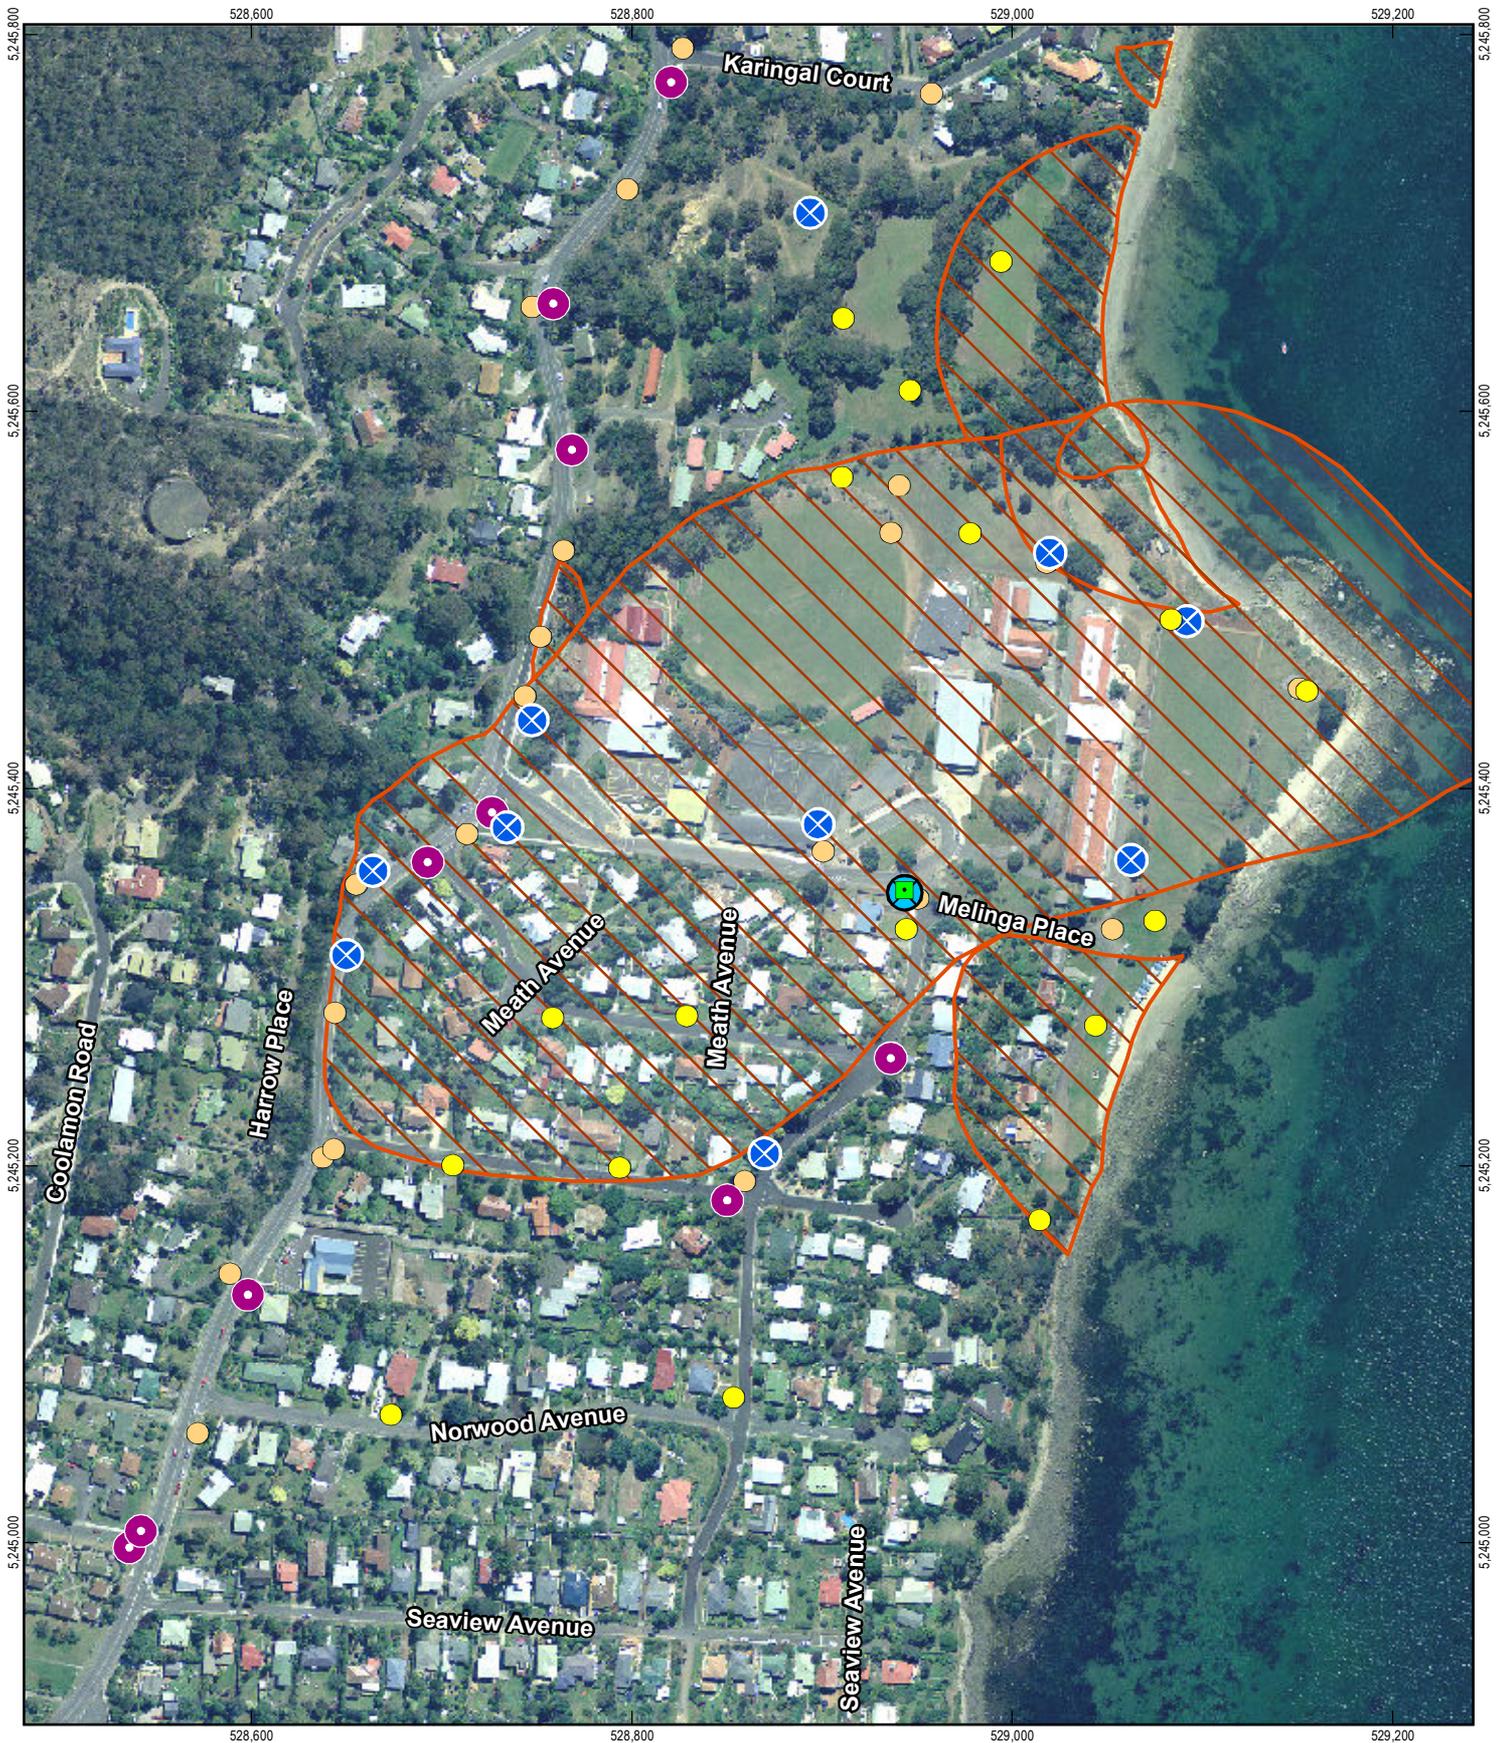
Appendix C – Site Plan - Instrumentation & Additional Survey Monitoring Points

In order to address this life-span issue, and to further our understanding of the landslide, two new boreholes were drilled near the intersection of Flinders Esplanade and Melinga Place in which an inclinometer casing and two piezometers have been placed. These are shown on Appendix C.
