STOREYS CREEK PRECIPITATION DAM

REPORT ON REHABILITATION

Tasmanian Development and Resources :
Storeys Creek precipitation dam : report on
rehabilitation / Thompson & Brett
Consulting Engineers 1994

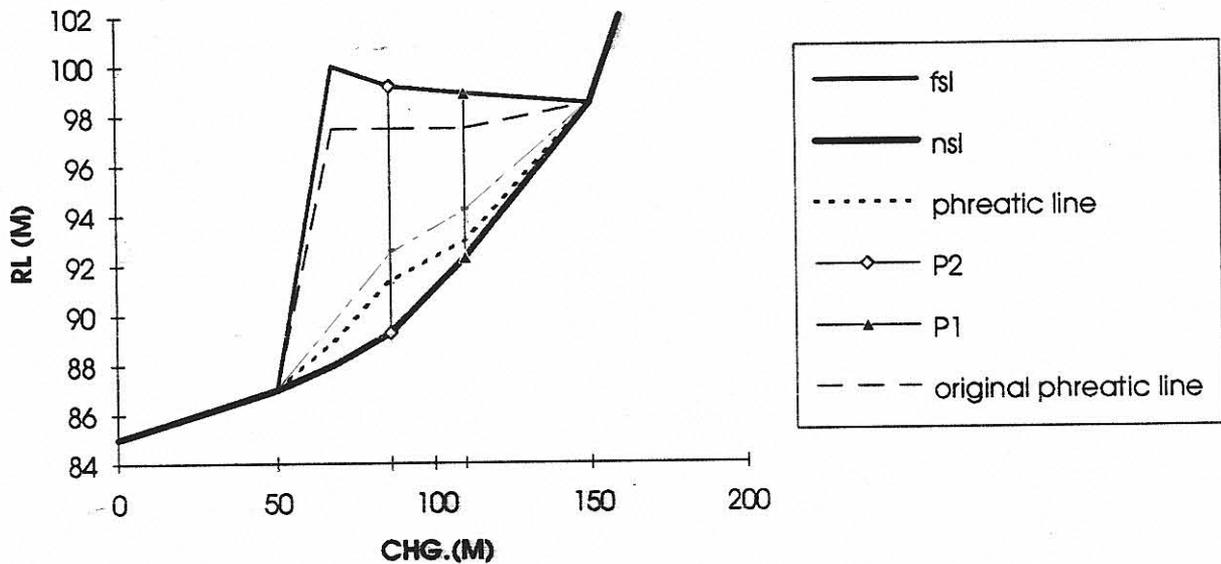
Figure 1
Indicated Change to Phreatic Line

Construction included the installation of two stand pipe piezometers which can be used to monitor groundwater levels in the storage. Measurements of water levels in the piezometers are shown in Table 1.

This shows a very low water table which is continuing to drop. An appropriate cross section is shown in Figure 1.

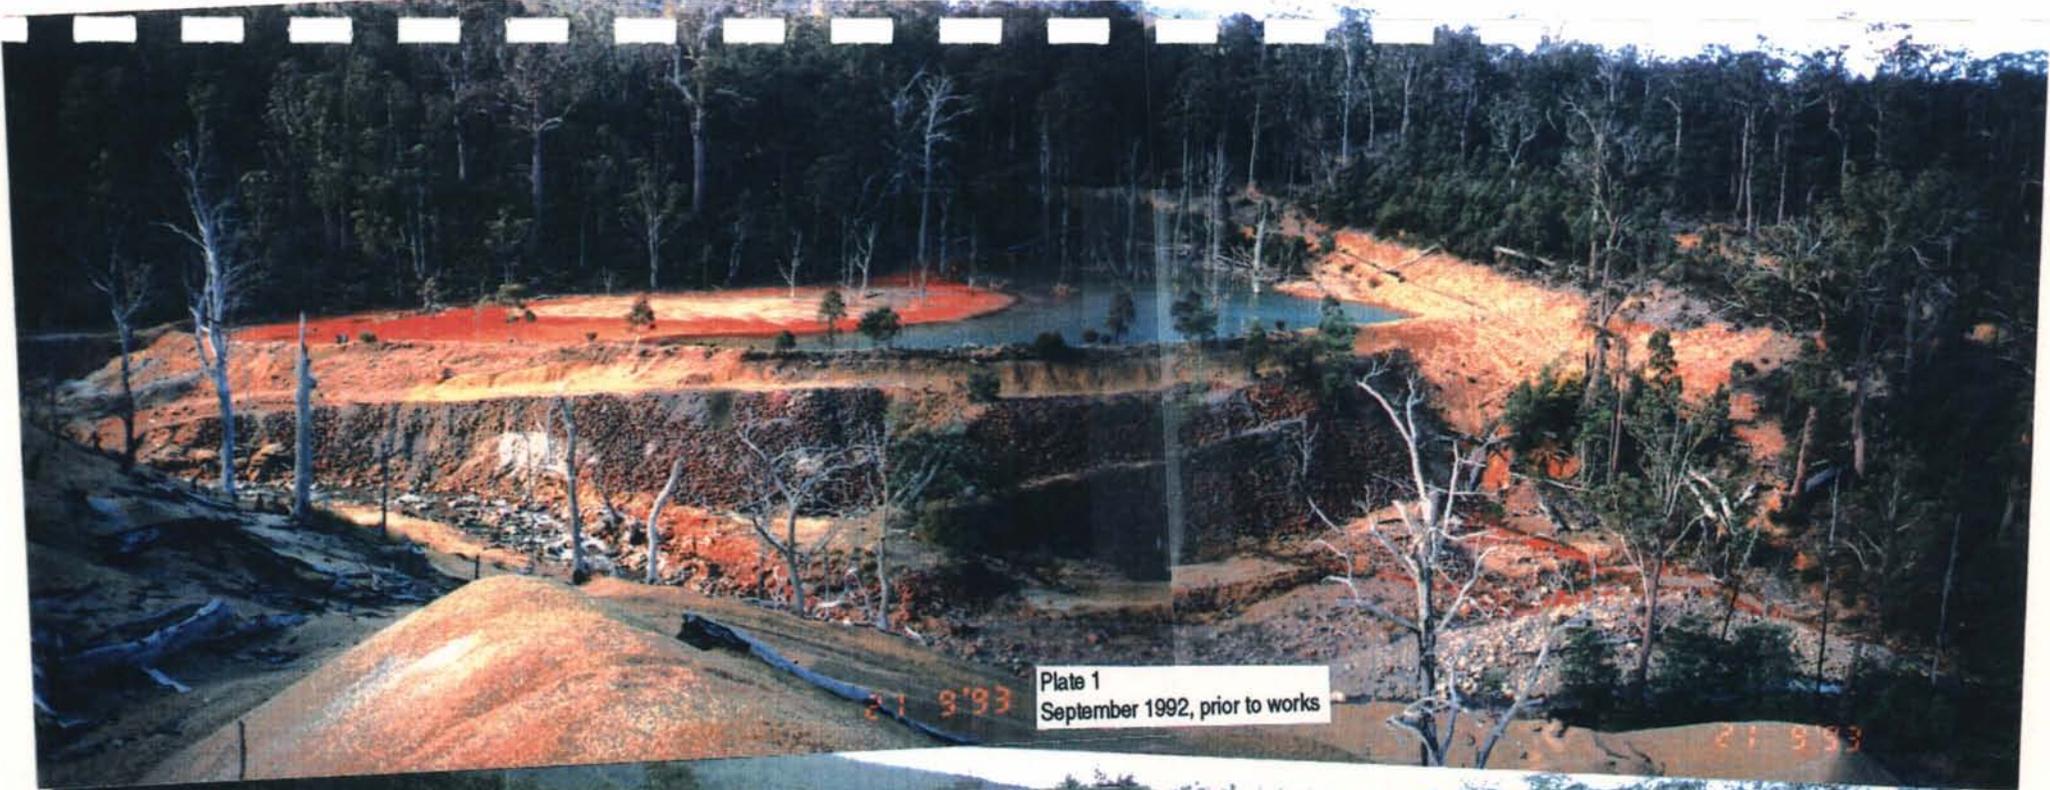
Plate 1
September 1992, prior to works

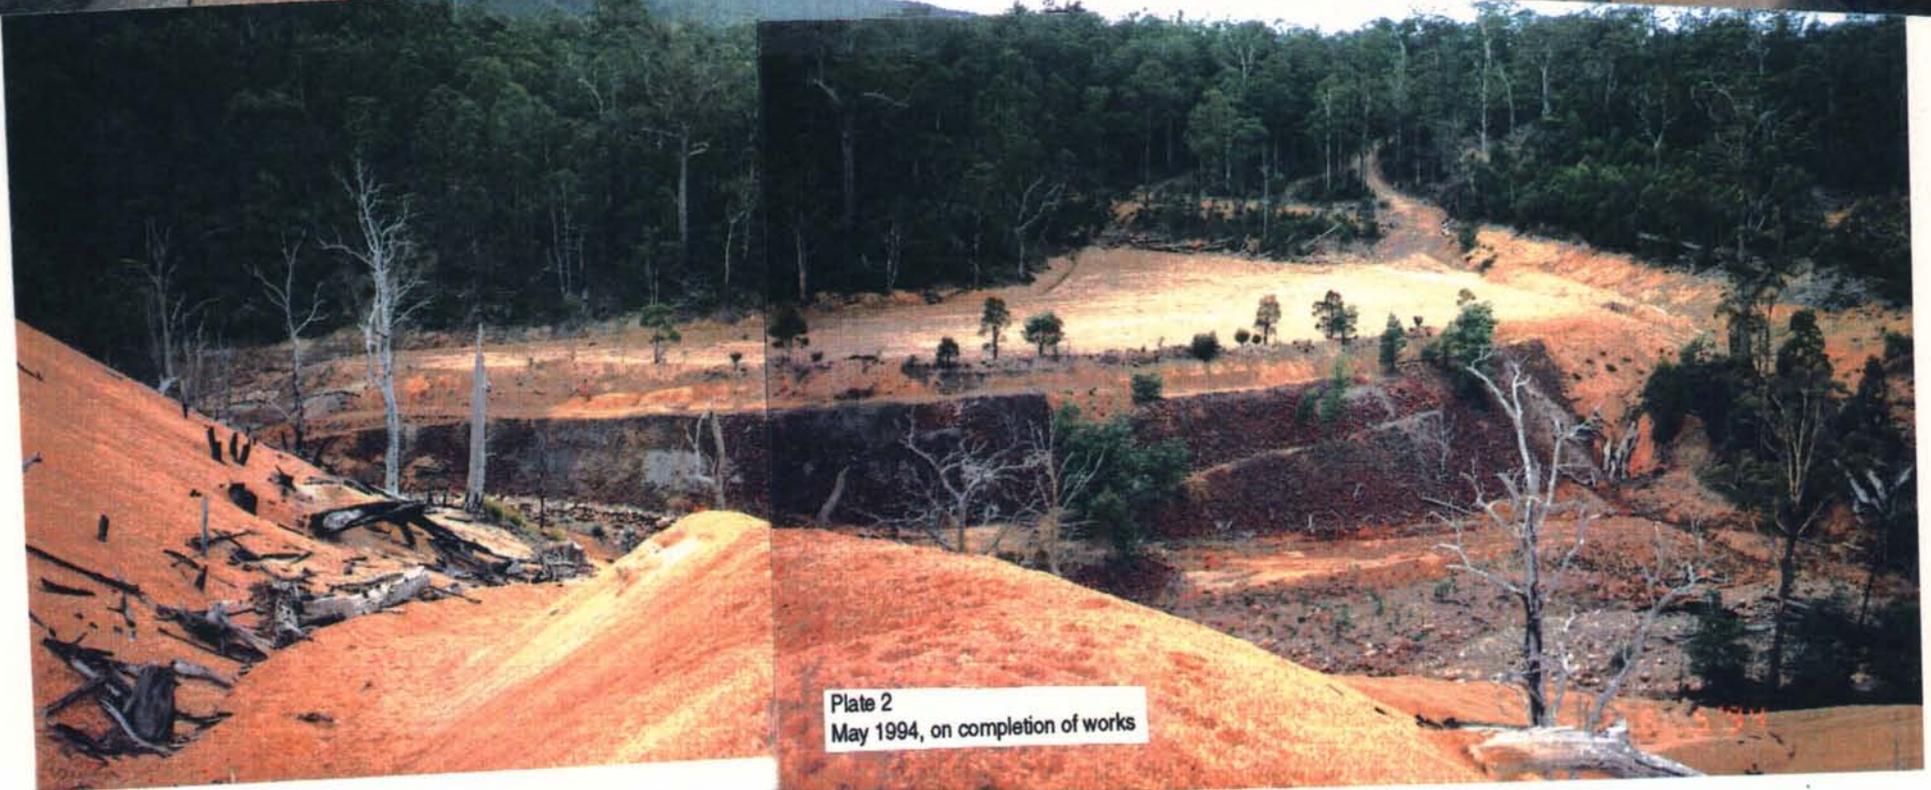
Plate 2
May 1994, on completion of works
