Mineral Resources Tasmania

ROSSARDEN MINE REHABILITATION

1997 REVEGETATION PROGRAMME SUMMARY

July 1997

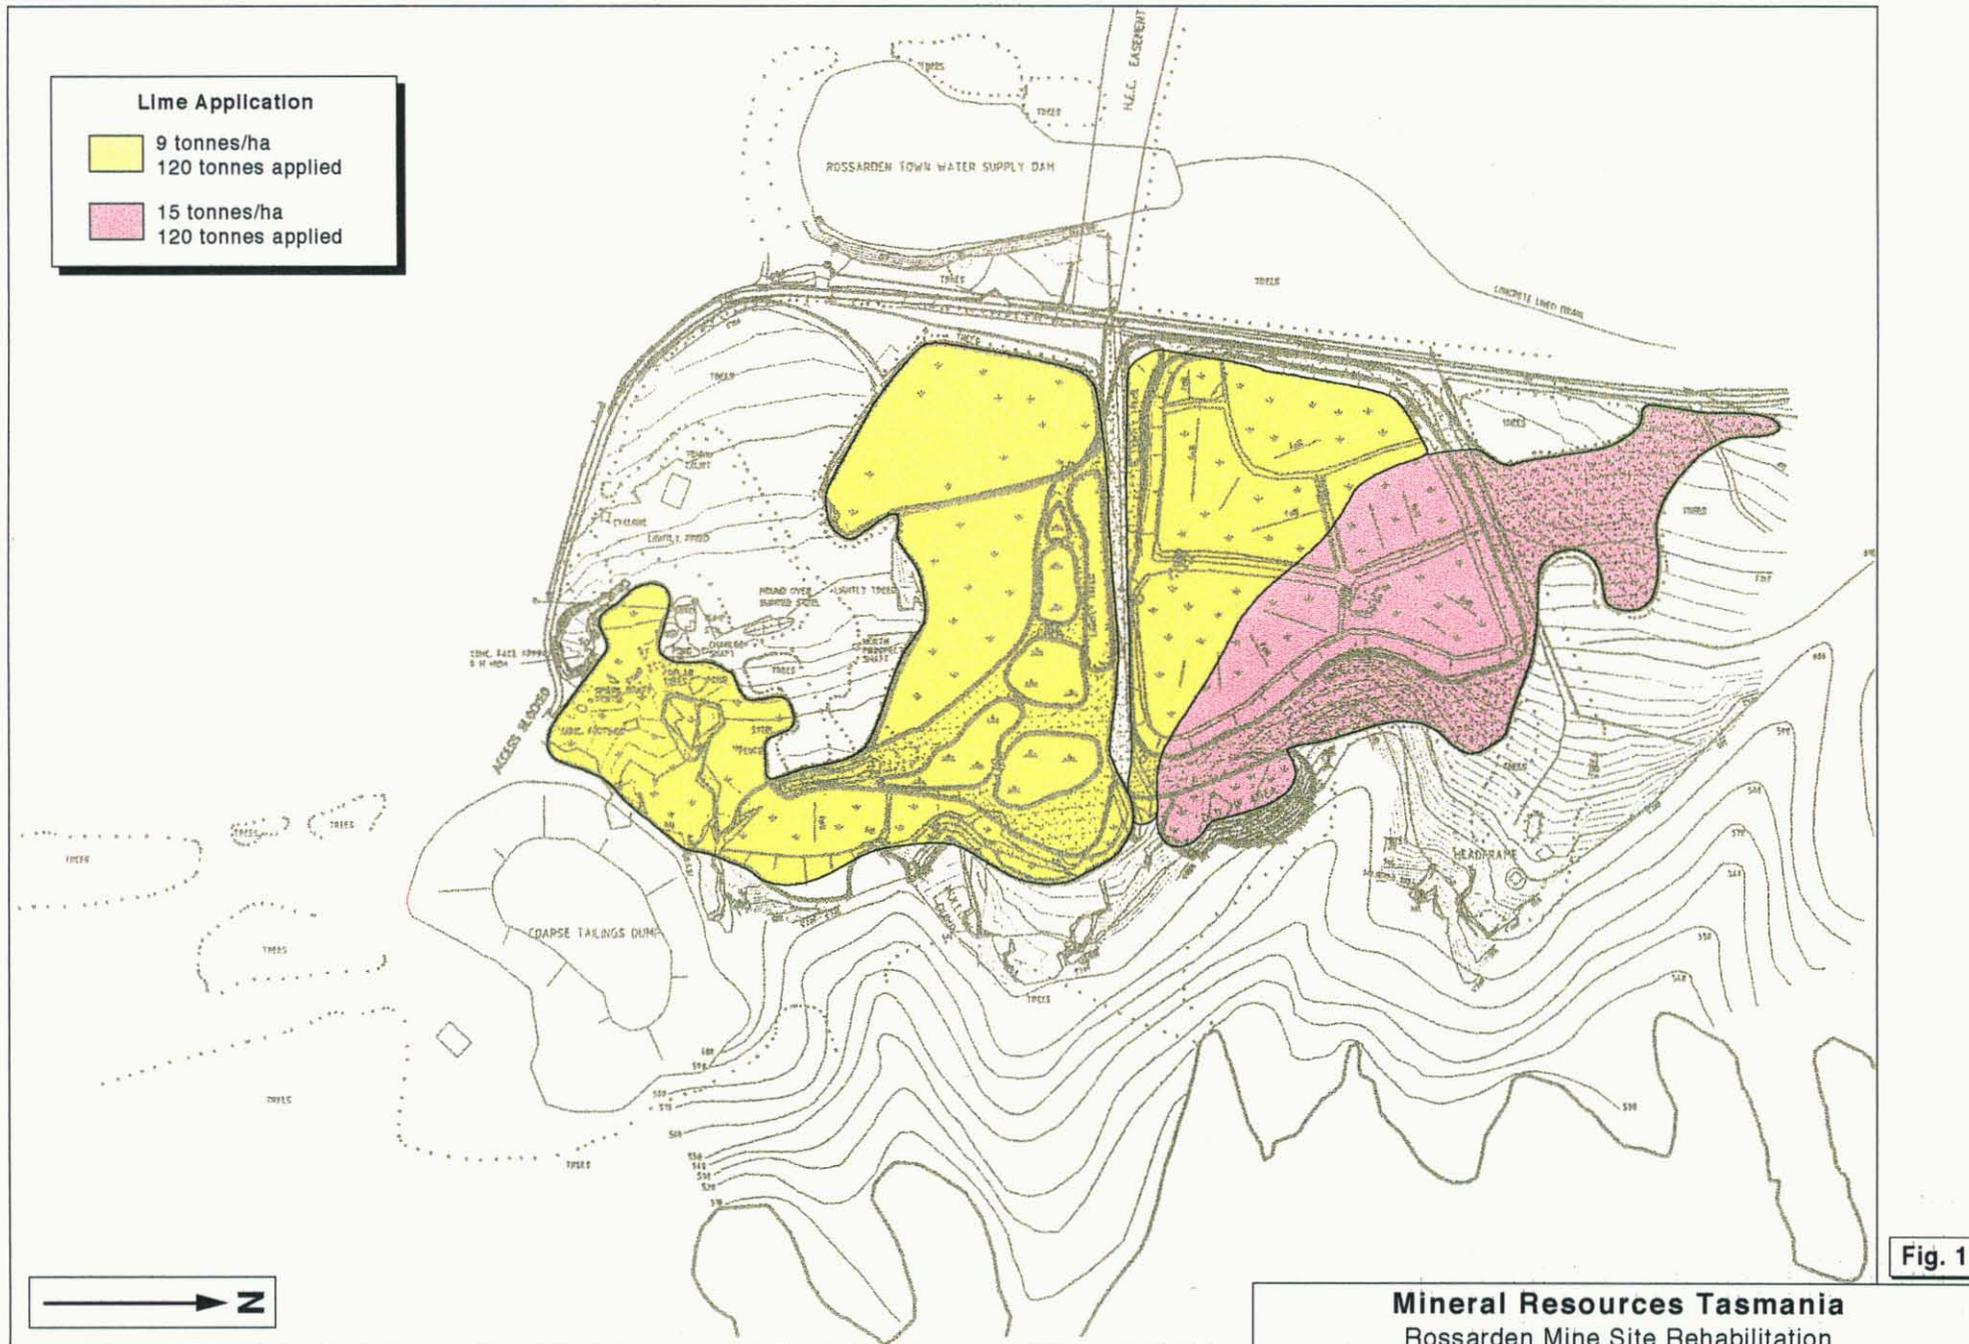
Exotic grass quantities were increased from the original design based on their availability at short notice and their ability to cope with difficult acid conditions identified in a broad assessment of the soil and clay pH, undertaken in April 1997. The pH of the exposed and capping clays varied greatly from isolated pockets of 8.2 to large areas of between 2.5 to 3.0 (approximately 8 ha). The majority of the clay had a pH of between 4.0 to 4.5.

3.1.1 pH and Lime Application (refer Figure 1)

Approximately 240 t of agricultural lime was applied, 9 tonnes /ha over 13 ha and 15 tonnes/ha over the remaining 8 ha.

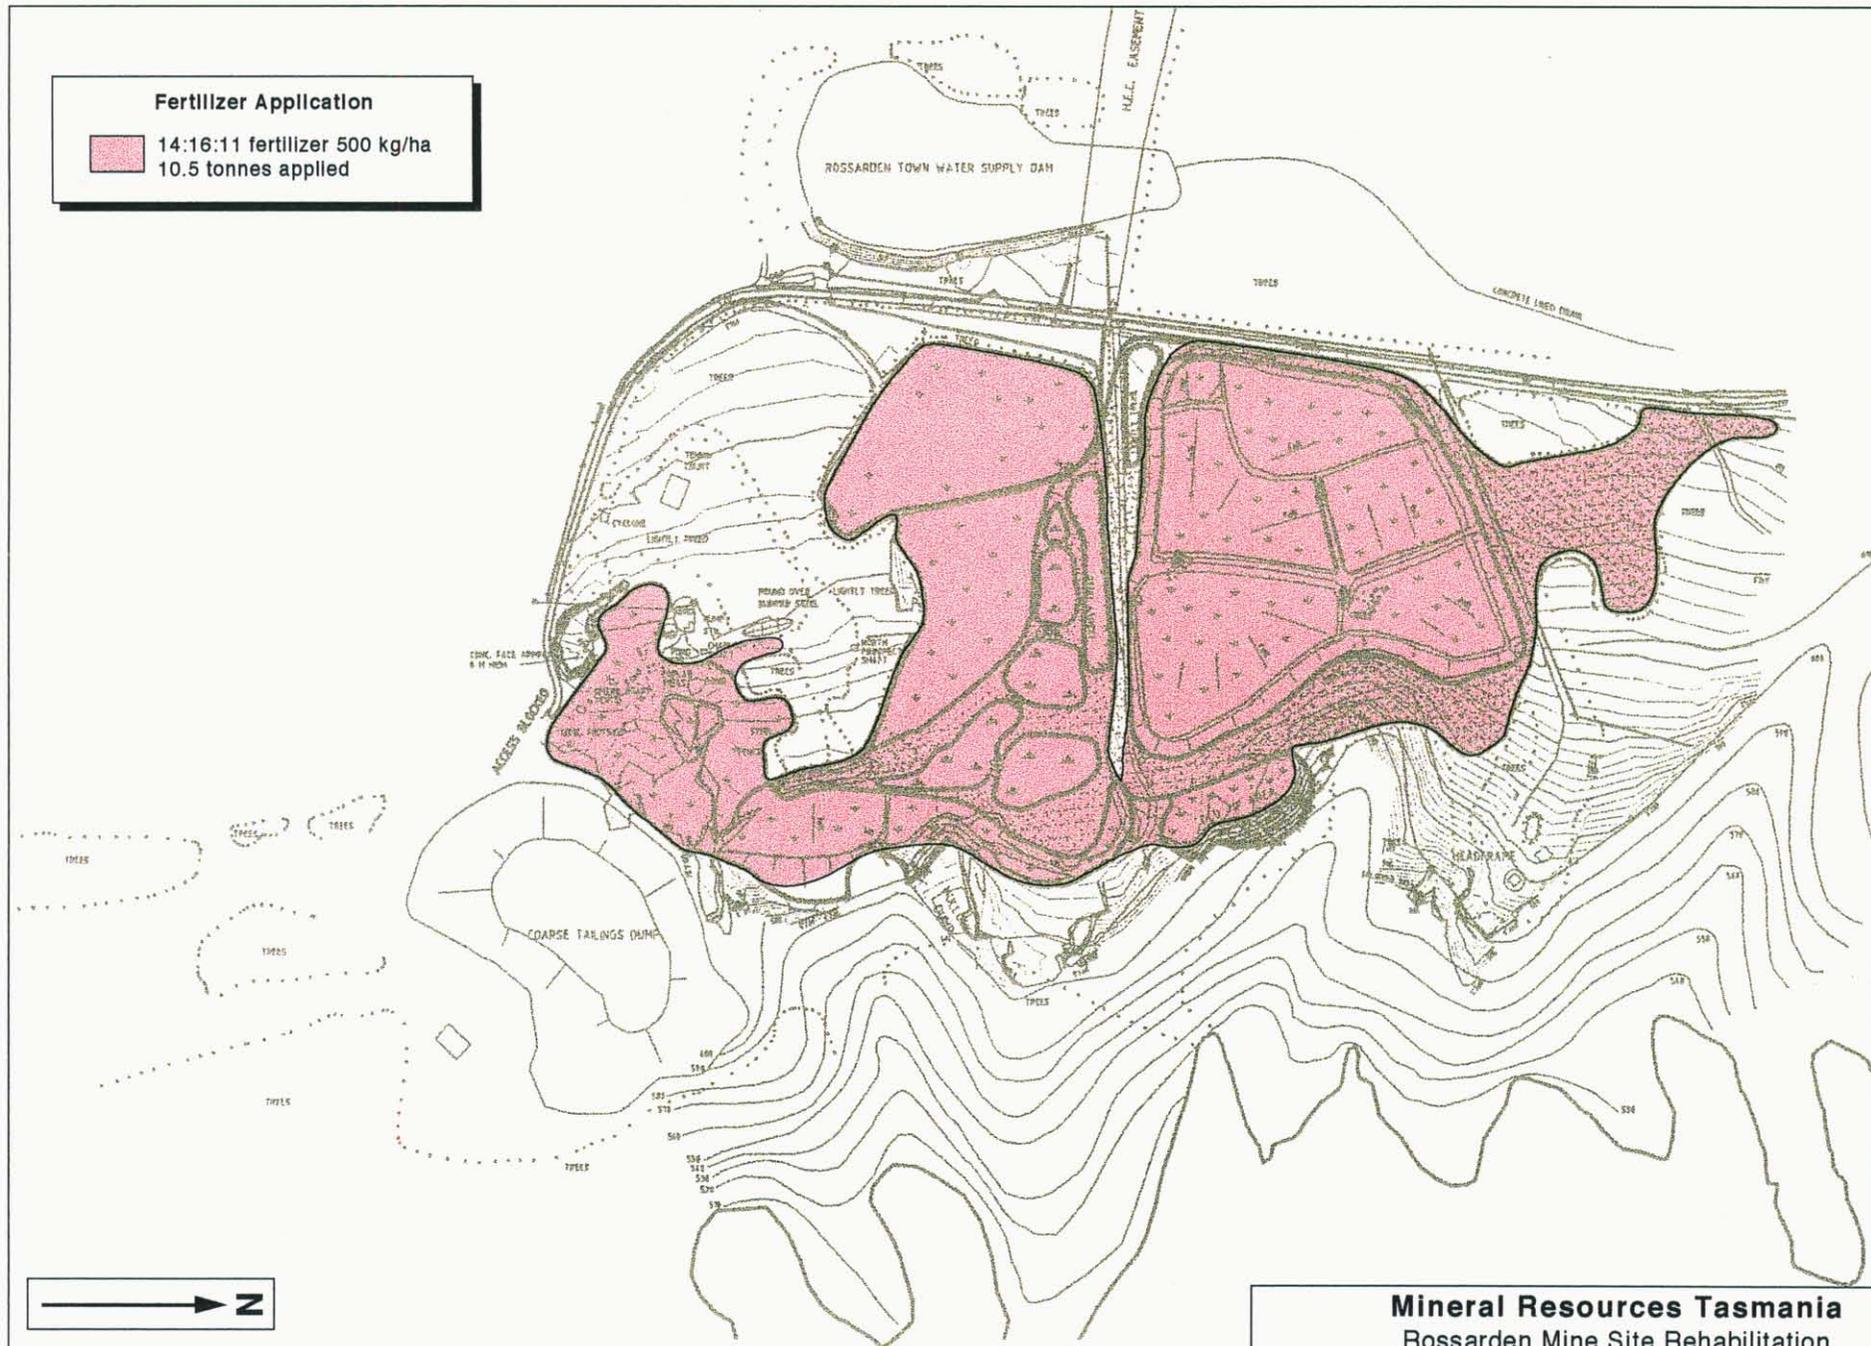
Fig. 2

3.1.2 Nutrient Application (refer Figure 2)

The N:P:K fertilizer 14:16:11 was applied at 500 kg/ha. A total of 10.5 tonnes and 0.6 tonnes of fertilizer was applied at Rossarden and Storeys Creel Precipitate Dam, respectively.

Generally, the clays used for capping the tailings were deficient of all major nutrients. Fertilizer was applied as a "starter" mix for both the exotic and native species. Nutrient analysis will be required in the future to determine the maintenance fertilizer regime required to maintain vegetative growth.

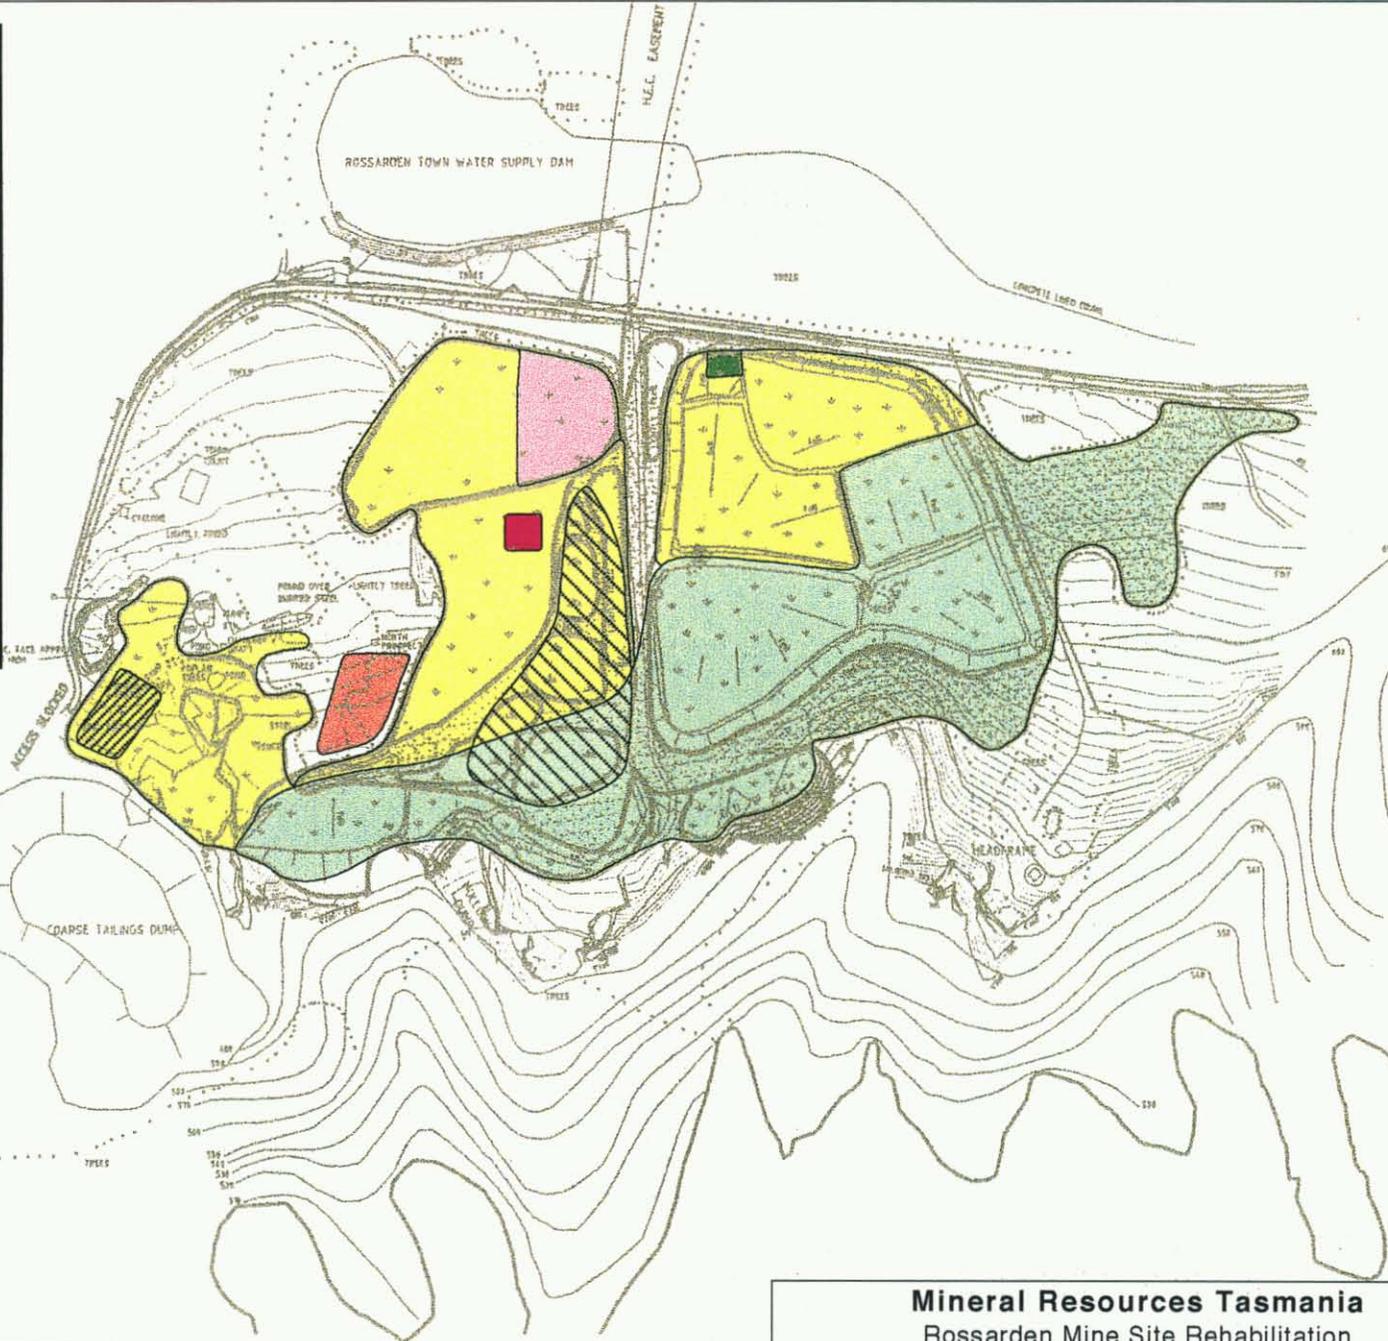
Fig. 3

Revegetation treatments are located and identified on Figure 3 and include all established trial plots.

- 3400 seedlings planted
- 1200 Poa. spp. "Virocells" planted
- 63 kg of native seed applied
- 1345 kg of exotic seed applied
- 50 Lomandra cuttings planted
- 200 Juncus cuttings planted

In addition to the original plan, several trial revegetation plots were established and they included the following :

- planting 1200 Virocell Poas
- placement of 200 *Juncus* transplants into poorly drained damp areas
- planting of 50 *Lomandra* cutting
- the establishment of a browsing animal proof fencing plot

The location of these plot are identified in Figure 3.

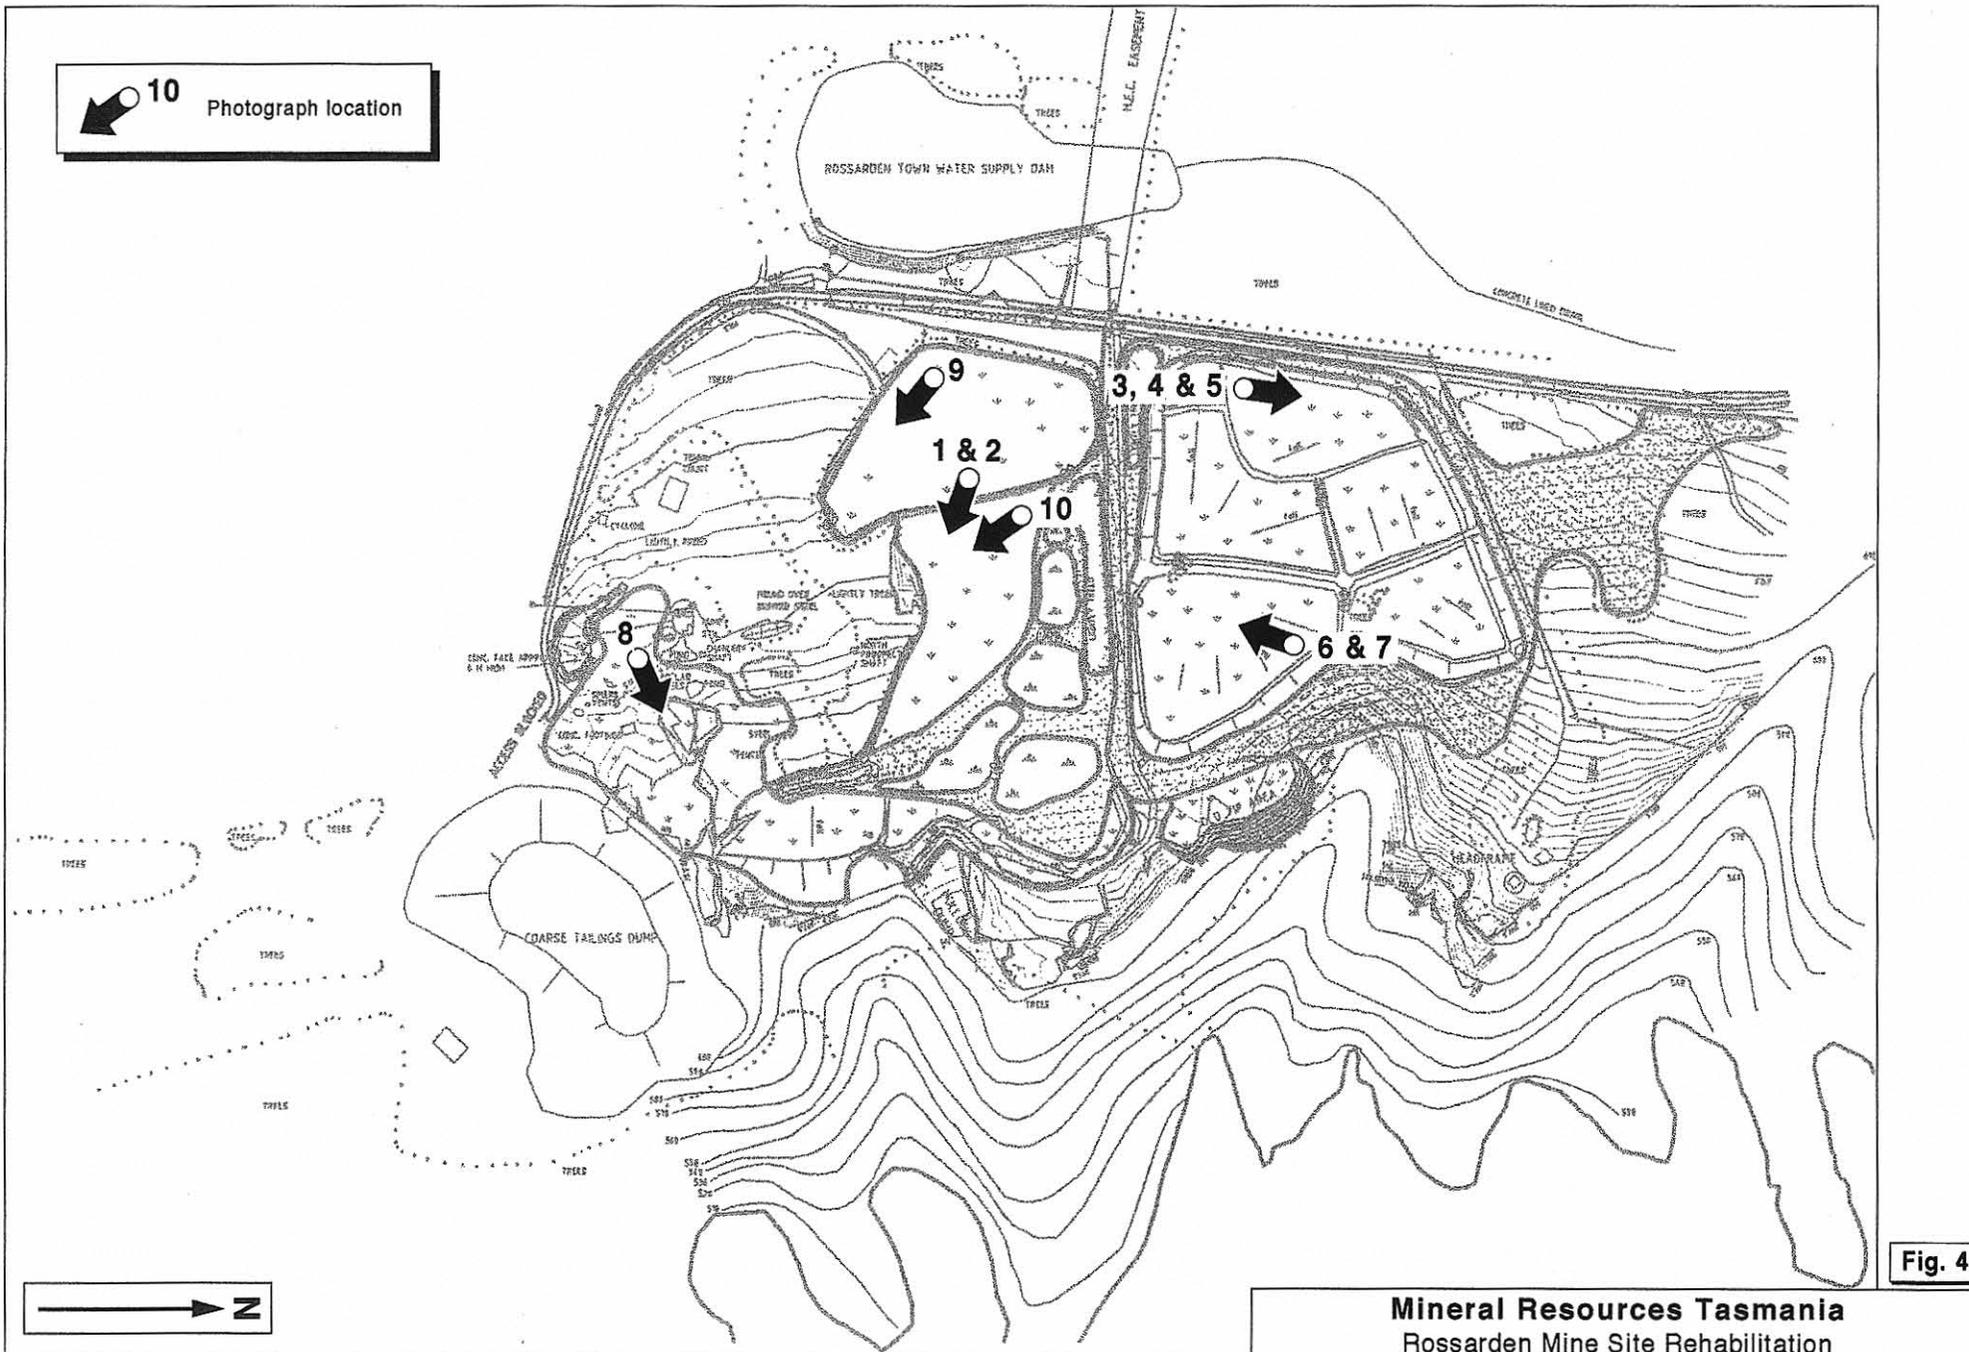
Fig. 4

Typical progressive rehabilitation photographs are attached and the location and direction of the photographs are identified in Figure 4.

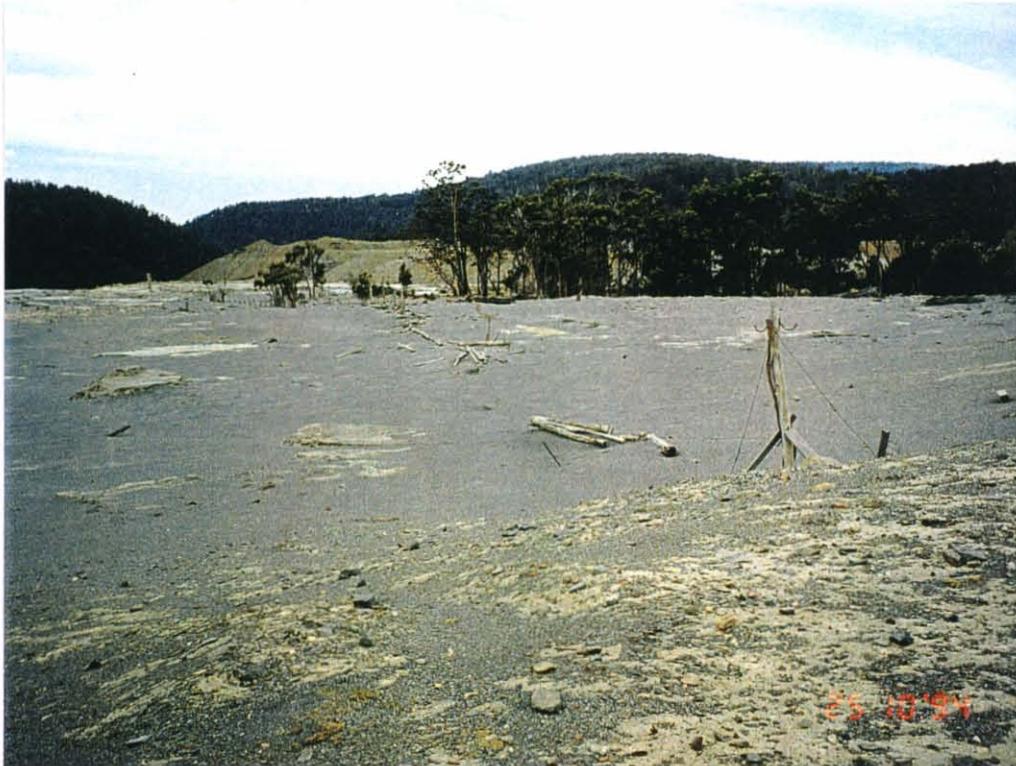
PHOTOGRAPH 1: COARSE TAILINGS DEPOSIT. OCTOBER 1994.

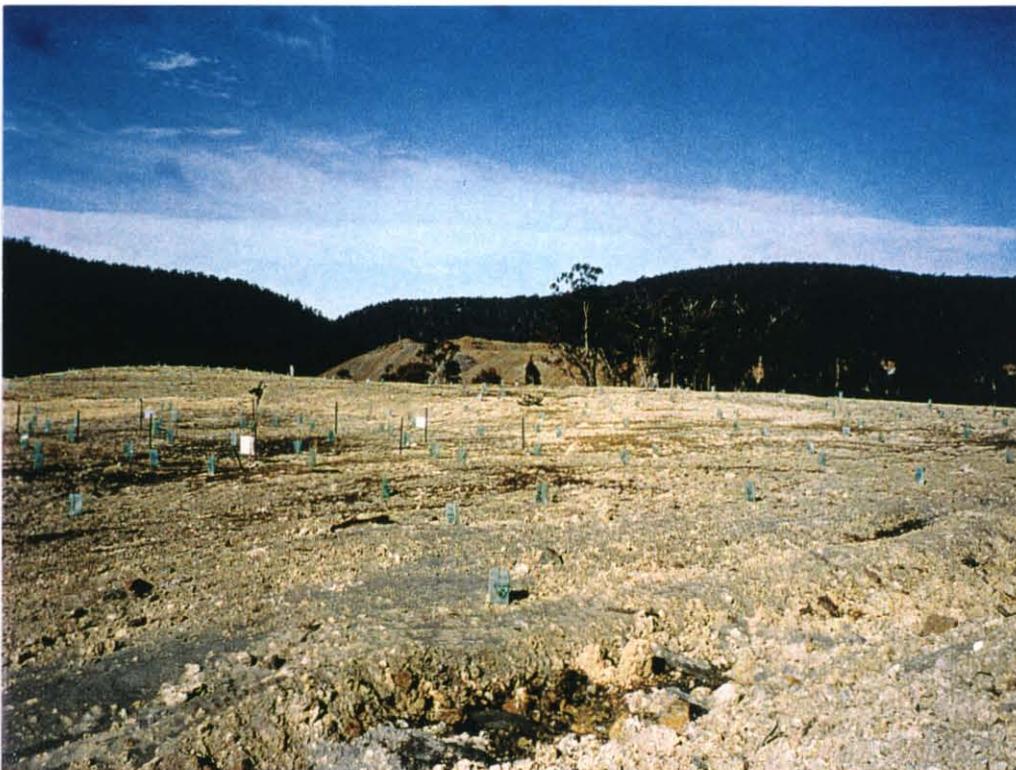
PHOTOGRAPH 2: COARSE TAILINGS DEPOSIT FOLLOWING CLAY COVERAGE AND REVEGETATION TREATMENTS. JULY 1997.

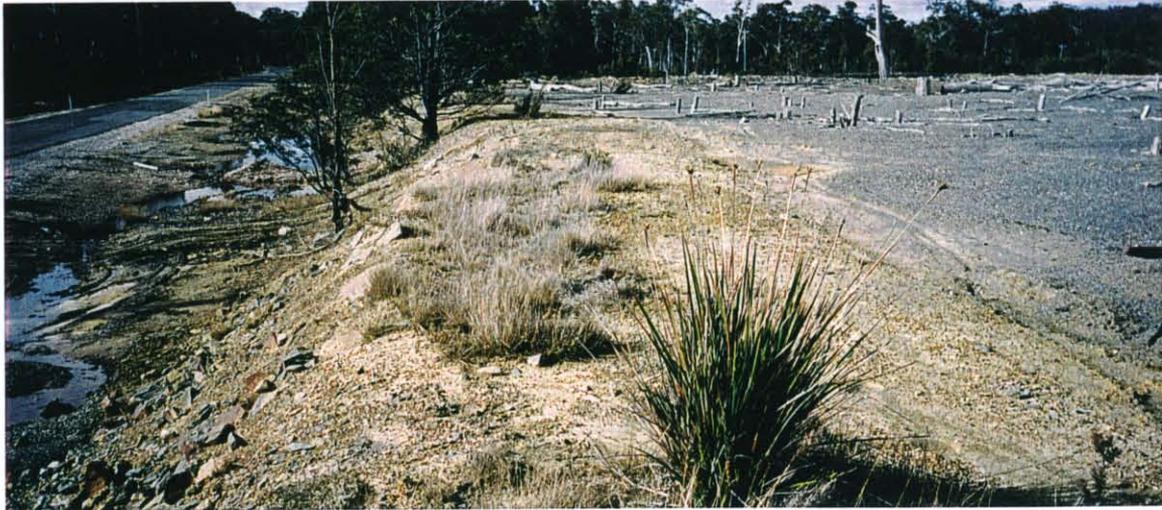
PHOTOGRAPH 3: CLAY DAM AND TAILINGS. SEPTEMBER 1992.

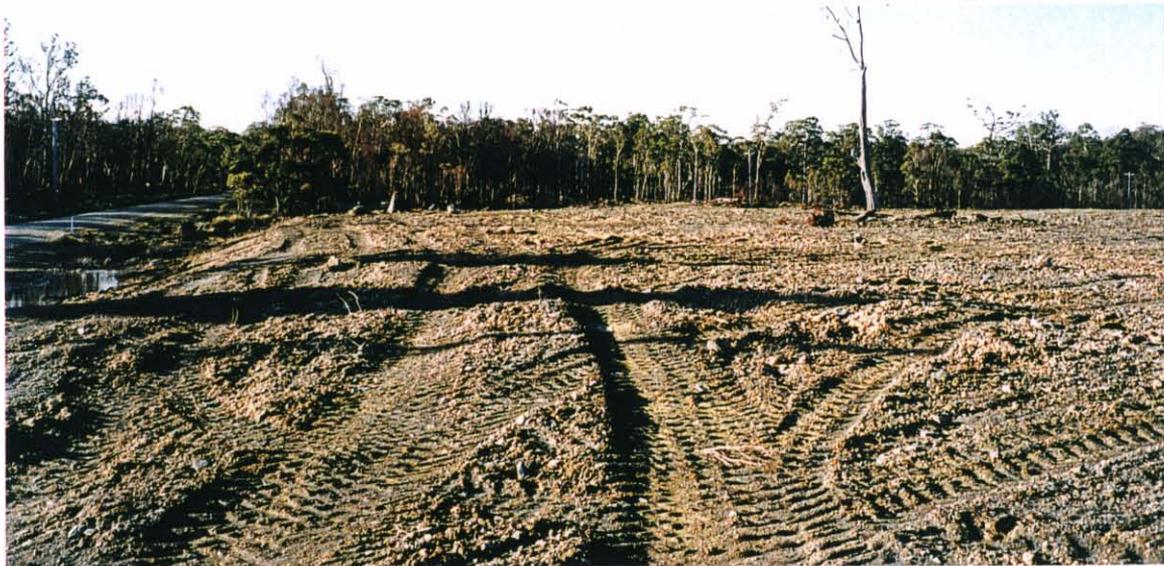
PHOTOGRAPH 4: CLAY DAM AND TAILINGS FOLLOWING CLAY COVERAGE. MAY 1997.

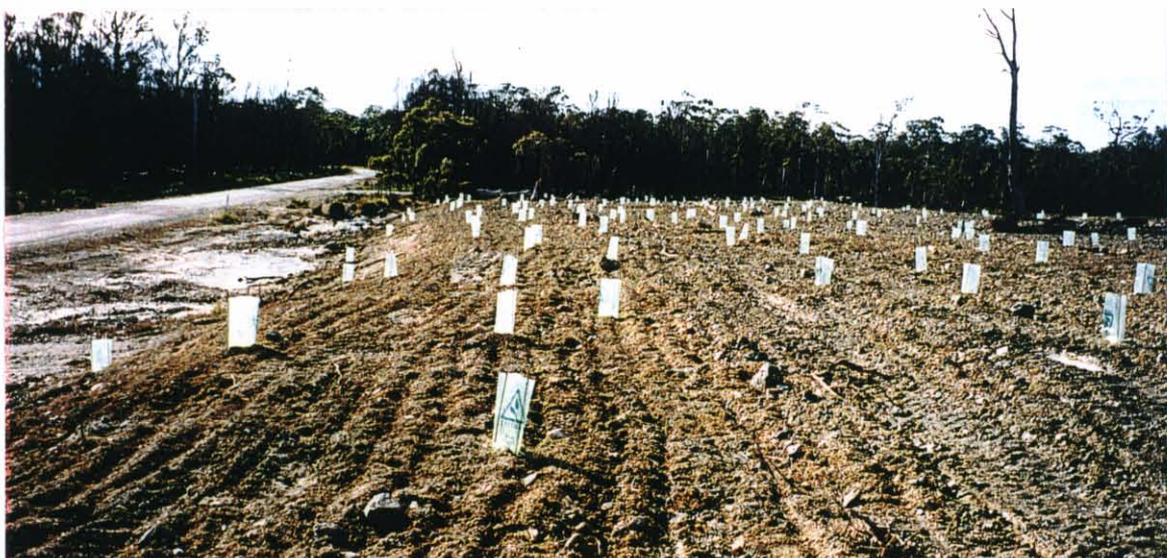
PHOTOGRAPH 5: CLAY DAM AND TAILINGS FOLLOWING CLAY COVERAGE AND REVEGETATION TREATMENT. JULY 1997.

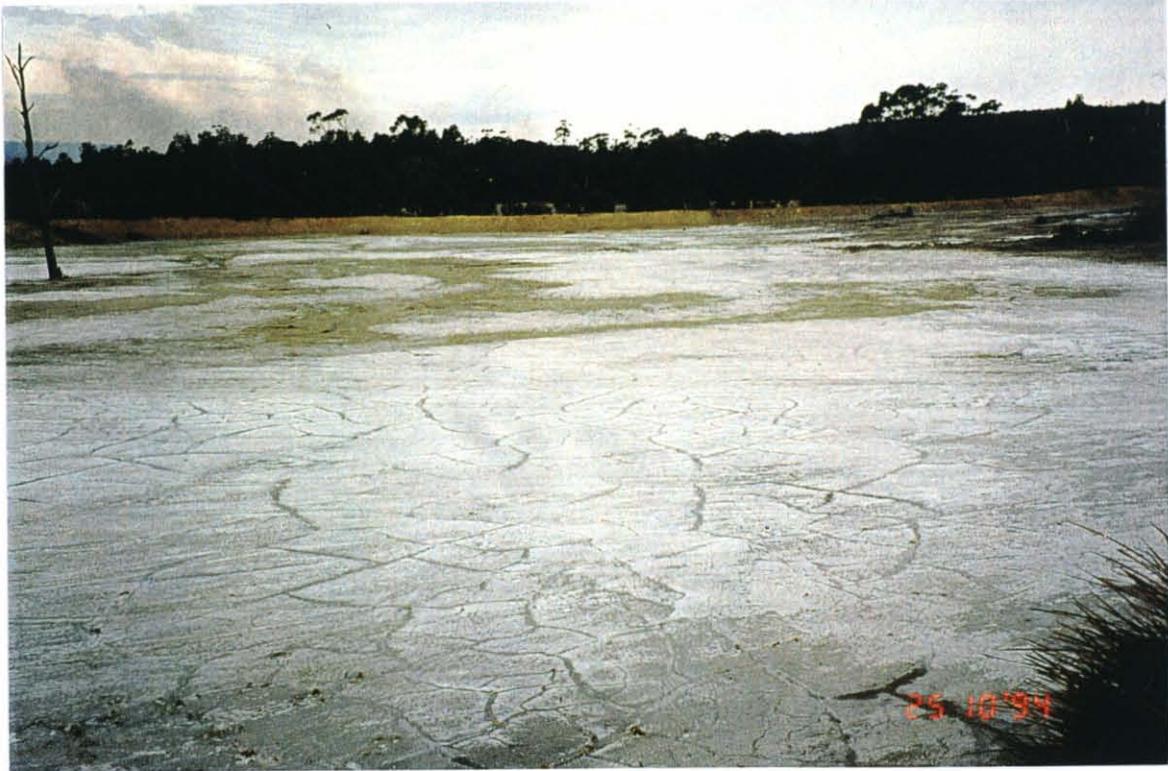
PHOTOGRAPH 6: SLIME TAILINGS DEPOSIT. OCTOBER 1994.

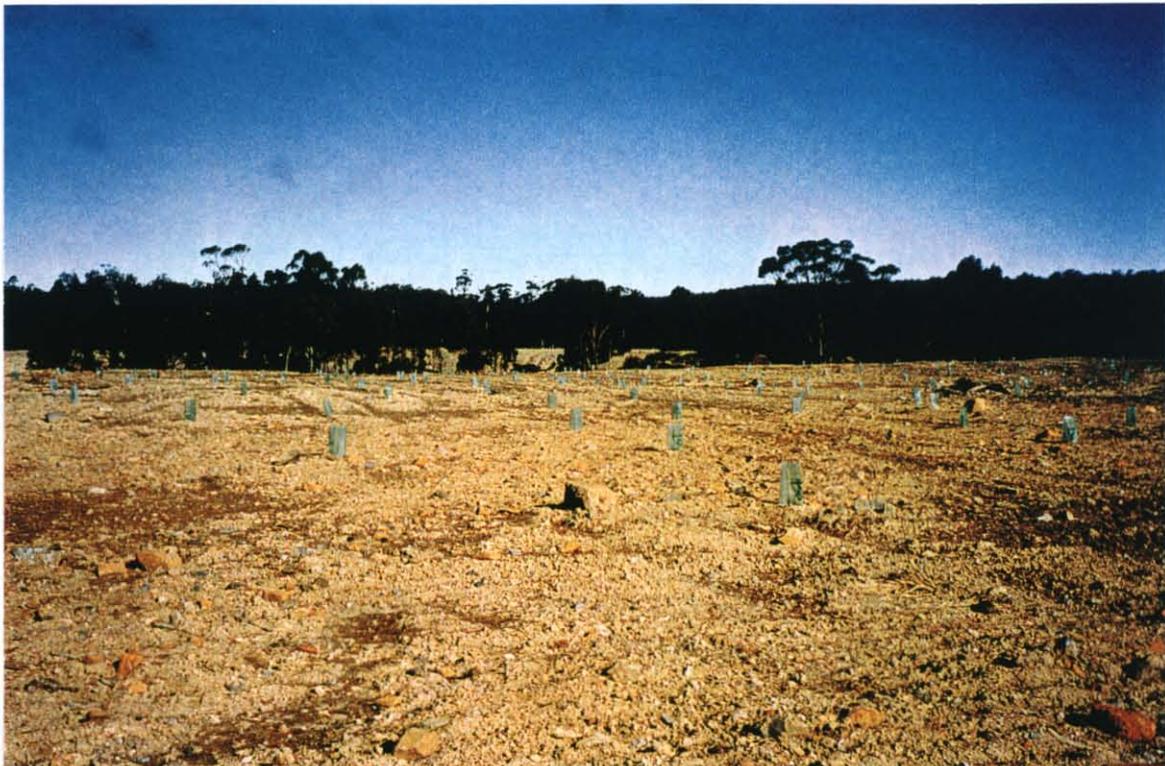
PHOTOGRAPH 7: SLIME TAILINGS DEPOSIT FOLLOWING CLAY COVERAGE AND REVEGETATION TREATMENTS. JULY 1997.

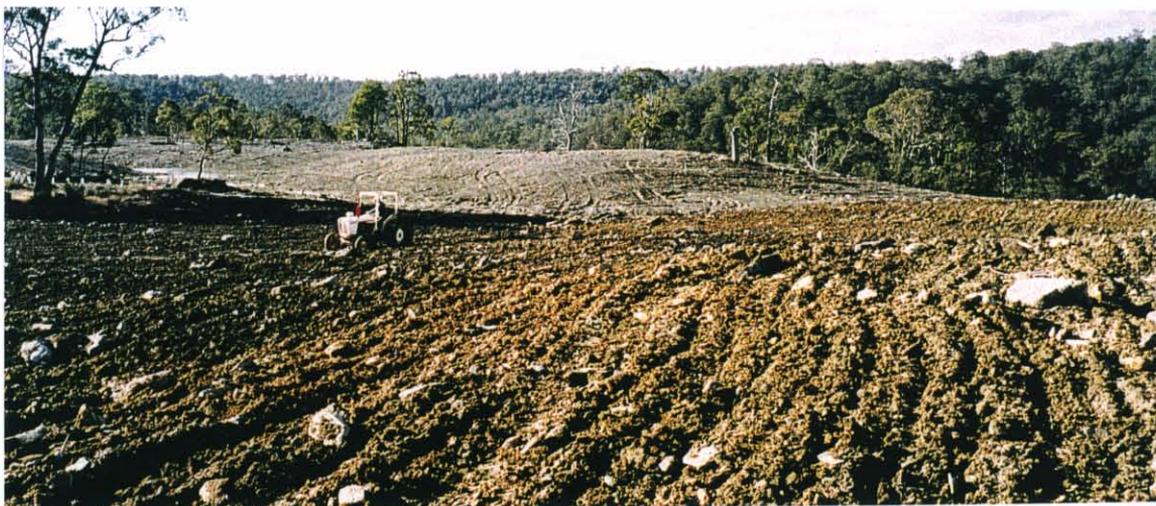
PHOTOGRAPH 8: SURFACE CULTIVATION FOLLOWING LIME AND FERTILIZER APPLICATION. JUNE 1997.

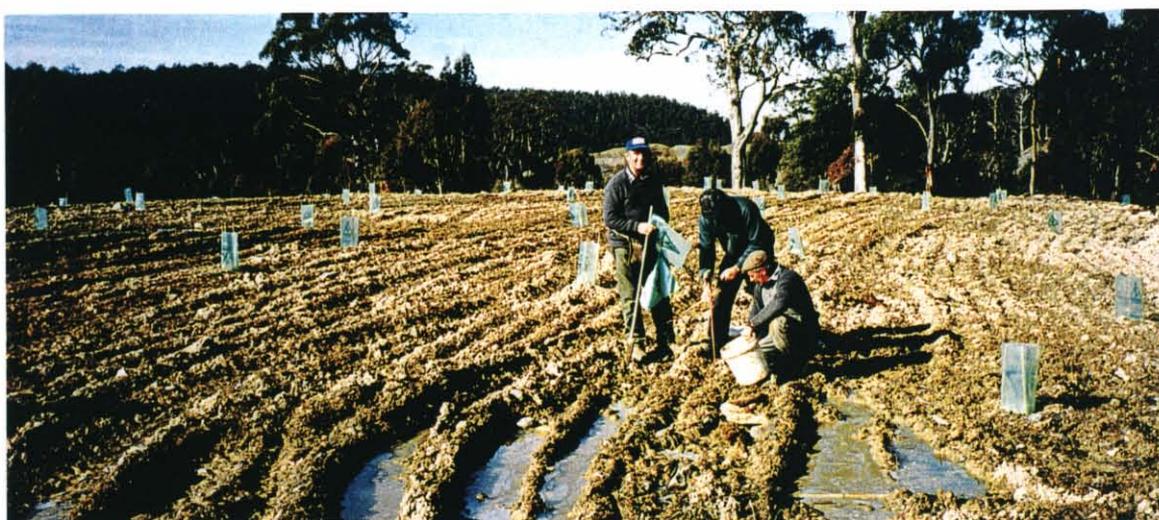
PHOTOGRAPH 9: SEEDLING PLANTING. JULY 1997.

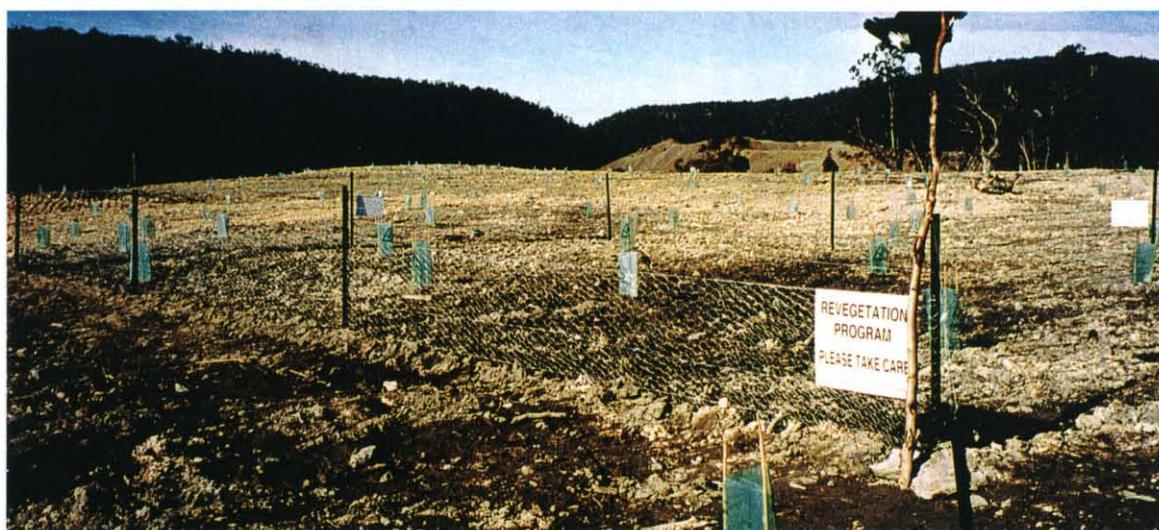
Native animals have already started to browse planted seedlings. Shooting permits have been obtained from the Forestry Corporation in order to implement limited control. Browsing will slow down site recovery significantly.

PHOTOGRAPH 10: BROWSING ANIMAL-PROOF FENCED PLOT. JULY 1997.
