MINERAL RESOURCES TASMANIA

REHABILITATION OF ABANDONED ALLUVIAL TIN MINES

Stage 1- Rehabilitation Concept Plans

*Project No: 13193
November 1997*

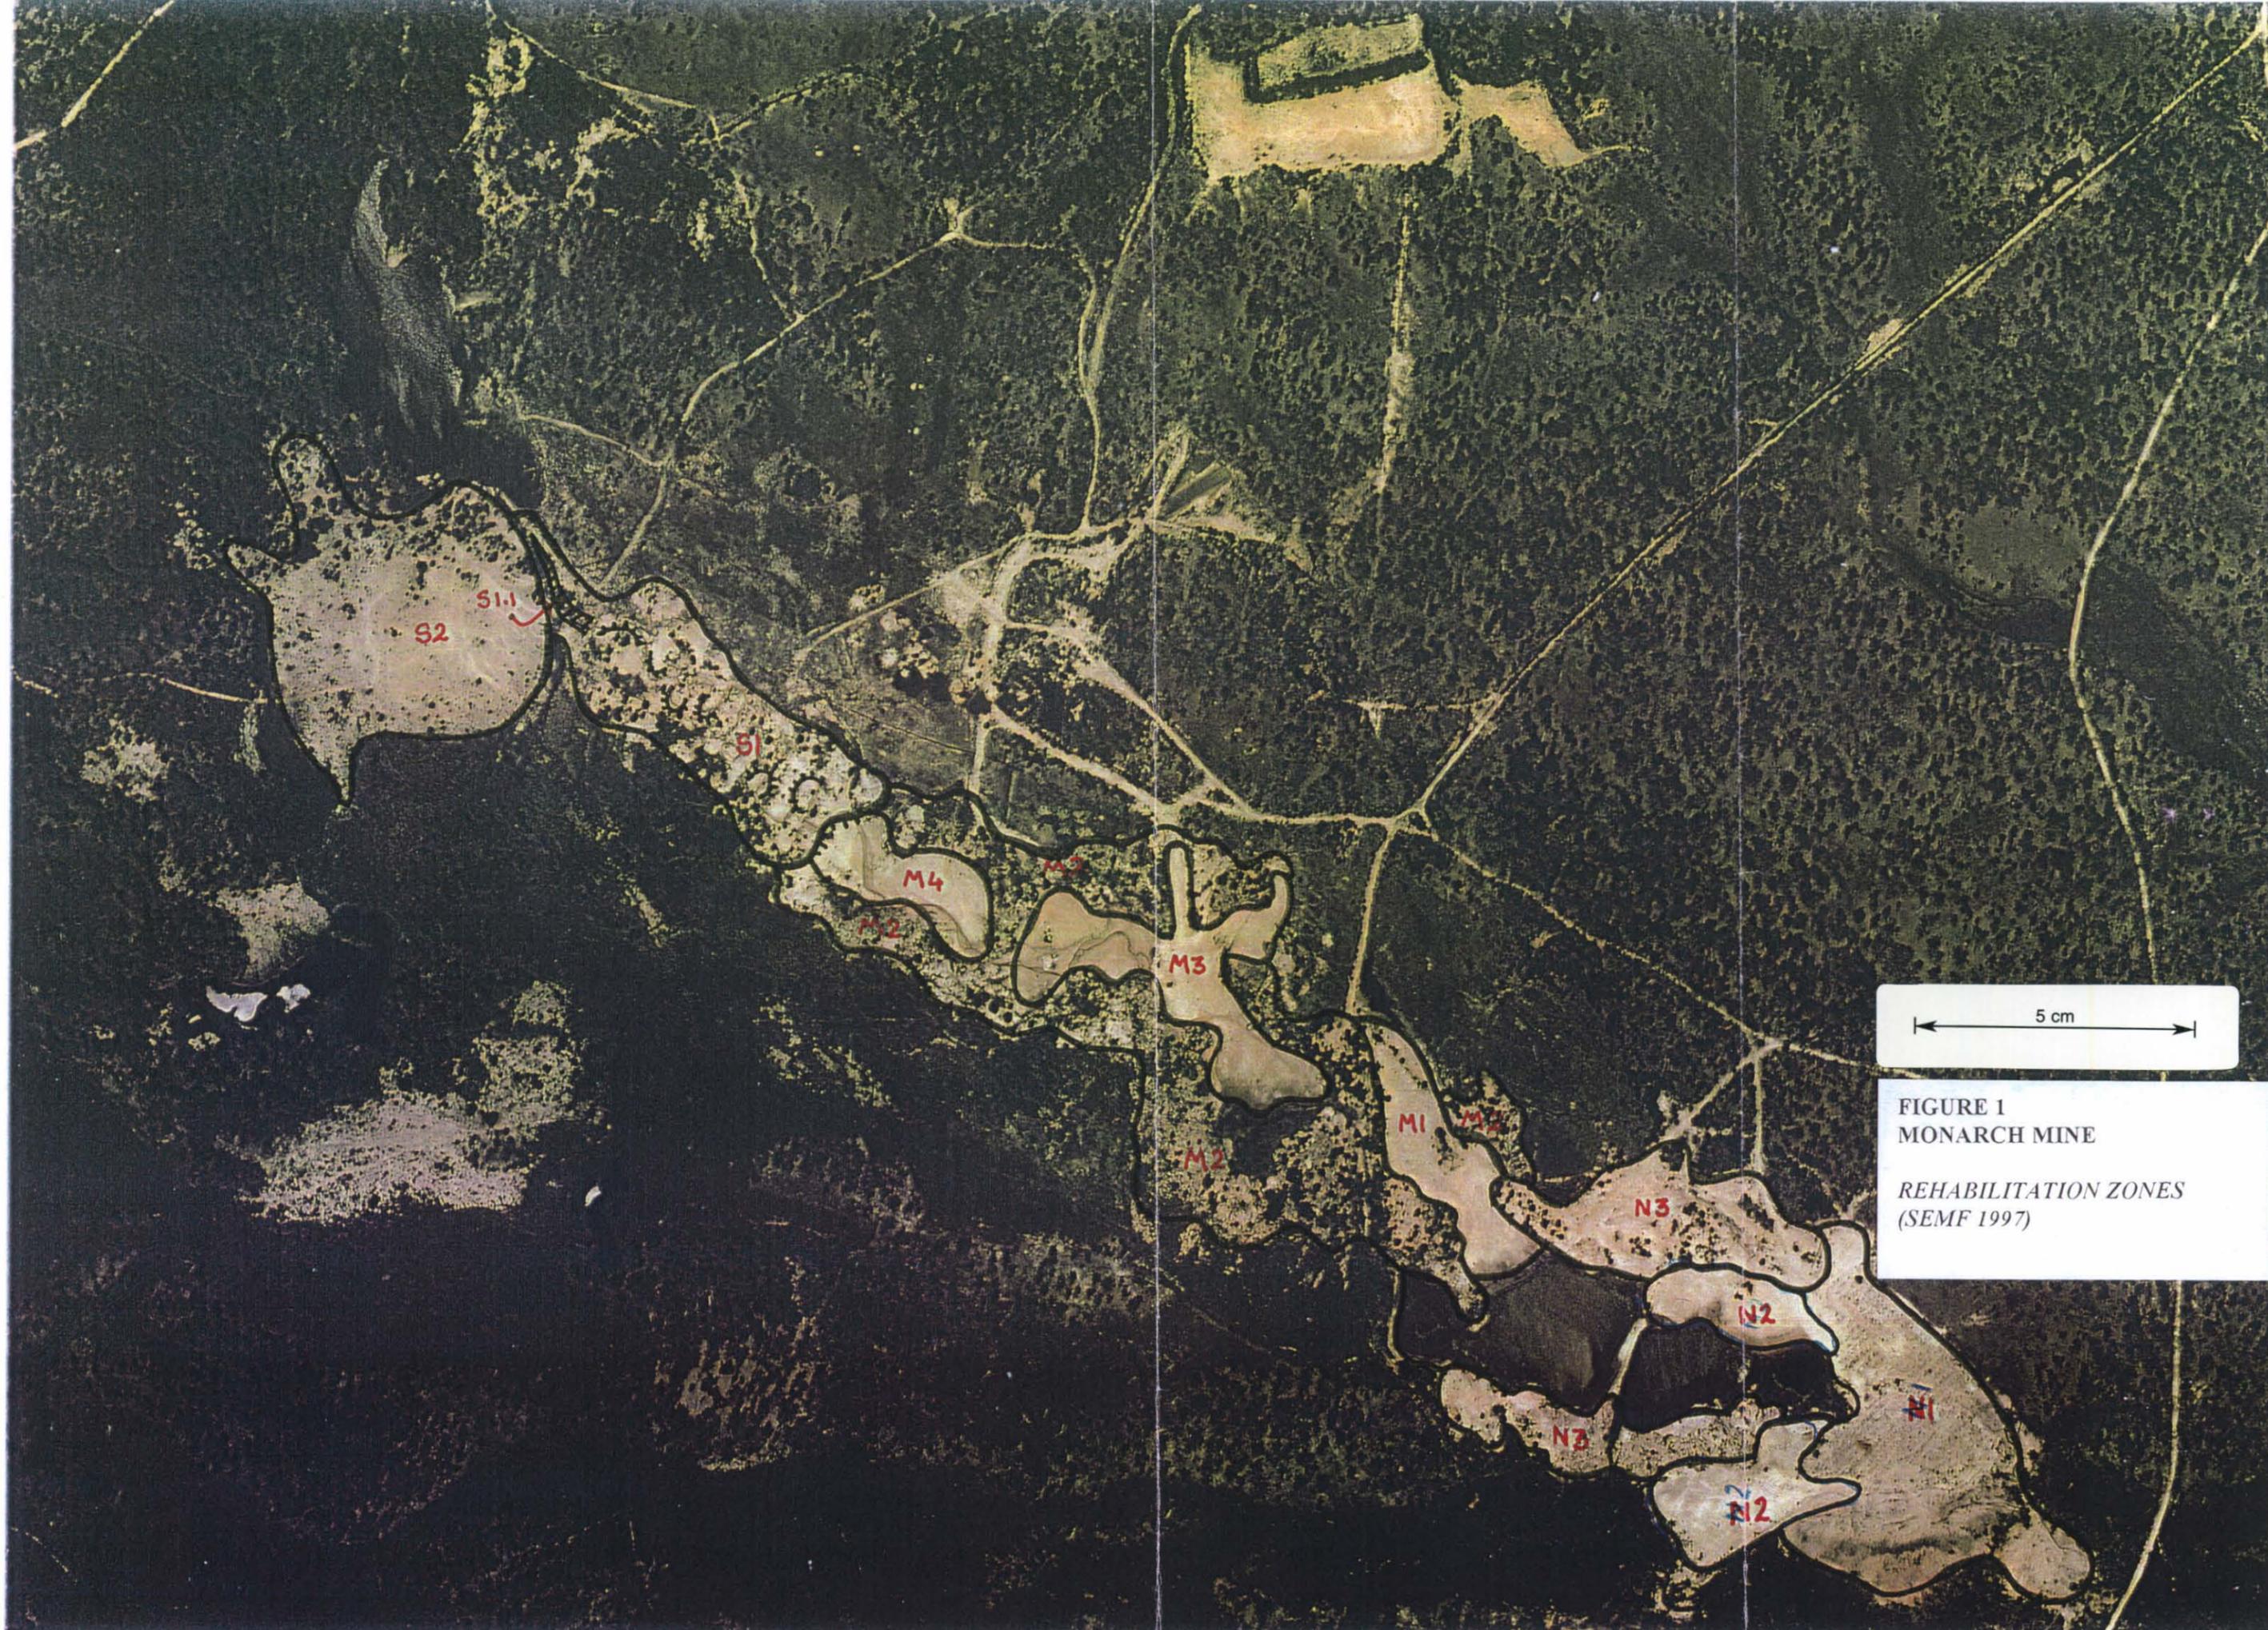
FIGURE 1
MONARCH MINE
REHABILITATION ZONES
(SEMF 1997)

This extensive central gully is approximately 78 metres in length, 8-12m wide and at it's maximum 12 metres deep. The gully is considered extremely active with extensive recent

slips and movement at both ends of it's length. The area is considered highly dangerous given the nearby School Camp and motorbike activities. Further, the significant sedimentation created by this channelling activity is impacting downstream areas and habitats.

This area is characterised by flat plain gravels with 5-8% organic and 15-20% clay content. Upstream erosion and moderate gullying have resulted in significant sedimentation within the area. The control of the sediment is important as it impacts upon a well structured downstream wetland. The border to this gravel plain is covered by mullock mounds which are 60-80% vegetatively covered and slowly encroaching upon the study zone. The placement of a settling pond upstream of the wetlands would significantly aid in sediment control.

This distinctive depositional gravel plain is surrounded by eroding banks (5-15 metres in height) to the south and east. Flowing across the zone is a central stream depositing significant sediment as in meanders. The area is generally highly active with extensive upstream erosion and downstream depositional activities occurring.

This area is a meandering basin stream with gravel deposition along the banks. It has a significant abundance of new vegetative growth. At the time of inspection an extensive heath cover dominated the surface. Larger Casuarina's scattering this area have deposited extensive layers of soil binding nettles. *Gahnia grandis* is in abundant growth, preventing significant erosion and sedimentation from surrounding banks and gullies. If sedimentation from upstream "S1.1" can be prevented this area will form a stable creek system. At present any earthworks in this area could do more damage than good.

This area is classified as a depositional gravel plain with minor clay material. There is evidence of sheet erosion into area "S.1.1" occurring across the borders of this plain. Vegetative development across the area is very poor with Casuarina's representing the only significant species. Given the flat expanse of this area and nearby location of the School Camp, the plain would provide an ideal location for revegetation trials. These trials would assist in the prevention of water and sediment ingress into "S1.1" gully system, but would only be a success if motorbike use can be kept of this plain.

This flat plain of depositional gravel borders a well defined wetland system to the east and the area "N1" to the west. Vegetative growth across this zone is sparse with little or no mature species and very few seedlings. The coarse gravels are poorly consolidated and are virtually free from clays, sands and organic materials. Ripping and fertiliser application may alleviate these problems, however as the area is utilised extensively by motorbikes such rehabilitation would prove fruitless. There was no evidence of erosion or off site sedimentation coming from this area.

The area defined by "N3" is composed of undulating mullock heaps (1-4 metres height). These heaps are largely gravel but contain some binding clays which are assisting in site stability and vegetative growth. The basins of many mullock heaps contain minor wetland ponds and from these areas new vegetative growth is occurring. The "N3" area is bordered by invading, well established bushland.

This area of gravel plains/fan is surrounded by dense vegetative stands. The area has minor 4 x 4 and motorbike activities that do not appear to impede the poor vegetative growth. Minor gullies exist in the upper levels of the fan, creating sediment depositions in the lower

This gently sloping area of coarse depositional gravels is characterised by poor vegetative growth and minor wind blown erosion. Past revegetation attempts have proved largely unsuccessful. This is partly attributed to the lack of clay fines and organic material within the soil and the motorbike activities of the area. Any sediment eroding from this zone does not have a significant impact on regional waterways as it is collected downstream by a well functioning wetland system.

This area was classified as a very stable undulating gravel/clay region, with little off site or border impact. Casuarina stands in the order of 3-6 metres, cover the area and impede any 4 wheel drive or motorbike activities (none were noted). Evidence of rabbit browsing on new growth was observed and warrens appear in the moderate gullies that flow into area. Casuarina nettles were stabilising gravels across the site, providing much needed organic material to the underlying substrate. Abundant marsupial activity was noted across this site.

The most viable solution to alleviate the problems associated with the active system lies with the construction of a 3-4 metre gabion wall at the gully exit point, this combined with the placement of dolerite quarry rock (300-1200mm) along the gully base will allow sediment to settle out in the gully, slow the impact friction of inflow water and eventually lead to the ponding, sedimentation and stabilisation of the gully structure.

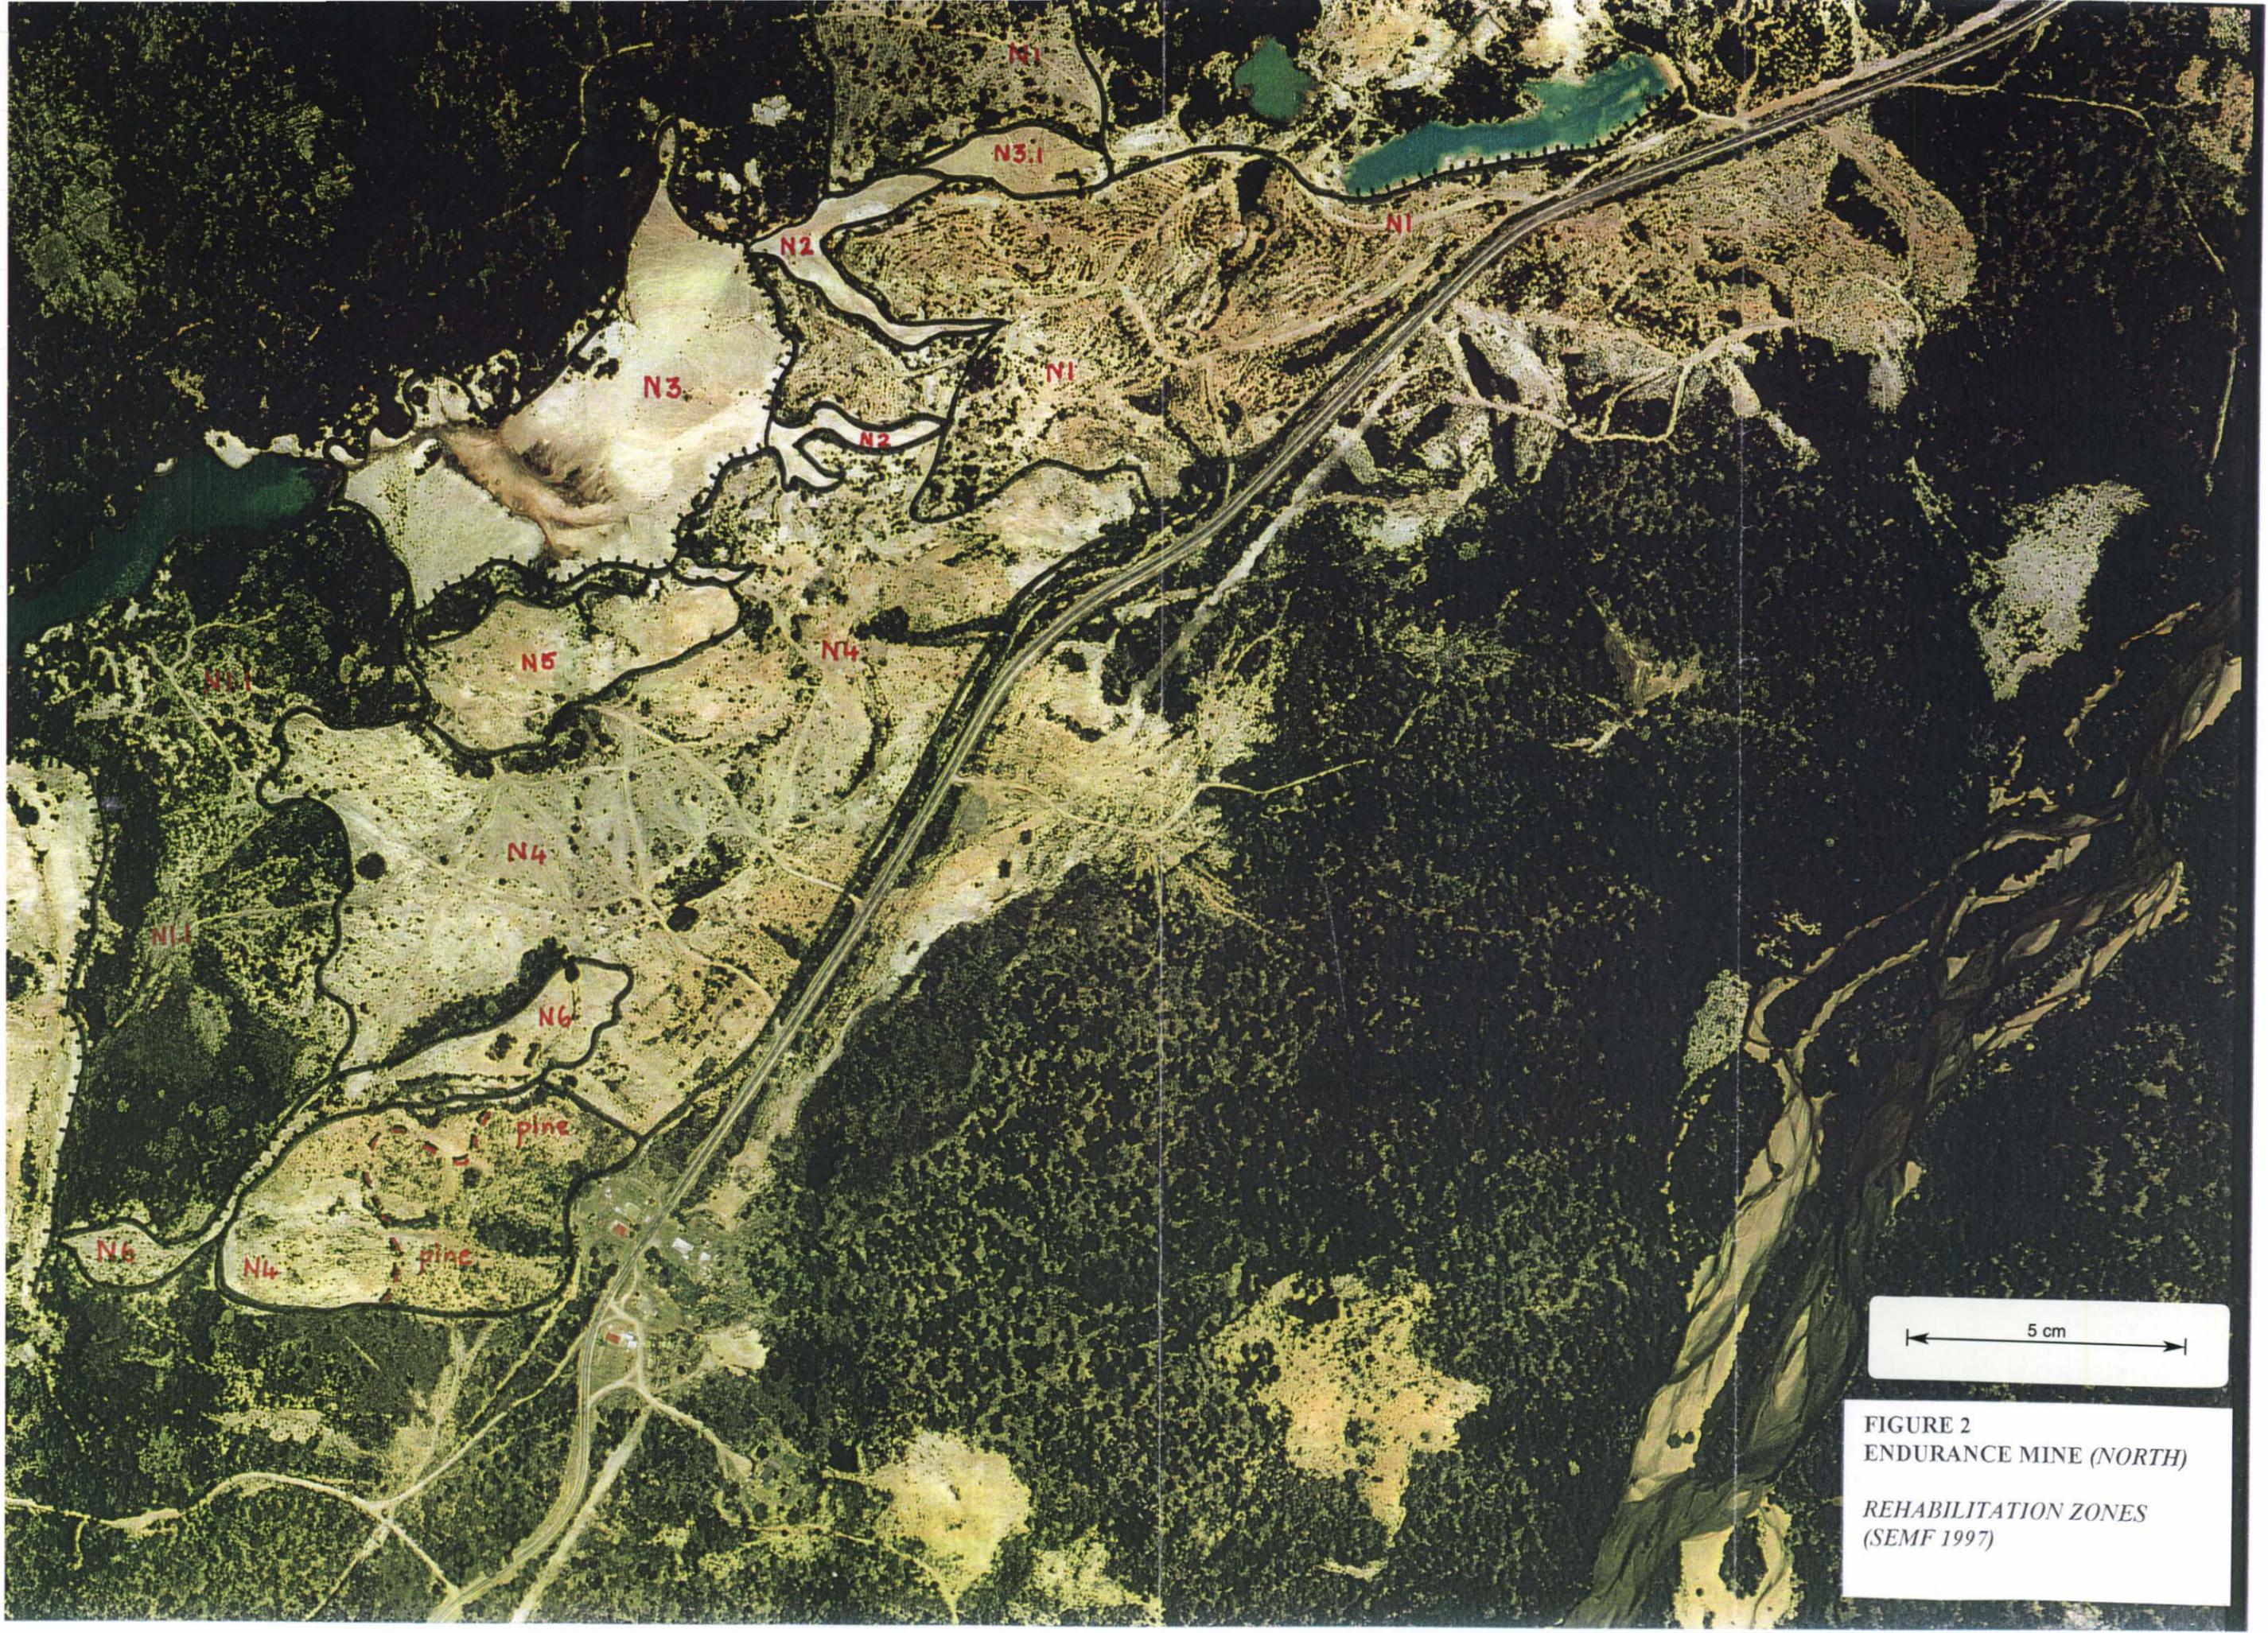
FIGURE 2
ENDURANCE MINE (NORTH)
REHABILITATION ZONES
(SEMF 1997)

A distinct area of gullying characterised by two distinct ravine systems operating off a well revegetating escarpment. These fast moving gullies have similar upslope stratigraphy, with

a 120-340mm gravel top layer underlain by an extensive clay/kaolinite layer 2-8 metres in thickness. Due to the fast activity of gulying, little vegetation survives across this region and down slope sedimentation has led to an extensive depositional fan. The origins of this landform appear to lie in water movement over an elevated layer of gravel tailings. High flow water activity has resulted in the continual erosion of upslope clay subsoils. The area is extremely dangerous for both recreational activities and machine based revegetation attempts. As such alternative land stabilisation techniques should be utilised, which may include low shock blasting.

This moderate east / west gully system has sparse vegetative cover across it's gravel and interspersed clay soils. Insipient gullying off the central system combines with extensive sheet erosion to create significant down slope sedimentation. The main vegetation is *Pinus radiata* and interspersed Acacia spp. The area lacks vital nutrients as evidenced by the slow vegetative growth and yellow appearance of tree leaves.

This area is similar to N6, with regard to vegetation cover and sheet erosion, and consists of sloping ground to cliff edges at location N3. Vegetation consists of interspersed *Pinus radiata*, Acacia spp, Eucalypt spp, and Casuarina's. In general the area is unstable and prone to growing gully erosion. Considerable domestic garbage was noted across the site.

A characteristic depositional plain of gravel tailings with little or no clay or organic material. As a result the zone is largely void of any significant vegetation. Moderate levels of erosion occur across the fan but appear localised to the "N1" escarpment. A small wetland system exists on the down slope assisting in the control of wind or water borne sediment migration.

A depositional plain of gravel tailings with little organic material but some clay deposits. The zone is similar to that of N3 but with increased clay levels and associated vegetation. Moderate levels of erosion occur across the fan but appear localised to the "N1" escarpment. Additional NPK application and ripping should see this area continue to stabilise.

An expansive area characterised by gently undulating topography and gravel/clay soils. Most vegetation is under 4 metres in height and comprised of *Pinus radiata*, *Eucalyptus amagdalina*, *pulchella* and *Acacia* spp. The area contain a numbers mining relics of (1960-70) and considerable domestic waste including an illegal tip site. Erosion and associated sedimentation is moderate but confined. The level of vegetative development appears to be keeping pace with erosion and sedimentation activities. Some insipient gullyng may require earthwork intervention to ensure the area remains stable.

An area similar in landform to "M4" characterised by gravel/clays, undulating landforms, some moderate perimeter gullying and older well established vegetation. The gravels across this zone have been stabilised by clay and organic material, which in turn has led to a thickening of vegetative undergrowth of Acacia, Eucalypt and Casuarina species. Whilst moderate gullying is occurring, the density of vegetation is ensuring that landform stability is maintained. As there are a number of degraded roads across this site thought should be given to ascertaining which are used for fire fighting purposes and which can be closed and ripped for revegetation.

A gravel based plateau with rich organic laced gravels and mature Banksia spp, Casuarina spp. and *Eucalyptus amagdalina*. The area is producing abundant seed and has no evident erosion or sedimentation. No further human input into this area is required at this point in time.

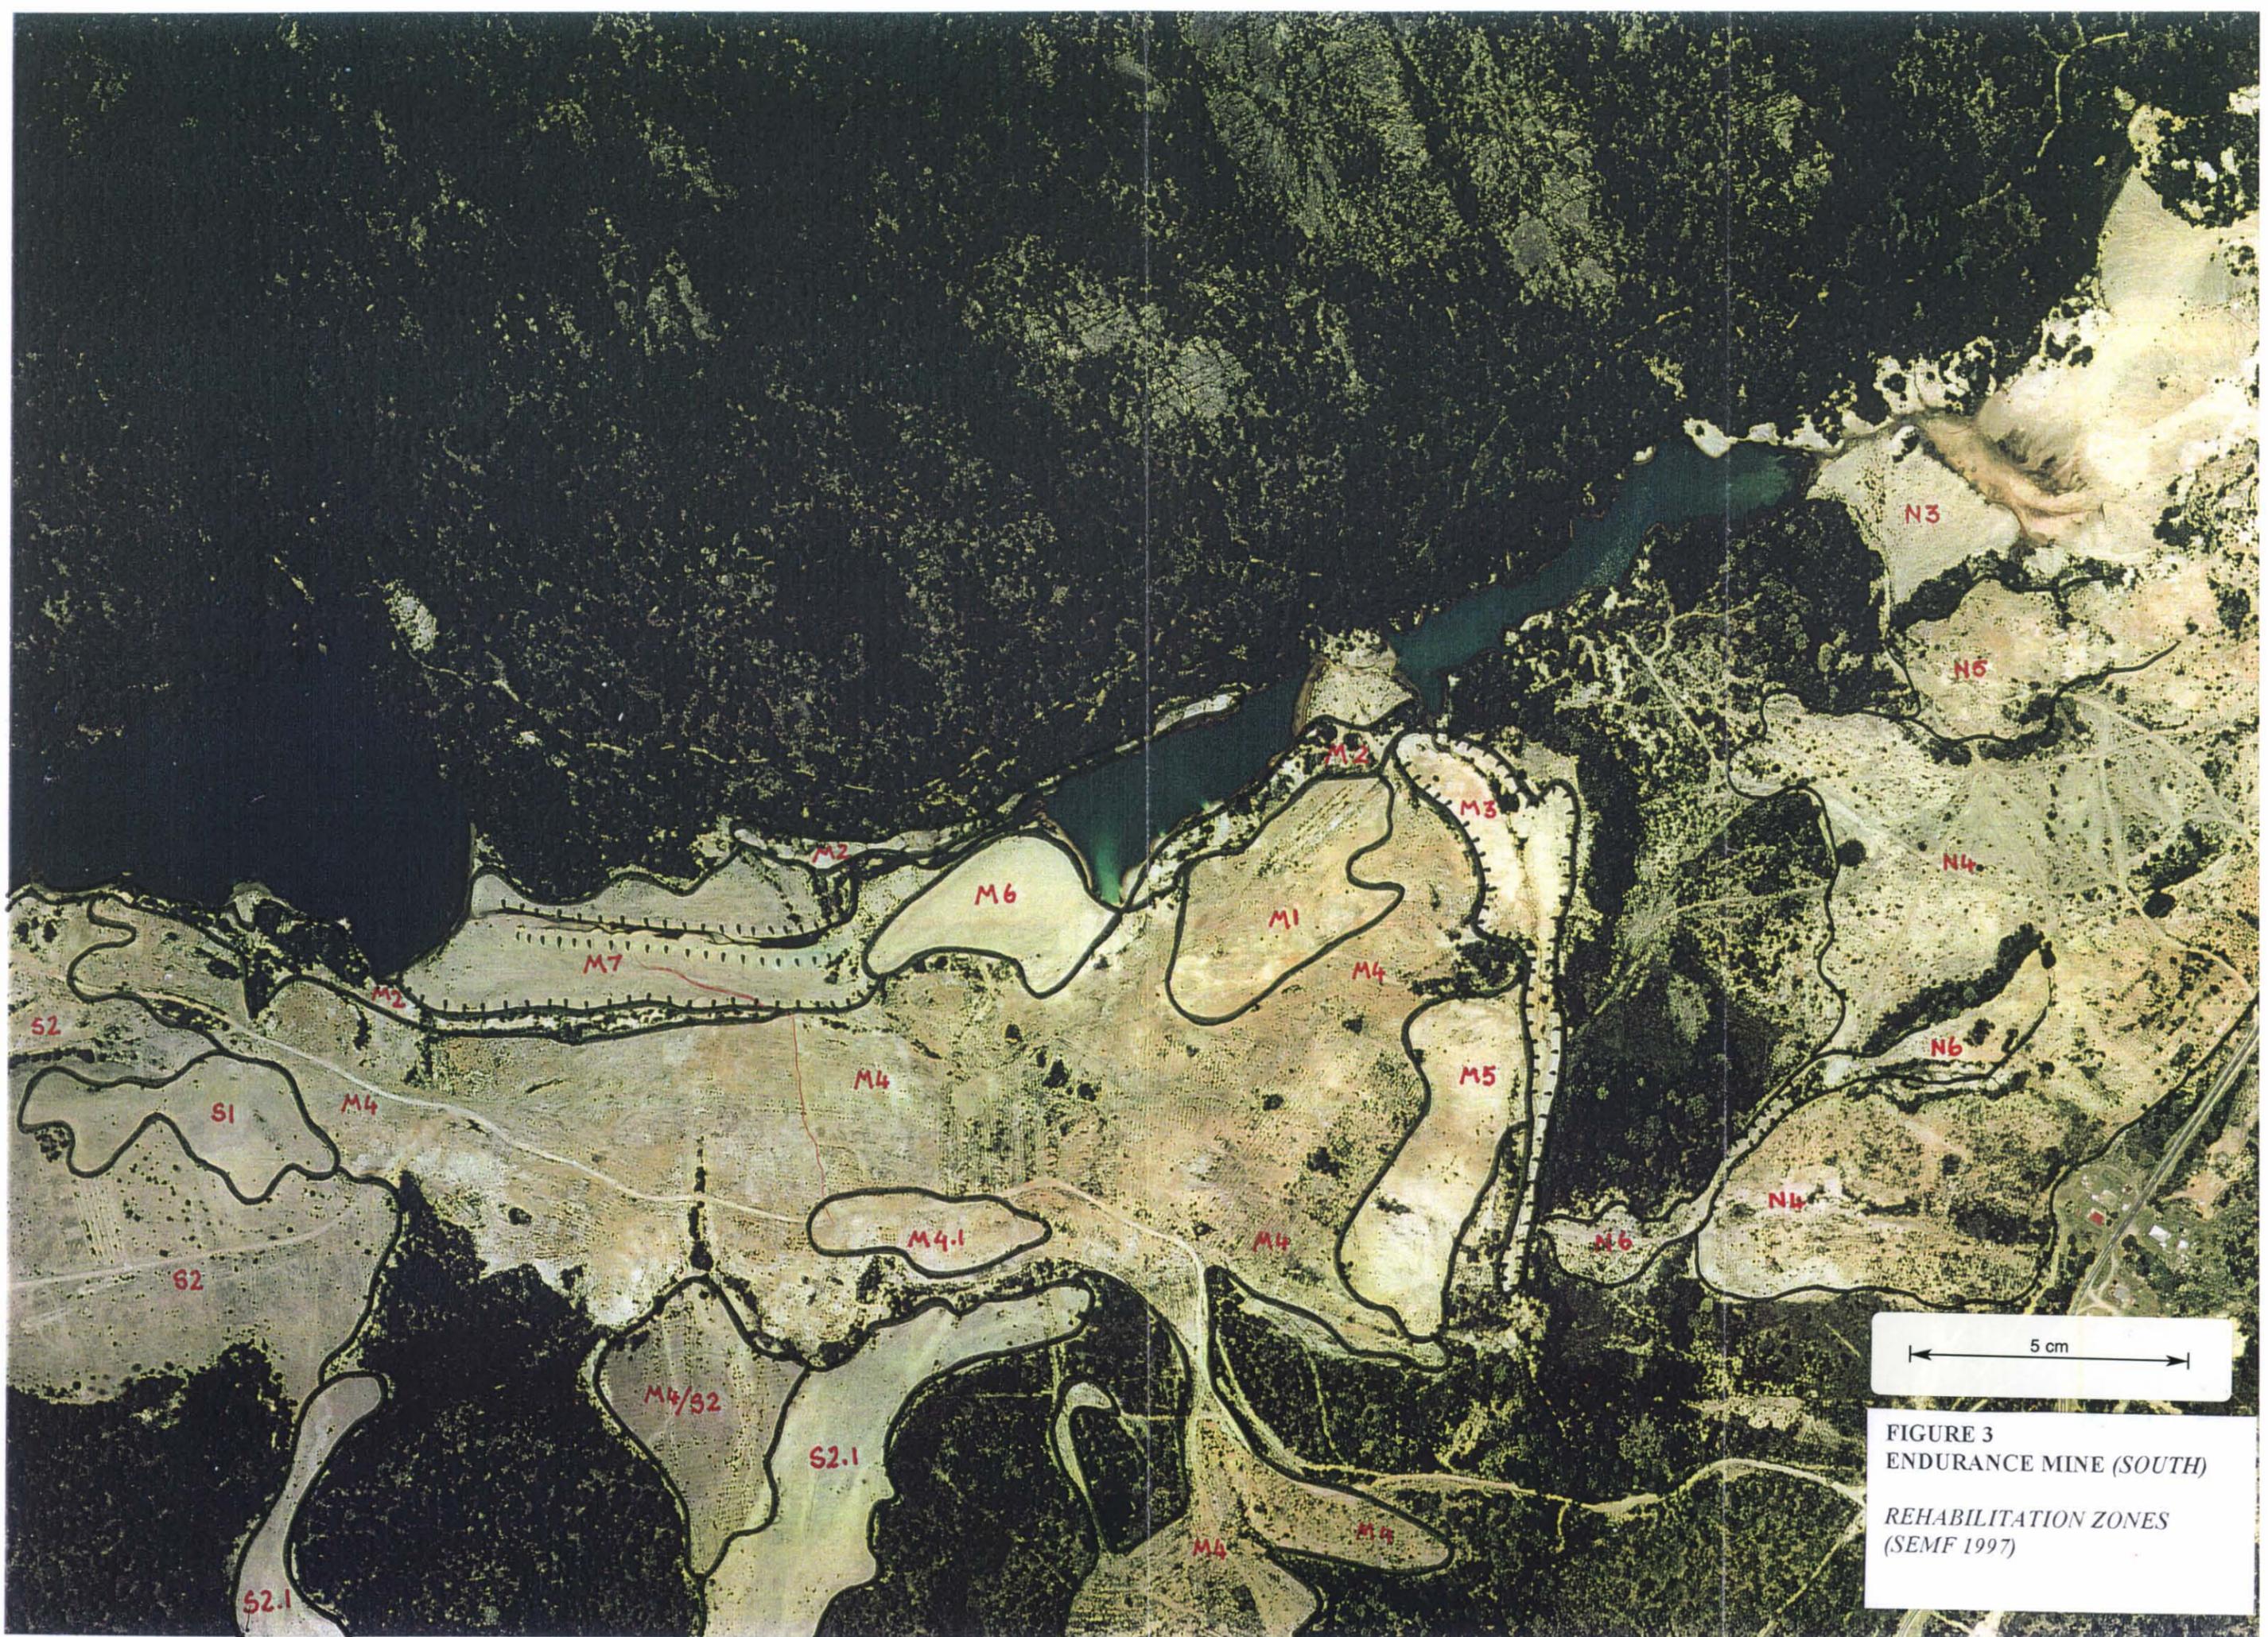
FIGURE 3
ENDURANCE MINE (SOUTH)
REHABILITATION ZONES
(SEMF 1997)

The "M3" area represents the largest gully system across the three mine sites. This highly active central gully is located between a well established Eucalypt/Acacia forest to the east and the extensive revegetated area of "M4" to the west. Central to the gullies erosion and original formation, is a stream flowing along the gully floor southward from the South Endurance lake. Approximately 15 main spur gullies are moving laterally off the central channel westward into well established revegetation. Surface gravels in this area have approximately 20% clay content, once this binding matrix is breached a highly friable kaolinite layer is exposed. Vegetative development is minimal due to the fast eroding surface. Possible remediation activities may include water diversion at the lake entrance and active excavator works on the lateral gully systems.

An expansive area of depositional coarse gravels (1-3 metres in depth) with little clay or organic material. Resultant vegetation is sparse and dominated by Acacia, Casuarina spp. and an unknown heath. This depositional area is bordered by native bushland and despite the ready supply of seeds natural revegetation is not occurring. A standard application of NPK is required to boost this area which is devoid of nutrients. The southern perimeter of the zone is bordered by a small creek, which receives surface and sub surface drainage from the zone. At strategic points across this creek evidence of acid drainage and resultant metal precipitation was observed.

A sample of this creek water was taken and analysed by the DELM laboratory for pH, metals and Sulphate, the results of this analysis are shown in Appendix D. Of immediate concern with regard to this sample is the presence of Aluminium in soluble form (pH 2.8) at a level 10,000 fold above the acceptable ANZECC limits for fresh water.

This area is a riparian escarpment bordering the adjacent lake system. The dominant gravel surface appears to have received clay and organic particles from the surrounding "M1" or bush areas. As such the soils are richer and support a variety of mature vegetation including Acacia, Casuarina and Eucalypt species. Unfortunately high flow events off the southern plains and northern bushlands combined with the proximity of the escarpment have led to relatively recent perimeter erosion along the lake borders. Recent slips suggest this activity is increasing into established vegetation stands. As with a number of areas, once the gravel capping is breached the kaolinite based subsoils erode rapidly.

This area is a gravel plain similar to M4 in it's topography, stratigraphy and landforms. However this area has not received the same attention as the latter with little NPK or vegetative input. As a result it is distinctively barren when compared to the latter area. Insipient gulling is occurring across the eastern fringe of this zone where it borders the extensive gully system of area M3. With little prospect for rapid vegetative development and with increasing gully activity the area requires earthwork intervention to stabilise eroding landforms.

An extensive gravel (tailings) fan ranging in depth from 8-10 metres with little or no clay or organic material. Westward water migration via lake overflows has carved a linear channel over 105 metres in length. The unconsolidated sediments are in continual migration resulting in a plain devoid of vegetation, similar to coastal coarse dune systems. The area is subject to lateral gullying, however these are not impacting extensively upon revegetated areas.

A characteristic depositional fan of gravel tailings with little or no clay or organic material. As a result the zone is largely clear of any significant vegetation. Moderate levels of erosion occur across the fan but appear localised to the escarpment. Extensive motorbike activity across the area appears to have little negative impact.

A gently sloping gravel plain with 20-30% clay content. The northern border of the zone contains extensive small gullying as it moves onto the lake border escarpment. A low density of vegetation was observed, however what has developed (above 2m) appears healthy. Moderate 4 wheel drive and motorbike activities appear to impact upon new vegetative growth as does an extensive rabbit population.

This small gravel/clay area sloping southward at 8 degrees, has been subject to extensive ripping and revegetation activities. Unfortunately revegetation attempts have been largely unsuccessful although ripping activities have assisted in land stabilisation. The area requires reseeding and NPK application to promote vegetative development.

A localised area of coarse elevated gravels utilised extensively by motorbikes. This activity combined with poor water retention (coarse gravels), and with little or no organic or clay material has led to an area devoid of vegetation. Despite these negative attributes, bike activity at Endurance is confined largely to this zone, where makeshift tracks and jumps have been developed. These activities are actually creating gentle slopes, preventing gullyng and off site sediment migration. Revegetation activities and associated earthworks are not recommended.

An expansive flat gravel/clay plain with an average slope of 4 degrees, covers approximately 55% of the South Endurance mine area, predominantly across the central plateau. The area contains most of the sites mining relics. This area has been subjected to extensive ripping and revegetation (species include; *Acacia mucronata*, *verticillata*, *longifolia*, *Restio tetraphyllus*, *Gahnia grandis*, and various *Leptospermum* and *Mellaleuca* spp.). These activities combined with natural regeneration has created a stable landform with sustainable vegetative development and little erosion, sedimentation or gullyng. Areas of denser vegetation located across this area provide a habitat for native fauna and a floral seed source.

Unfortunately lateral gully erosion from perimeter areas including "M5", "M7", "M3", "M1" and "M2" are jeopardising the viability of this landform. As this is the largest stable zone across the mine area priority should be placed on addressing the worst of these lateral gullies (As detailed in sections above).

An area similar to "M4" in that it is a gently sloping landform that has received previous ripping and revegetation. Unlike area "M4" it has coarser gravels, no clays, and little organic material. Resultant vegetation is sparse and dominated by Acacia and Casuarinas spp. Bordered by bushland, *Gahnia grandis* and an unknown heath are progressively encroaching across denuded areas and providing a promising outlook for site stability. In general the area is a stable landform with low traffic volumes, a number of safe mining relics and relatively low rates of sedimentation and erosion.

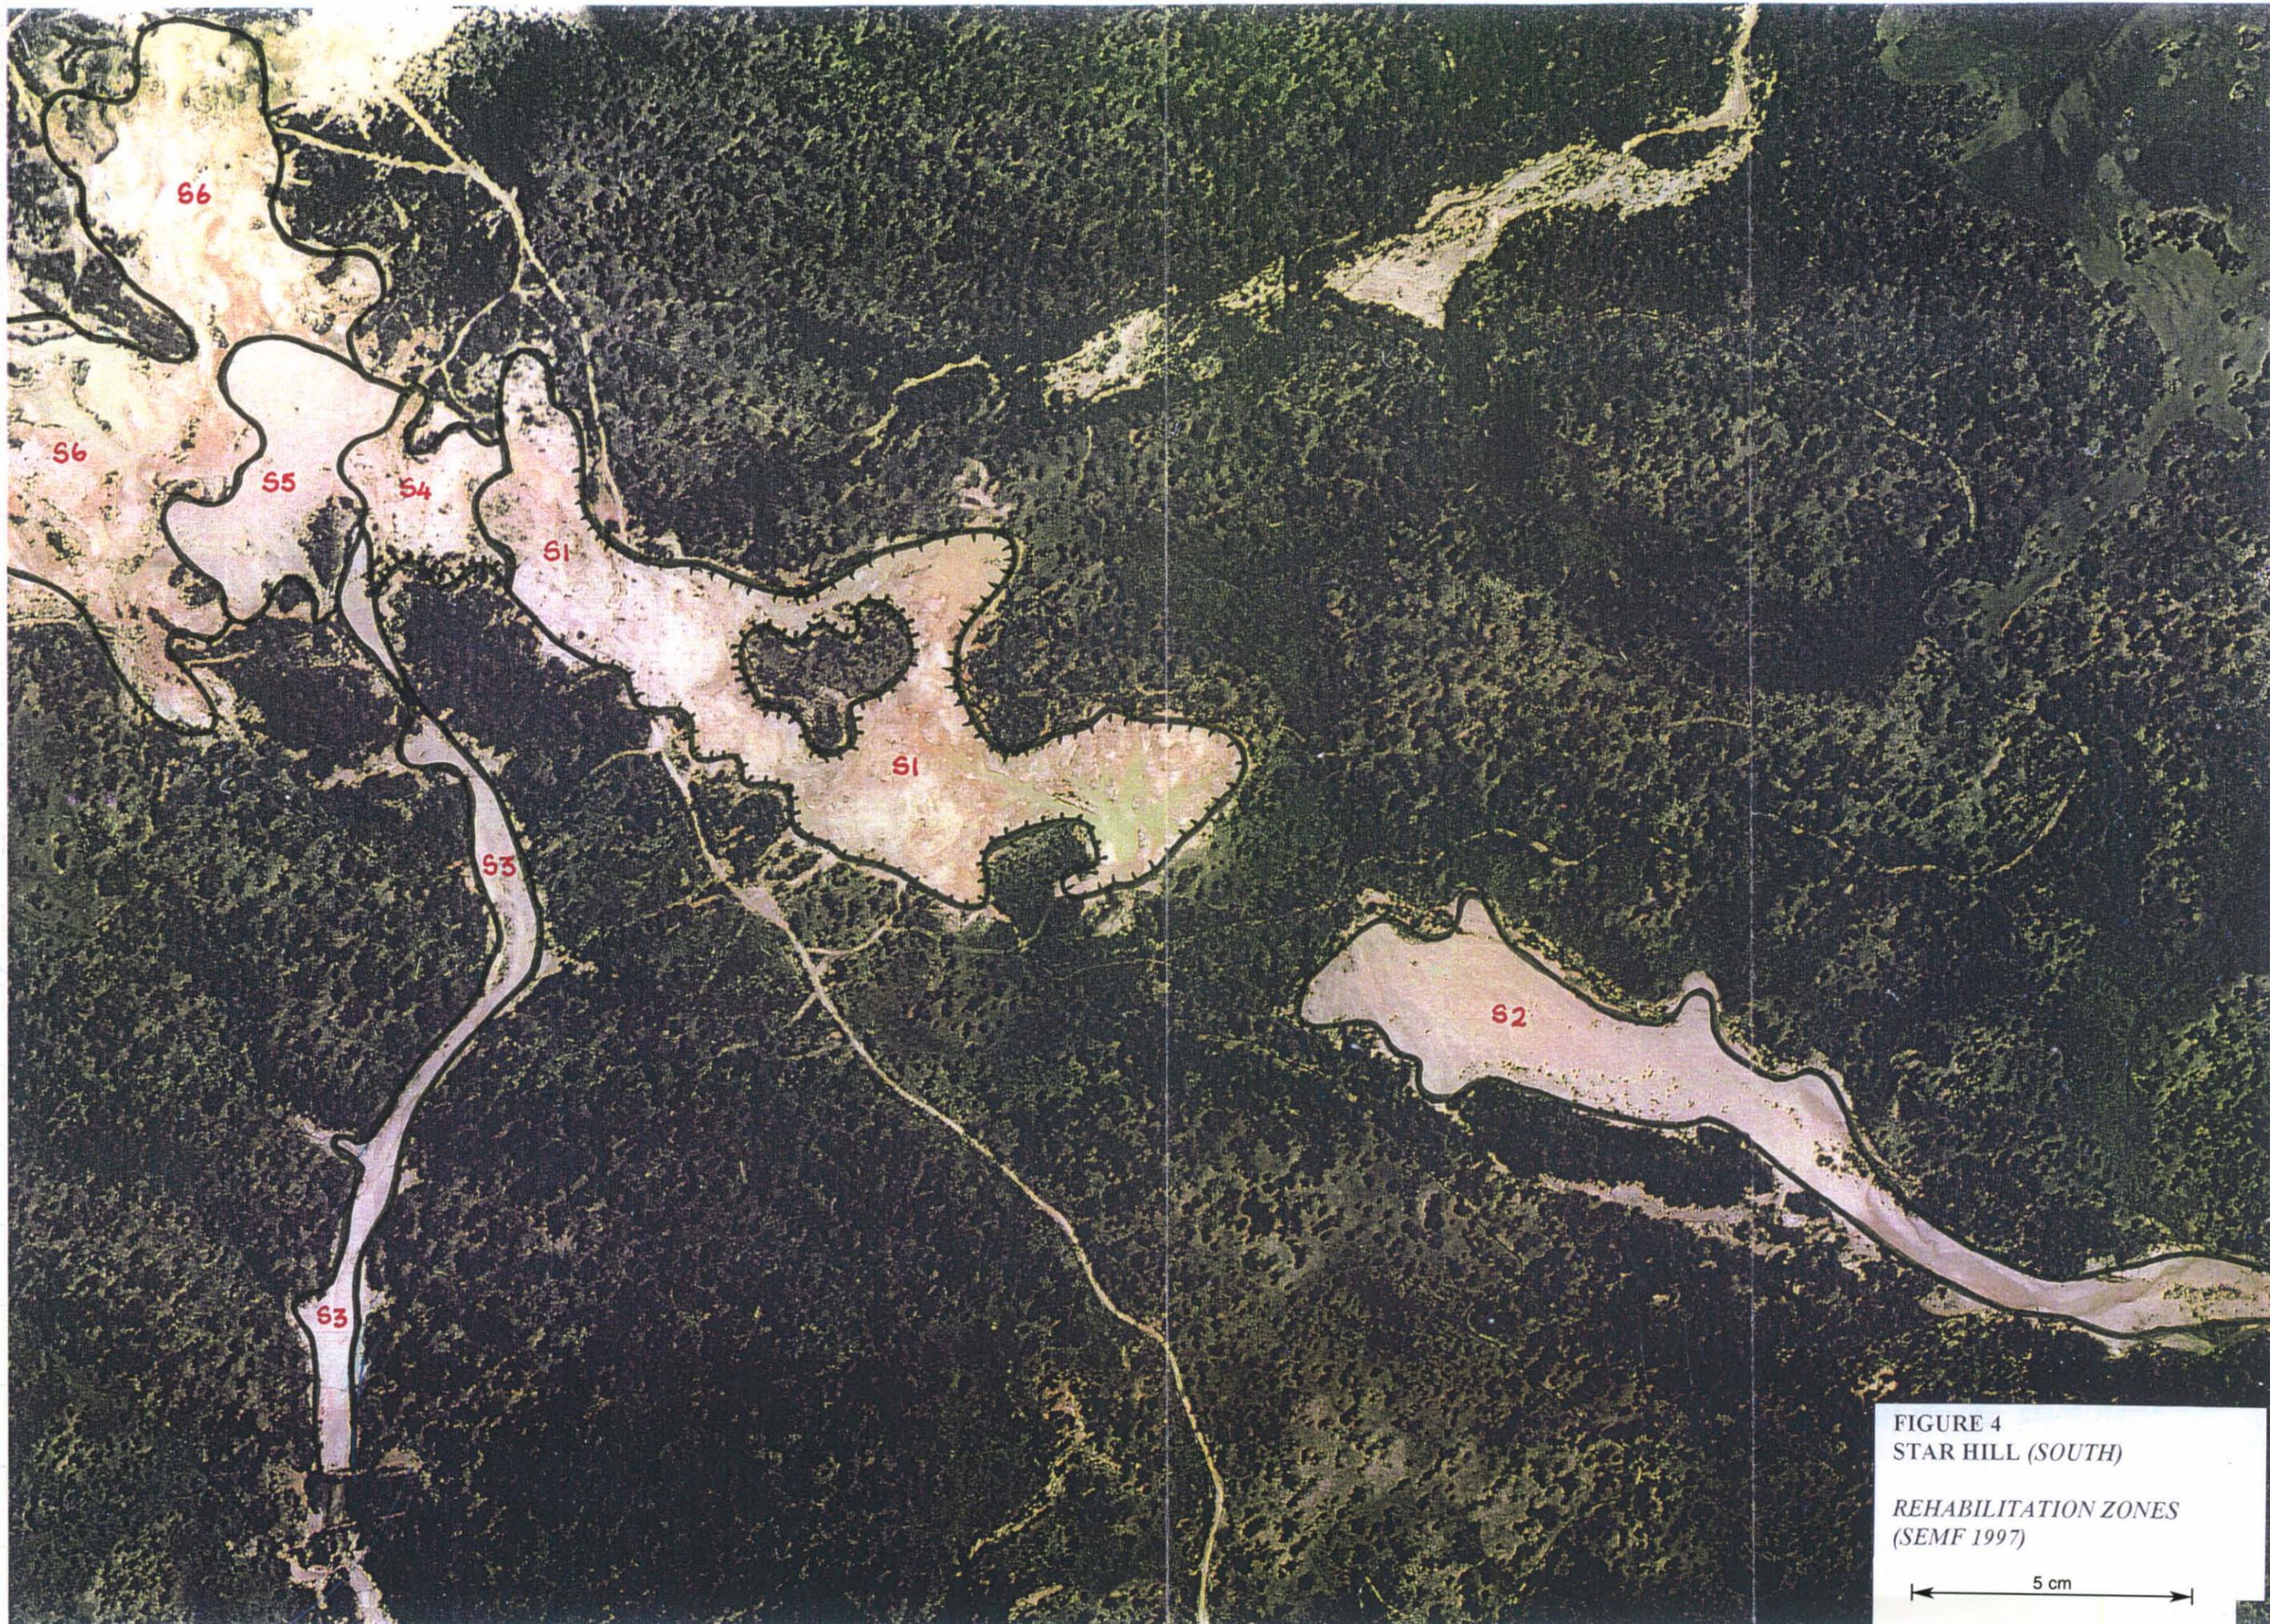
FIGURE 4
STAR HILL (SOUTH)
REHABILITATION ZONES
(SEMF 1997)

Area S1 forms the dominant extraction landform at Star Hill and is easily observed from aerial photographs. This area located on the pinnacle of Star Hill has been subject to extensive alluvial extraction activities leaving a resultant basin of highly friable sands. Significant wind and water based erosion has left a characteristic landscape of elevated vegetative islands, sand pans, iron pans, silt pans and silt lakes. The surrounding area and vegetated islands are dominated by *Eucalyptus amagdalina*, *Eucalyptus pulchella*, Casuarinas and Kunzea. The thickness of surrounding vegetation has prevented gully movement off this area and no "off site" active sediment deposition is occurring.
