Mineral Resources Tasmania
STORYS CREEK
PRECIPITATE DAM DRILLING
REPORT

29 September 1998

Mineral Resources Tasmania : Storys Creek
precipitate dam drilling report / John Miedecke
and Partners Pty Ltd 1998

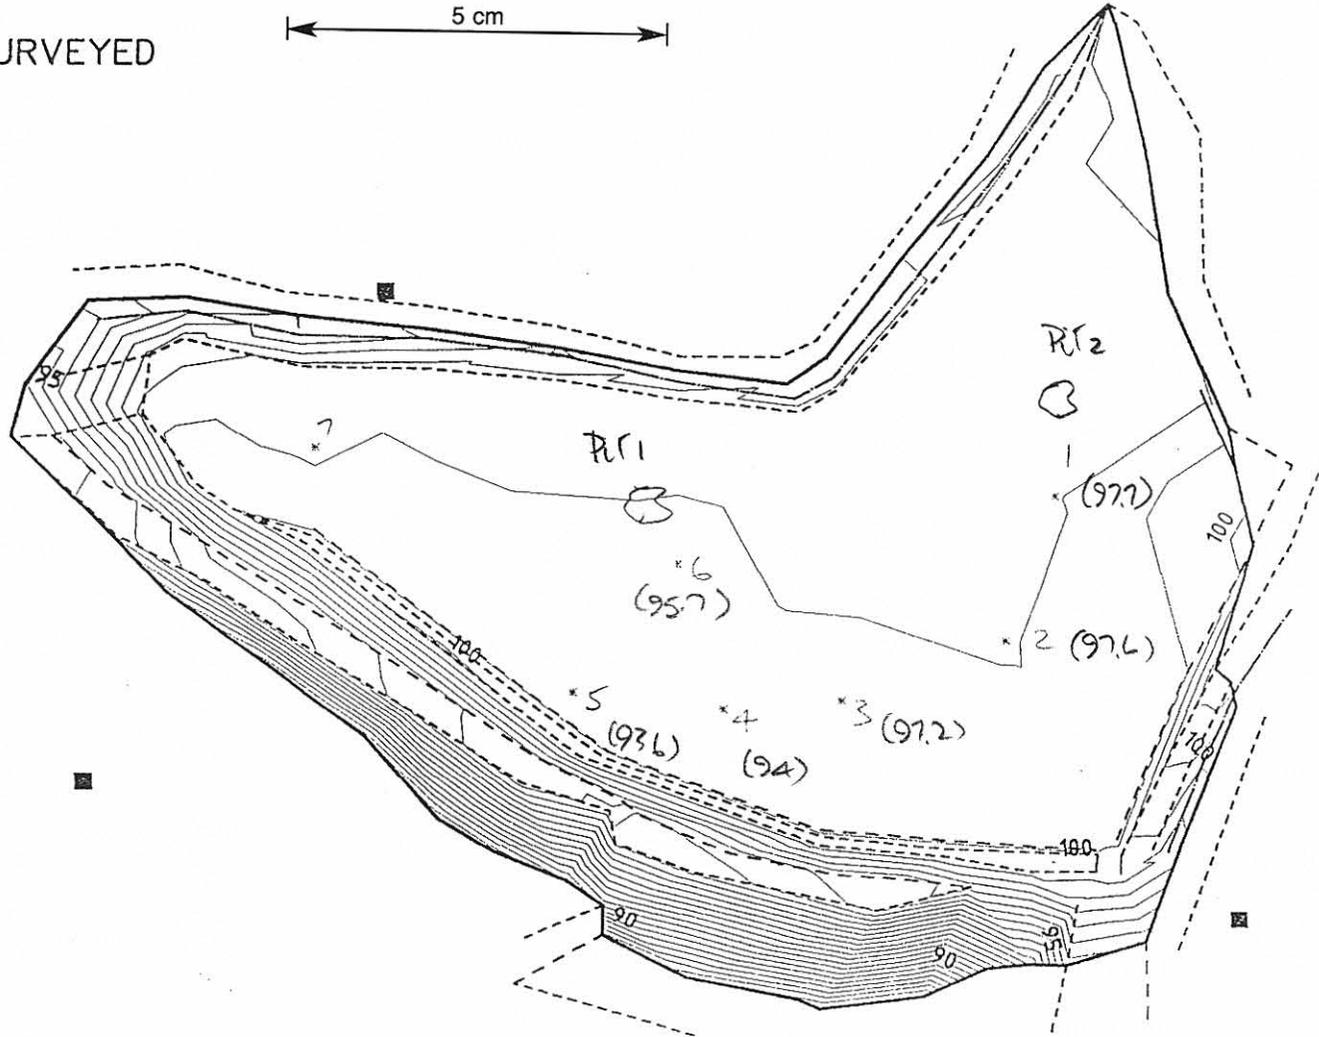
Storys Creek Precipitate Dam
Auger Drilling Location Plan

The location of the seven holes are illustrated on Figure 1 and the reduced level (to an arbitrary datum) surveyed. Each hole was logged and the results are shown in Table 1. The bottom of each hole was noted for quantity survey purposes. Composite samples were taken of representative materials throughout the profile for geochemical testwork.

The water table within the storage was monitored by measuring the standing level in the boreholes (water levels are noted in Figure 1). This indicates that the tailings dam phreatic level is quite deep near the embankment, but rises sharply away from it. This is consistent with a dam constructed by spigotting tailings from the embankment. Water movements are expected to be through the storage, and expressed as the leakage at the base of the dam wall.

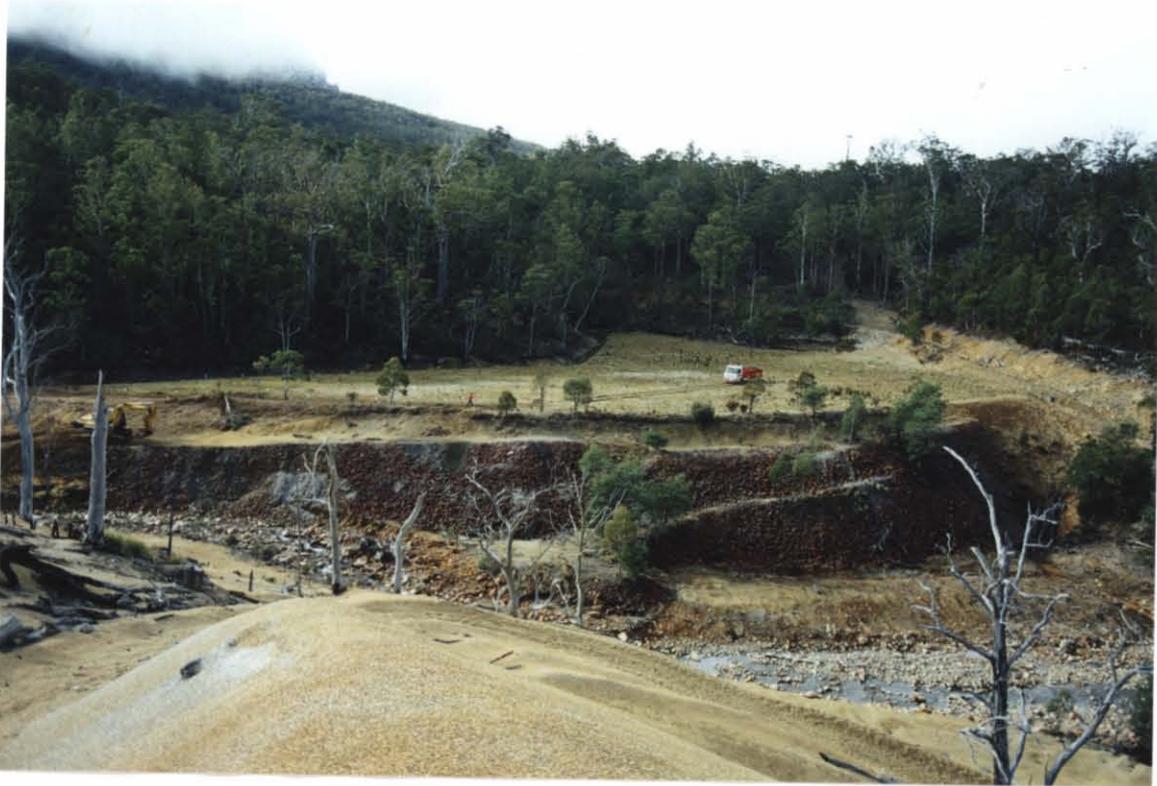
Photograph 1 Precipitate Dam Storys Creek, showing wall and surface

Pit 1 was comprised of sand sized tailing particles, with damp materials (presumably the water table) nearly at the bottom of the pit. A this layer of clay was underlain by a 300mm layer of fine residue (caustic soda precipitate) . Underneath this material was a consistent coarse tailing material. Photograph 1 shows the pit.

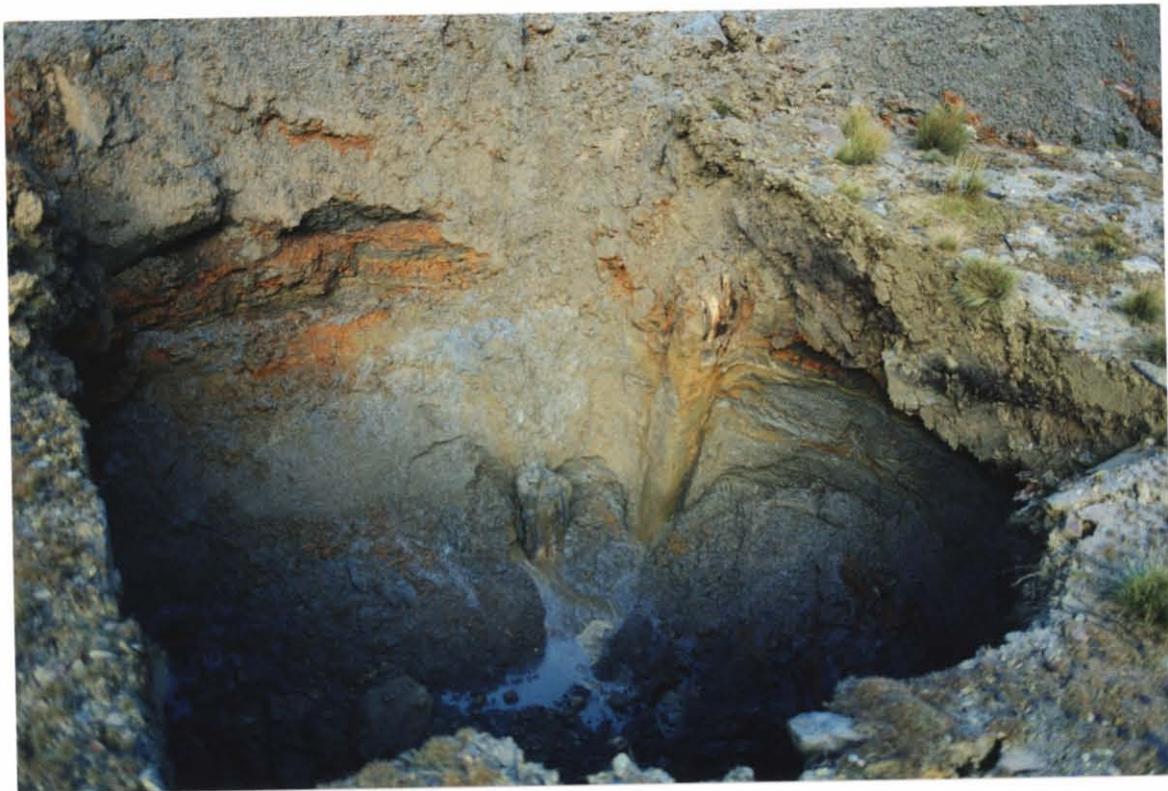
Photograph 3 Precipitate Dam Pit 2

Pit 2 consisted of a similar upper horizons, but with finer tailings saturated materials at depth, with subsequent wall failure (Photograph 3).

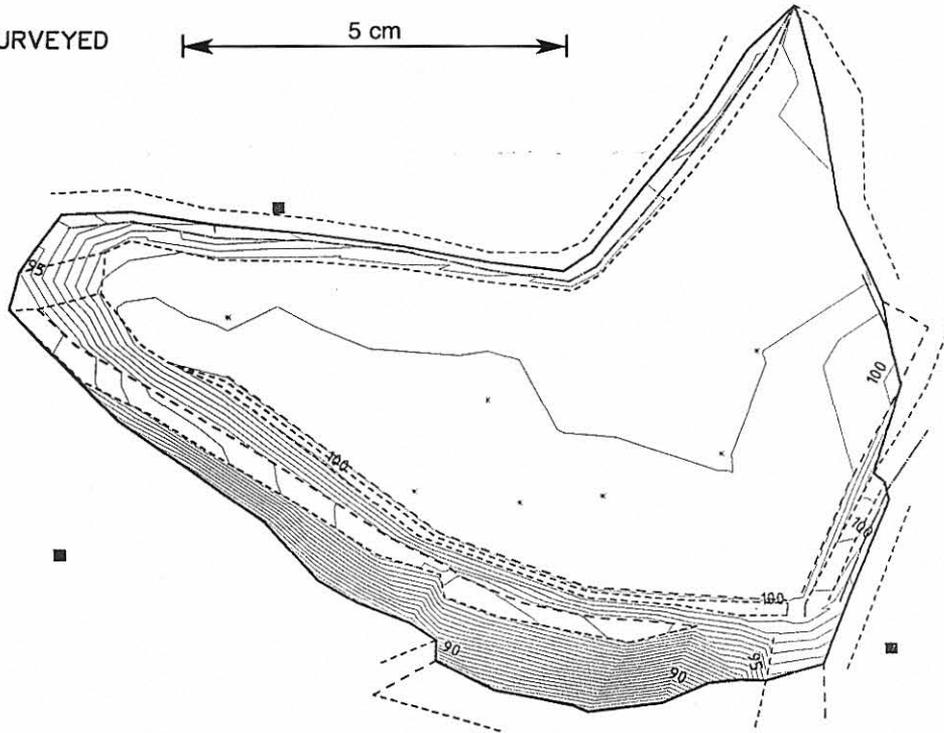
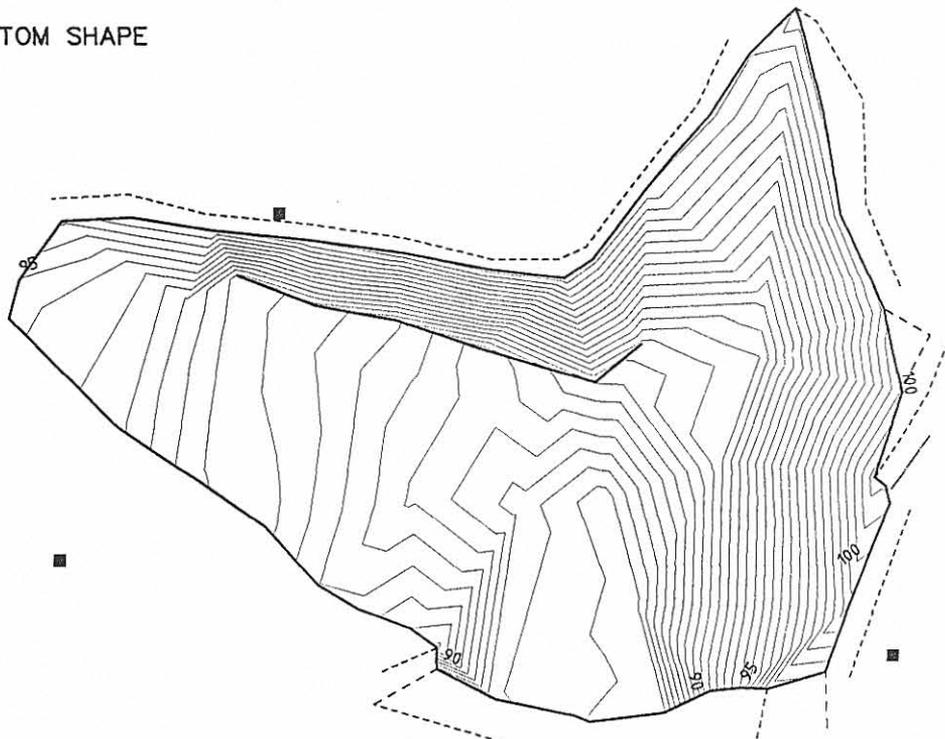
Plan of Contours

Rear dam slope assumed to be same as cut batter

Rear dam slope extended to intercept dam depth

as per depths provided by client at bore holes.

Dam base is estimated per the above and likely

shape pre-construction

VOLUME ESTIMATED TO BE 64,000 m³
