Mineral Resources Tasmania

"The Rehabilitation of Abandoned Tin Mines in North Eastern Tasmania"

DAM INSPECTION REPORTS

**MINERAL RESOURCES TASMANIA
NORTH EAST MINES
DAM INSPECTION REPORTS
STAR HILL, MONARCH & LITTLE BLUE LAKE**

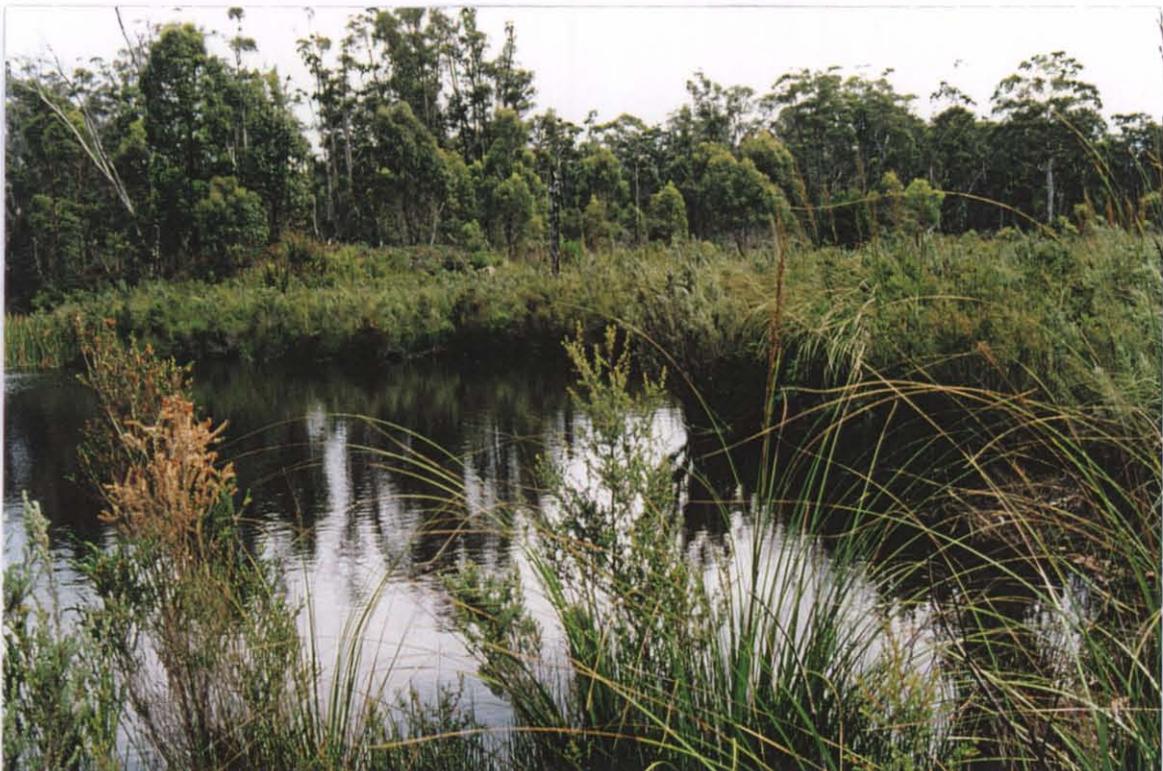
The Monarch dam is a low flat fill holding water above the Monarch workings. The dam itself appears stable but it is in danger from the scour occurring further down the outlet channel. Work is already documented to arrest this scour.

2. Monarch Dam

Some trimming may be required to the spillway and channels once the scour is stabilised. A bridge, or culvert may be considered in the future to allow access across the spillway to the flats. This would reduce the likelihood of damage from recreational vehicles.

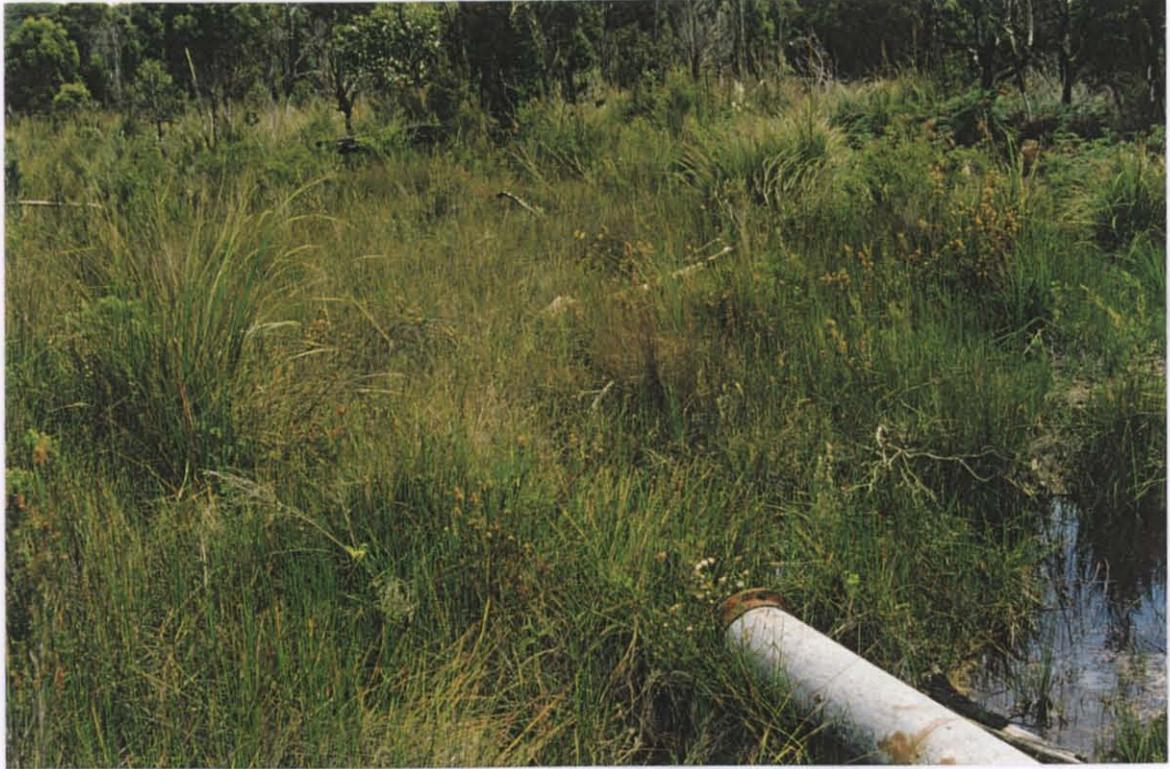
3. Monarch Dam Spillway

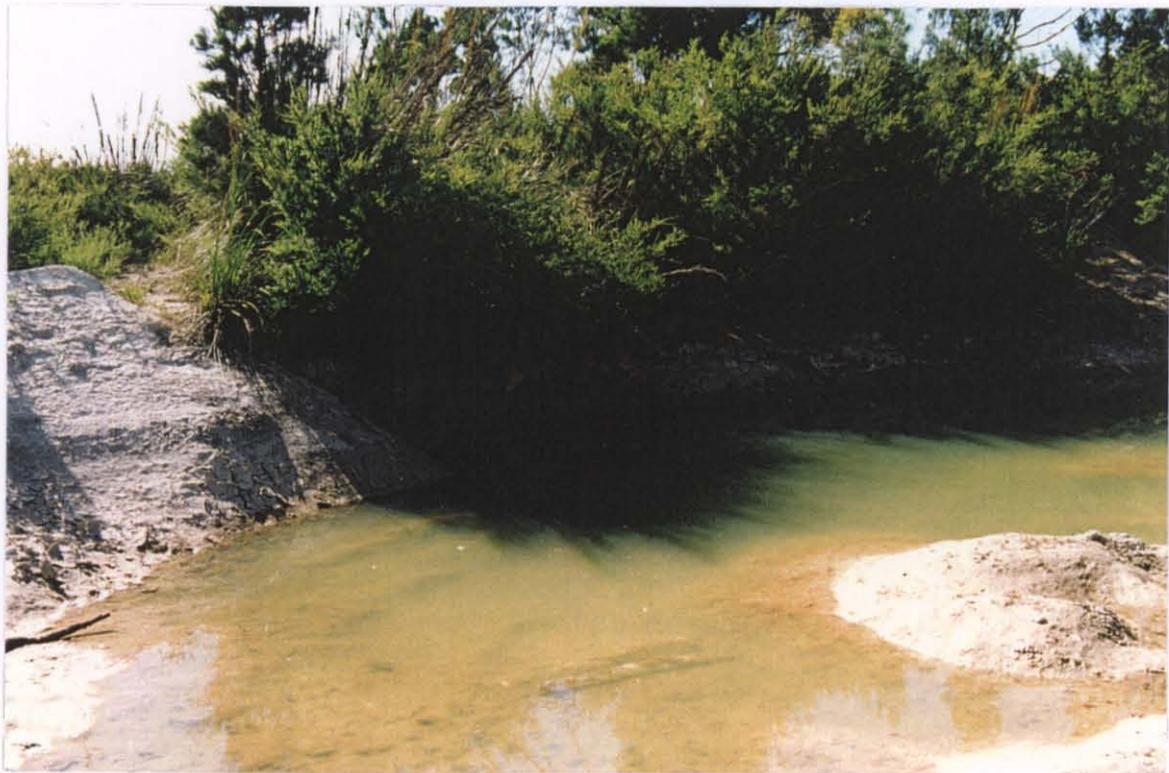
This is the upper dam of the series on Hardens Ravine. It is scoured and undercut below a tree but the effect of failure is considered small. The impoundment is small and surrounded by dam 2.

4. Star Hill 1

No work is urgently required but scour repair will be necessary in the next year or two if the dam is to be retained.

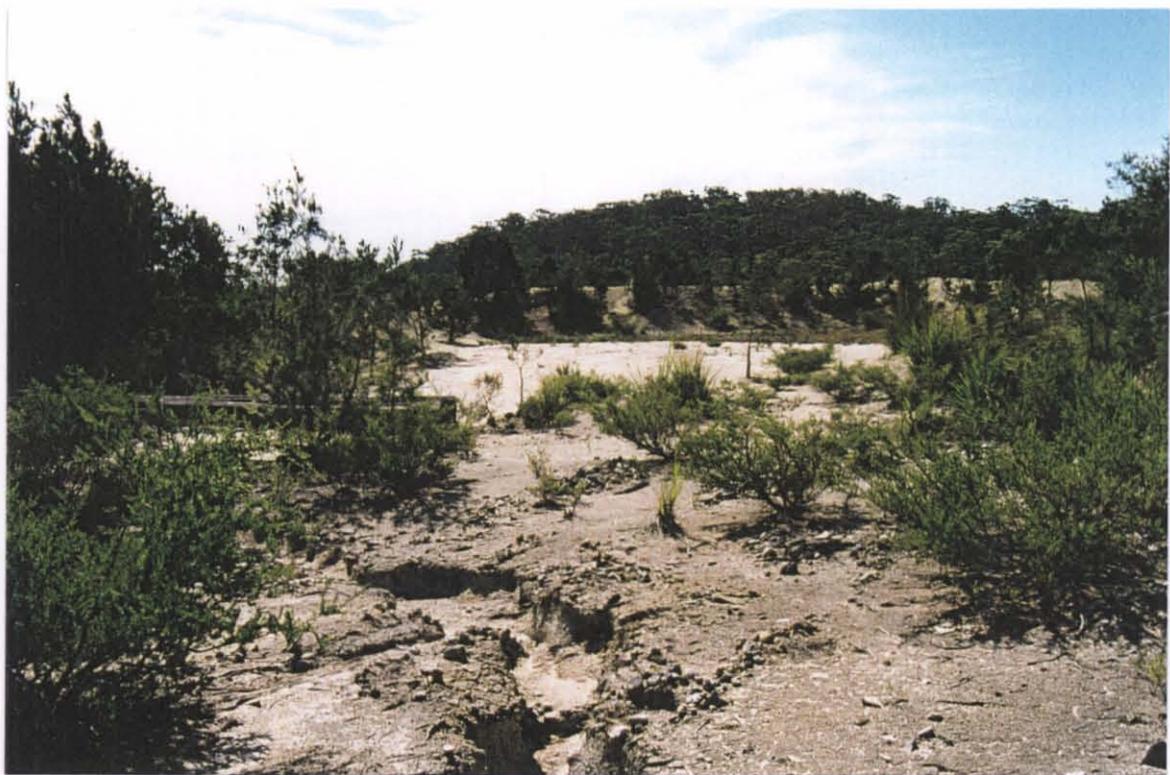
The spillway is scouring and the outlet includes a deep hole with fallen trees serving as energy dissipaters. The wall is scoured in several places.

5. Scour at the inlet to Dam 2

This dam is collecting runoff and serving as an initial sediment trap. It is recommended that it be retained in the short term and remedial work be carried out on the spillway and wall. The level of the spillway should not be raised.

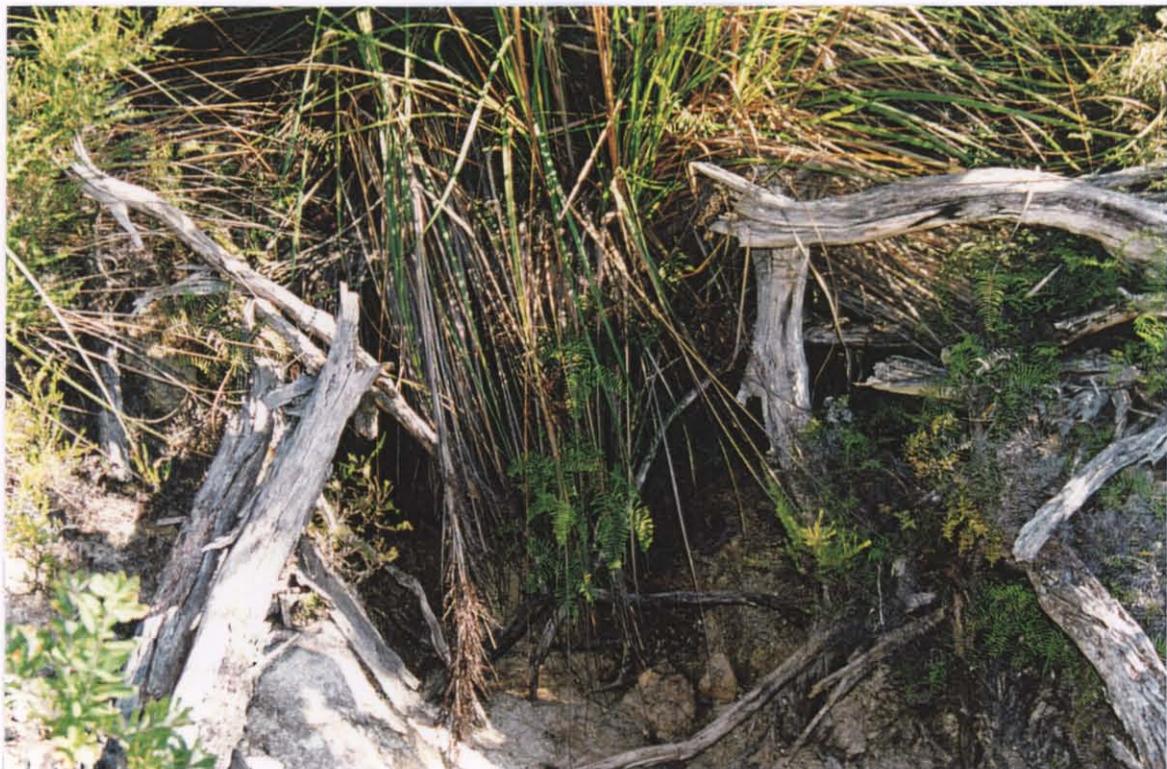
The second dam in the series collects runoff from both sides of the valley around dam 1. The top water level has been lowered by cutting a deeper spillway near the northern end.

6. Dam 2 Spillway

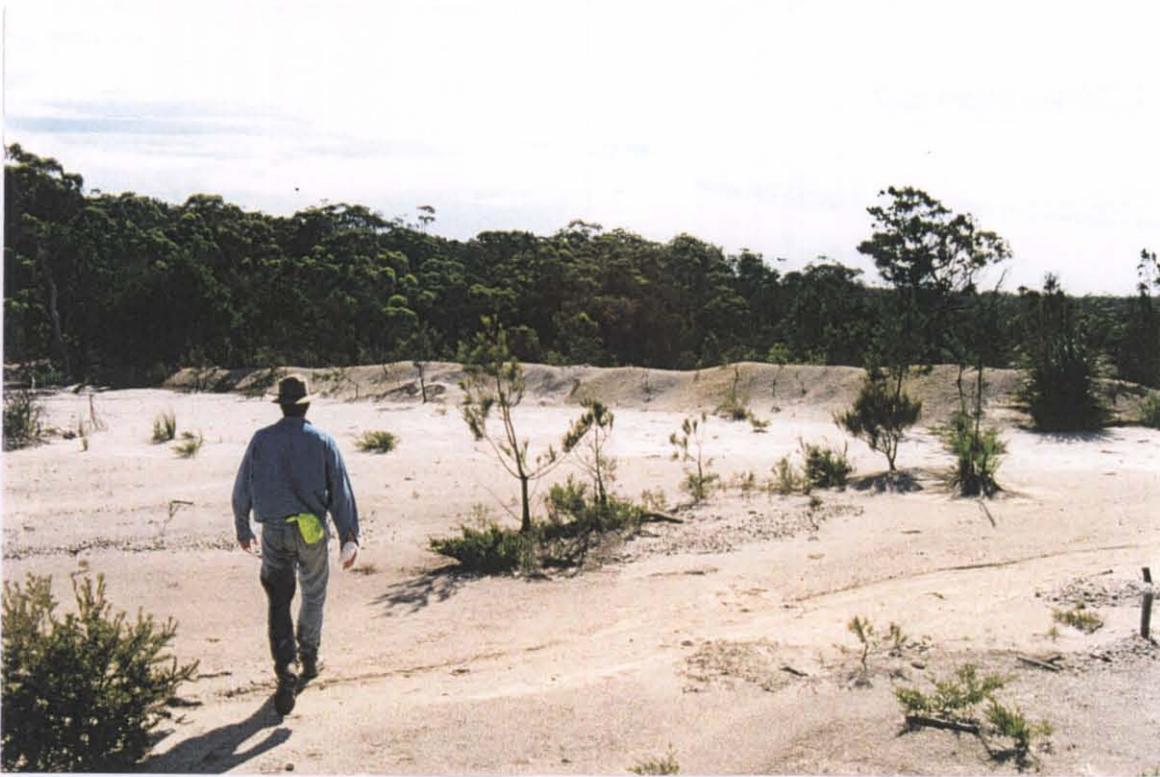
Star Hill 3 is breached and there is no report.

7. "Dam" 3, no impoundment

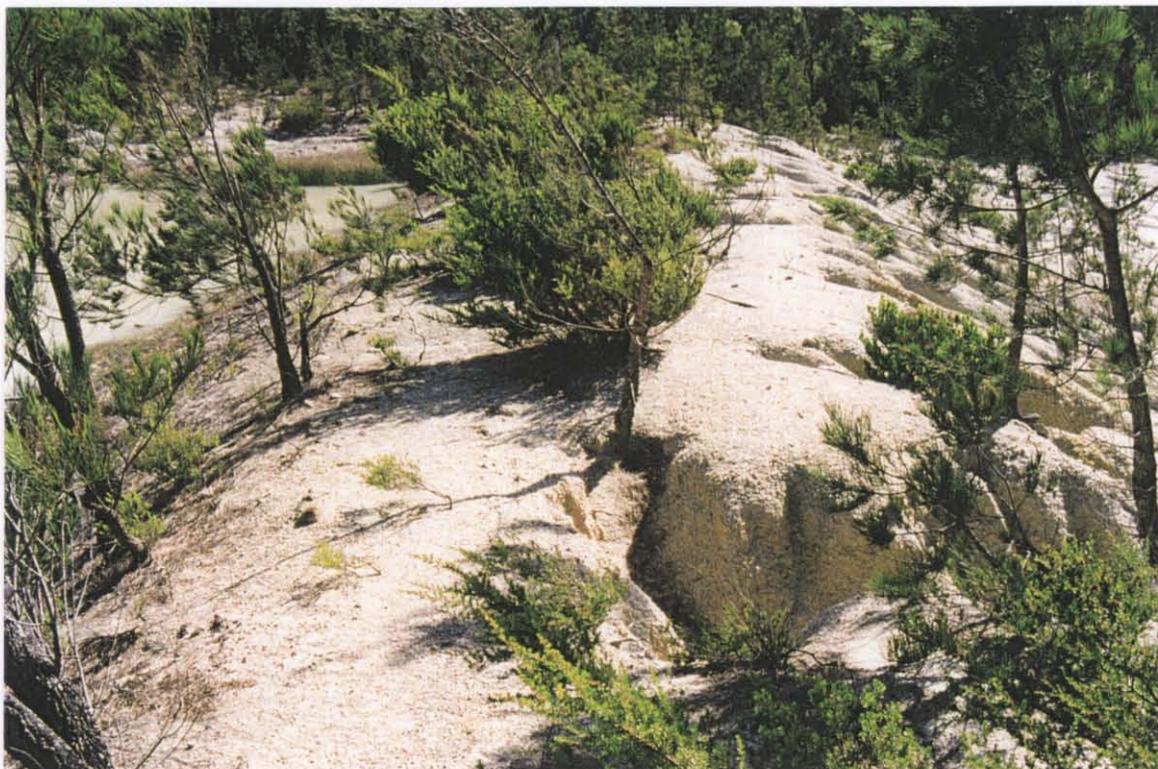
The northern 55 metres of the wall are vegetated on the downstream side and in good condition, even though steep. The southern section and the spillway are barren and badly scoured in some areas. There is seepage near the area of worst scouring in the wall. The spillway channel is in danger of scouring back into the spillway and thence lowering the impoundment.

9. Scour on Dam 4

Urgent work is recommended to repair the scouring on the face, vegetate the face, and provide an improved outlet channel for the spillway.

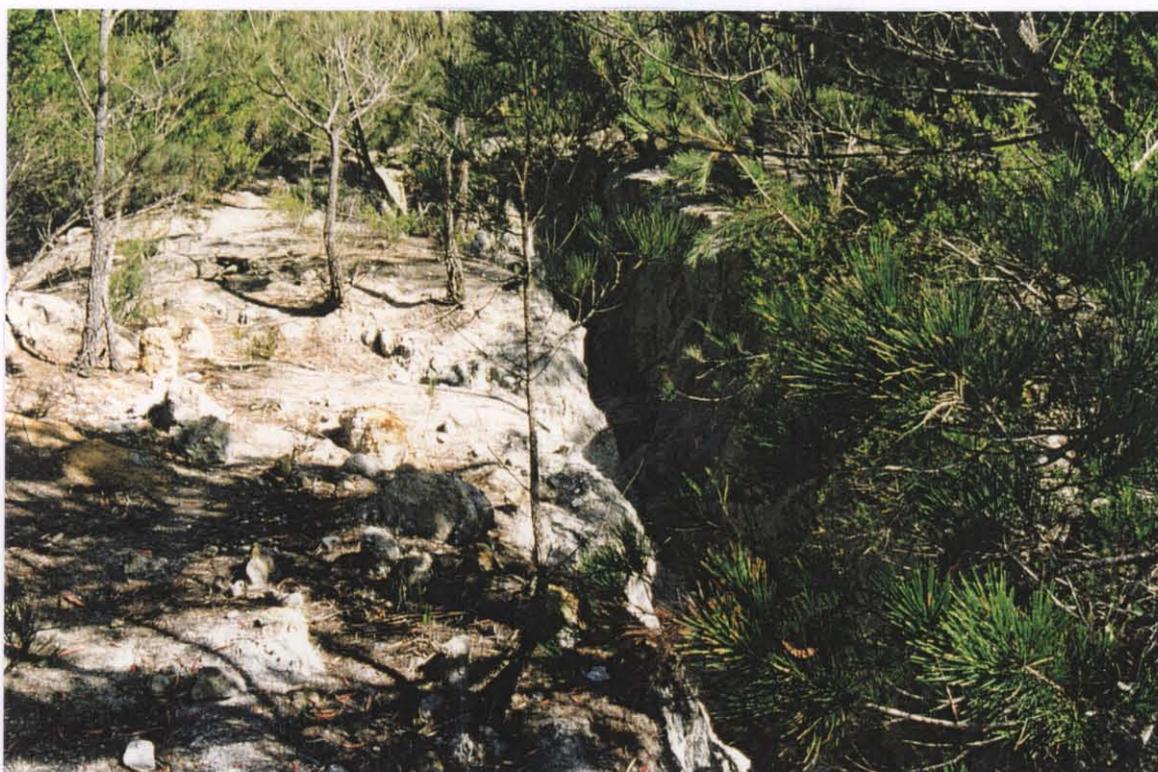
10. Spillway Channel scour, Dam 4

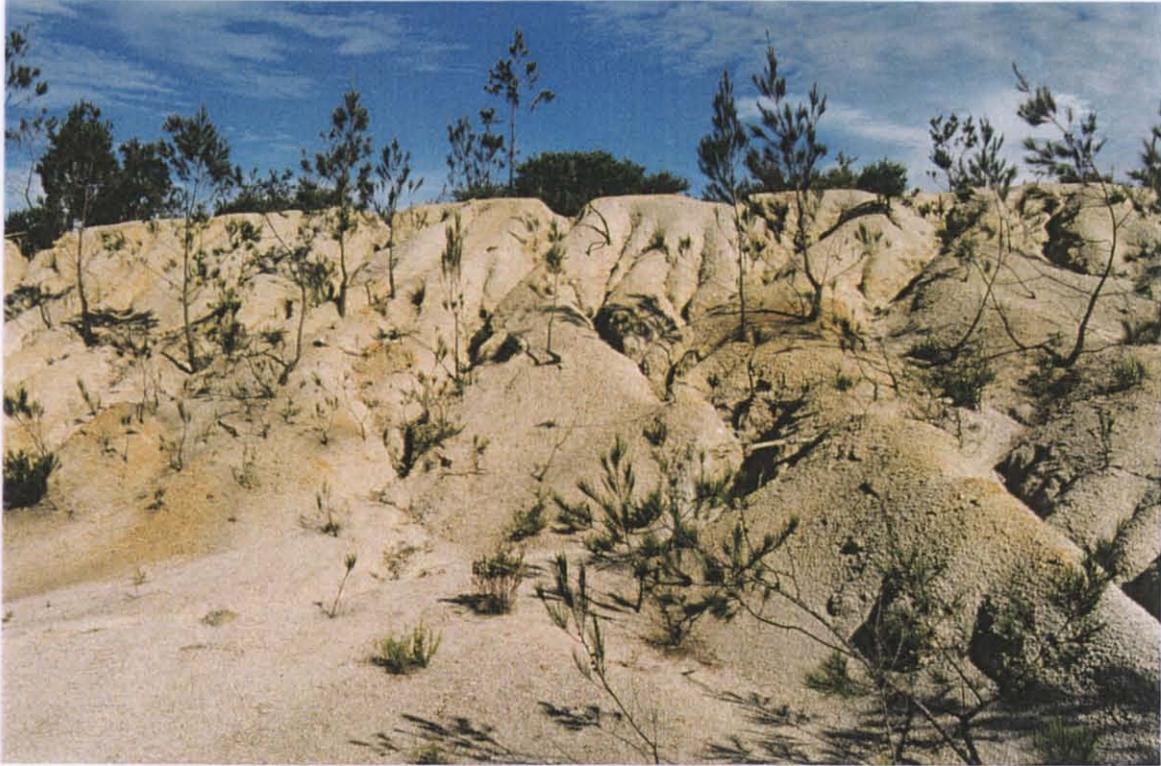
11. Downstream Face Dam 4

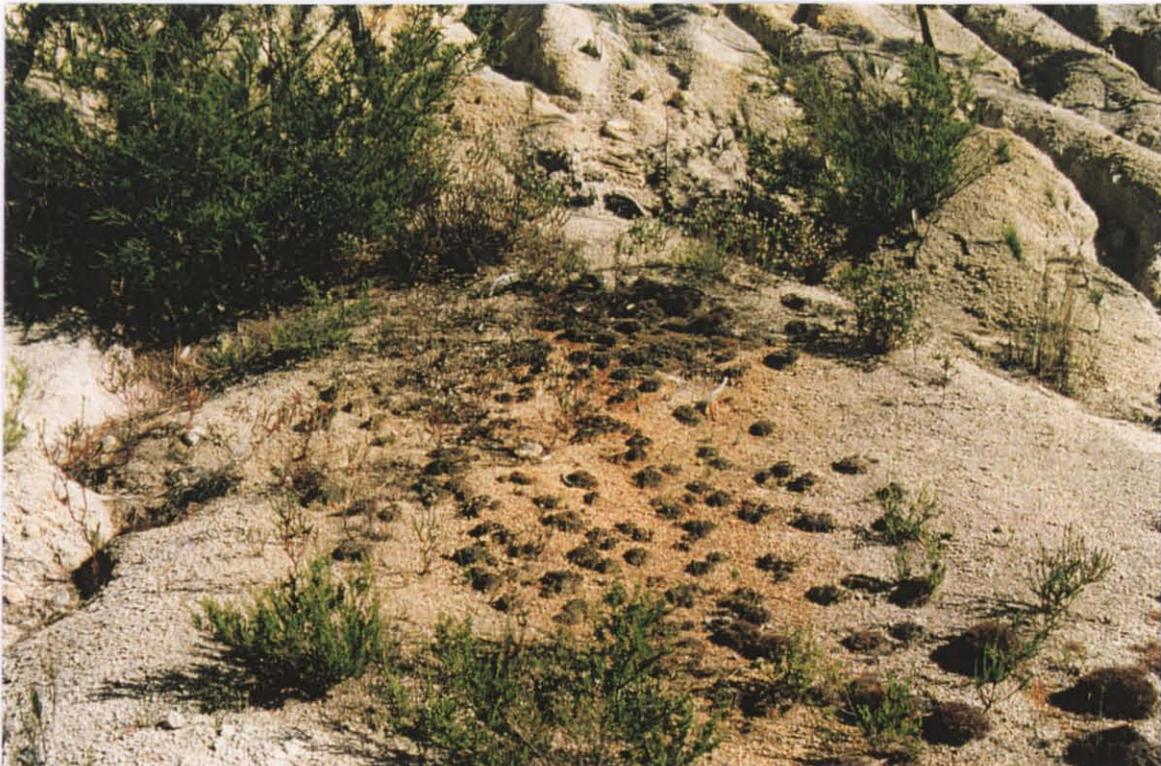
12. Leakage Dam 4

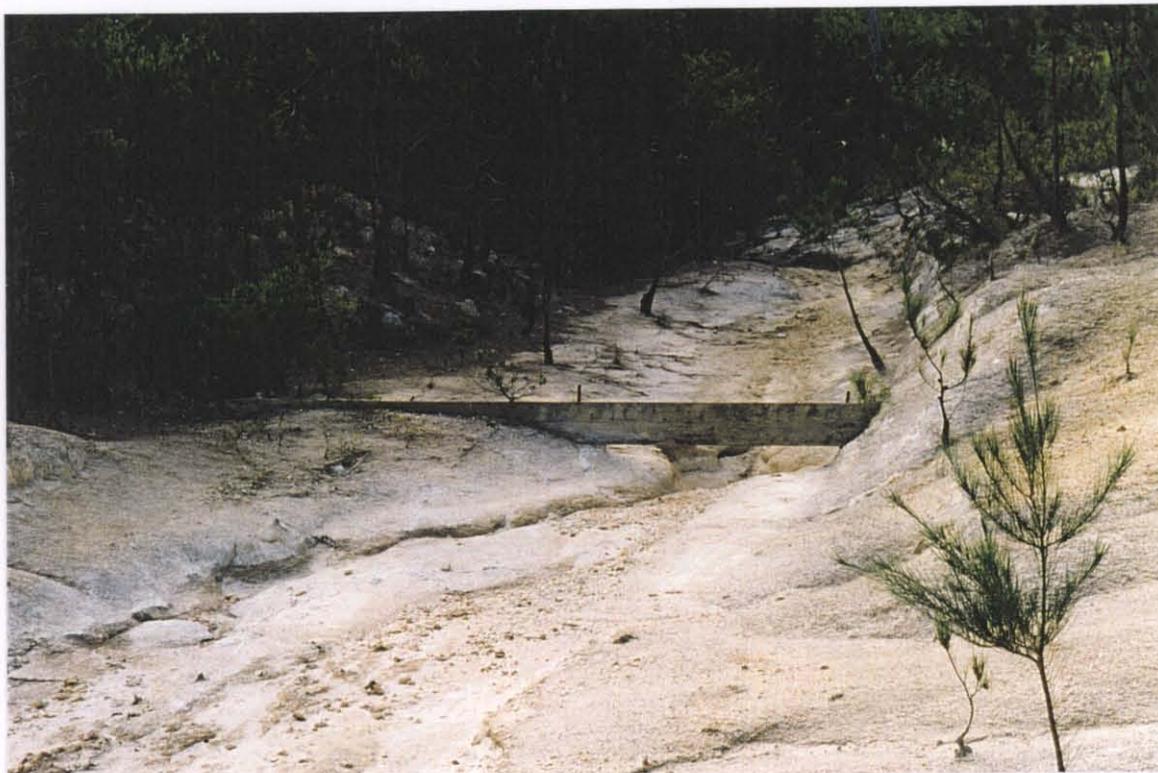
The spillway is in fair condition but needs to be trimmed and stabilised.

13. Spillway Dam 5

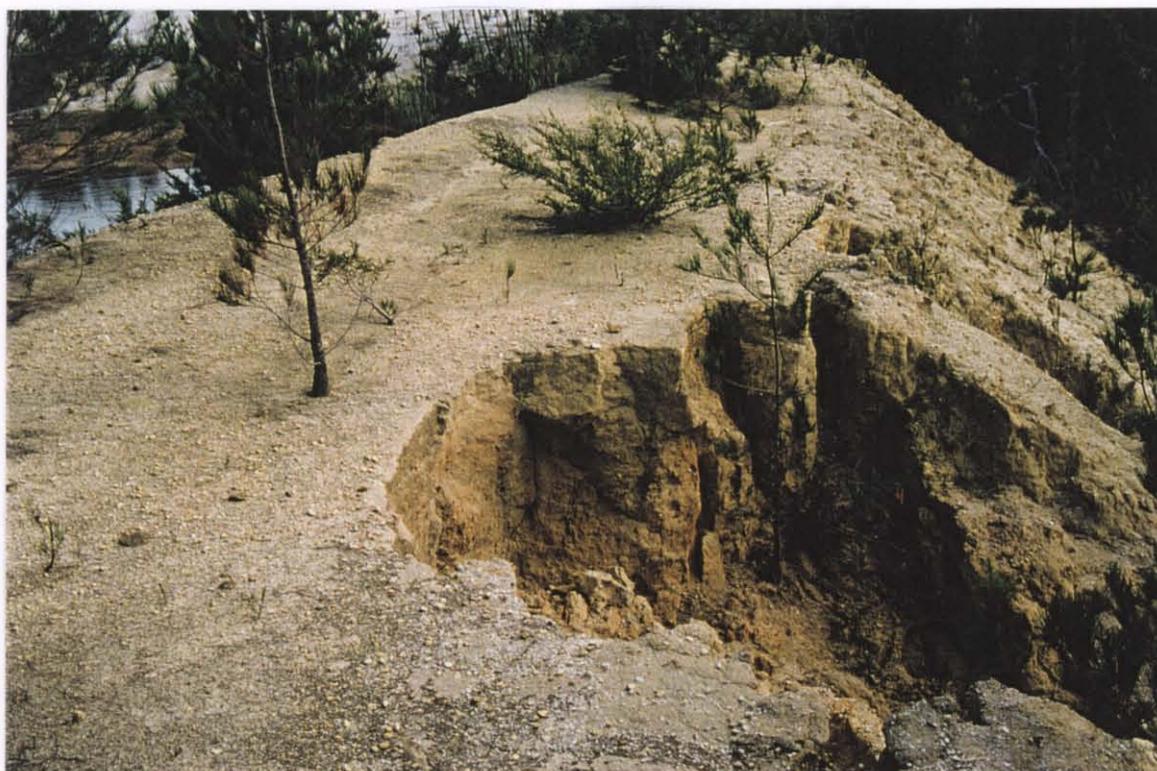
There are two leakage areas on the dam and several scours, one severe on the downstream face near one on the leakages. The scour requires urgent attention, and the leakage should be further investigated.

14. Scour, Dam 5

Work recommended is scour repair, consideration of downstream toe flattening, and vegetation.

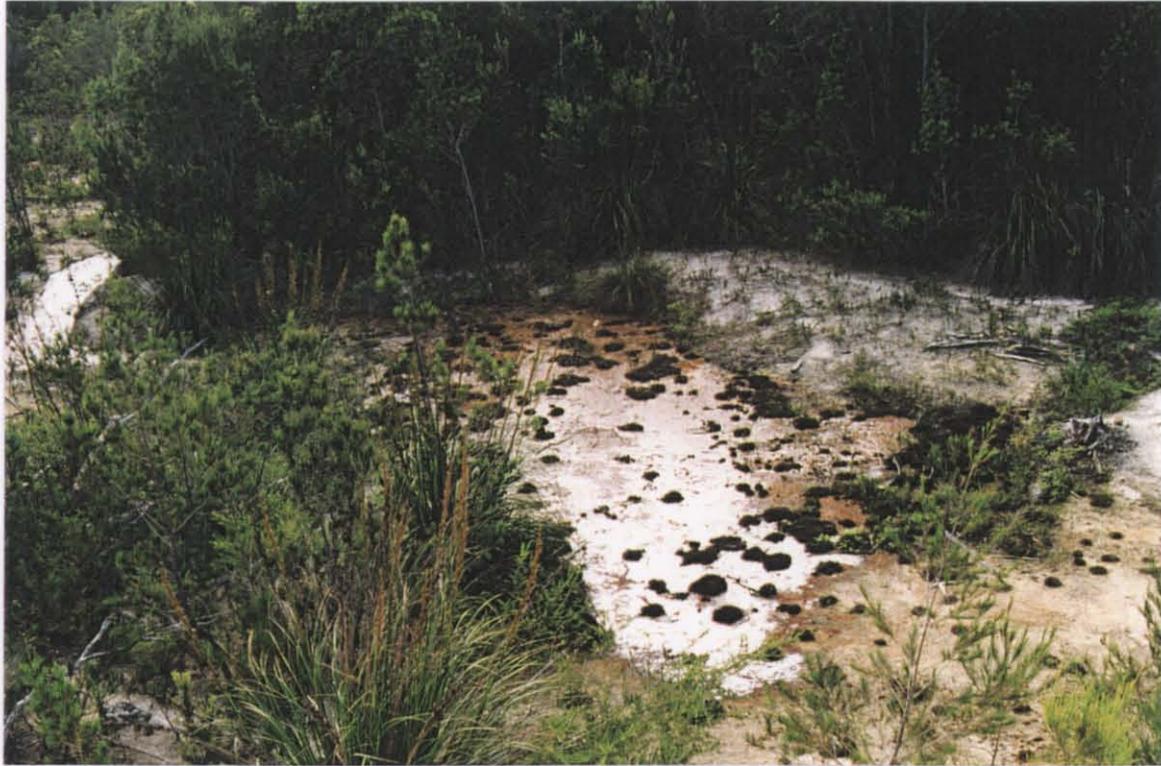
15. Leakage Dam 5

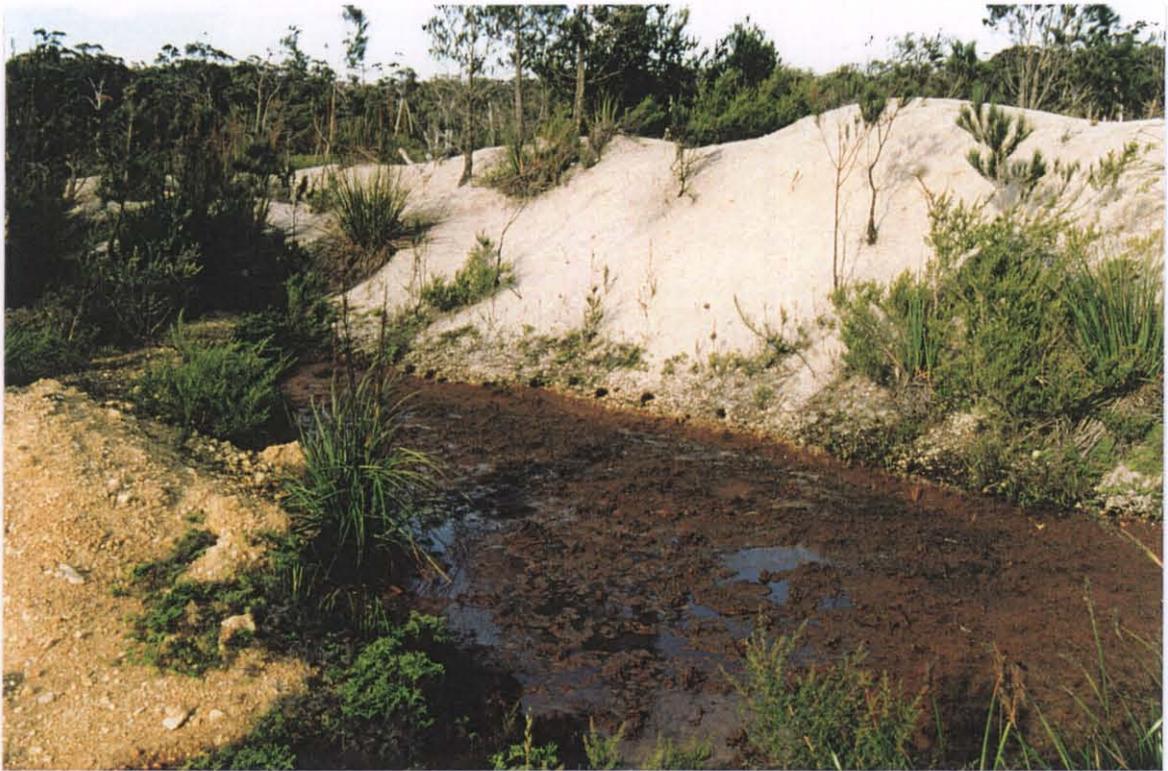
There are two areas of leakage near the western end, one under or around the end of the structure and the other near a scour.

17. Leakage, Dam 6

It is recommended that the scours be repaired and the downstream face be further investigated to determine whether flattening is required.

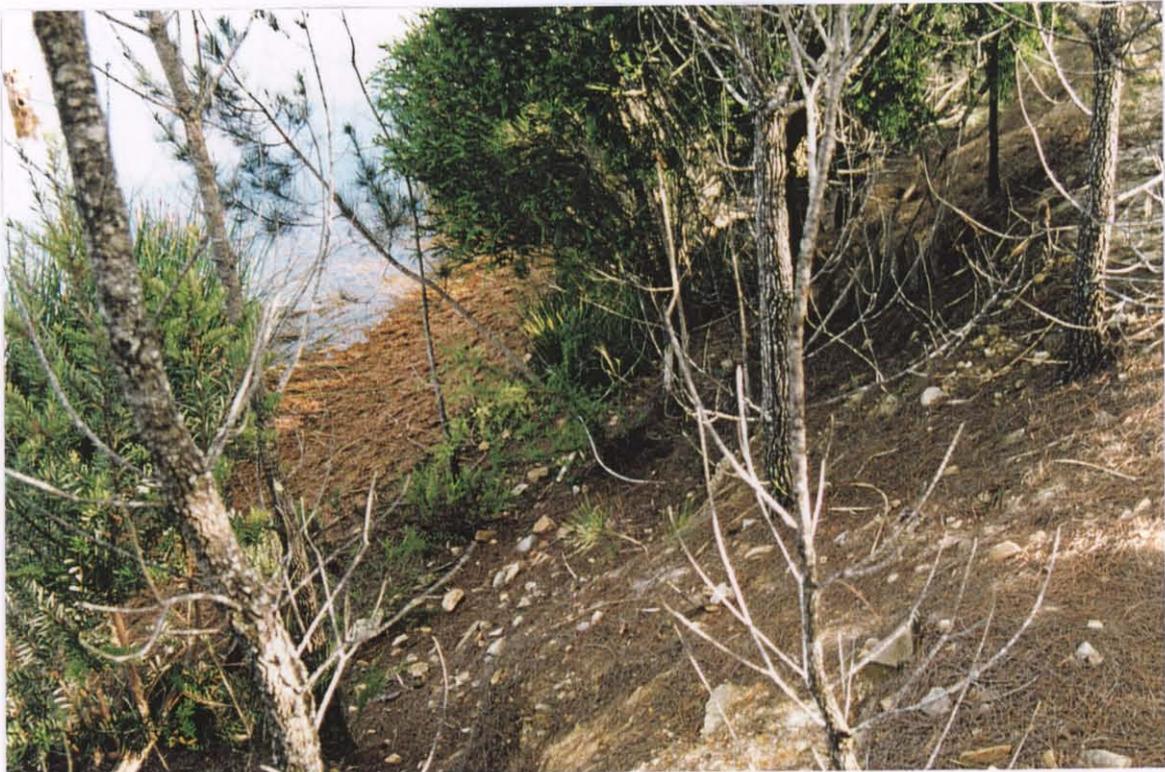
The downstream slope is 37 degrees and the upstream slope 39 degrees above a flat beach. Most of the dam is vegetated as is the spillway.

18. Steep Upstream Face and Beach, Dam 6

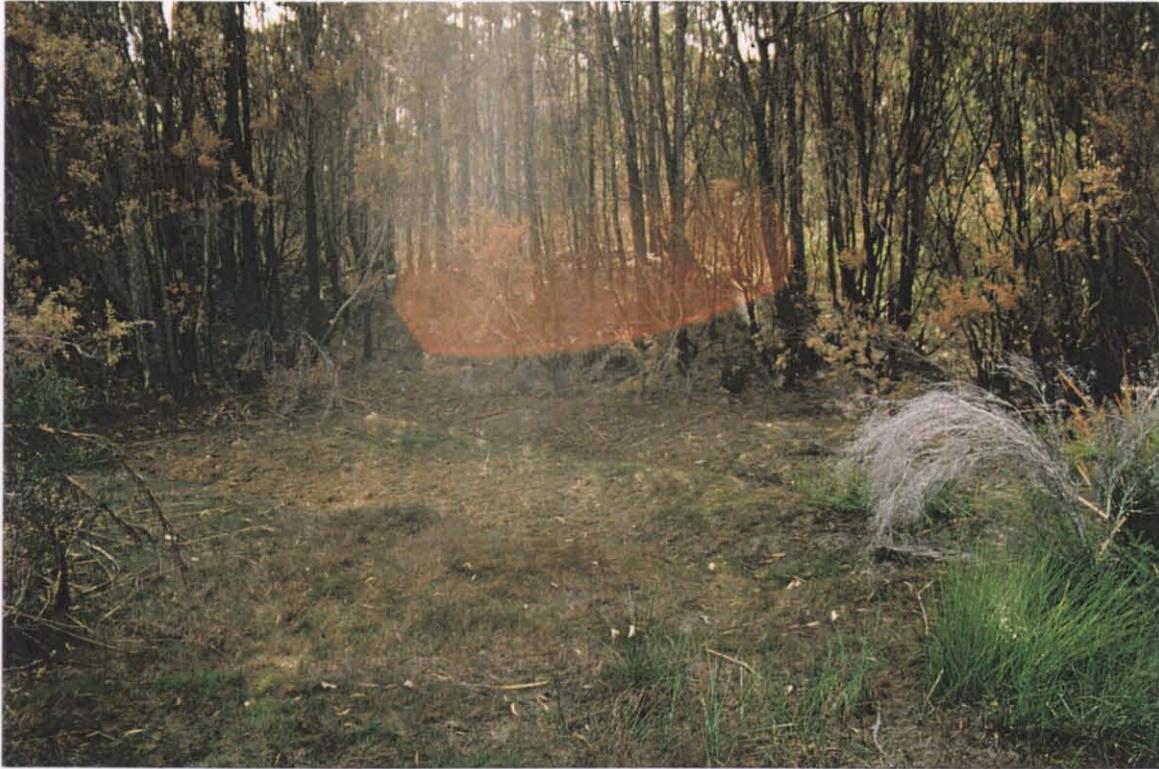
The spillway has recently been burnt off but may revegetate.

19. Spillway, Dam 6

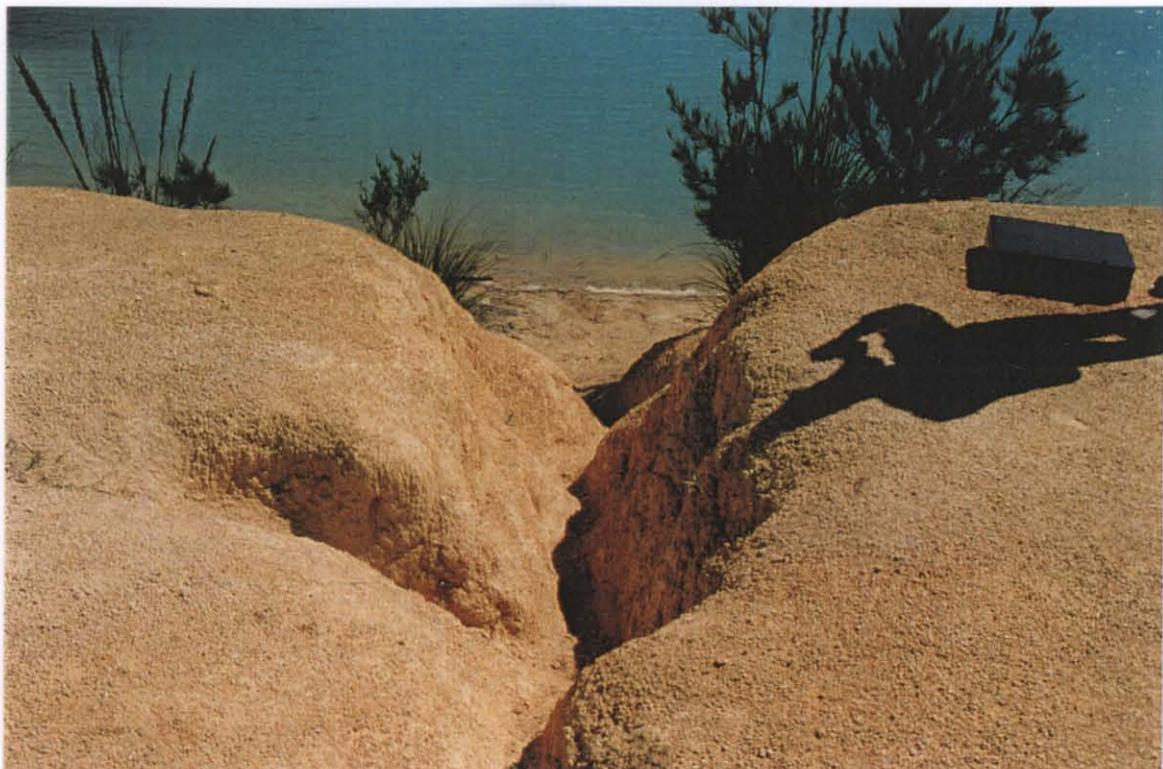
The wall is only partly vegetated and is severely scoured in several locations where the surface is barren. There is a scour pipe built into the wall and evidence of leakage adjacent to the pipe. No constructed spillway has been located.

23. Upstream Face Scour

It is recommended that a spillway be constructed to keep the water level down to the present position. This will avoid water pressure on the steeper upstream section of the dam. Scours in the wall should be repaired, and barren areas vegetated. The scour pipe needs to be further investigated to determine whether it requires sealing or grouting to prevent failure.

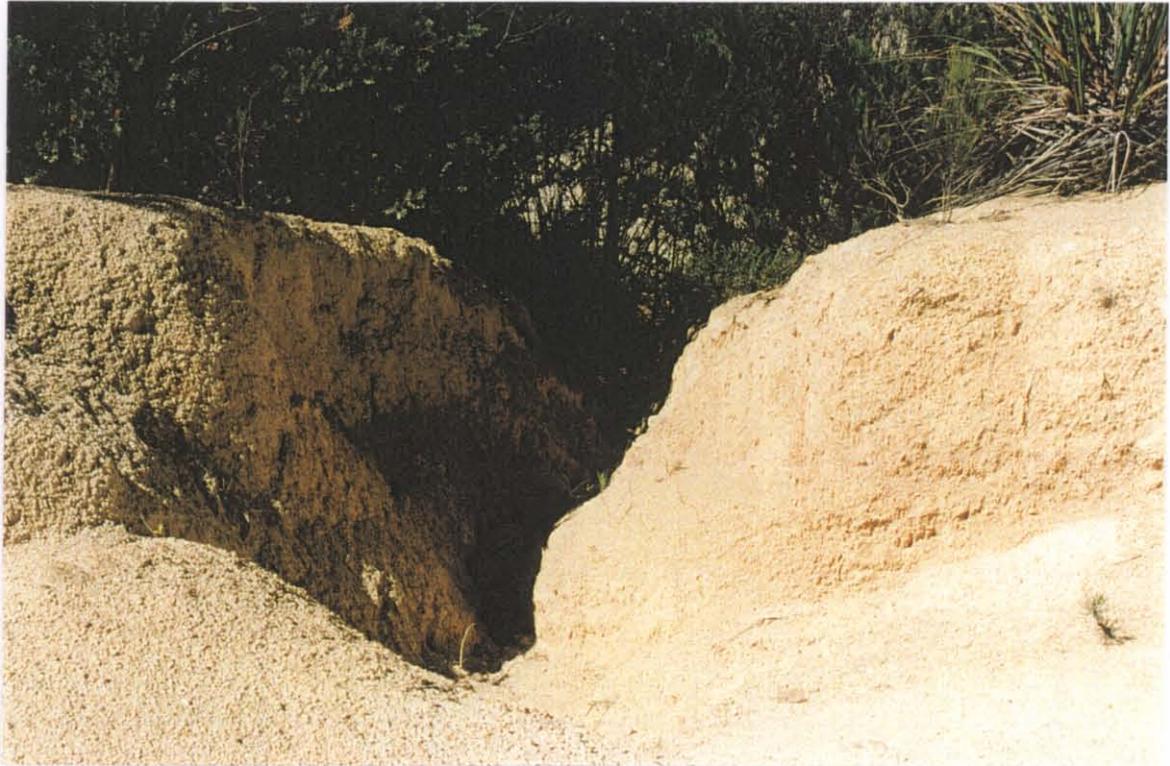
24. Downstream Face Scour

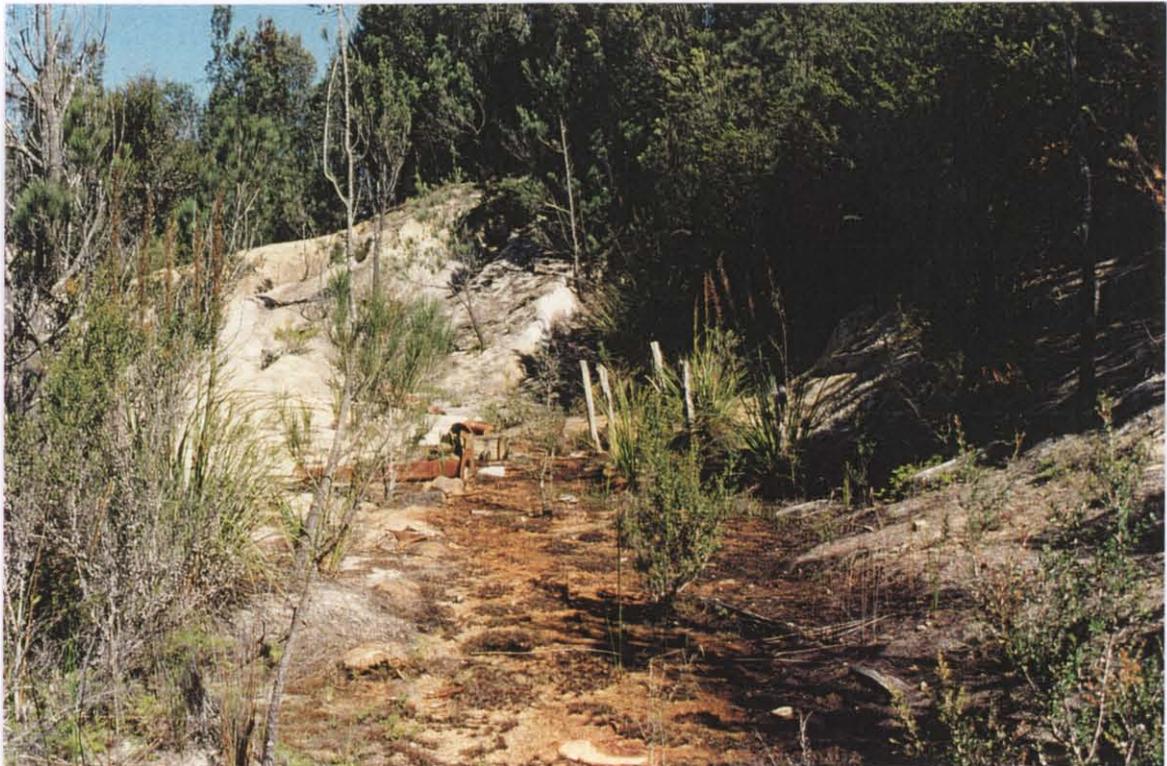
The Little Blue Lake dam has a scour pipe built into the wall. There is evidence of leakage along this pipe although no evidence that the valve has been operated in recent times. The spillway for the dam has not been located, and the scour pipe may have been used in the past to relieve pressure on the wall.

25. Scour Pipe Leakage

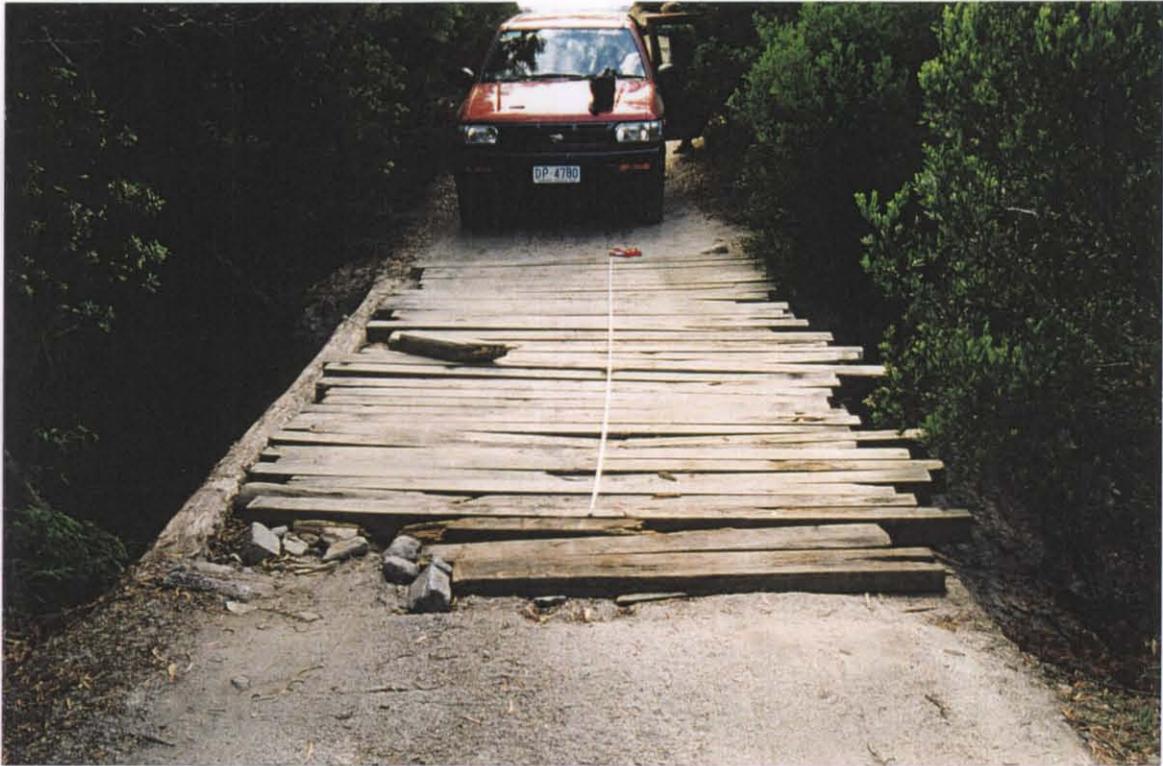
The deck has been repaired with sawn treated pine which is breaking as traffic crosses the bridge.

A1. Cat Gully Deck

The bridge is unsafe and requires replacement. As one of the main supports is broken, removal of the entire structure is the easiest way to access the work.

Replacement with a culvert, either box or circular is likely to be the cheapest repair. At this time hydrology of the area is not defined, and further information needs to be obtained to determine the area which drains through this cut.

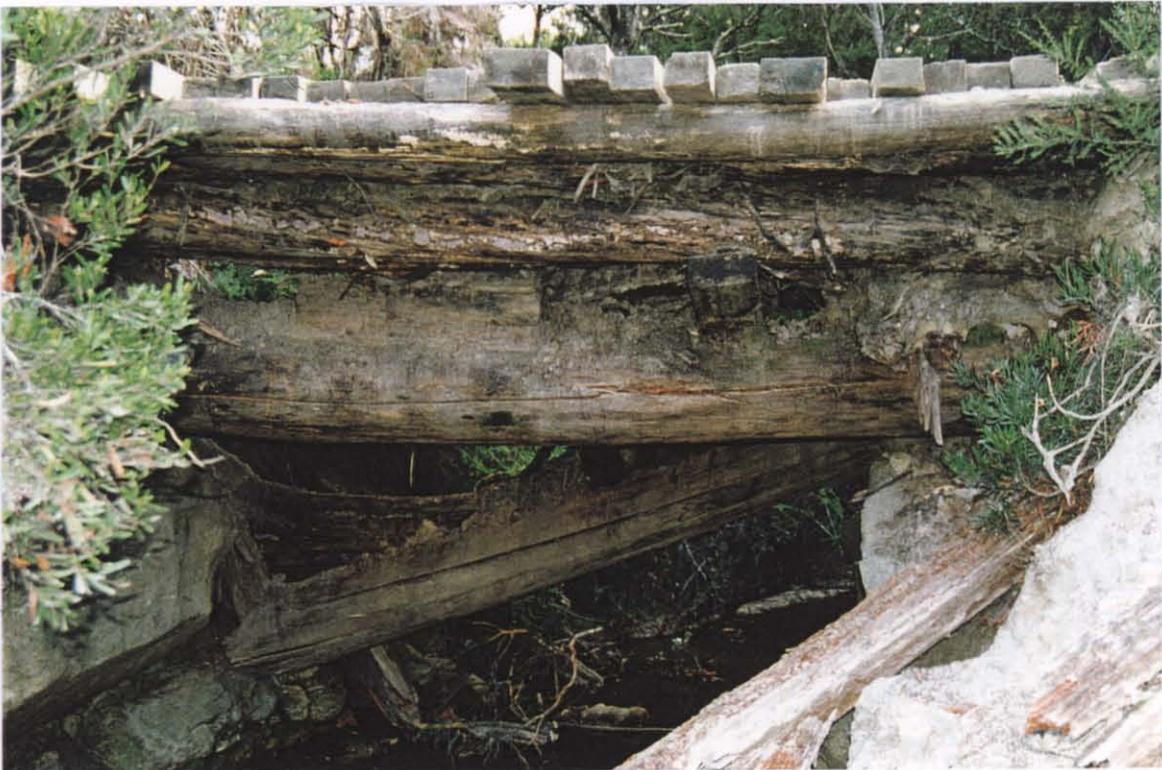
One of the main support logs has broken away and support is now shared through several smaller logs in the upper layer.

A2. Cat Gully Bearers

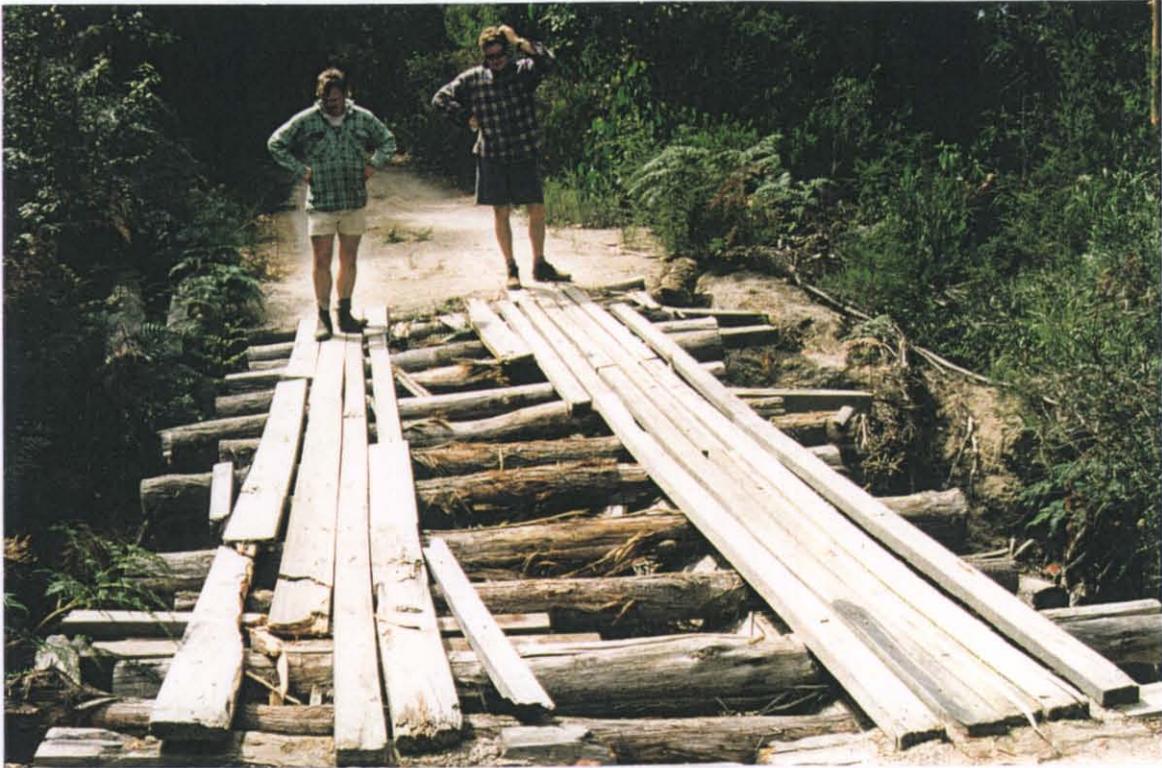
The bridge comprises four 200 mm diameter poles spanning the length with 125 mm diameter poles at right angles to the bearers. The decking is loose sawn timbers laid on the approximate line of wheel paths. Deck timbers are partly hardwood and partly softwood, in various stages of disrepair.

The bearers and cross members are in reasonable condition for light traffic but the deck is unstable. Redecking and packing to distribute loads on to all cross members is required.

A3. Blue Lake Deck

It is estimated that this work could be carried out with sawn green hardwood, 50 mm thick for about \$2,000. No documentation has been allowed. No barriers are included.

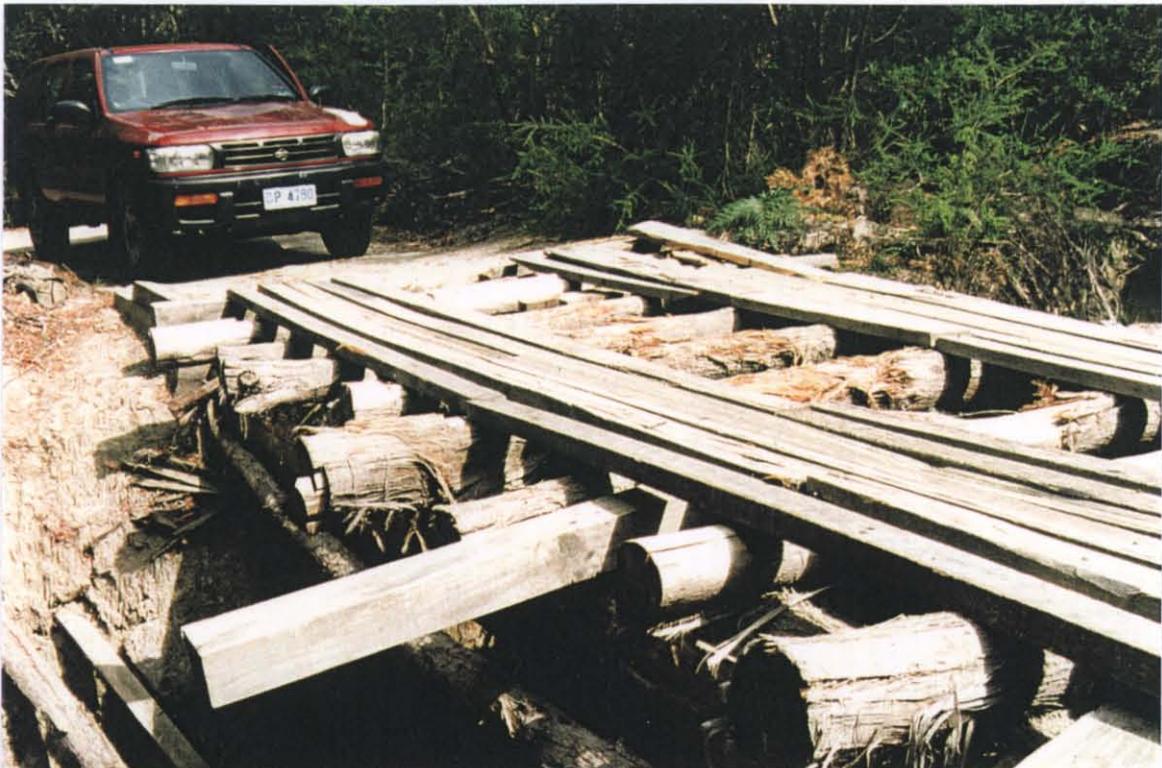
A4. Blue Lake Supports
