# David Steane & Associates

## Summary of Work Done at Oakdene Road (to be read in conjunction with Specifications in Proposal A)

P 333.765153 DAV      969466  
Summary of work done at Oakdene Road /  
David Steane & Associates 1999

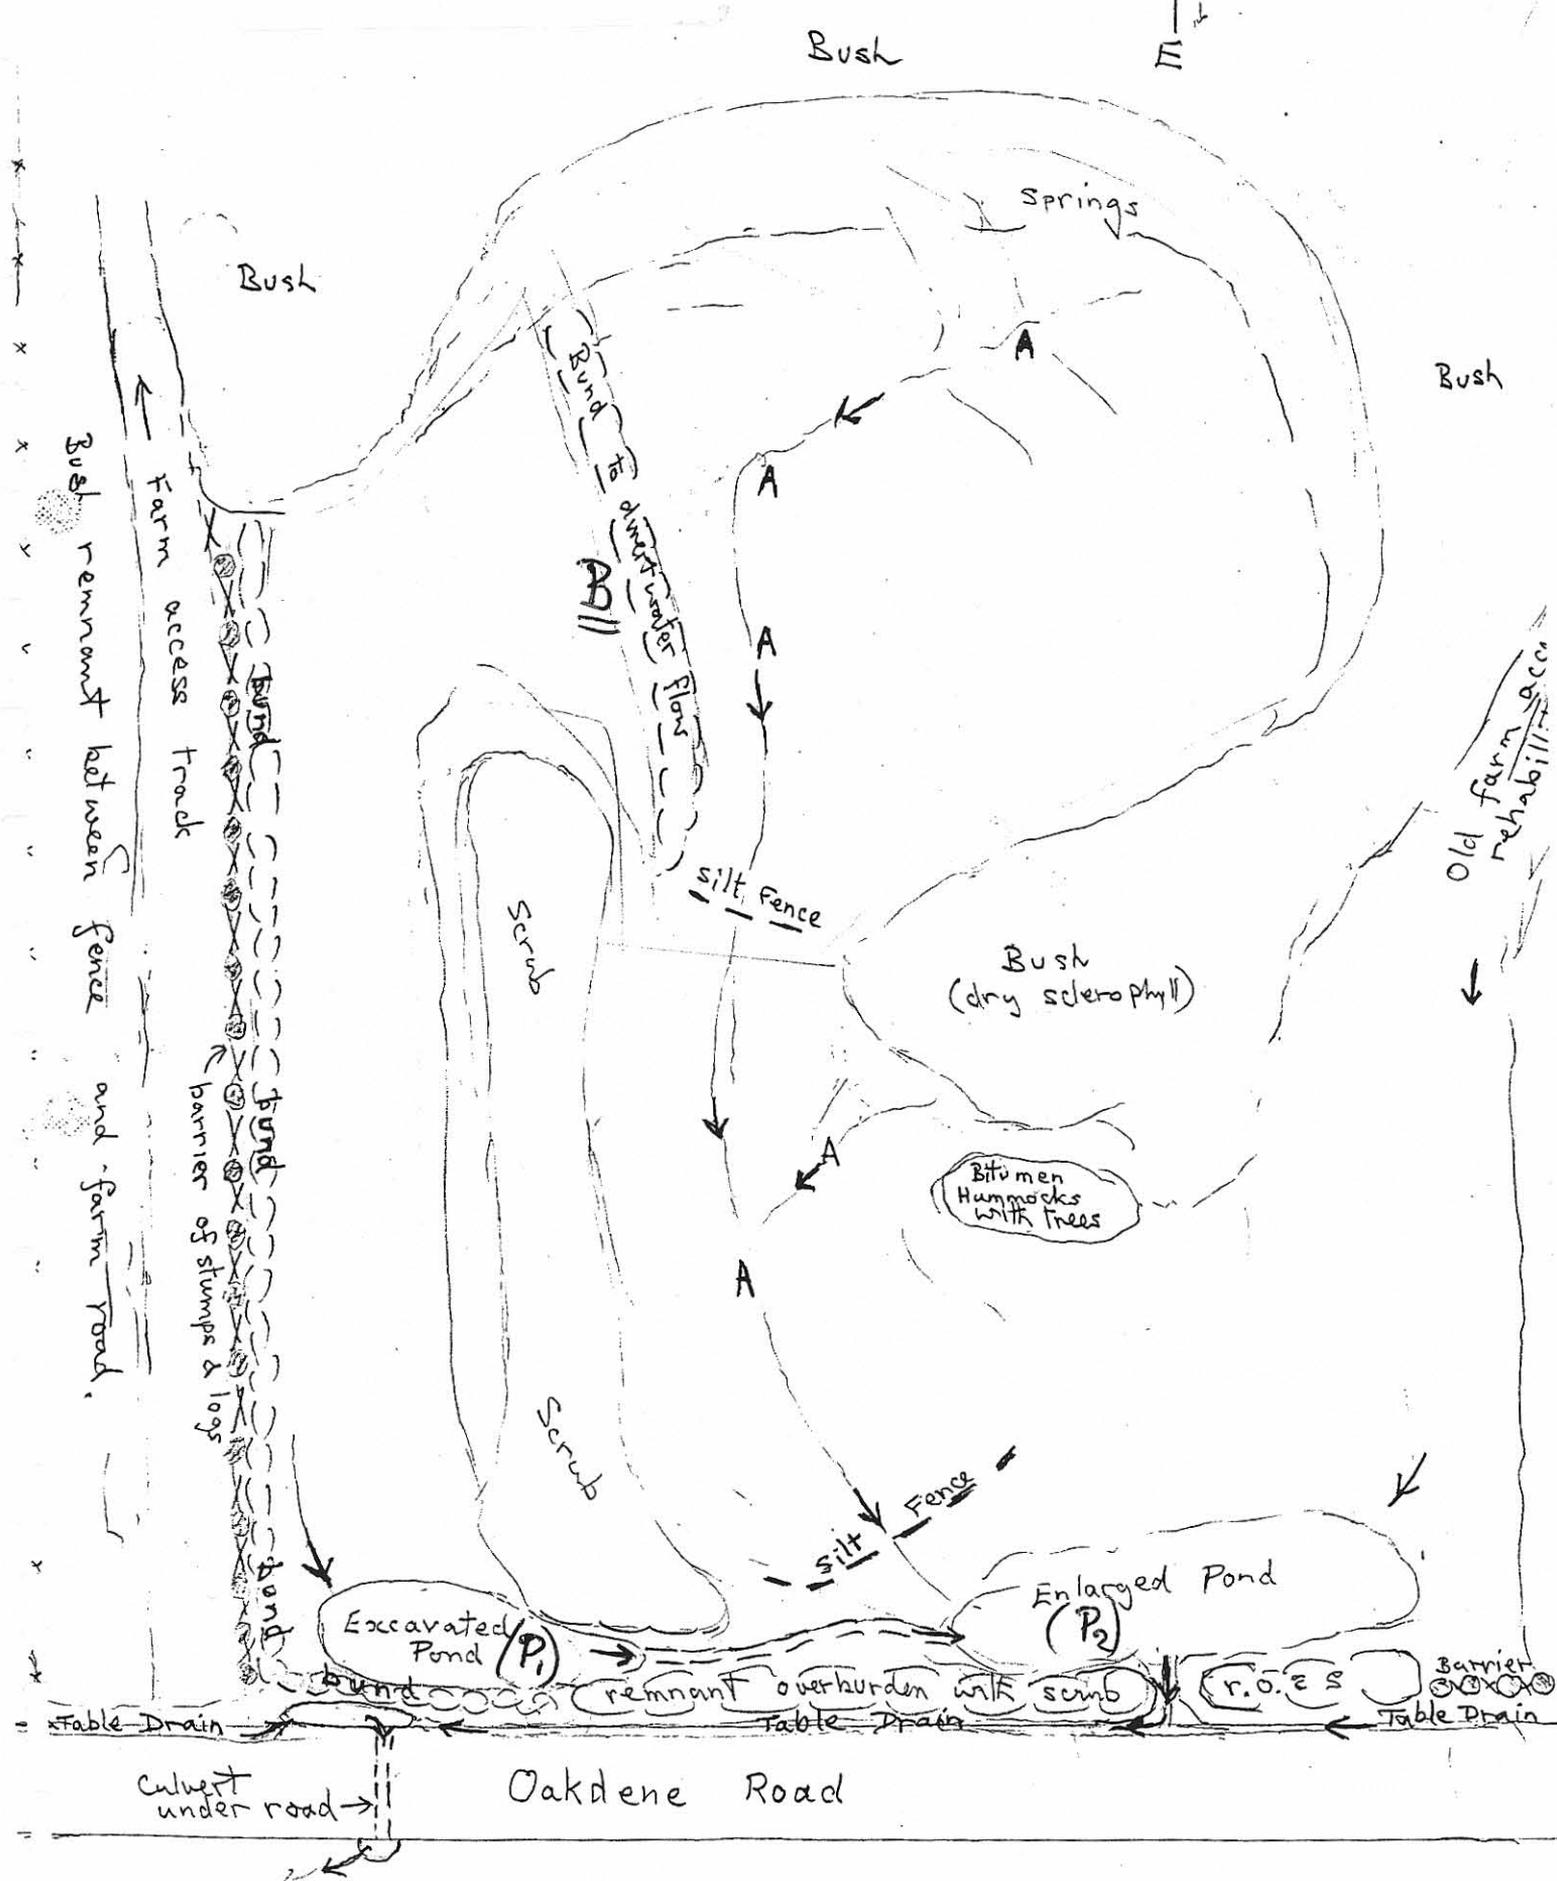
# SITE 1.

**1. Water Diversion**

- 1.1 A bund **B** was constructed to divert water from upper area SE and E towards pond (P2) and to limit flow down slope near farm access road on S side.
- 1.2 A holding pond (P1) was excavated near bottom of access road, but instead of spilling to table drain the overflow was directed through a cutting to the second pond (P2) which, in turn, spills through a vegetated drain to the table drain and thence back to the culvert near the farm access track.
- 1.3 Final drainage lines indicated by heavy arrows

**2. Revegetation and other Works**

- 2.1 Cutting grass and sedges planted in short lines and clumps across drainage lines.
- 2.2 Silt fences still to be constructed as indicated during spring.  
Erosion and siltation not serious to date. No heavy sediments are passing pond (P2) to reach table drain.
- 2.3 Area outlined and cross hatched in red was sown with seeds treated with Smokewater.
- 2.4 Balance area sown with seed **not** treated with Smokewater, although "hard" seeds treated with boiling water.

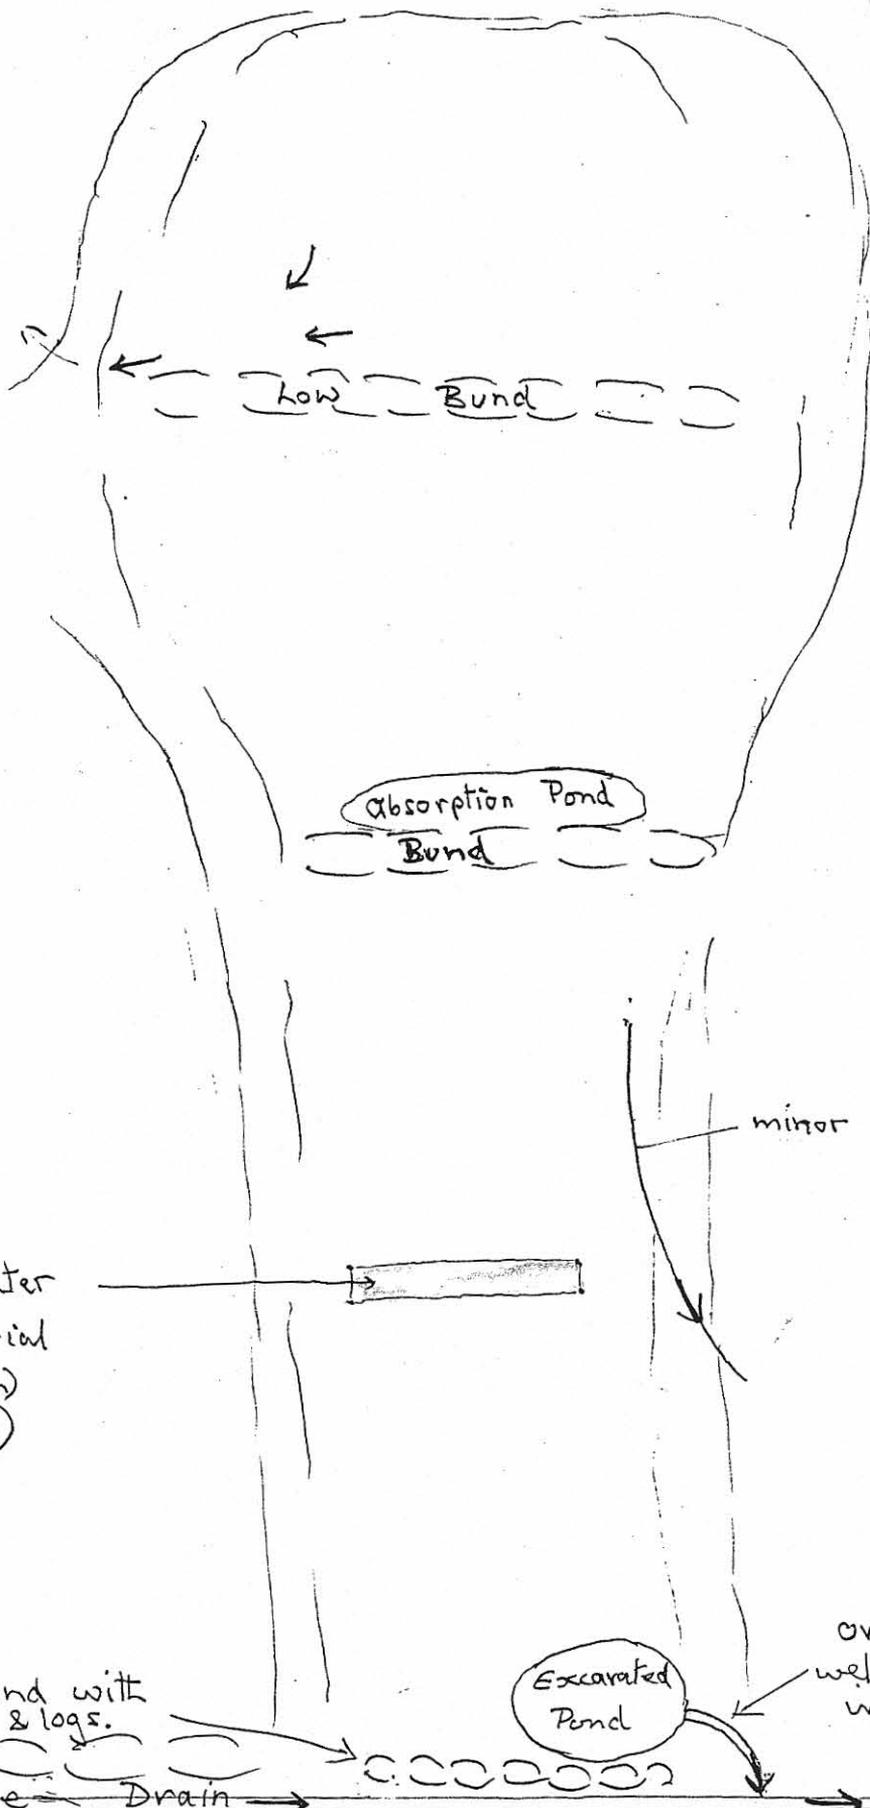
SITE 2.

### **1. Water Management**

- 1.1 Earthworks including filling of erosion gullies, top soiling, etc greatly reduced run off.
- 1.2 Cross bunds and absorption ponds as illustrated further reduced risk of any run-off from upper half of area.
- 1.3 Pond excavated at bottom of area to hold and settle water before spilling to roadside table drain.

### **2. Vegetation**

- 2.1 Whole area sown with native seeds without pre treatment with Smokewater.
- 2.2 Plot established (pegged at corners) and treated by spraying with **Smokewater "Direct"** at +/- 100 ml/m<sup>2</sup>.

Smoke water  
Direct  
spray trial  
(2m x 20m)  
(100ml/m<sup>2</sup>)

minor scour channel

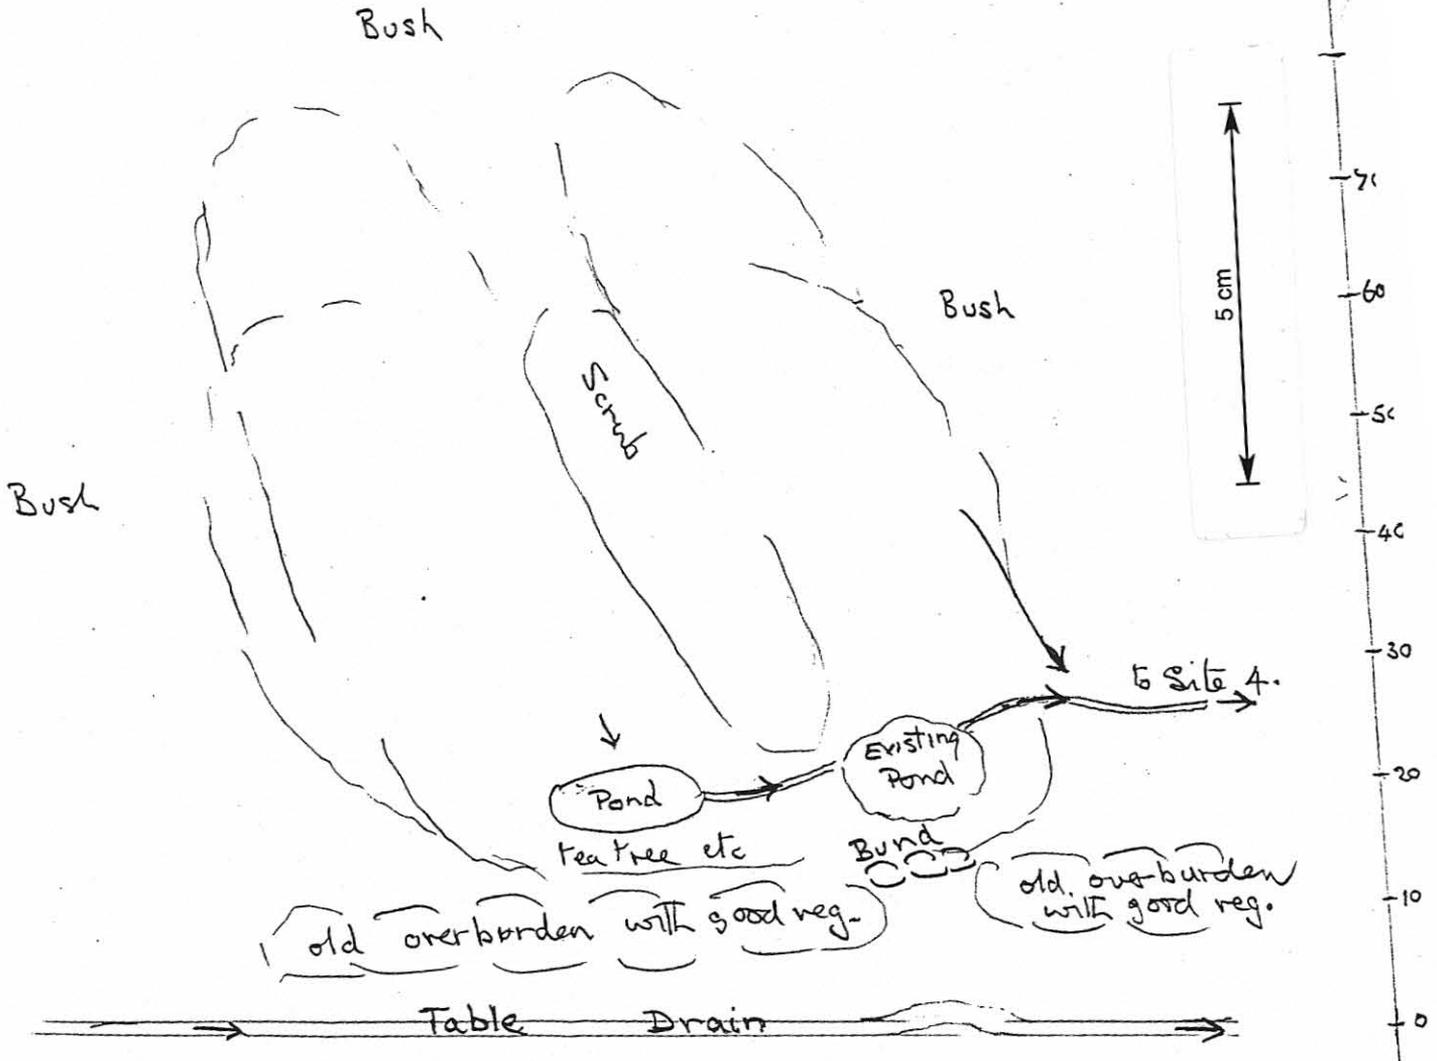
SITE 3.

### **1. Water Management**

- 1.1 Earthworks to minimise run-off included top soiling, ripping and minor cross slope bunds.
- 1.2 Ponds at bottom of two bays connected and drain extended northwards to Site 4 and thence to Site 5. No direct spill to roadside table drain.

### **2. Vegetation**

- 2.1 No Smokewater treatment.
- 2.2 Whole area sown with seed mix in which hard-coated seed were treated with boiling water.

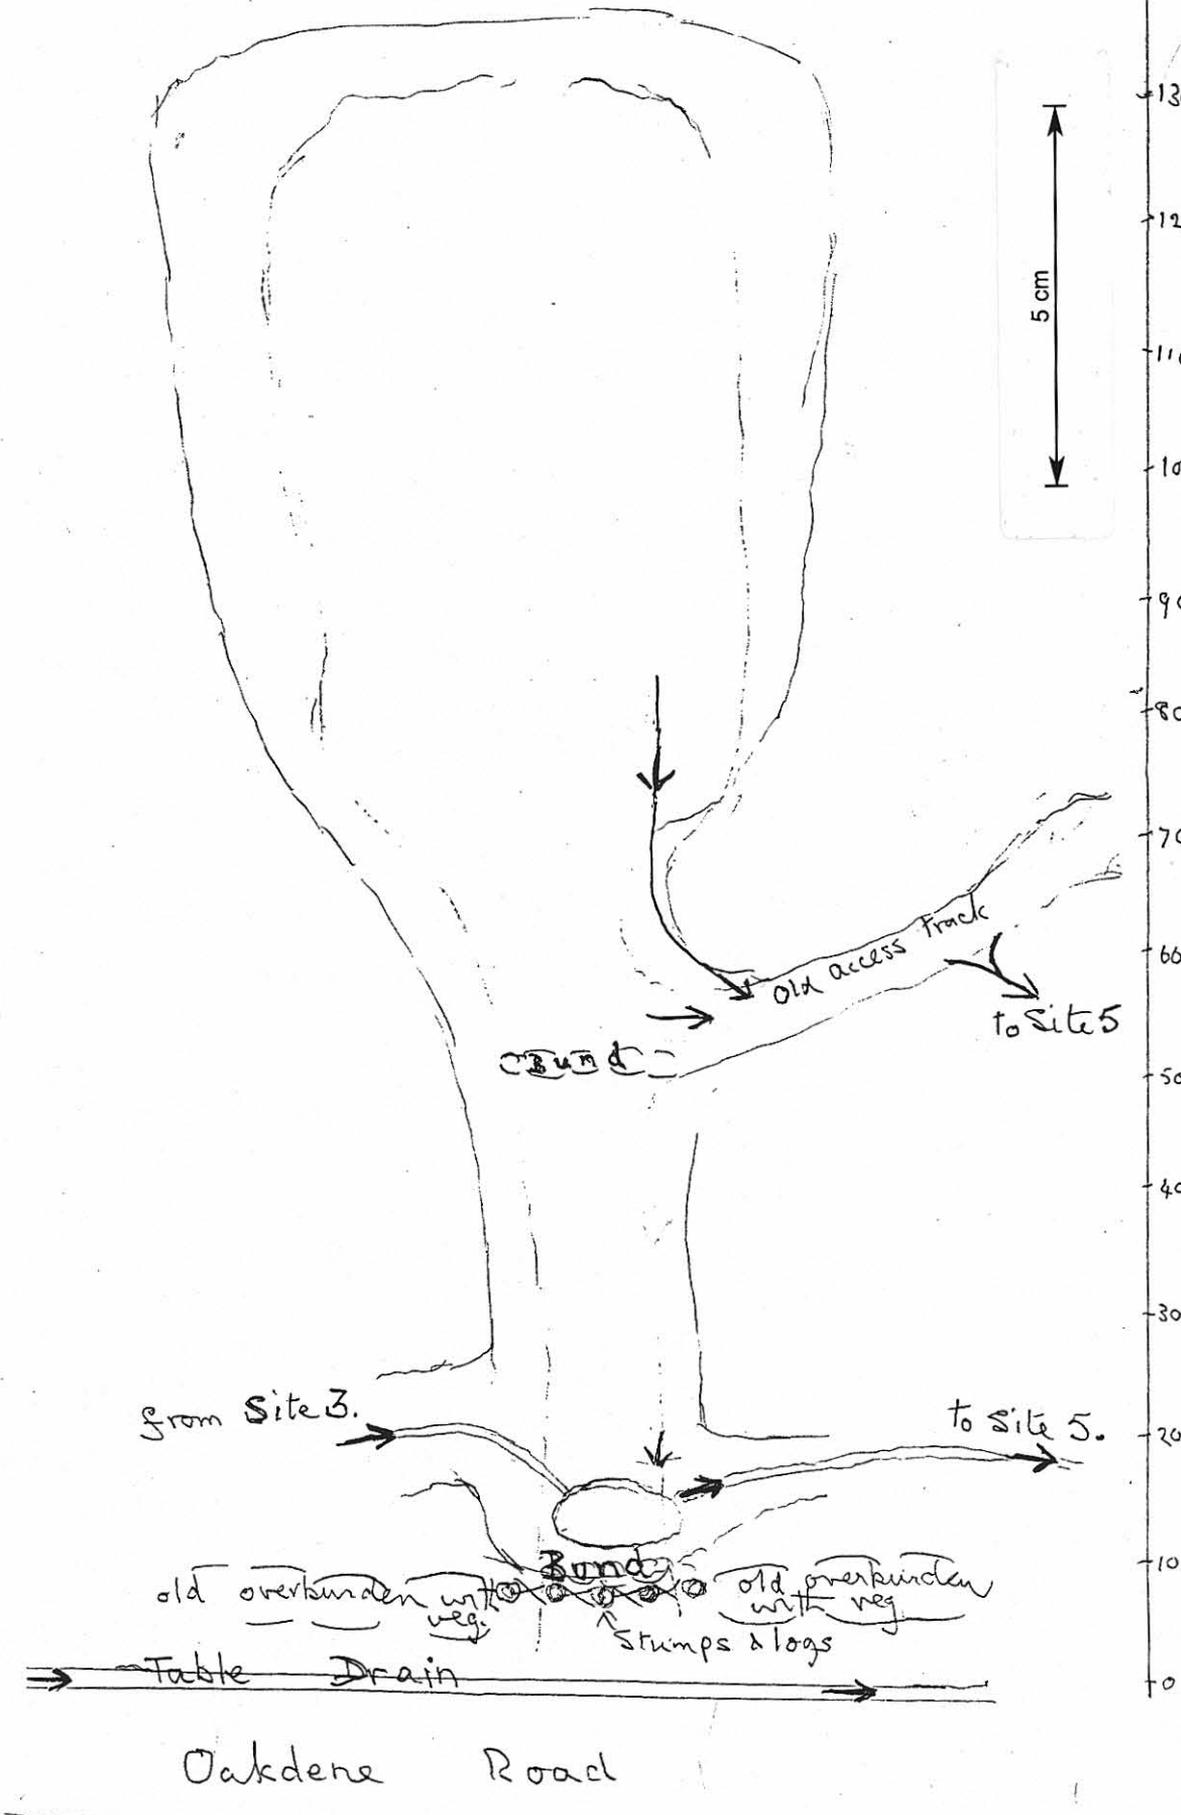
SITE 4

### **1. Water Management**

- 1.1 Earthworks to maximise infiltration and minimise run-off.
- 1.2 A bund +/- 50 m from road to divert minor run-off northwards to Site 5.
- 1.3 At bottom of area a small holding pond excavated and retained by roadside bund, and a through drainage system excavated from Site 3. to the pond and on to Site 5.

### **2. Vegetation**

No Smokewater used. Seed treatment as for Site 3.

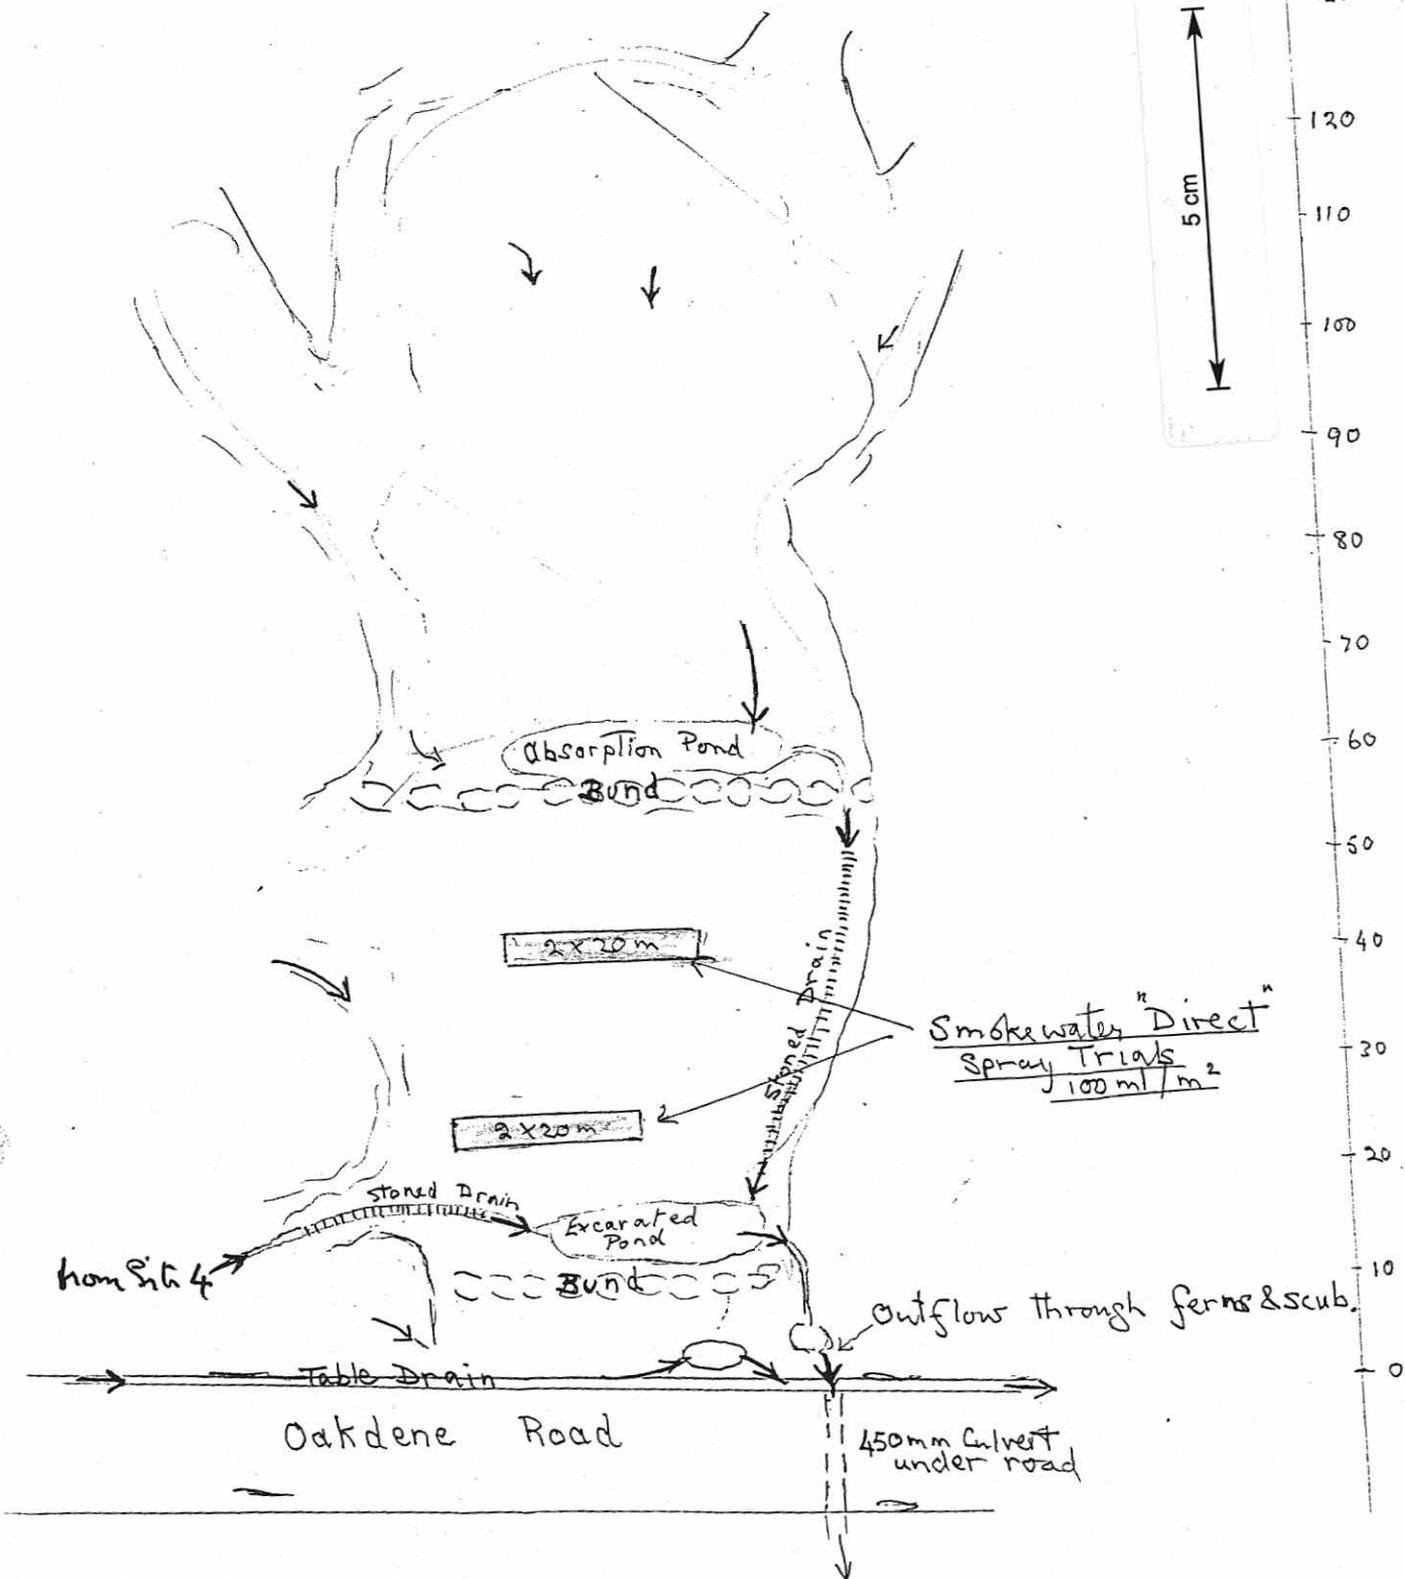
SITE 5

### **1. Water Management**

- 1.1 Erosion lines filled and area soiled and ripped, etc. to reduce gradients and minimise run-off.
- 1.2 Major cross slope bunds constructed at about 10 m and 60 m from road with absorption ponds above.
- 1.3 Two drains stoned as indicated to reduce scour.
- 1.4 Some further structural work (rock chute or drop structure) will be installed in spring and some silt fence will also be set up.

The bottom pond is deep enough to settle and hold sediments with minimal risk of sediments reaching table drain at road.

### **2. Vegetation**

- 2.1 Upper part of Site 5 sown with seed treated with Smokewater. (See area marked in red).
- 2.2 Balance area sown with seed treated as for Areas 3 and 4.
- 2.3 Two plots +/- 20 m and +/- 40 m from road pegged out and sprayed with Smokewater "Direct" at 100 ml/m<sup>2</sup>.
