**REHABILITATION OF MINING LANDS TRUST FUND**  
**Report on Works undertaken ~2000 - 2001 Financial Year**

By Revel Munro  
October 2001

# **1 Cat Gully area adjacent to Blue Lake, Endurance Mine, South Mt Cameron.**

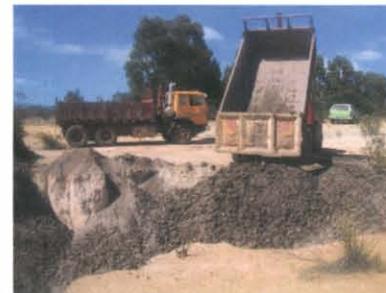
Tertiary vegetation remnants and slucebox remains were common. The photo to the left shows the surface rock to be oxidized. The heaps just below the surface are pyritic, and the sulfurous nature of the material is not conducive for plant growth.

**Action:** photo shows some of the hundreds of m<sup>3</sup> of mine waste with piles of tailings, (also grey) positioned to cover the mine waste.

A veneer of less pyritic tailings now covers the highly sulfurous mine debris in all the gully heads.

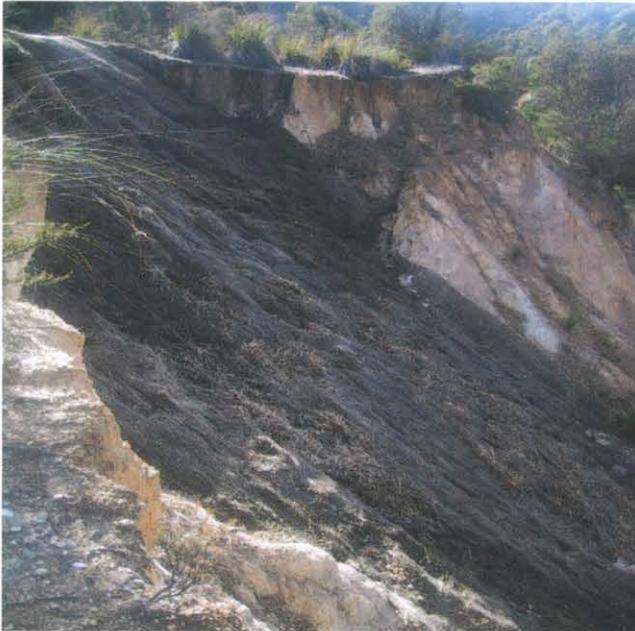
Gully [m] (see) Figure 2. Before treatment took the form of a 9m high face resulting from mass movement. In the wetter months soft decomposed granite continually slumped, forming a receding steep face.

Considering the steepness of the works slumping failure of the works is a possibility. When last inspected in September all treatment was intact.

**Action:** Many truckloads of tailings were tipped over the bank covering the area at the angle of rest. With some difficulty, a straw / jute matting / straw covering 'sandwich' was secured over the gravels. Heavy doses of seed and fertilizer were broadcast.

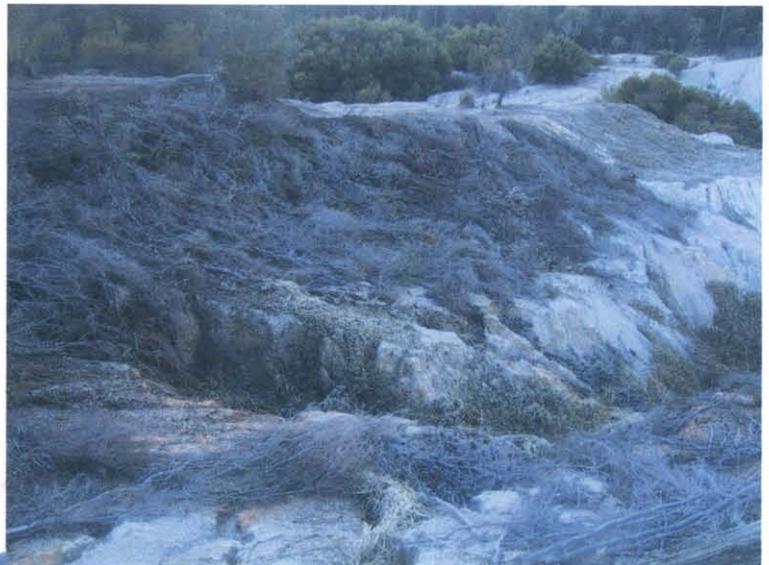
Gully [j], (pictured right) has been previously battered by Stormoway Constructions in 1998 as part of the incomplete rehabilitation treatment. The works have subsequently continued to erode leaving a large, steep, central gutter and a rilled amphitheatre.

**Action:** Rehabilitation has commenced without the reintroduction of machinery. Scrub, seed, fertiliser and hay have been applied and runoff controlled. Erosion has been minimal this winter.

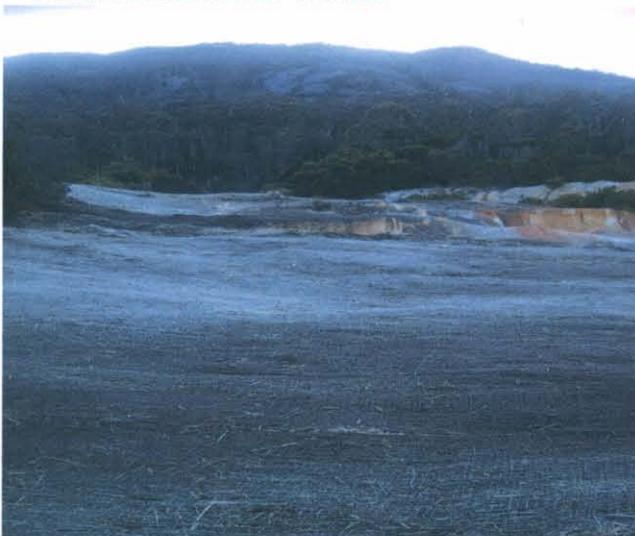
Flat, but rilled surfaces of bare decomposed granite were in need of rehabilitation. The photo on the left is an example after treatment.

Such treated surfaces have been very stable in the five months since treatment.

**Action:** Rehabilitation has involved filling gullies and scarifying with the tractor. Straw and covering jute matting was

applied to the worked up surface. Native seed and fertiliser was applied. Triticale from the straw has germinated. Only in inaccessible gullies has cereal growth escaped severe browsing by macropods and rabbits.

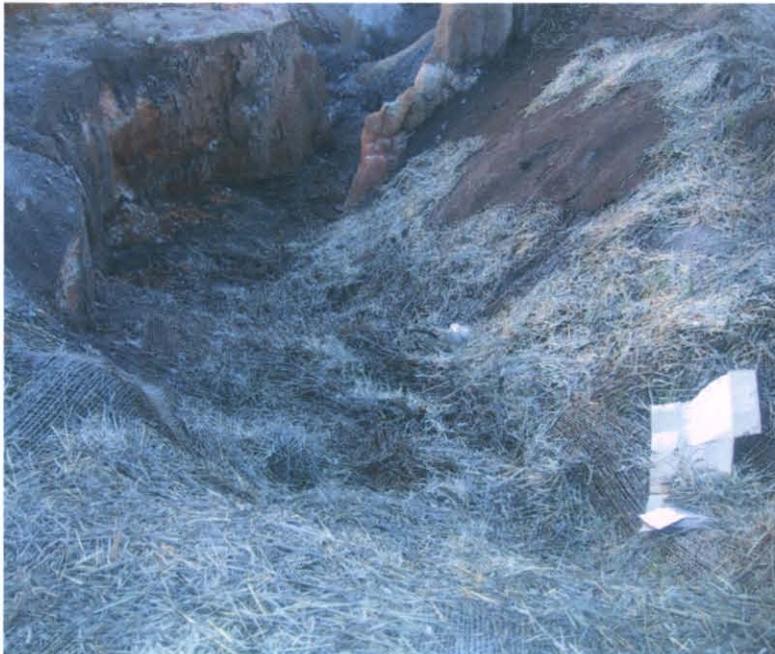
Pictured left is Gully [b] after treatment. This gully is typical of most that were mainly created by runoff.

Action: Application of mine rubble, tailings, straw and jute matting with seed and fertiliser added, has successfully (to date) stabilized all gullies treated.

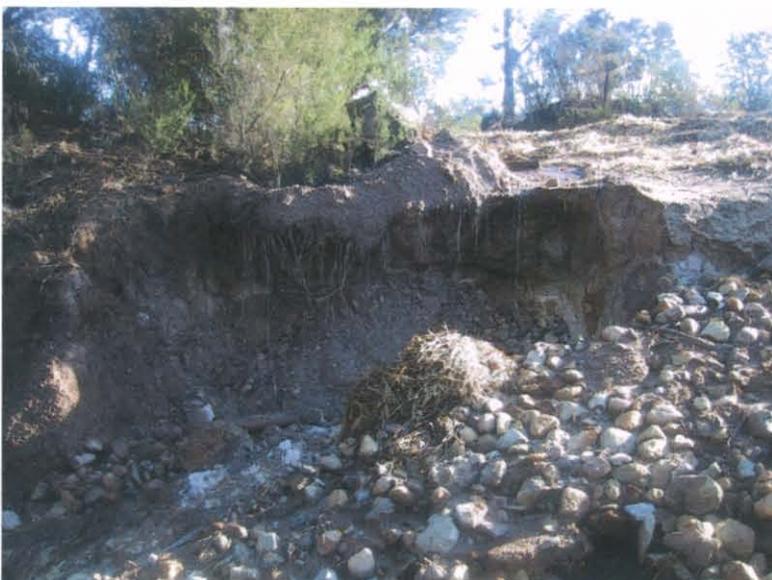
Some erosion to the flank of a rock chute (pictured left) was caused in August 2001 by a breached levee. The levee was later repaired by hand.

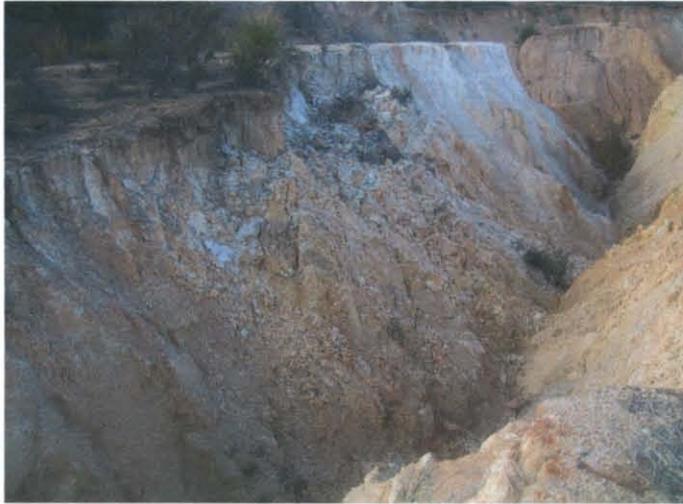
Gullies not yet treated such as this portion of [I] system have continued to slump and erode during the winter wet of winter and spring of 2001.

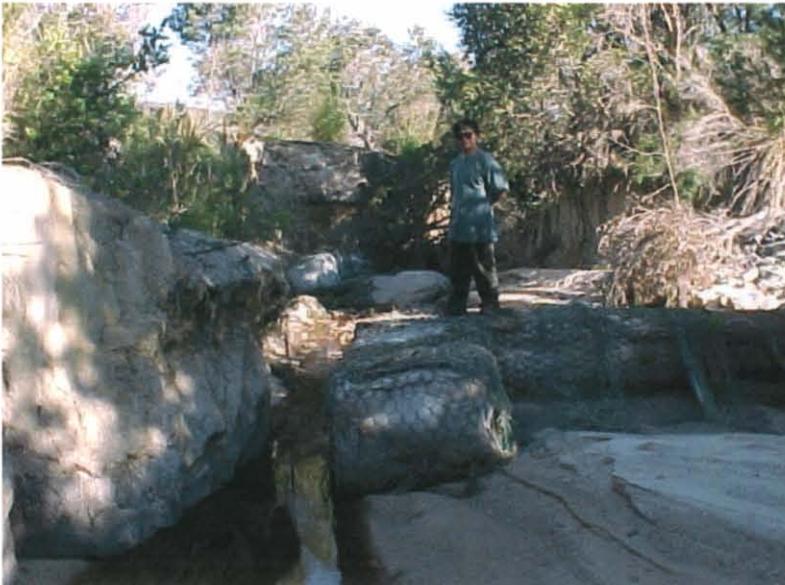
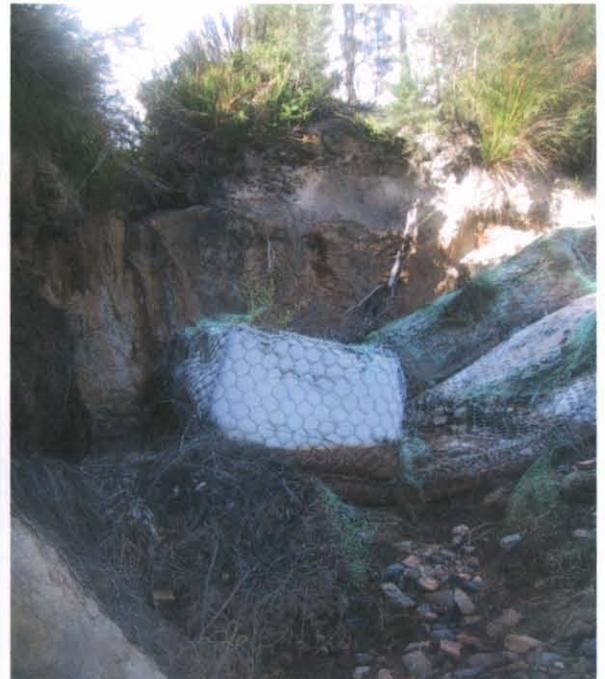
Inadequacies of the gabion structures were apparent from the onset of the first winter rains. The western margins Gabions 4 and 6 were breached, temporarily repaired and subsequently repaired and strengthened with rock armor. During a flash flood on January 4<sup>th</sup> 2000 the other margin of gabion 6 was breached. Possibly in domino fashion, Gabions 5, 4, 3, & 2 slumped and were subsequently breached as their supporting reno mattresses also slumped. Large volumes of the supporting tailings were rapidly eroded by the flash flood. The photos below show the resultant damage.

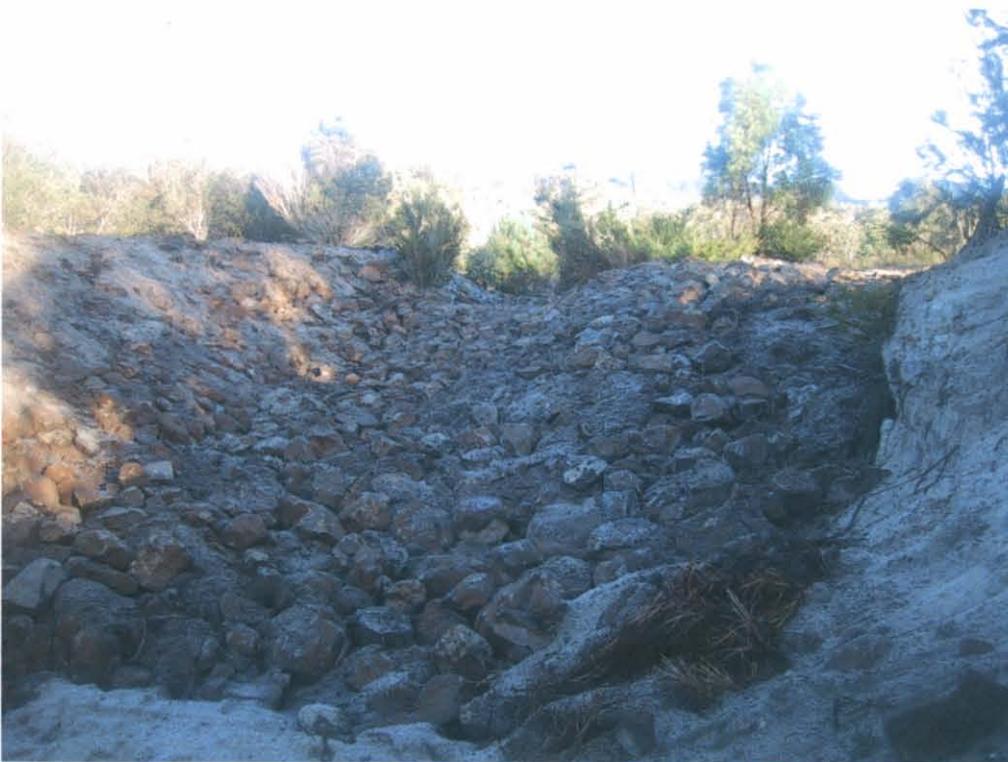
Gabions 2 and 3 were the most seriously affected control structures. The distorted wire baskets have now been buried and replaced with a continuous rock ramp (pictured left) that has been keyed at depth. Extensive channel armoring, and a design to incorporate a side flood overflow channel are part of the latest works.

Ray Symons of Gladstone was again hired this summer to complete repairs to the gully affected by the collapsed gabion structures utilizing the rock stockpile and geotextile. Rock chute structures were constructed to either encompass or replace Gabions 2, 3, 4 and 5. Gabion 1 above the gully remained intact and in no need of maintenance. Gabion 6 was adequately repaired the previous year. The lowest structure, Gabion 7 has been substantially strengthened and armored as its stability is most crucial to the integrity of the whole project.

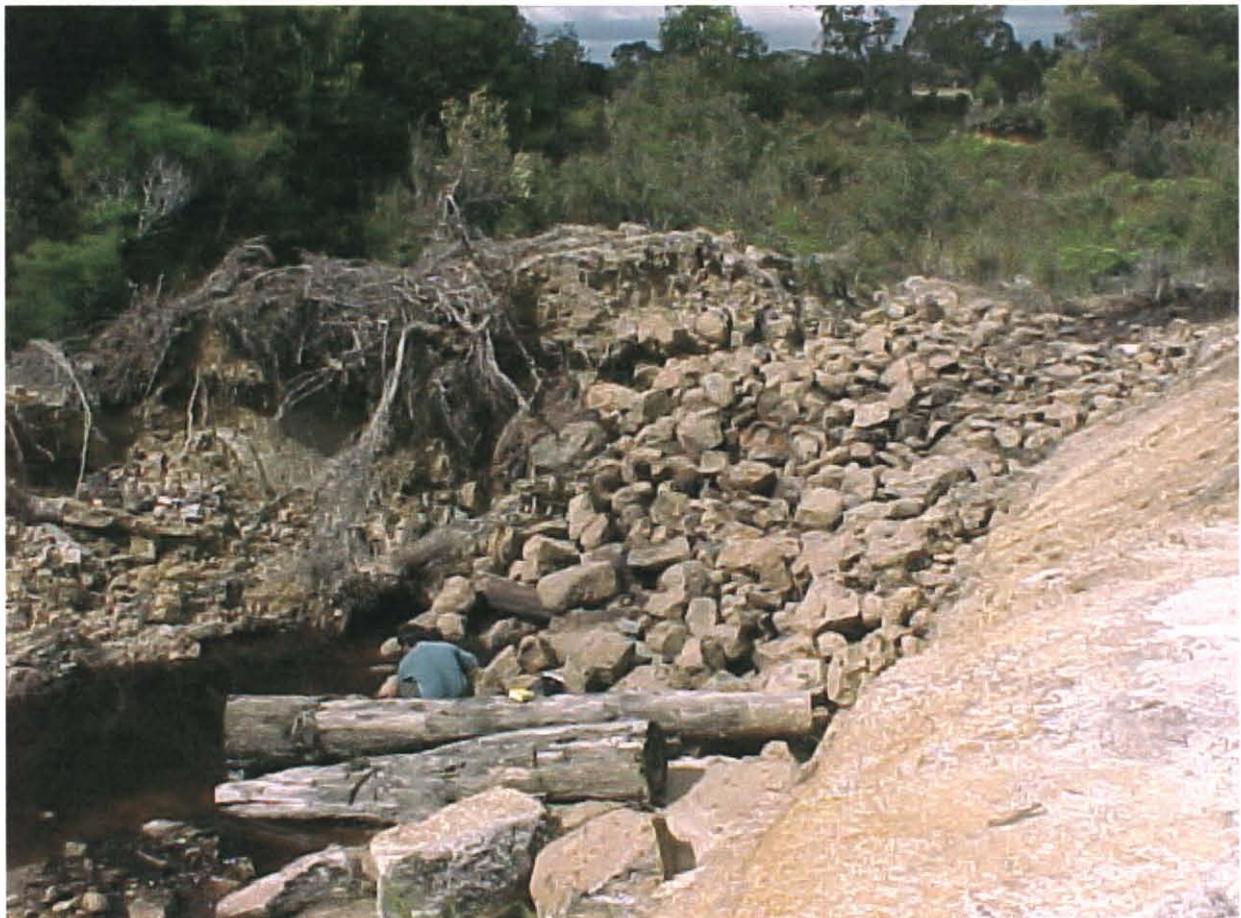
Works this year has been limited to continued inspection. Both the riffle and the channel are stable. Ongoing inspection is recommended as it is apparent that the drain carries large amounts of runoff at times.
