STORYS CREEK

JIG TAILINGS RELOCATION REPORT

JUNE 2003

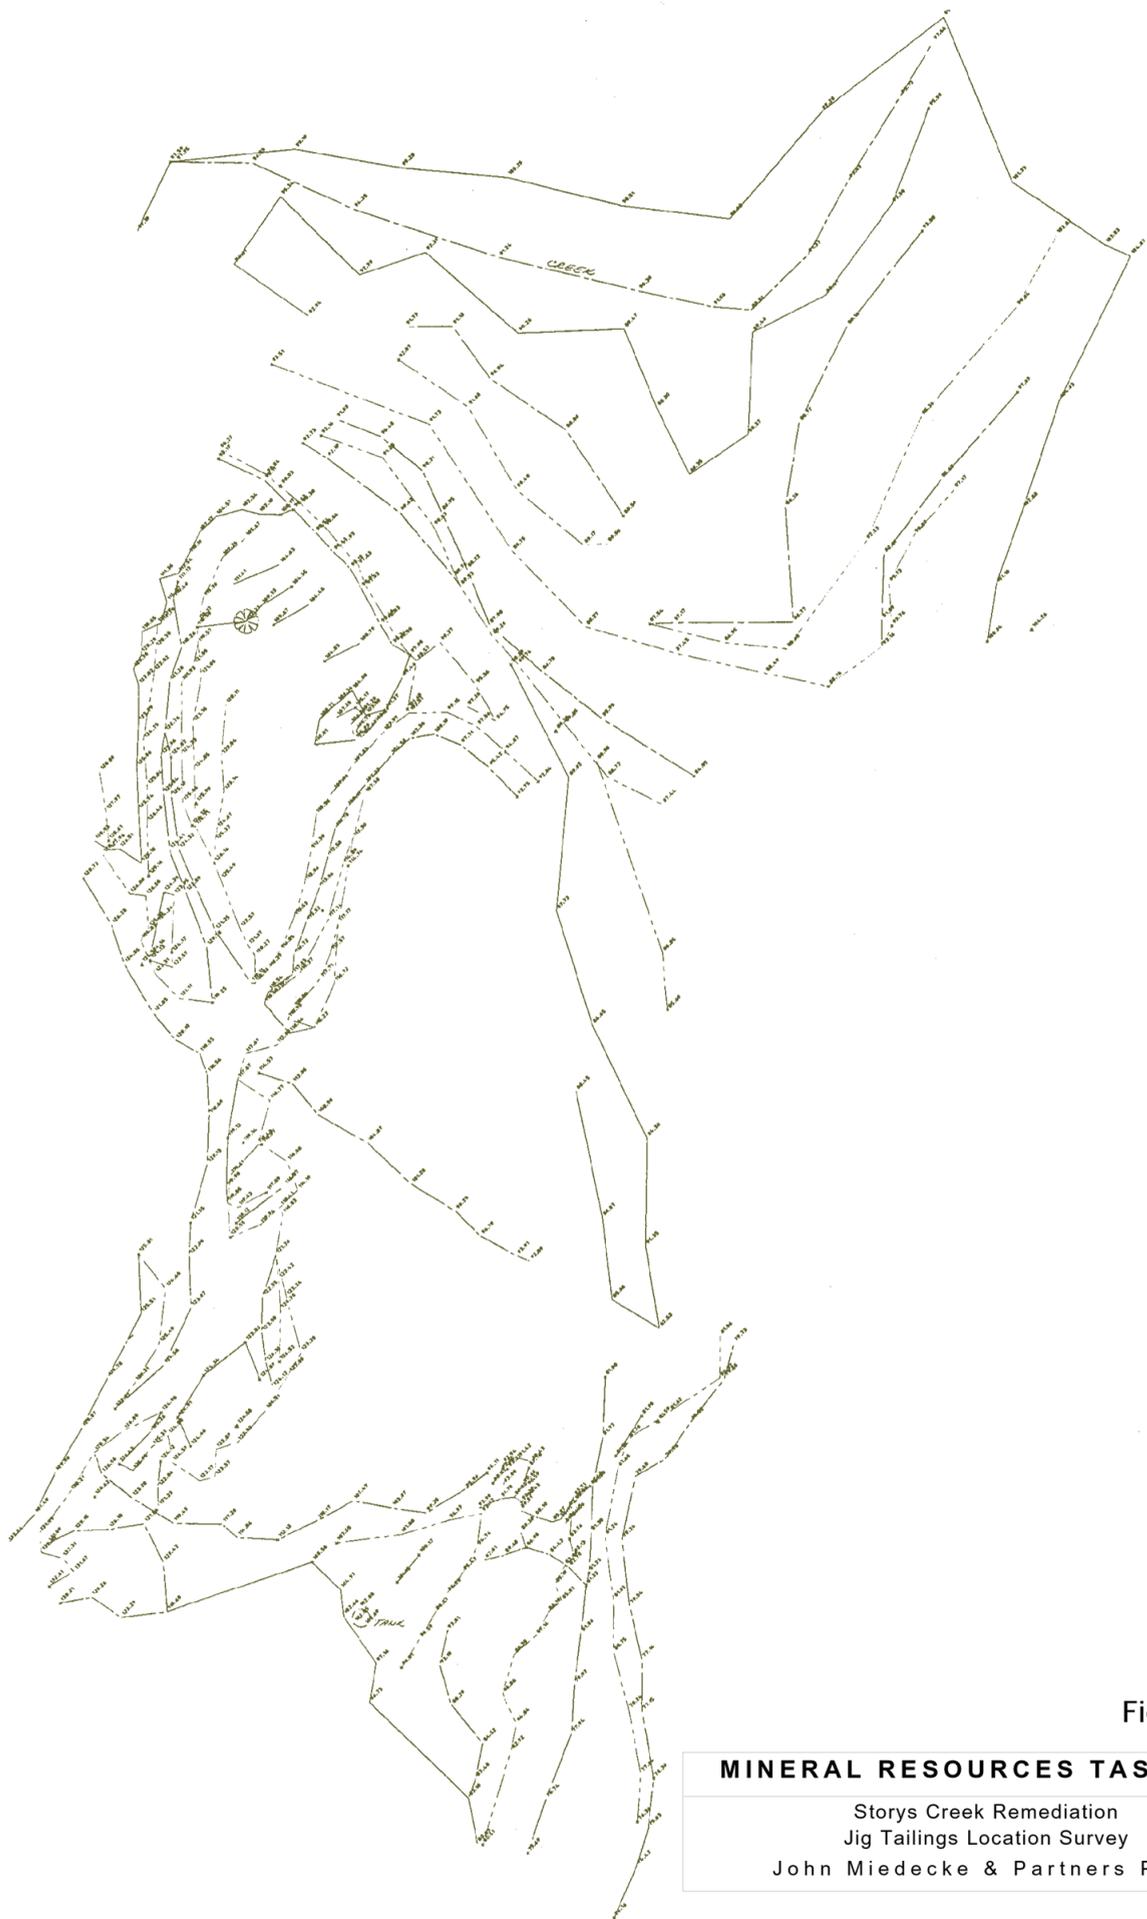
Figure 3 shows a plan of the jig tailings area.

The estimate of the volumes by the surveyor was 50,000m³.

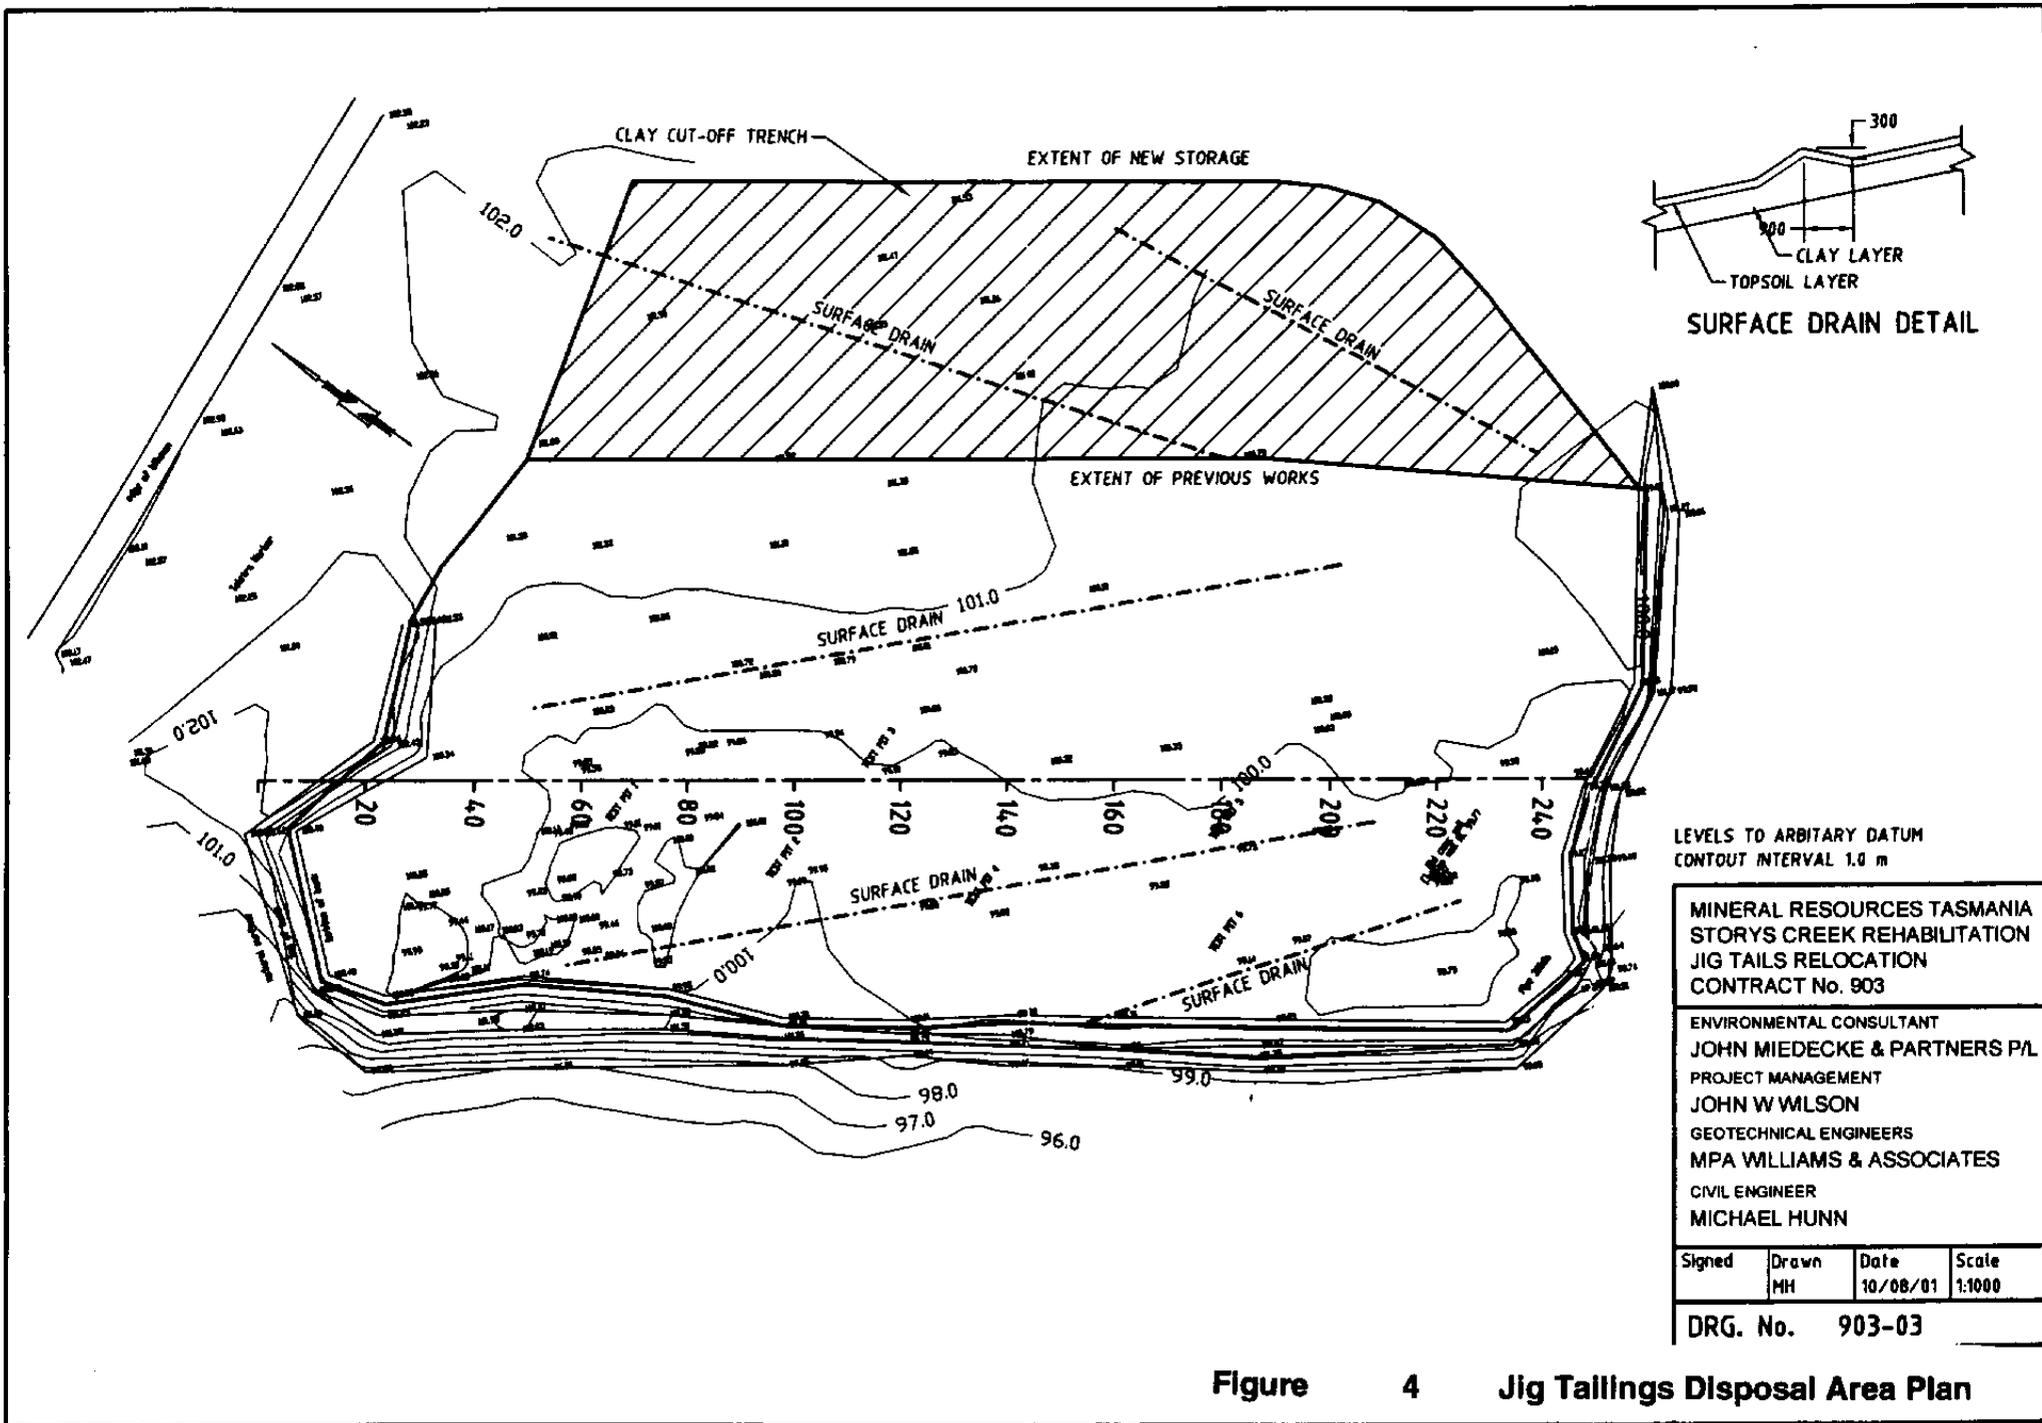
Figure 4 Jig Tailings Disposal Area Plan

The area selected for the relocated tailings was the eastern side of the disposal area used for the relocated precipitate dam tailings materials. Provision had been made for this in the design and construction. Figure 4 shows the plan.

The design was as a mound with side slopes consisting of between 1:4 and 1:6 side slopes, with a surface area of approximately 1ha hectares. Figures 4, 5 and 6 show the design plan and sections of the storage. The slopes graded into the surrounding topography with a toe drain directing runoff to the Storys Creek catchment via settlement dams.

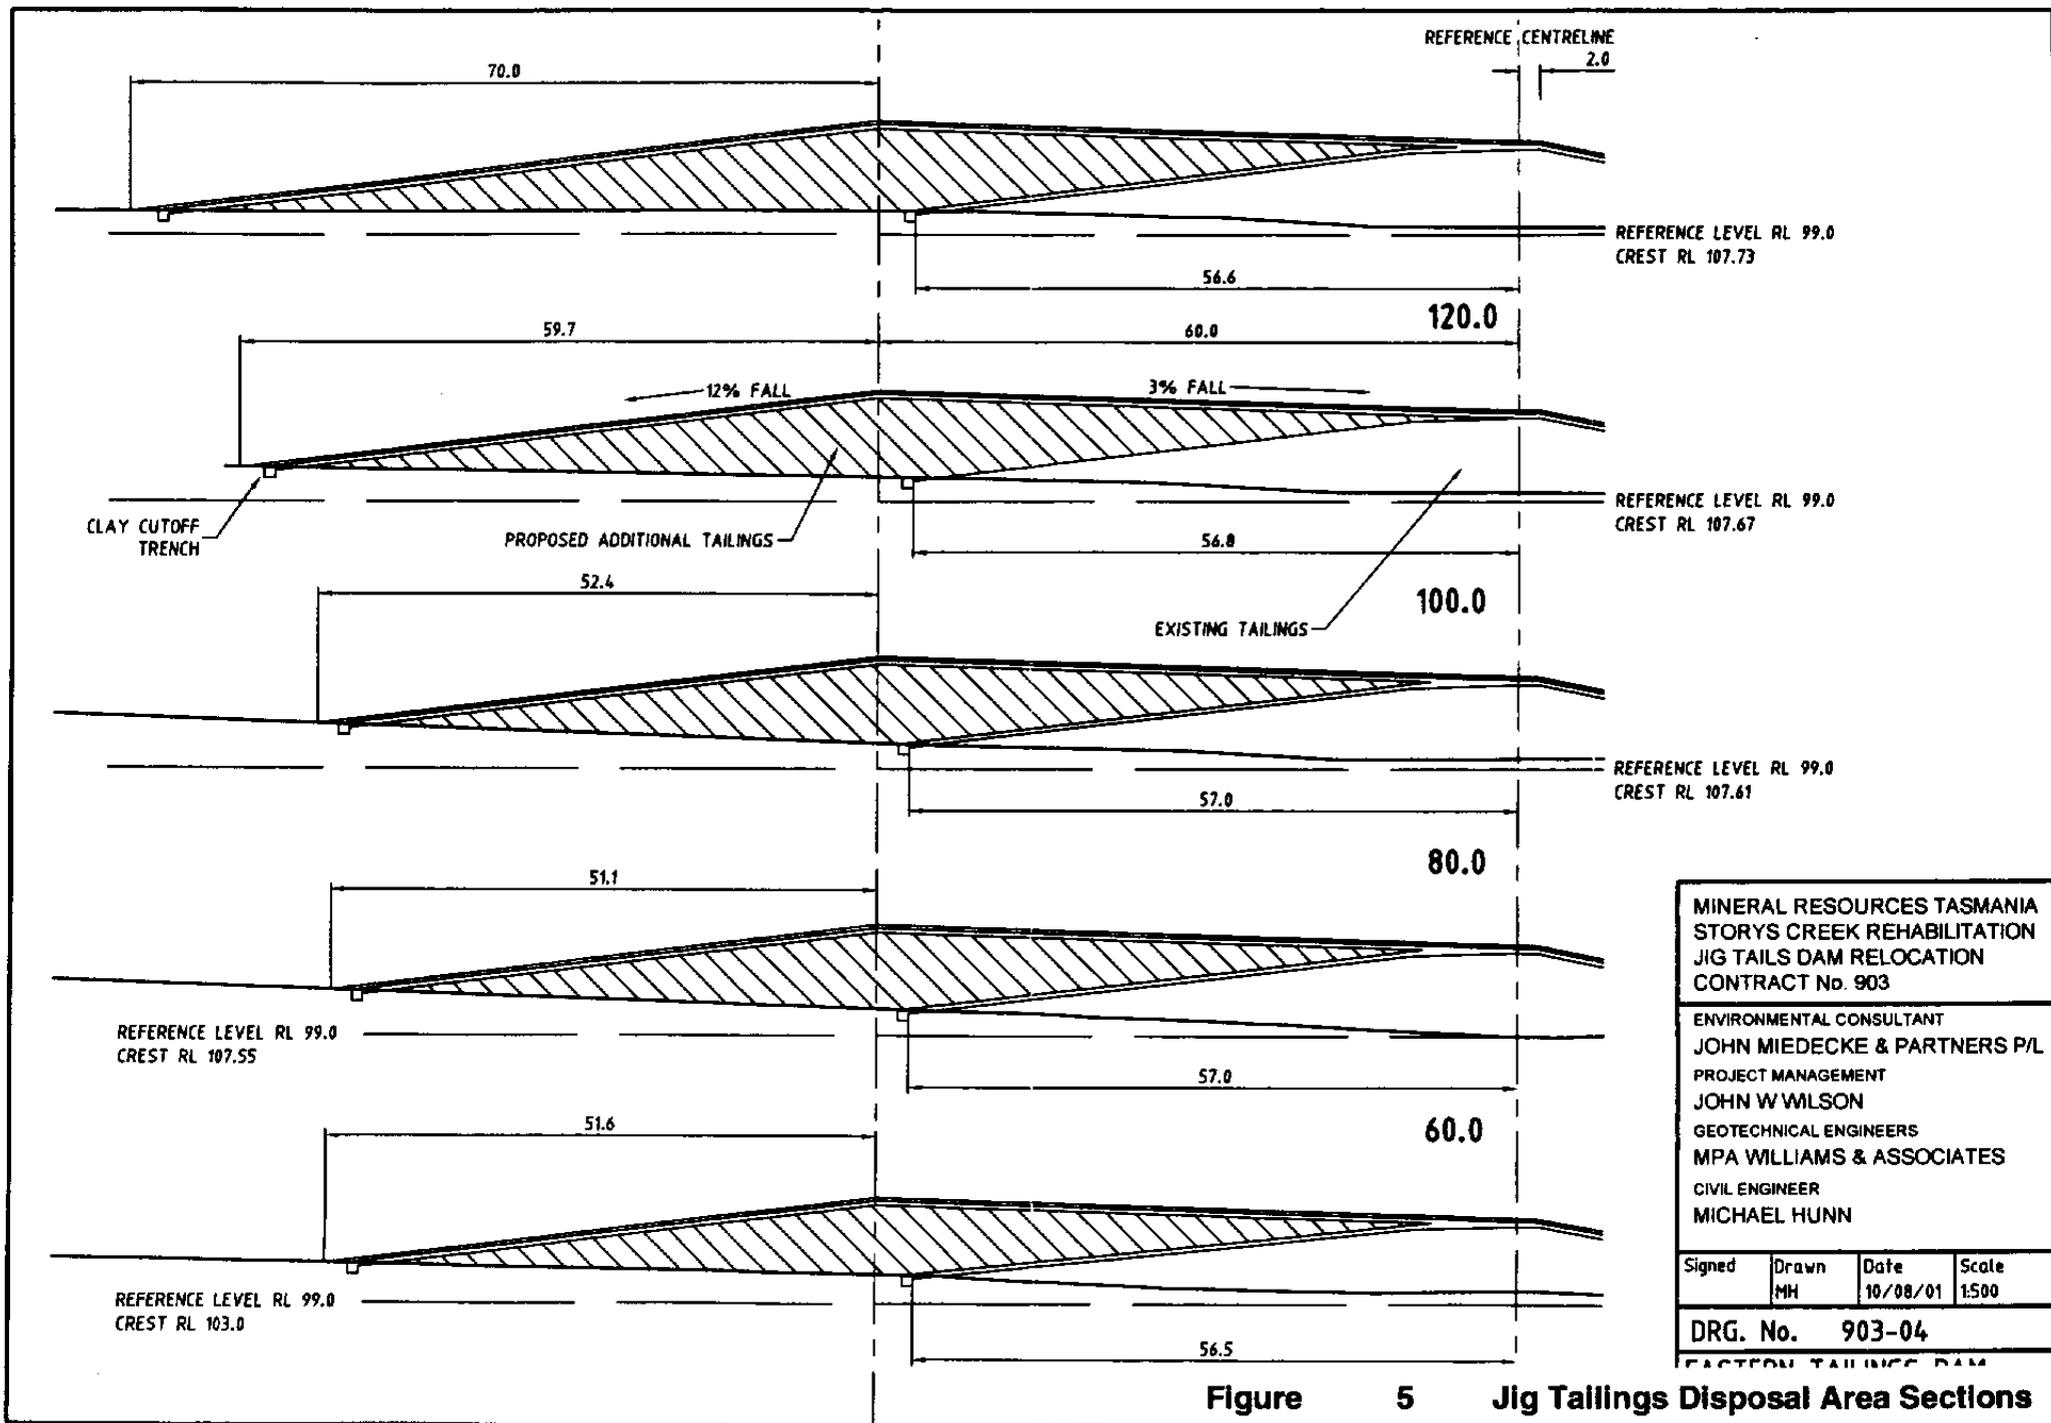
Figure 5 Jig Tailings Disposal Area Sections

The boundaries of the storage was excavated through the existing tailings (on the western side into basement material to form a key and leachate barrier. This excavation was backfilled with clay (see Figures 5 and 6).

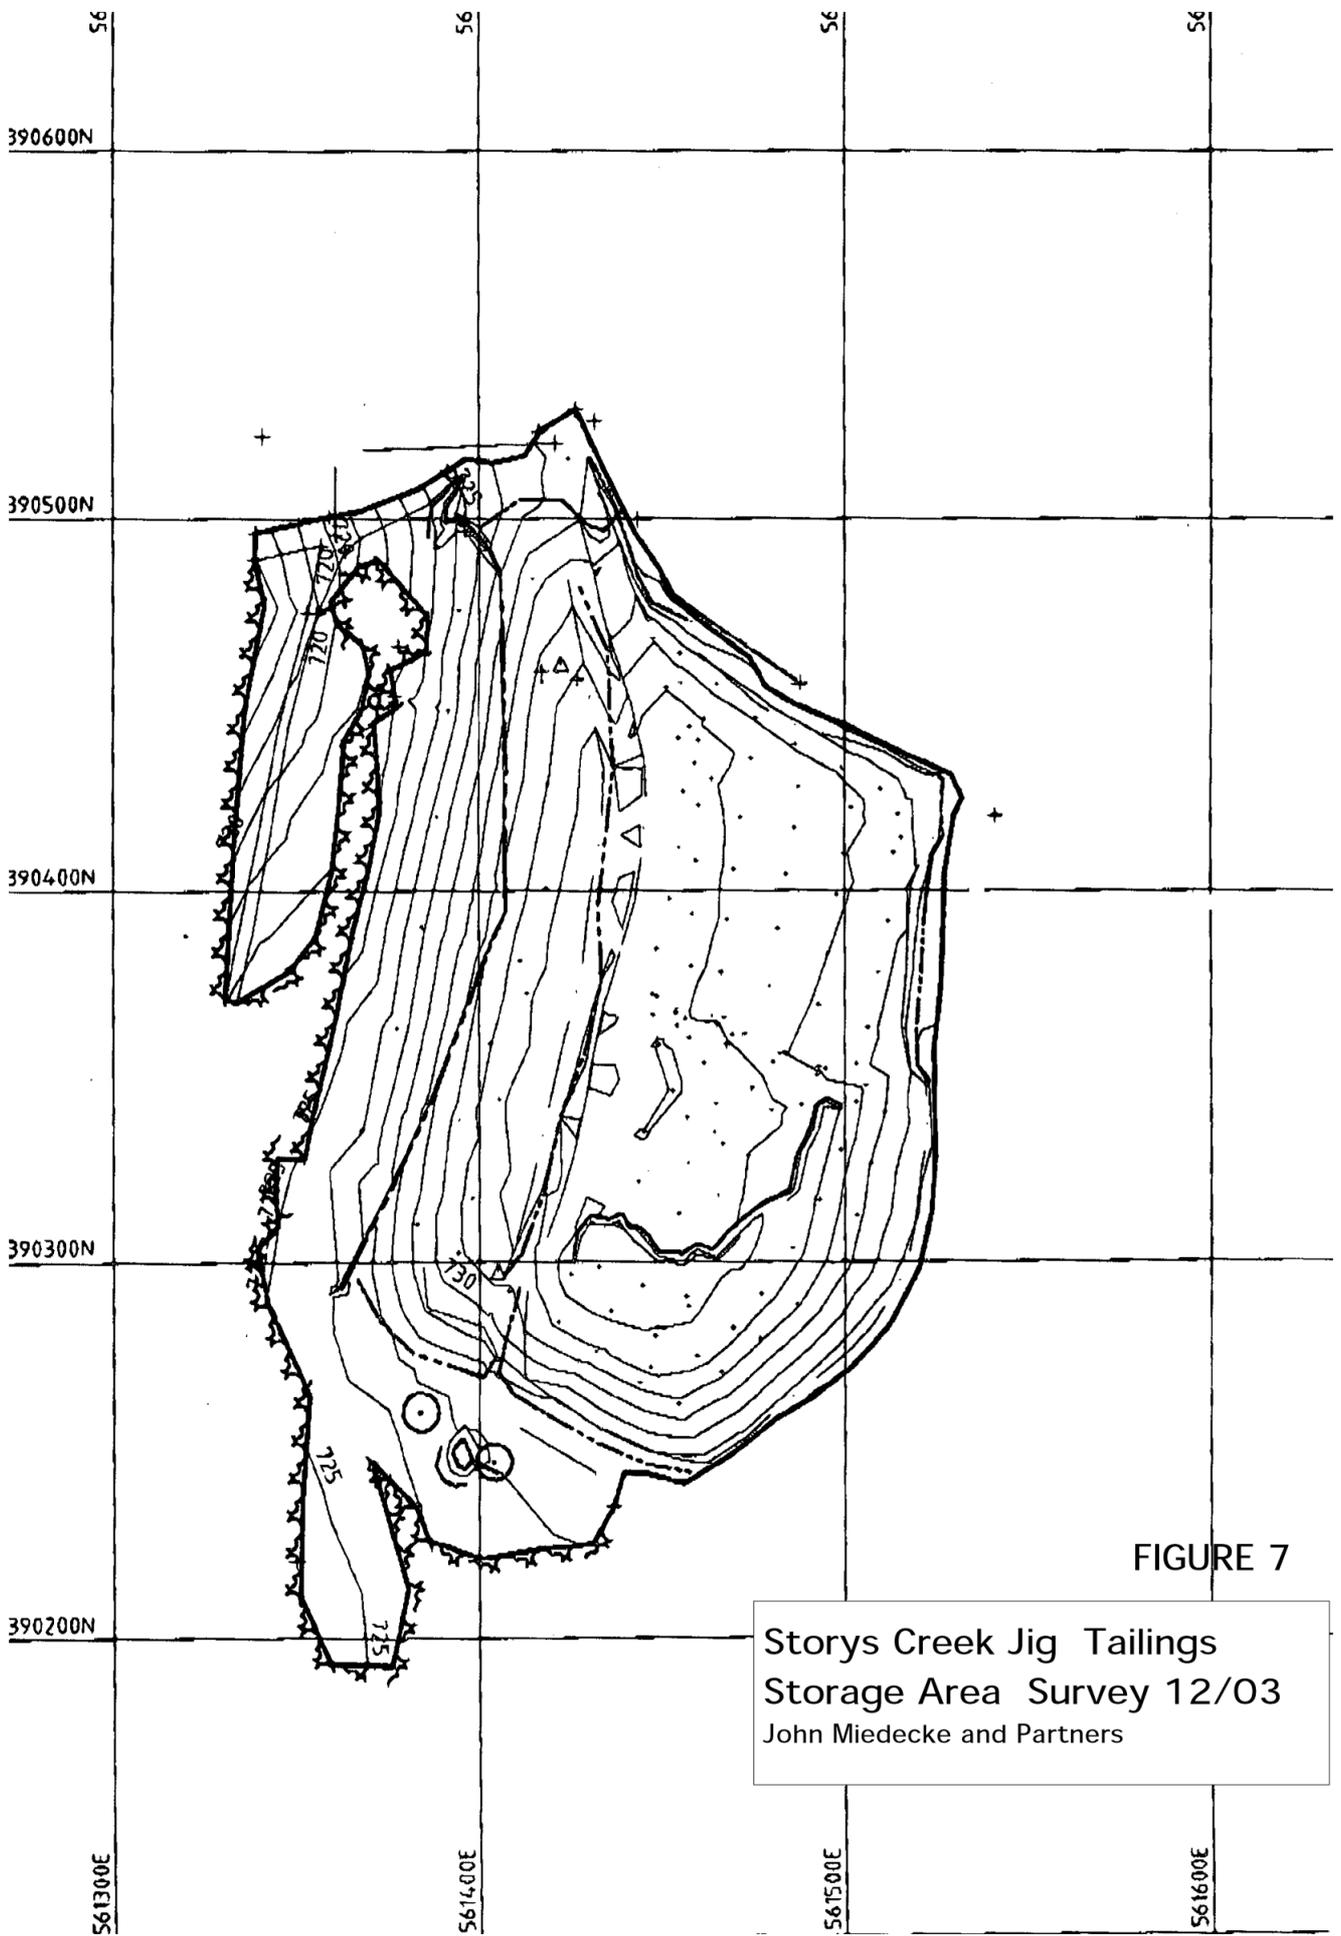
FIGURE 7

higher to include the additional tailings materials and the sides steepened. Additional drainage berms were installed. The clay capping was reduced in thickness to use available materials and reduce the budget. Figure 7 shows the survey plan in late December 2002. Additional materials were placed and this is not a final survey plan.

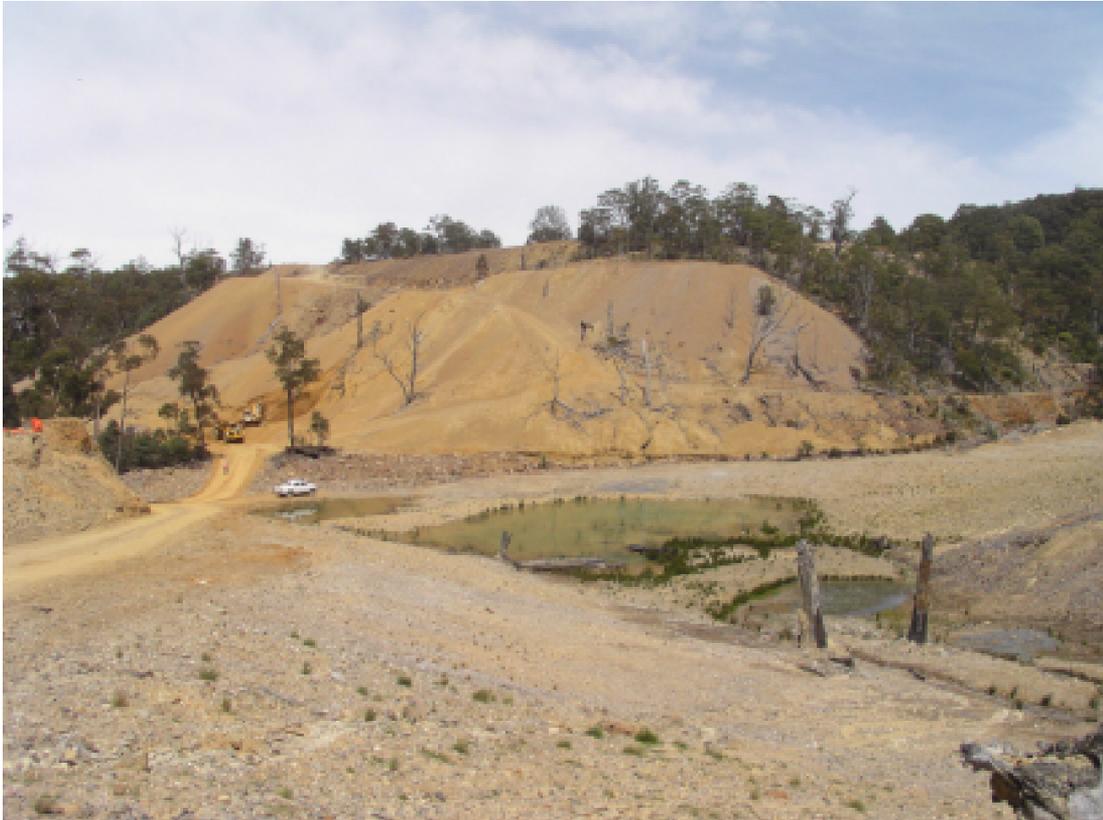
View of Jig Tailings Deposits Nov 2002

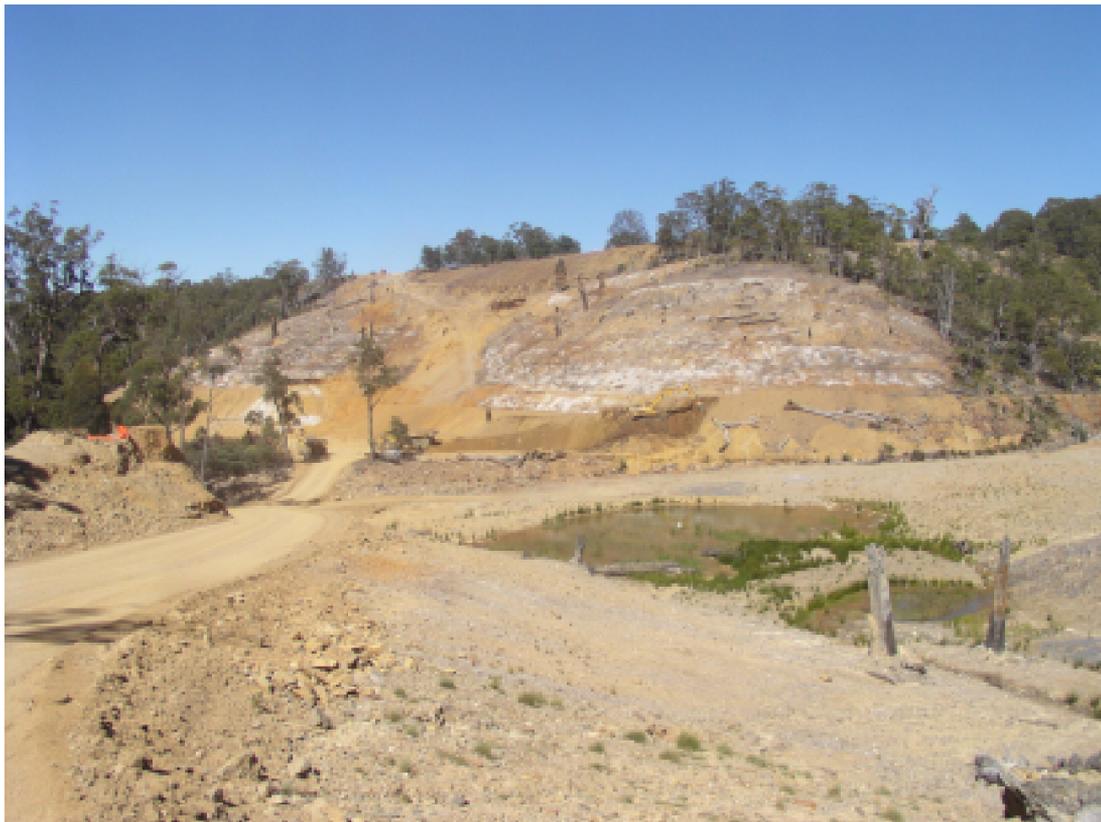
View of Jig Tailings Deposits February 2003

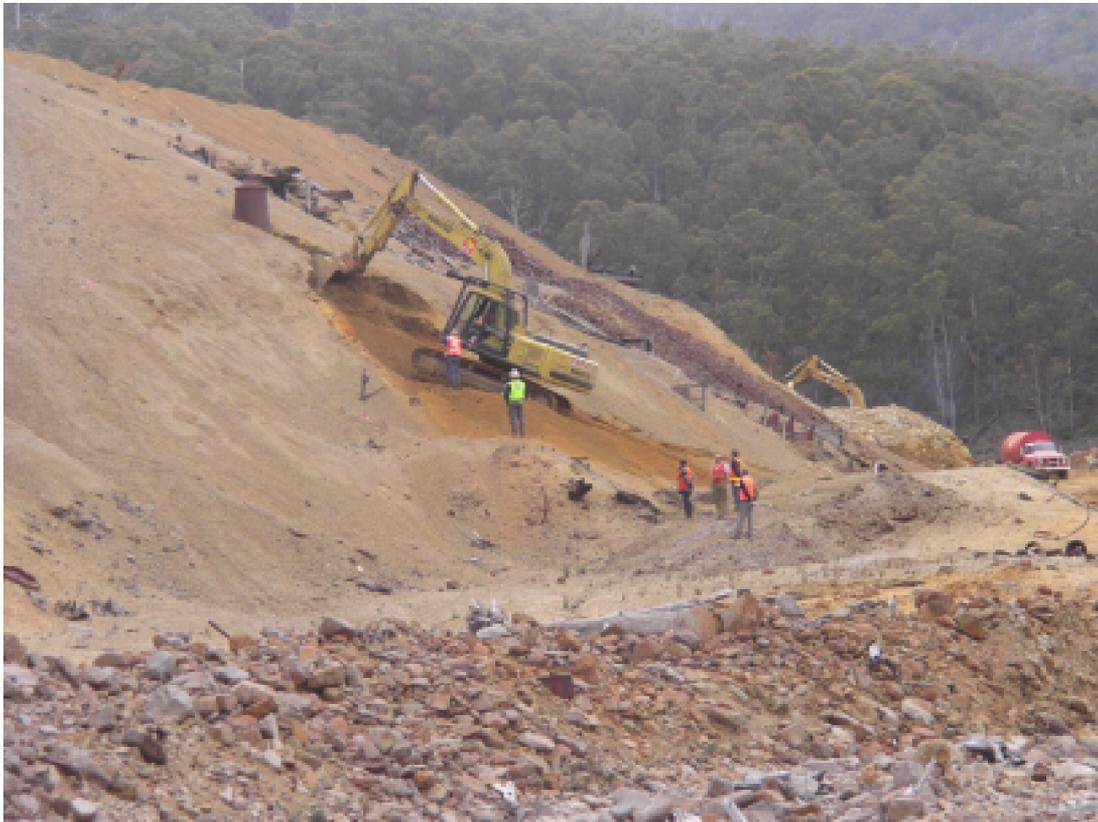
Excavator Clearing Old Battery Area

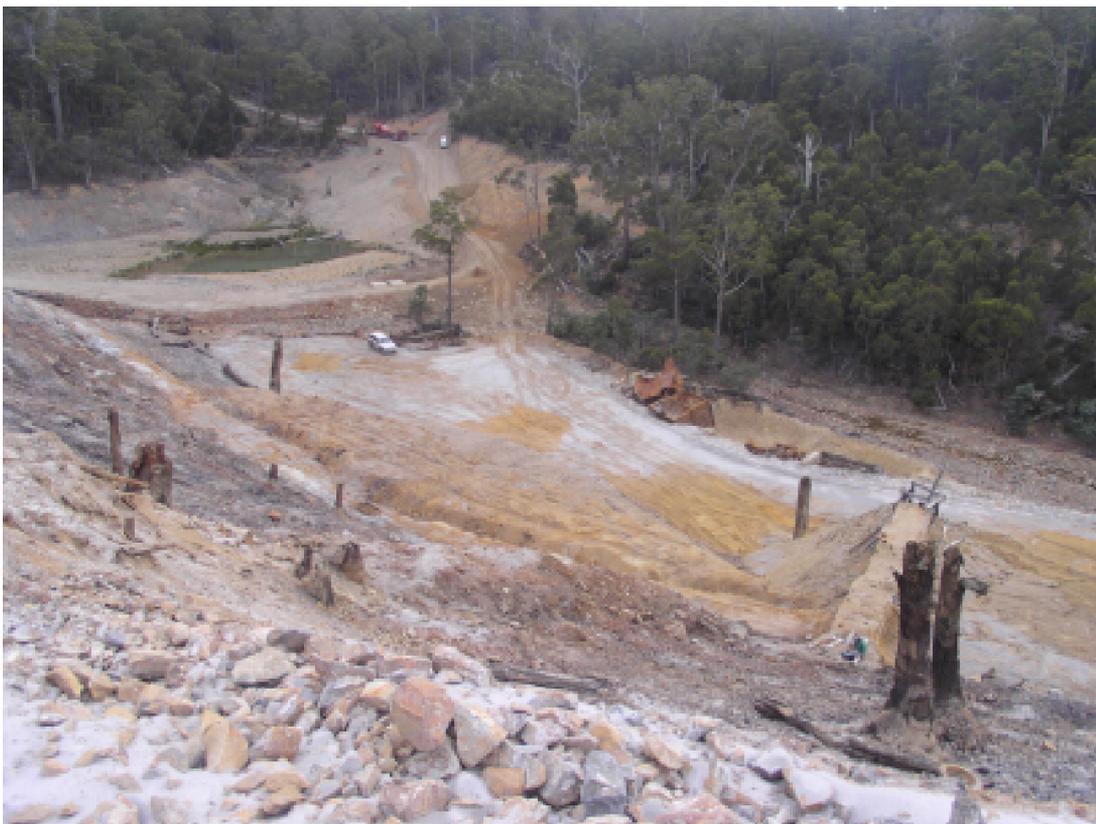
View of Tramway and Old Adit Entrance

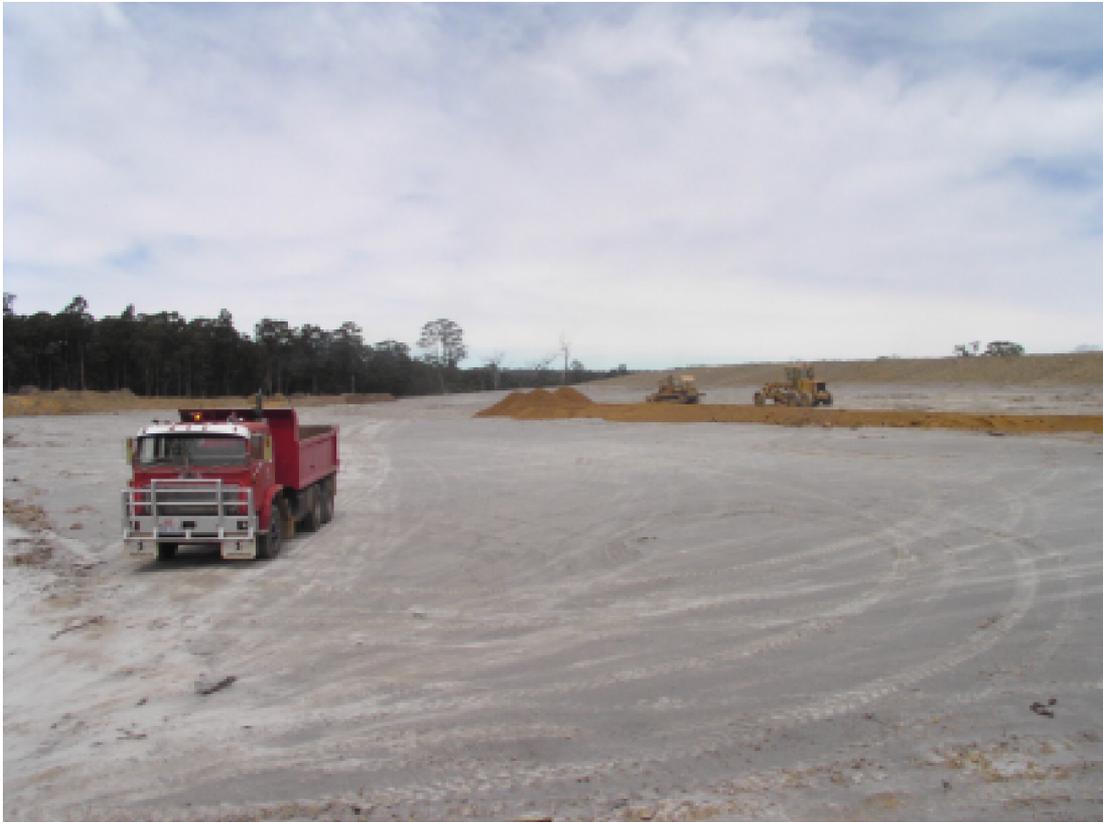
Disposal Area - Prepared Base

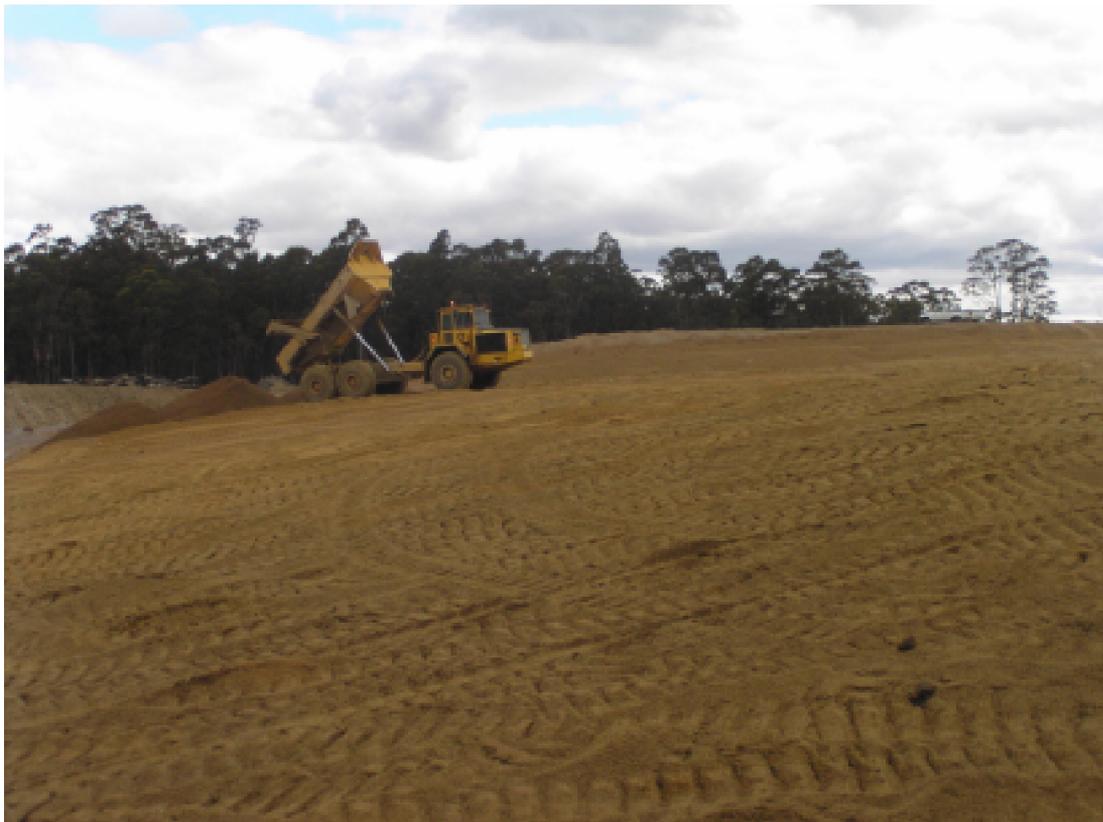
Placing Tailings

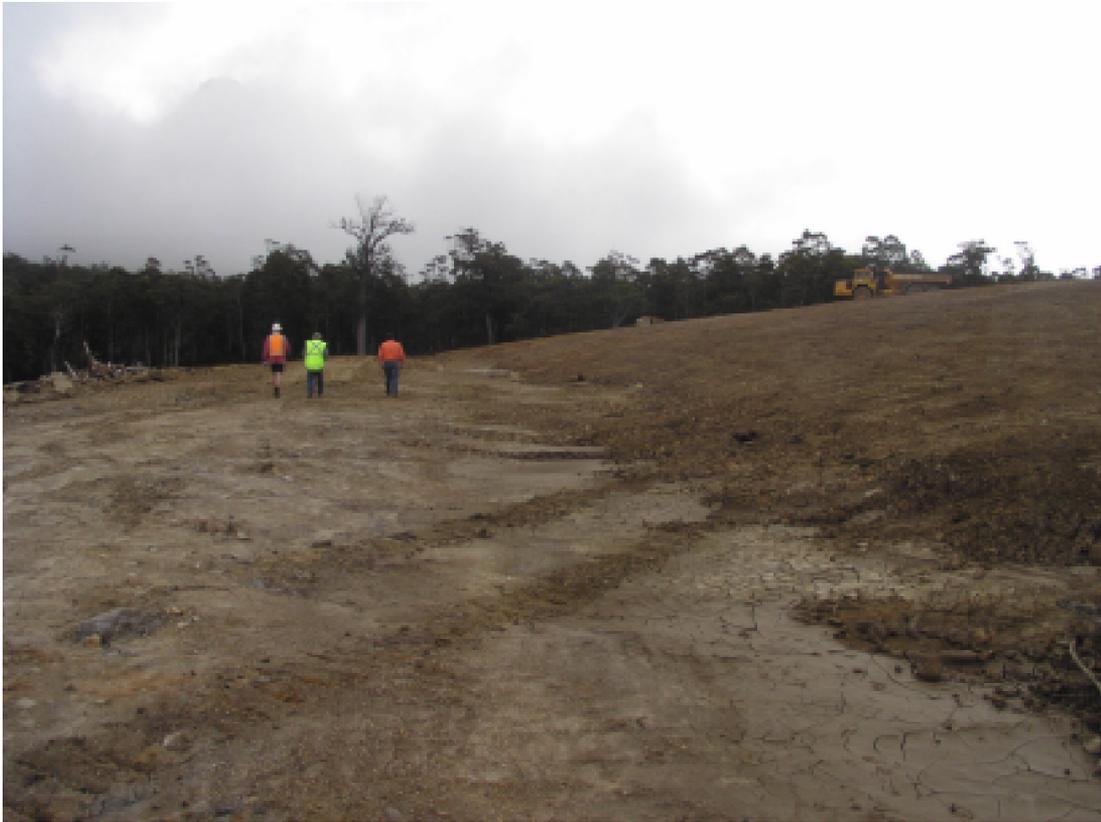
Drain on Final Surface of Deposit Area

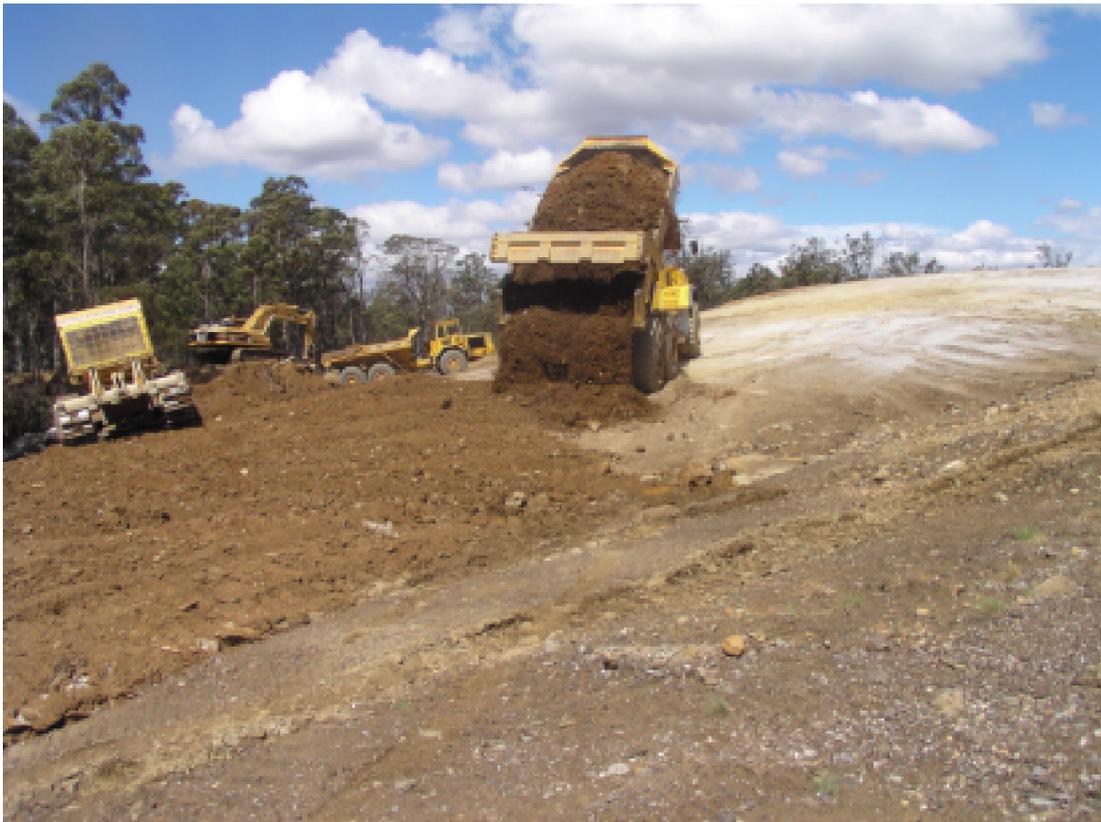
Placing Topsoil

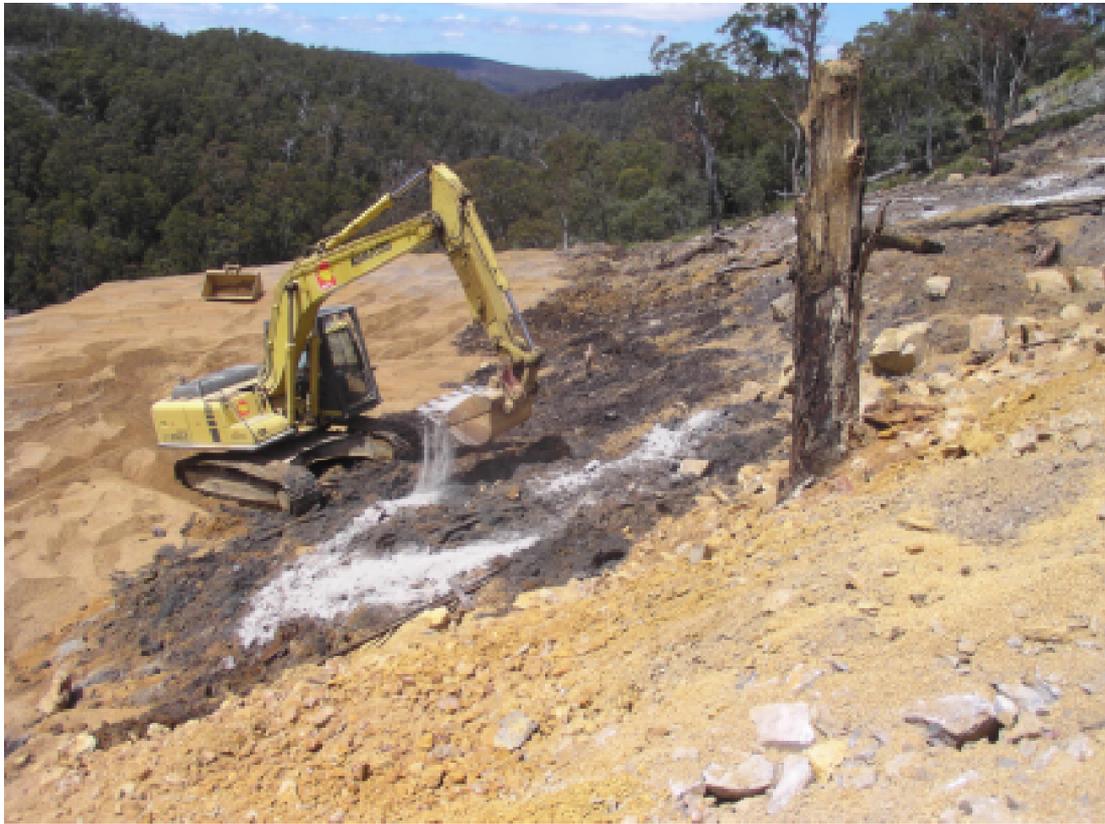
Placing Limestone on Slopes

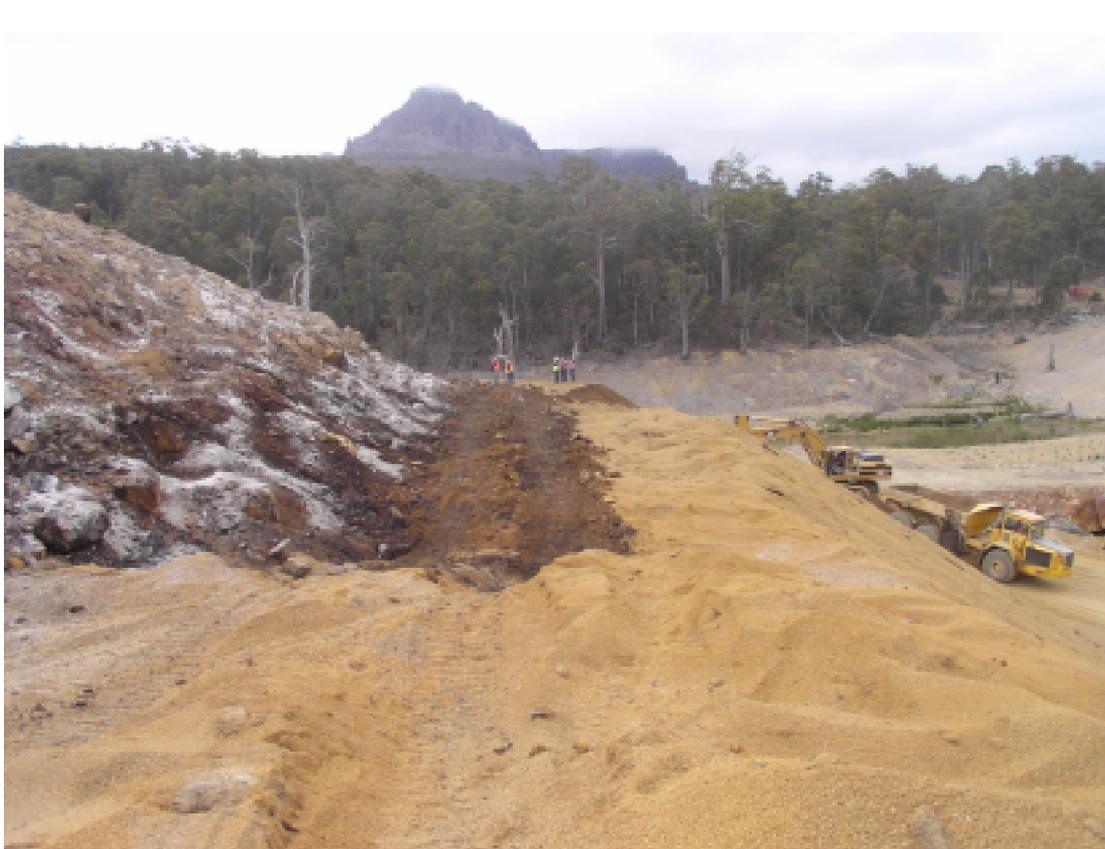
Final Surface After Tailings Removal
