FLY-BY-NIGHT MINE - WATER QUALITY INVESTIGATION

REPORT FOR MINERAL RESOURCES TASMANIA

18 June 2013 - Final - Project No: 2821.004

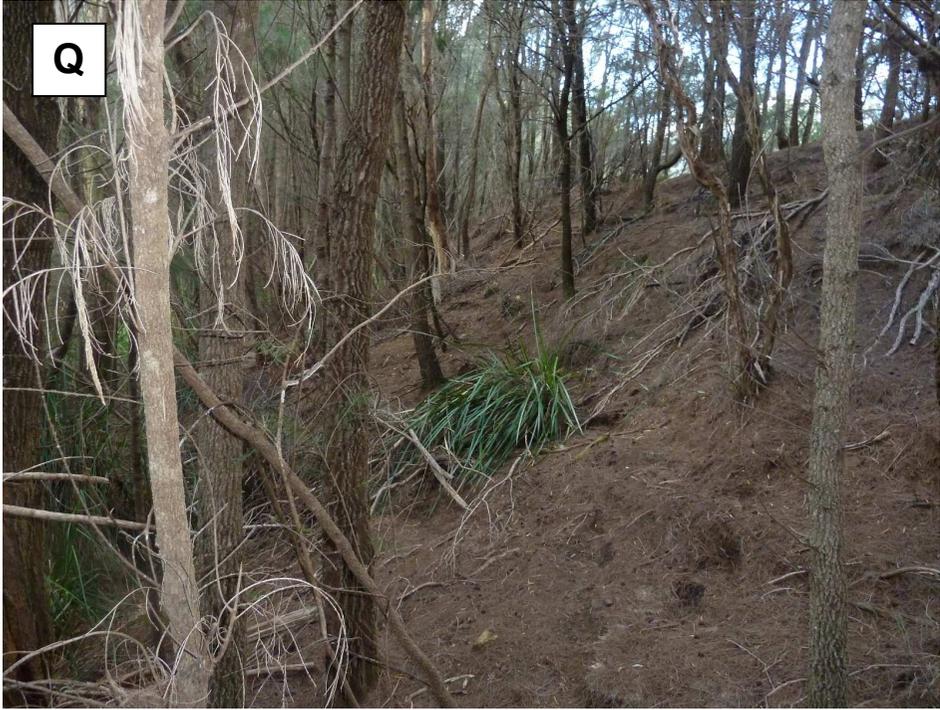
- Q Back side of Fly-By-Night dam wall. The dam wall is covered with tall thick *Allocasuarina* re-growth.
- R Point at which water appears and forms a new channel on the back site of Fly-By-Night dam wall. The water may come from the nearby spill way (moving underground rather than over the spill way).

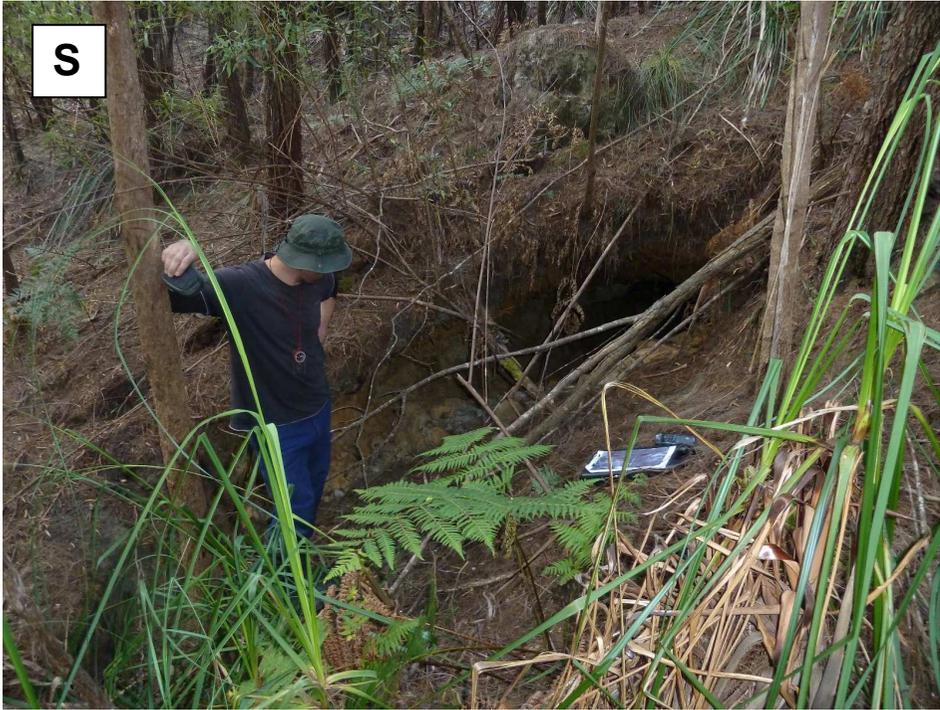
- S Large eroded opening on the north eastern end of the Fly-By-Night dam wall (Figure 6)
- T A damp area behind (and at the base of) Fly-By-Night dam wall.

That being said, it is likely that any appropriate rehabilitation works completed within the catchment would contribute to an improvement in water quality, and the repair or appropriate modification of the dam wall may need to be carried out as a matter of priority, to avoid a sudden flood release of water and sediment as a result of a potential breach of this structure.
