Storey's Creek Site – Asbestos Concentration Levels Methodology

Site Inspection and Assessment Conducted on the 16th April 2017

By Peter Stucki

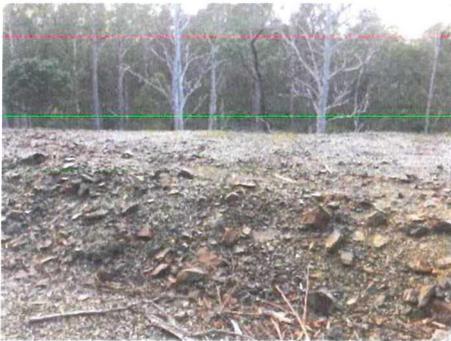
PIC OF BUNDING AROUND TOP OF TIP FACE

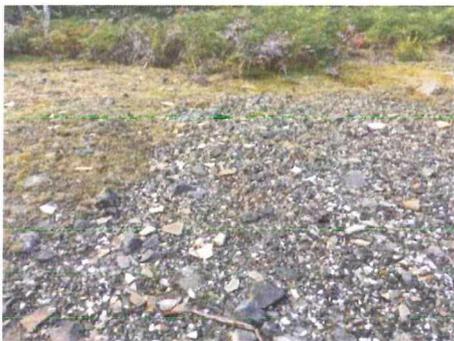
PIC OF FLAT AREA BETWEEN BUNDING AND TIP FACE

Unfortunately, it was not possible to gain access to the banks of the tip face and gully as it was deemed unsafe and covered with vegetation overgrown. However, the flat section, at the top of the tip face, could be remediated. The same method of remediation as mentioned for L/2 contamination would be undertaken.

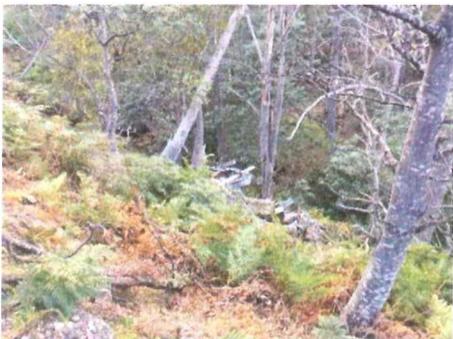
PIC OF PART OF TIP FACE

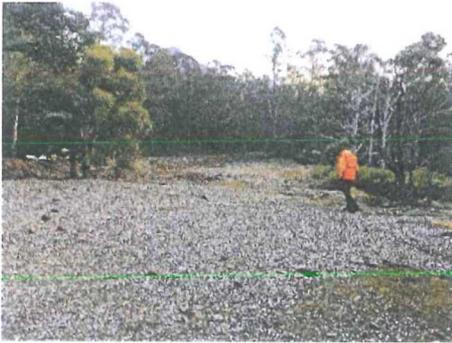
- hundreds of small pieces of asbestos cement sheet debris are mixed in amongst the soil and pebbles. This level of contamination indicates a L/4 grading.
- the likelihood of asbestos debris having been pushed down into the tip.

PIC OF L/4 CONTAMINATED AREA BETWEEN BUNDING AND TIP FACE. APPROX 90m X 15m

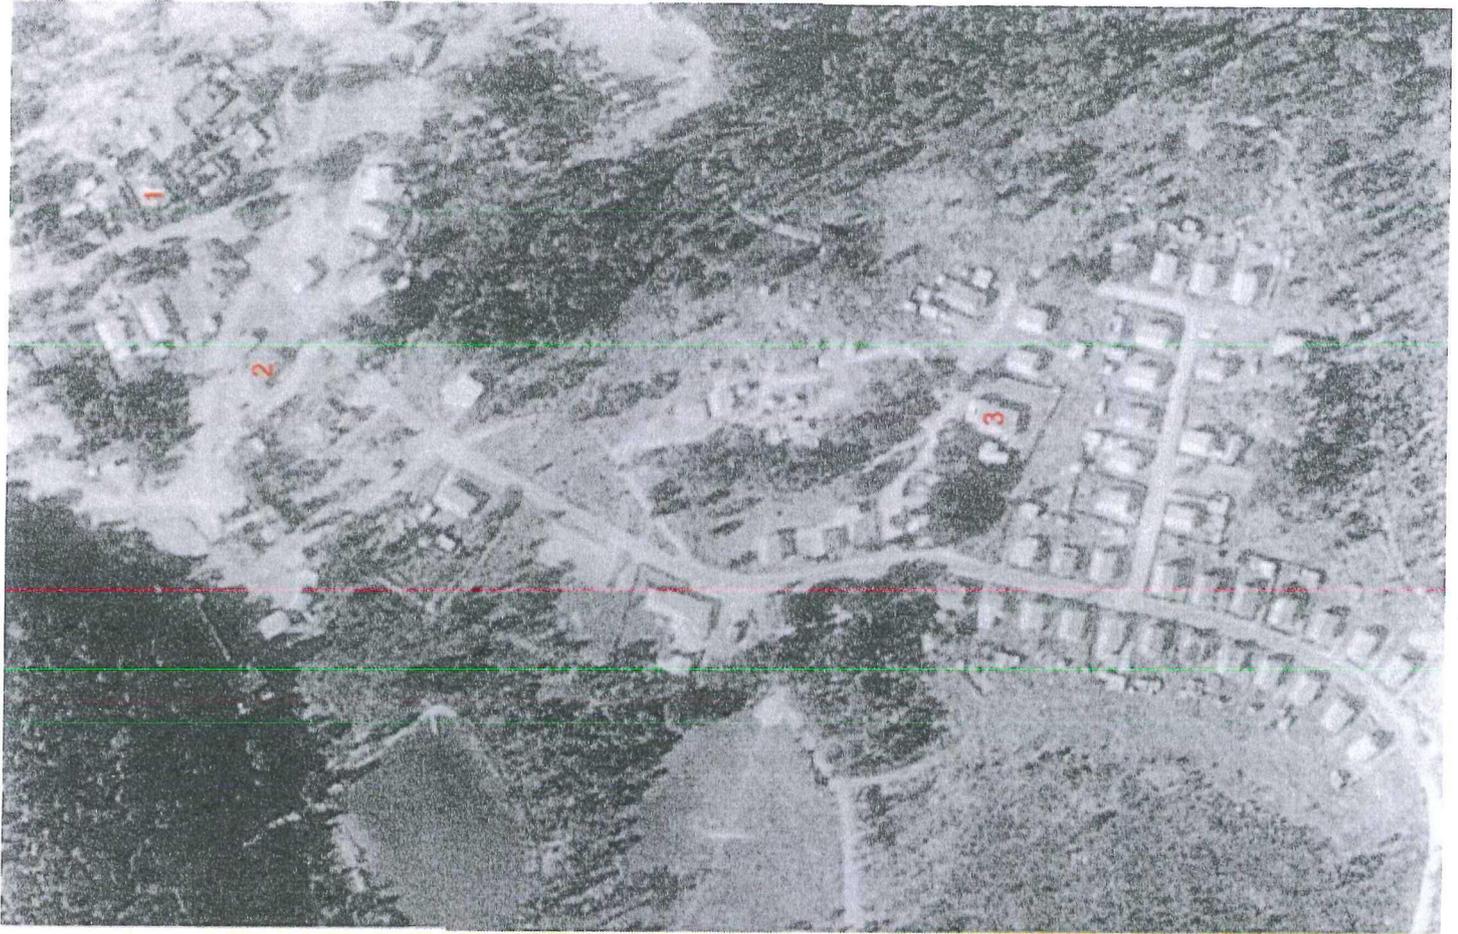
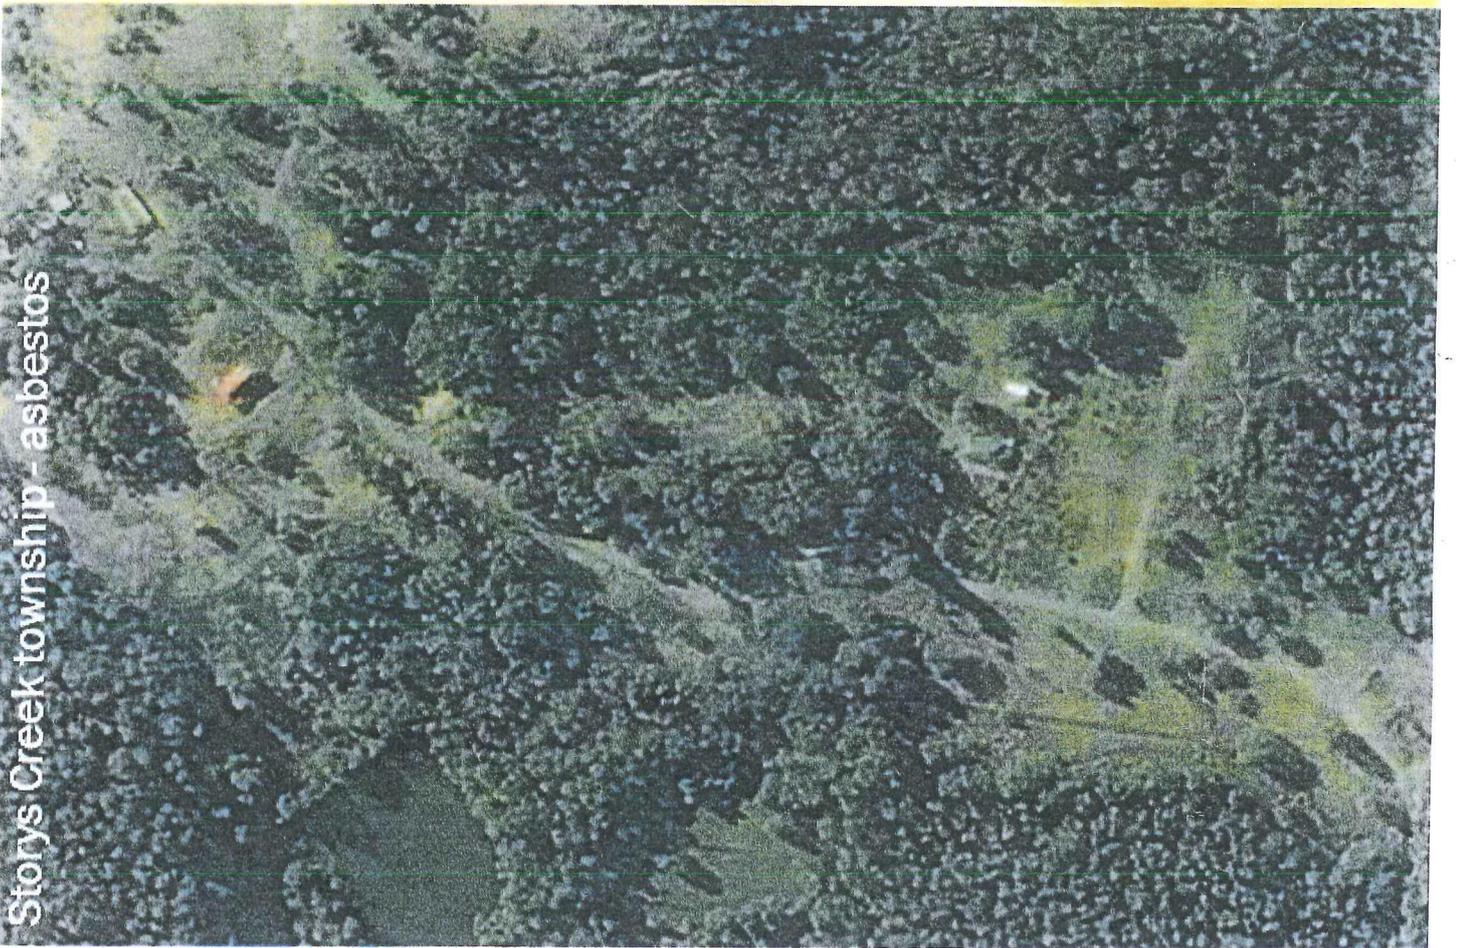
Storys Creek township - asbestos

L/1 = NO ASBESTOS DETECTED
	L/2 = LIGHT CONTAMINATION - ASSESSED AT LESS THAN 5 PIECES
	L/3 = MEDIUM CONTAMINATION - ASSESSED AT BETWEEN 5 TO 20 PIECES
	L/4 = HEAVY CONTAMINATION - ASSESSED AT GREATER THAN 20 PIECES

P.1		L/1 = NO ASBESTOS DETECTED	
P.2		L/1 = NO ASBESTOS DETECTED	
P.3		L/1 = NO ASBESTOS DETECTED	
P.4		L/1 = NO ASBESTOS DETECTED	
P.5		L/1 = NO ASBESTOS DETECTED	
P.6		L/1 = NO ASBESTOS DETECTED	
P.7		L/1 = NO ASBESTOS DETECTED	
P.8		L/4 = HEAVY CONTAMINATION - ASSESSED AT GREATER THAN 20 PIECES	
P.9		L/4 = HEAVY CONTAMINATION - ASSESSED AT GREATER THAN 20 PIECES	PIPE LAGGING BETWEEN P.9 & P.10
P.10		L/4 = HEAVY CONTAMINATION - ASSESSED AT GREATER THAN 20 PIECES	AROUND CONCRETE SLAB - 12m IN FROM P.10
P.11		L/1 = NO ASBESTOS DETECTED	
P.12		L/1 = NO ASBESTOS DETECTED	
P.13		L/1 = NO ASBESTOS DETECTED	
P.14		L/1 = NO ASBESTOS DETECTED	
P.15		L/1 = NO ASBESTOS DETECTED	
P.16		L/1 = NO ASBESTOS DETECTED	
P.17		L/4 = HEAVY CONTAMINATION - ASSESSED AT GREATER THAN 20 PIECES	AROUND CONCRETE SLAB - 15m IN FROM P.17
P.18		L/2 = LIGHT CONTAMINATION - ASSESSED AT LESS THAN 5 PIECES	
P.19		L/4 = HEAVY CONTAMINATION - ASSESSED AT GREATER THAN 20 PIECES	LARGE ASBESTOS PIPES EXPOSED. PIPES CONTINUE BELOW GROUND AND ARE EXPOSED AGAIN 20m IN FROM P.19

P.20		L/1 = NO ASBESTOS DETECTED	
P.21		L/1 = NO ASBESTOS DETECTED	
P.22		L/1 = NO ASBESTOS DETECTED	
P.23		L/4 = HEAVY CONTAMINATION - ASSESSED AT GREATER THAN 20 PIECES	BETWEEN P.23 AND THE ROAD
P.24		L/4 = HEAVY CONTAMINATION - ASSESSED AT GREATER THAN 20 PIECES	BETWEEN P.24 AND THE ROAD
P.25		L/4 = HEAVY CONTAMINATION - ASSESSED AT GREATER THAN 20 PIECES	BETWEEN P.25 AND THE ROAD
P.26		L/4 = HEAVY CONTAMINATION - ASSESSED AT GREATER THAN 20 PIECES	BETWEEN P.26 AND THE ROAD
P.27		L/1 = NO ASBESTOS DETECTED	
P.28		L/1 = NO ASBESTOS DETECTED	
P.29		L/3 = MEDIUM CONTAMINATION - ASSESSED AT BETWEEN 5 TO 20 PIECES	BETWEEN P.29 AND THE DRAIN
P.30		L/3 = MEDIUM CONTAMINATION - ASSESSED AT BETWEEN 5 TO 20 PIECES	BETWEEN P.30 AND THE DRAIN
P.31		L/3 = MEDIUM CONTAMINATION - ASSESSED AT BETWEEN 5 TO 20 PIECES	BETWEEN P.31 AND THE DRAIN
P.32		L/3 = MEDIUM CONTAMINATION - ASSESSED AT BETWEEN 5 TO 20 PIECES	BETWEEN P.32 AND THE DRAIN

P.33		L/3 = MEDIUM CONTAMINATION - ASSESSED AT BETWEEN 5 TO 20 PIECES	BETWEEN P.33 AND THE DRAIN
P.34		L/3 = MEDIUM CONTAMINATION - ASSESSED AT BETWEEN 5 TO 20 PIECES	BETWEEN P.34 AND THE DRAIN
P.35		L/3 = MEDIUM CONTAMINATION - ASSESSED AT BETWEEN 5 TO 20 PIECES	BETWEEN P.35 AND THE DRAIN
P.36		L/3 = MEDIUM CONTAMINATION - ASSESSED AT BETWEEN 5 TO 20 PIECES	BETWEEN P.36 AND THE DRAIN
P.37		L/4 = HEAVY CONTAMINATION - ASSESSED AT GREATER THAN 20 PIECES	BETWEEN P.37 AND THE ROAD
P.38		L/4 = HEAVY CONTAMINATION - ASSESSED AT GREATER THAN 20 PIECES	BETWEEN P.38 AND THE ROAD
P.39		L/4 = HEAVY CONTAMINATION - ASSESSED AT GREATER THAN 20 PIECES	BETWEEN P.39 AND THE ROAD
P.40		L/2 = LIGHT CONTAMINATION - ASSESSED AT LESS THAN 5 PIECES	BEHIND P.40 - AROUND CAR WRECKS
P.41		L/2 = LIGHT CONTAMINATION - ASSESSED AT LESS THAN 5 PIECES	BEHIND P.41 - AROUND CAR WRECKS
P.42		L/2 = LIGHT CONTAMINATION - ASSESSED AT LESS THAN 5 PIECES

P.43		L/4 = HEAVY CONTAMINATION - ASSESSED AT GREATER THAN 20 PIECES	
P.44		L/4 = HEAVY CONTAMINATION - ASSESSED AT GREATER THAN 20 PIECES	
P.45		L/4 = HEAVY CONTAMINATION - ASSESSED AT GREATER THAN 20 PIECES	
P.46		L/4 = HEAVY CONTAMINATION - ASSESSED AT GREATER THAN 20 PIECES	
P.47		L/1 = NO ASBESTOS DETECTED	OVERGROWN AROUND P.47
P.48		L/1 = NO ASBESTOS DETECTED	OVERGROWN AROUND P.48
P.49		L/2 = LIGHT CONTAMINATION - ASSESSED AT LESS THAN 5 PIECES	CLEARING IN FRONT OF P.49
P.50		L/4 = HEAVY CONTAMINATION - ASSESSED AT GREATER THAN 20 PIECES	
P.51		L/4 = HEAVY CONTAMINATION - ASSESSED AT GREATER THAN 20 PIECES	
P.52		L/4 = HEAVY CONTAMINATION - ASSESSED AT GREATER THAN 20 PIECES	
P.53		L/4 = HEAVY CONTAMINATION - ASSESSED AT GREATER THAN 20 PIECES	
P.54		L/2 = LIGHT CONTAMINATION - ASSESSED AT LESS THAN 5 PIECES	IN BRACKEN
P.55		L/2 = LIGHT CONTAMINATION - ASSESSED AT LESS THAN 5 PIECES	IN BRACKEN
P.56		L/2 = LIGHT CONTAMINATION - ASSESSED AT LESS THAN 5 PIECES	IN BRACKEN

P.57		L/2 = LIGHT CONTAMINATION - ASSESSED AT LESS THAN 5 PIECES	IN BRACKEN
P.58		L/2 = LIGHT CONTAMINATION - ASSESSED AT LESS THAN 5 PIECES	
P.59		L/1 = NO ASBESTOS DETECTED	
P.60		L/1 = NO ASBESTOS DETECTED	
P.61		L/1 = NO ASBESTOS DETECTED	
P.62		L/1 = NO ASBESTOS DETECTED	
P.63		L/4 = HEAVY CONTAMINATION - ASSESSED AT GREATER THAN 20 PIECES	VINYL TILE DEBRIS - IN FROM P.63
P.64		L/4 = HEAVY CONTAMINATION - ASSESSED AT GREATER THAN 20 PIECES	VINYL TILE DEBRIS - IN FROM P.64
P.65		L/4 = HEAVY CONTAMINATION - ASSESSED AT GREATER THAN 20 PIECES	VINYL TILE DEBRIS - IN FROM P.65

P.66		L/4 = HEAVY CONTAMINATION - ASSESSED AT GREATER THAN 20 PIECES	VINYL TILE DEBRIS - IN FROM P.66
P.67		L/4 = HEAVY CONTAMINATION - ASSESSED AT GREATER THAN 20 PIECES	VINYL TILE DEBRIS - IN FROM P.67
P.68		L/2 = LIGHT CONTAMINATION - ASSESSED AT LESS THAN 5 PIECES	
P.69		L/2 = LIGHT CONTAMINATION - ASSESSED AT LESS THAN 5 PIECES	
P.70		L/2 = LIGHT CONTAMINATION - ASSESSED AT LESS THAN 5 PIECES	
P.71		L/1 = NO ASBESTOS DETECTED	
P.72		L/3 = MEDIUM CONTAMINATION - ASSESSED AT BETWEEN 5 TO 20 PIECES	
P.73		L/4 = HEAVY CONTAMINATION - ASSESSED AT GREATER THAN 20 PIECES	LARGE ASBESTOS PIPES
P.74		L/4 = HEAVY CONTAMINATION - ASSESSED AT GREATER THAN 20 PIECES	LARGE ASBESTOS PIPES
P.75		L/4 = HEAVY CONTAMINATION - ASSESSED AT GREATER THAN 20 PIECES	
P.76		L/4 = HEAVY CONTAMINATION - ASSESSED AT GREATER THAN 20 PIECES	
P.77		L/4 = HEAVY CONTAMINATION - ASSESSED AT GREATER THAN 20 PIECES	
P.78		L/4 = HEAVY CONTAMINATION - ASSESSED AT GREATER THAN 20 PIECES

P.79		L/4 = HEAVY CONTAMINATION - ASSESSED AT GREATER THAN 20 PIECES	
P.80		L/3 = MEDIUM CONTAMINATION - ASSESSED AT BETWEEN 5 TO 20 PIECES	
P.81		L/3 = MEDIUM CONTAMINATION - ASSESSED AT BETWEEN 5 TO 20 PIECES	
P.82		L/3 = MEDIUM CONTAMINATION - ASSESSED AT BETWEEN 5 TO 20 PIECES	
P.83		L/1 = NO ASBESTOS DETECTED	
P.84		L/1 = NO ASBESTOS DETECTED	
P.85		L/1 = NO ASBESTOS DETECTED	
P.86		L/1 = NO ASBESTOS DETECTED	
P.87		L/3 = MEDIUM CONTAMINATION - ASSESSED AT BETWEEN 5 TO 20 PIECES	
P.88		L/2 = LIGHT CONTAMINATION - ASSESSED AT LESS THAN 5 PIECES	
P.89		L/2 = LIGHT CONTAMINATION - ASSESSED AT LESS THAN 5 PIECES	
P.90		L/2 = LIGHT CONTAMINATION - ASSESSED AT LESS THAN 5 PIECES	
P.91		L/2 = LIGHT CONTAMINATION - ASSESSED AT LESS THAN 5 PIECES	
P.92		L/1 = NO ASBESTOS DETECTED	
P.93		L/1 = NO ASBESTOS DETECTED	
P.94		L/1 = NO ASBESTOS DETECTED	
P.95		L/1 = NO ASBESTOS DETECTED	
P.96		L/1 = NO ASBESTOS DETECTED

P.97		L/2 = LIGHT CONTAMINATION - ASSESSED AT LESS THAN 5 PIECES	
P.98		L/2 = LIGHT CONTAMINATION - ASSESSED AT LESS THAN 5 PIECES	
P.99		L/1 = NO ASBESTOS DETECTED	
P.100		L/4 = HEAVY CONTAMINATION - ASSESSED AT GREATER THAN 20 PIECES	AROUND CONCRETE SLAB - 10m IN FROM P.100 DRUM ALSO CONTAINS DEBRIS
P.101		L/2 = LIGHT CONTAMINATION - ASSESSED AT LESS THAN 5 PIECES	2 X LARGE PIECES OF ASBESTOS SHEET - 20m IN FROM P.101
P.102		L/1 = NO ASBESTOS DETECTED	
P.103		L/1 = NO ASBESTOS DETECTED

The friable pipe lagging located adjacent to P.9 and P.10 should be immediately removed by a A-Class Licenced asbestos removalist. This contamination is regarded as the highest risk at the site.

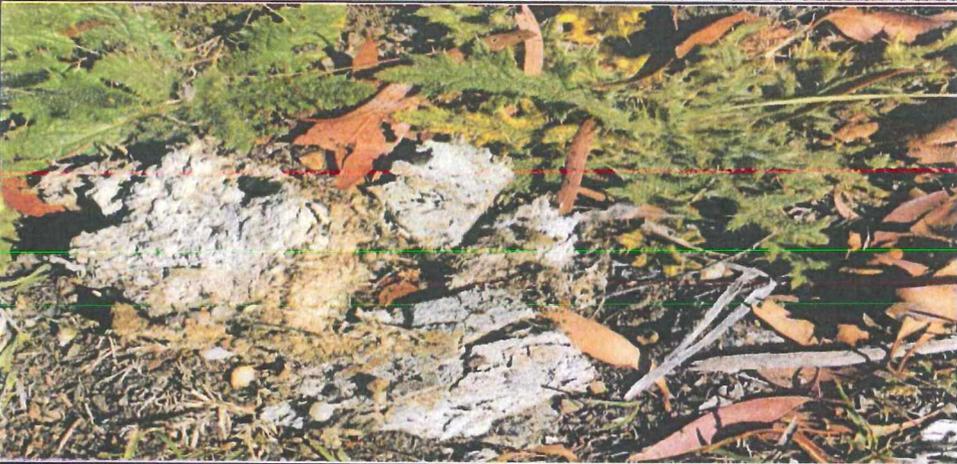
- pipe lagging between P.9 and P.10, refer Appendices #2
 - millboard found near the two concrete slabs that are the source of all the broken vinyl floor tiles. The millboard debris was bagged and removed from site by Aegis AC Pty Ltd.

PIC OF MILLBOARD DEBRIS FOUND AMONGST TILE DEBRIS, NEAR THE TWO SLABS. WAS BAGGED AND REMOVED FROM SITE BY AEGIS AC PTY LTD

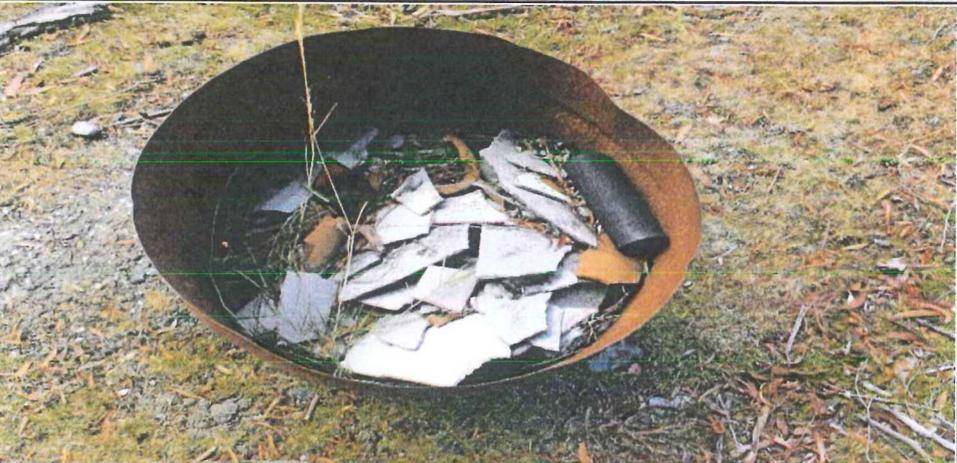
PIC OF DRUM CONTAINING ASBESTOS SHEET DEBRIS

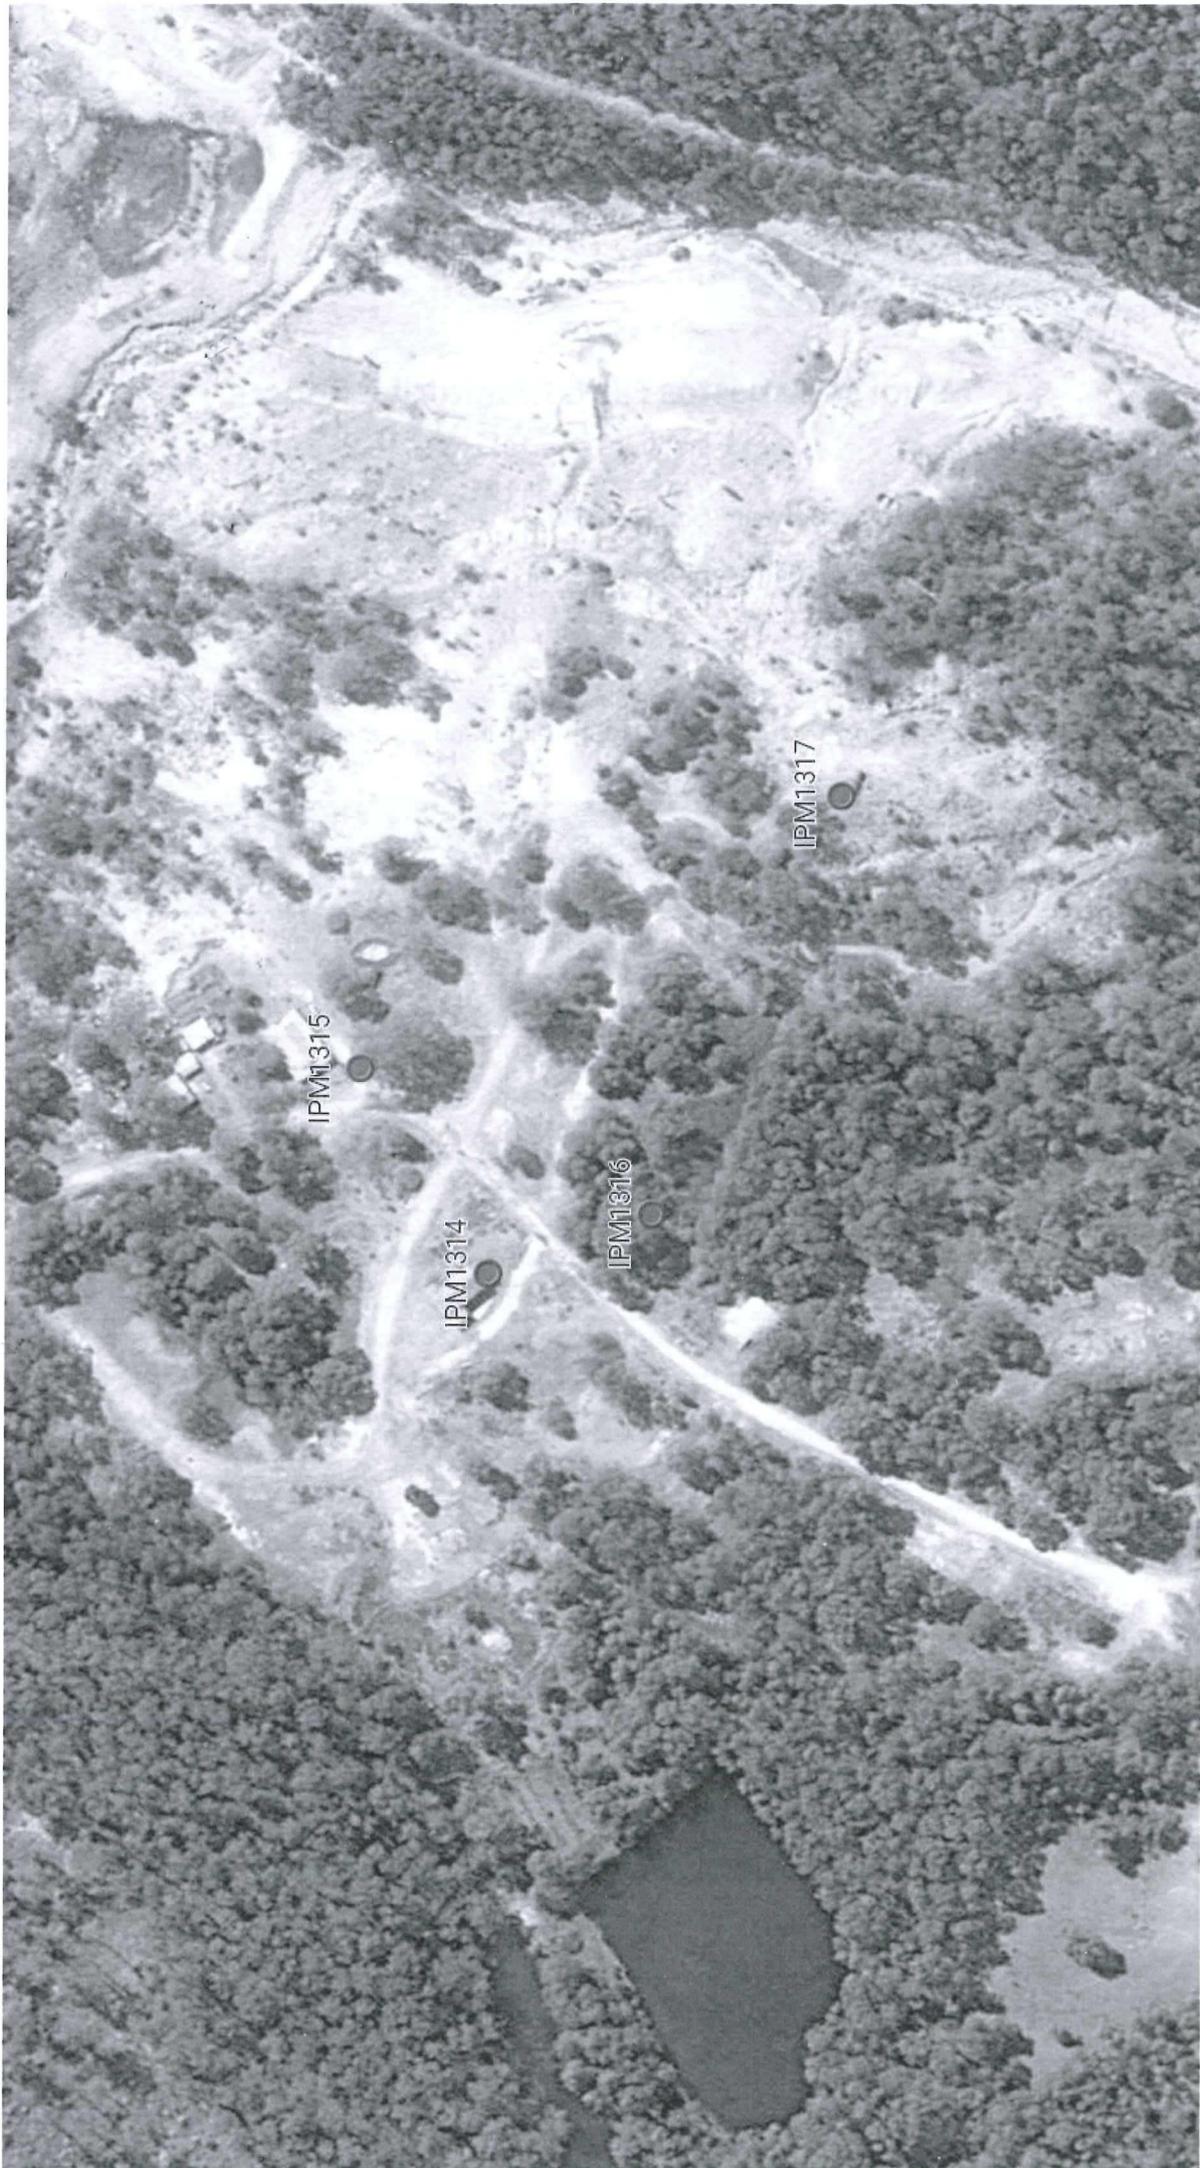
Comments: Control Monitoring was conducted outdoors at Storys Creek, during the mapping of scattered asbestos containing material located across the site. Detailed locations shown on attached figure.

The respirable fibre levels recorded in the area(s) listed above was less than the lower limit of detection of 0.01 fibres per ml. The concentration of airborne respirable fibre is within Safe Work Australia's Action Level and is consistent with typical background respirable fibre levels.
