August 2025

# Annual Report

## Rehabilitation of Mines 2024-25

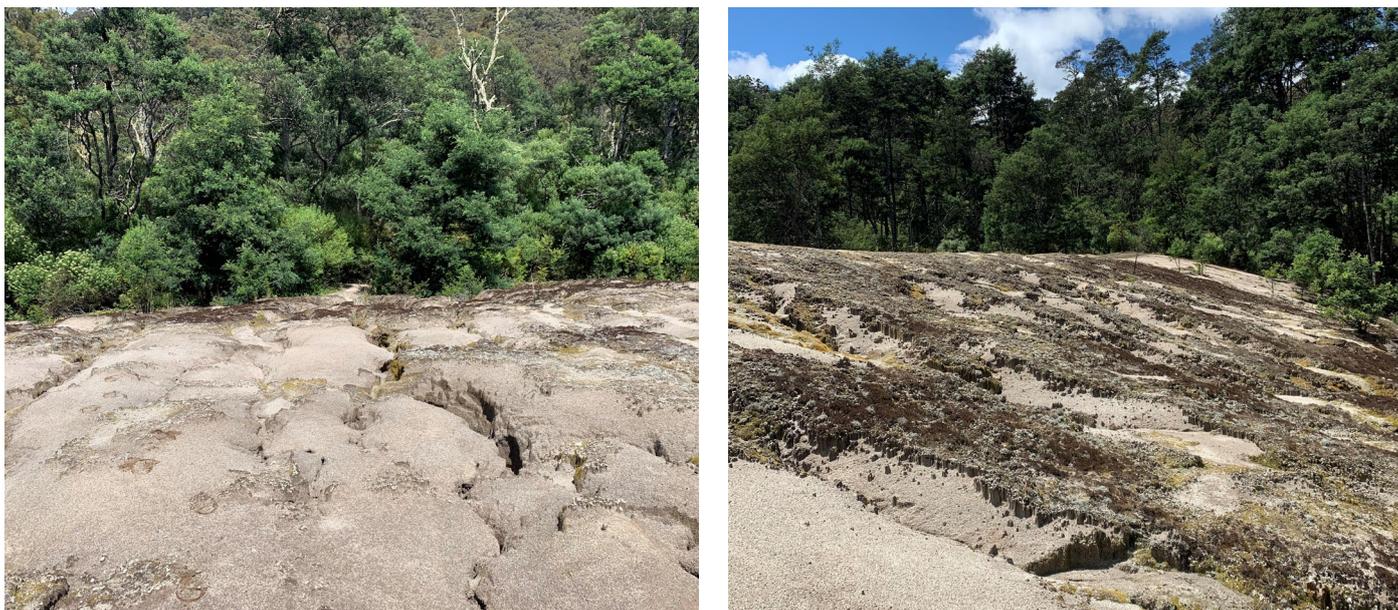
Figure 2. Erosion mitigation required on the Anchor dam wall (October 2024).

Despite underlying stability, significant rill erosion is evident on the dam face. In October 2024, granulated fertiliser was spread on the batter slope of the dam wall to promote the establishment of lichen and moss for stability (Figure 2). The site was inspected in February 2025 and little change was observed. MRT will investigate further options involving surface coverings and revegetation for potential funding by the RTF in 2025/26.

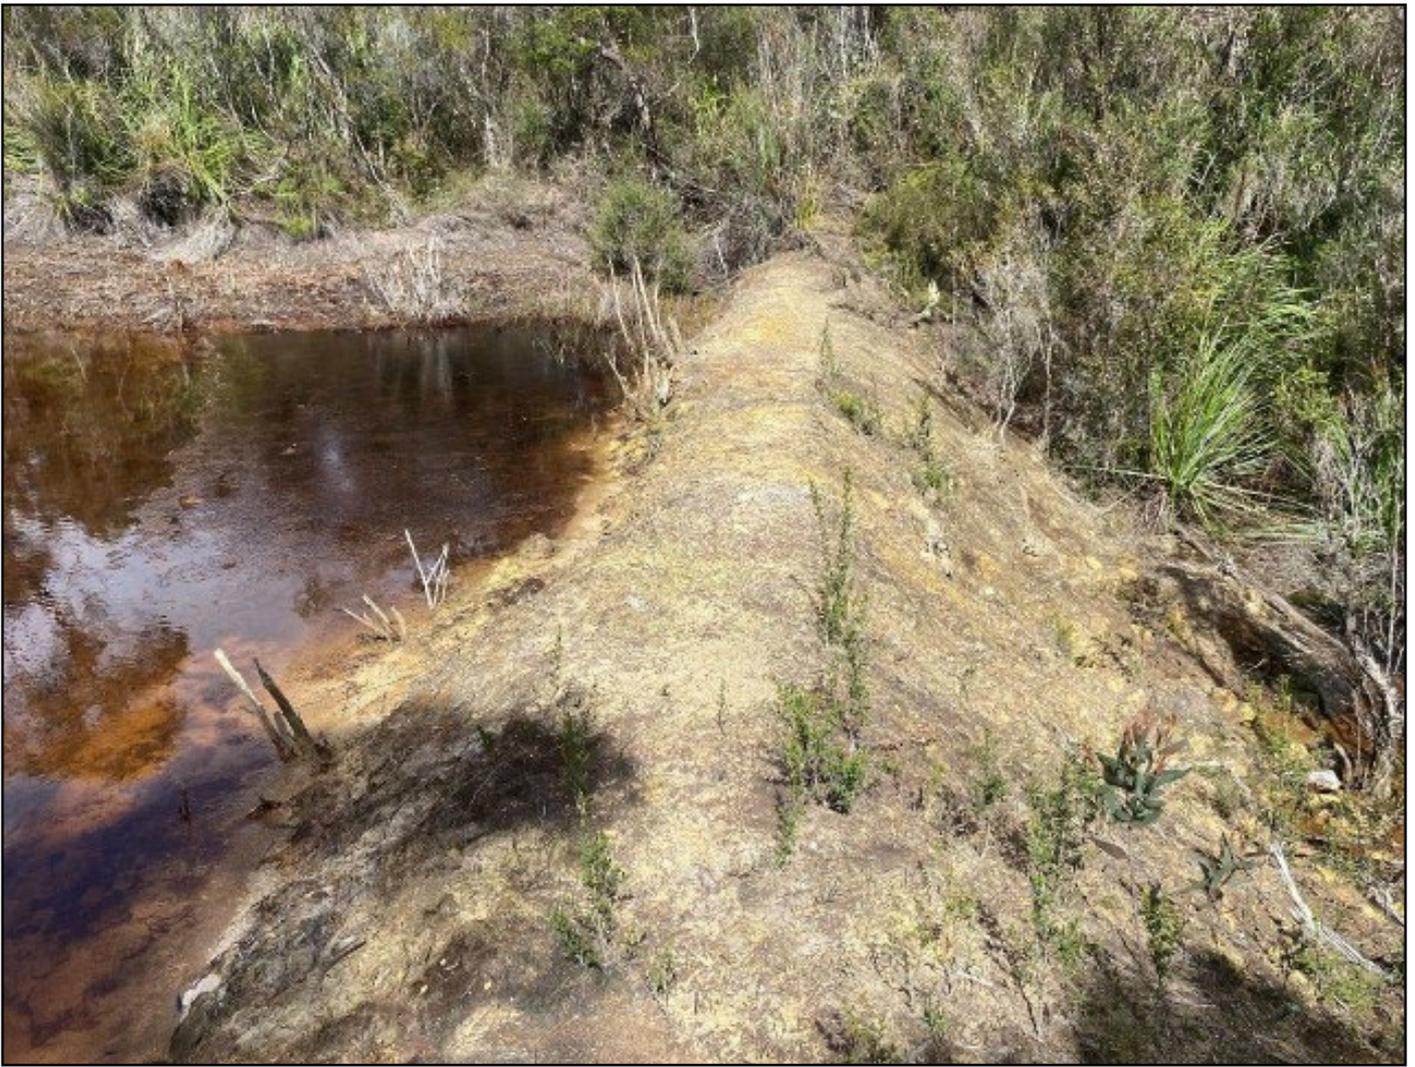
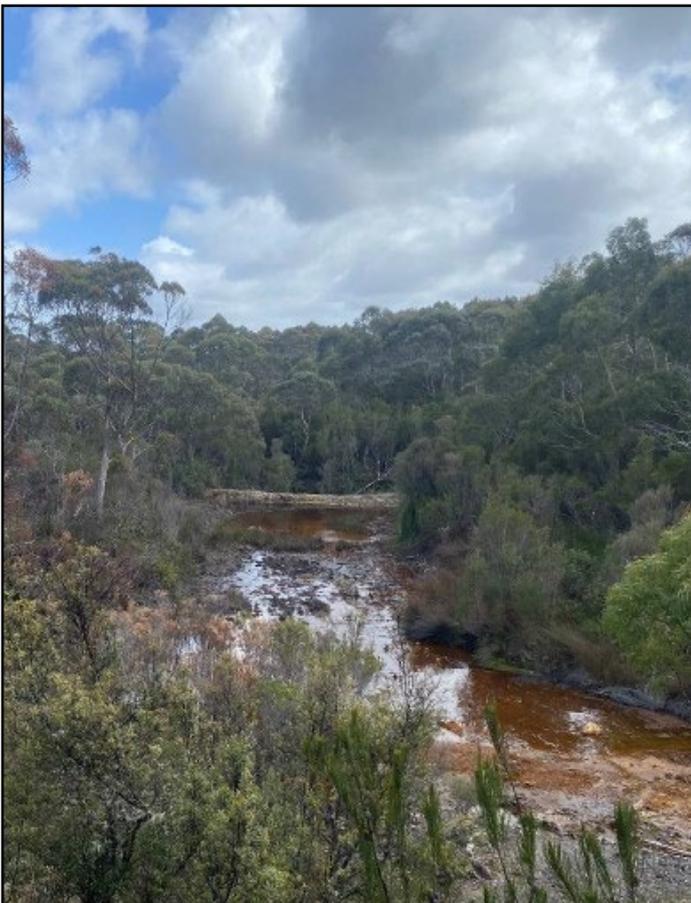
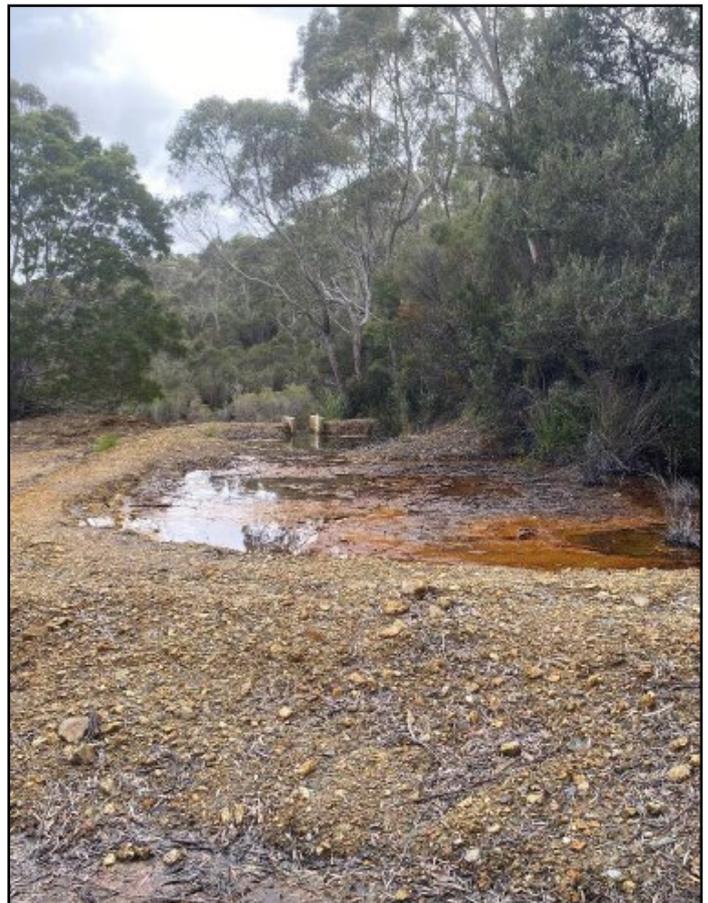
Mineral Resources Tasmania, funded through the RTF, has undertaken several studies to inform decision-making around the ongoing management of the Balfour Central Shaft (BCS) site. Proximal to the BCS is the repository dam which retains a significant volume of metalliferous sludge. The condition of this dam is very important as failure of the dam could result in the release of metalliferous sludge from storage, negatively impacting the downstream environment. A dam inspection in 2022 showed that the dam was in poor repair and does not meet the current standards of dam construction. Continuous dam surveillance is required to meet ANCOLD guidelines.

Figure 4. Balfour Site features including sludge dam (bottom left), Balfour Central Shaft (bottom right) and dam embankment wall (top), January 2025.

The RTF has commissioned GHD to complete a design and bill of quantities for the upgrade of the embankment wall in order to mitigate risk of failure and long-term need for dam safety surveillance (Figure 4). The design program is forecast for completion in September 2025, with potential for commissioning and commencement of on ground works within the financial year. Concurrently, further options are being considered for the long-term rehabilitation of the Balfour site.

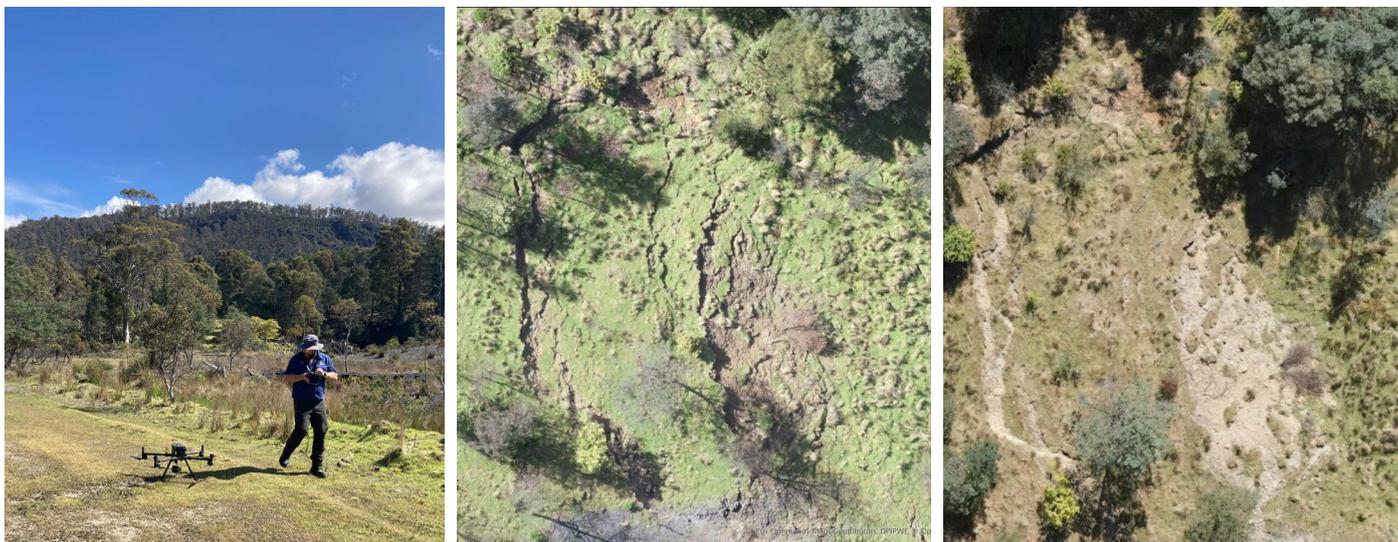
Landslide monitoring at Merrywood Coal Mine, initiated in October 2022, is ongoing as part of a statewide active landslide study led by the MRT Geohazards team (Figure 5). The program integrates drone imagery, geological, meteorological, and site-specific data to assess subsidence patterns in relation to environmental and climate factors. Surveillance in October 2024 included the inspection of previously installed tell-tales, confirming ongoing displacement, particularly near shear lines at the landslide crest. While the landslide currently poses minimal risk to public safety due to its remote location, MRT will maintain regular monitoring as part of its broader geohazard risk management strategy and to inform ongoing rehabilitation at the site.

Figure 5. Comparison of photogrammetry from November 2022 (Centre) to March 2023 (right).

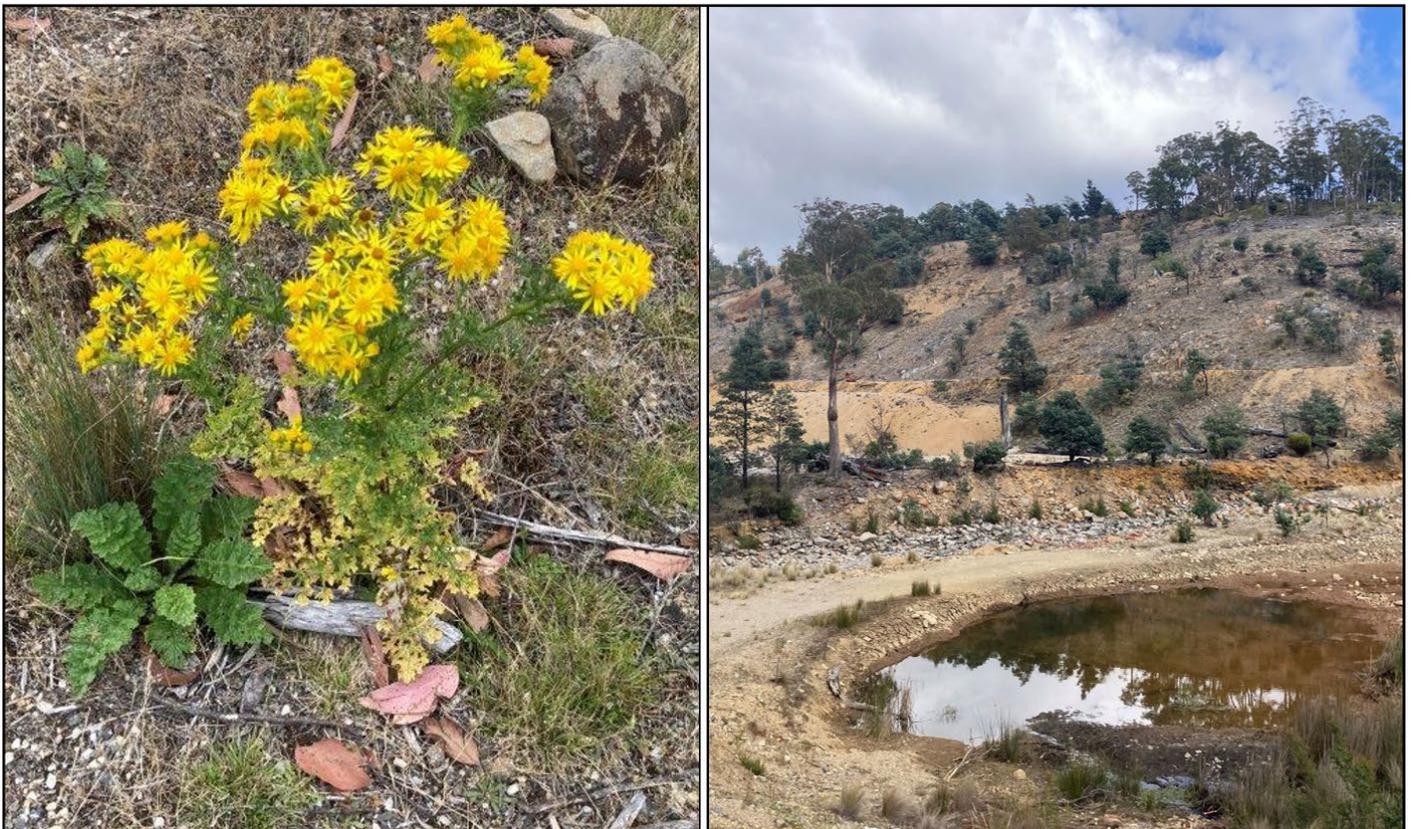
Ragwort is a declared weed under the *Tasmanian Biosecurity Act 2019* and has an associated statutory weed management plan recommending eradication as the most appropriate management objective. The RTF funded an autumn weed control effort, which was completed in April 2024 (Figure 7). The intent of the effort was to eradicate first year rosettes in order to reduce the number of likely flowering individuals in summer 2025/2026. Weed mapping will be scheduled for early December 2025 and follow-up control is proposed for January 2026.

Figure 7. Ragwort (*Senecio jacobaea*) and main face of milling precinct where greatest population was surveyed, January 2025.

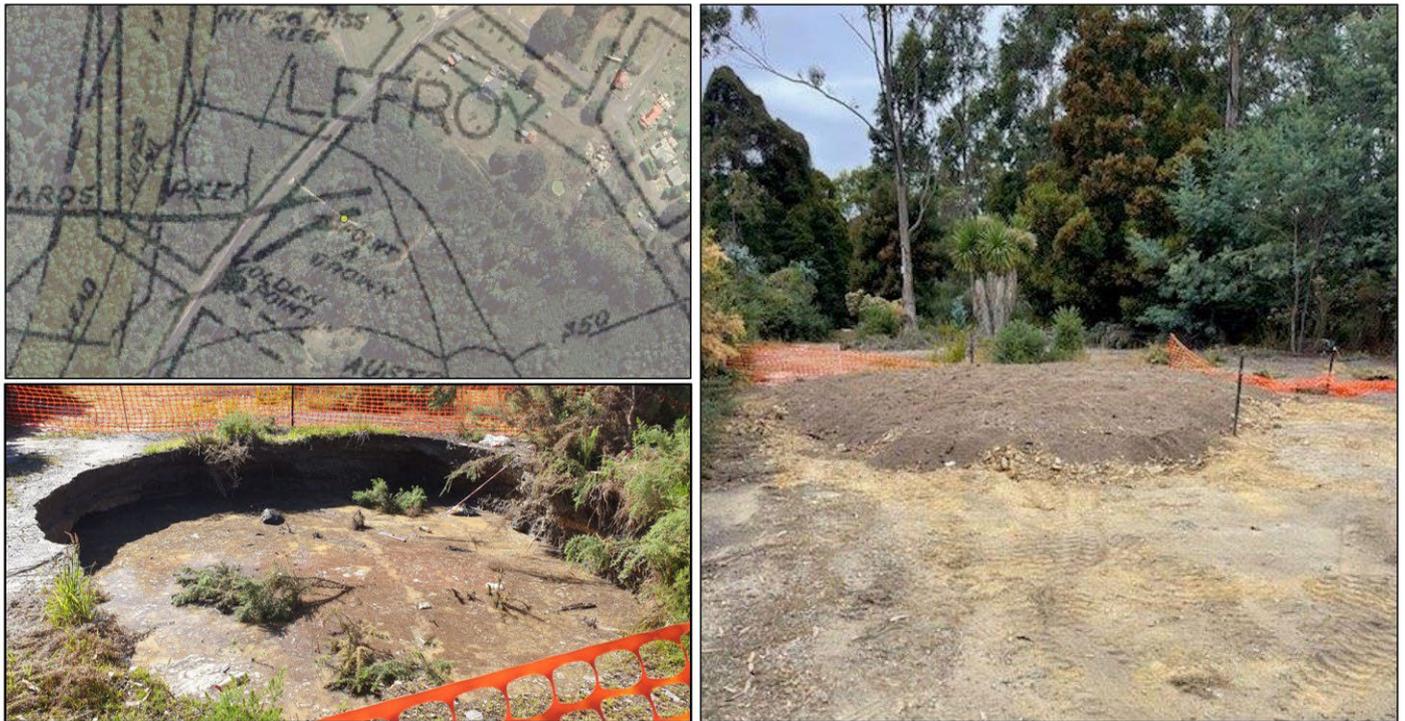
The Tasmanian Parks and Wildlife Service (PWS) reported a surface collapse in proximity to the Lefroy township in October 2024. Historical mining records indicated that the ground subsidence was likely associated with the Point and Crown shaft and workings. Remediation works involving excavation, back filling with clean fill, and leveling were completed in March 2025 (Figure 9).

Figure 9. Historical workings overlay (top left), sinkhole (bottom left), and remediation works (right), Lefroy, 2024/25.

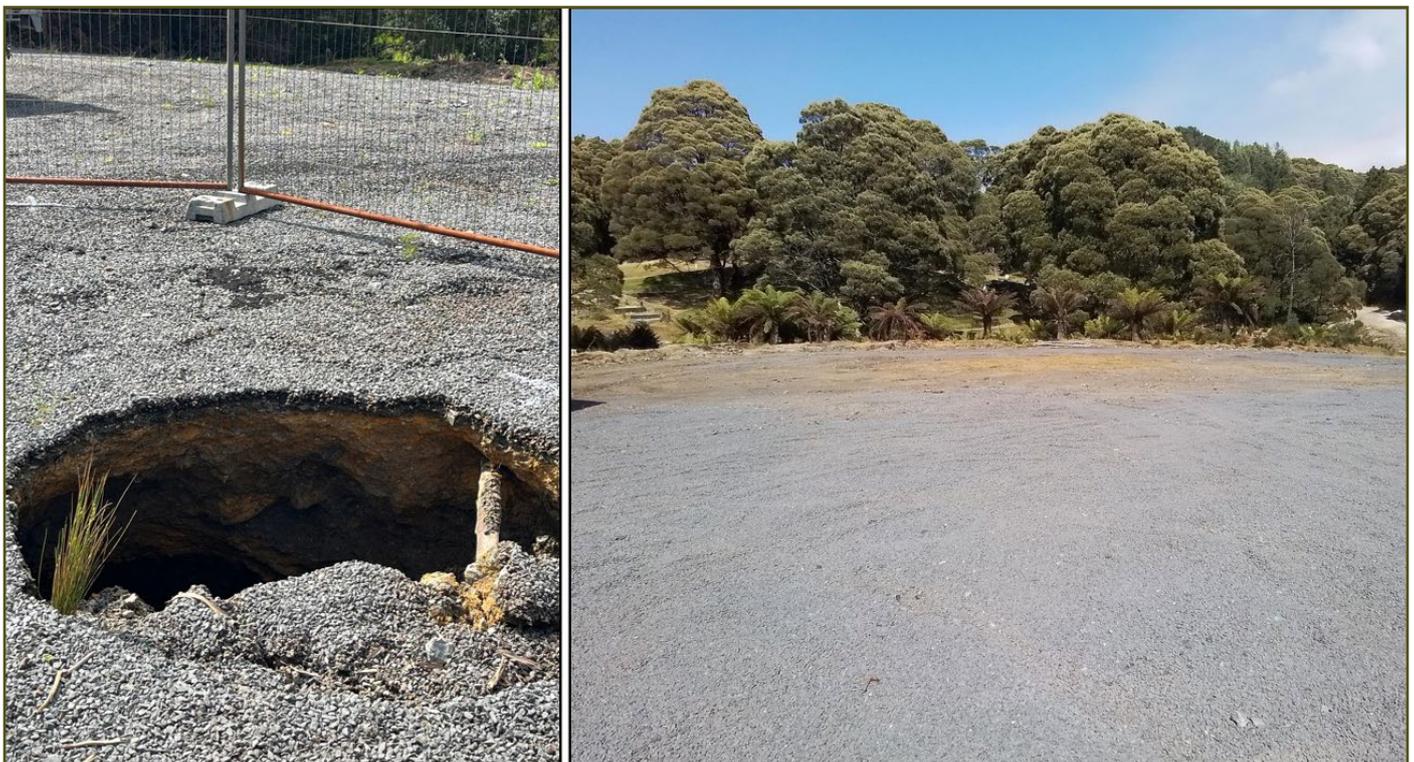
Mineral Resources Tasmania were contacted by the West Coast Council regarding subsidence at the Zeehan cemetery car park (Figure 10). Historical records indicated a likely association with Queen No. 2 shaft and drives. MRT provided the West Coast Council with advice regarding best practice approach for remediation and the RTF contributed partial funding for remediation works. Work was completed in February 2025.

Figure 10. Sinkhole (left) and completed remediation (right), Zeehan Cemetery, March 2025.

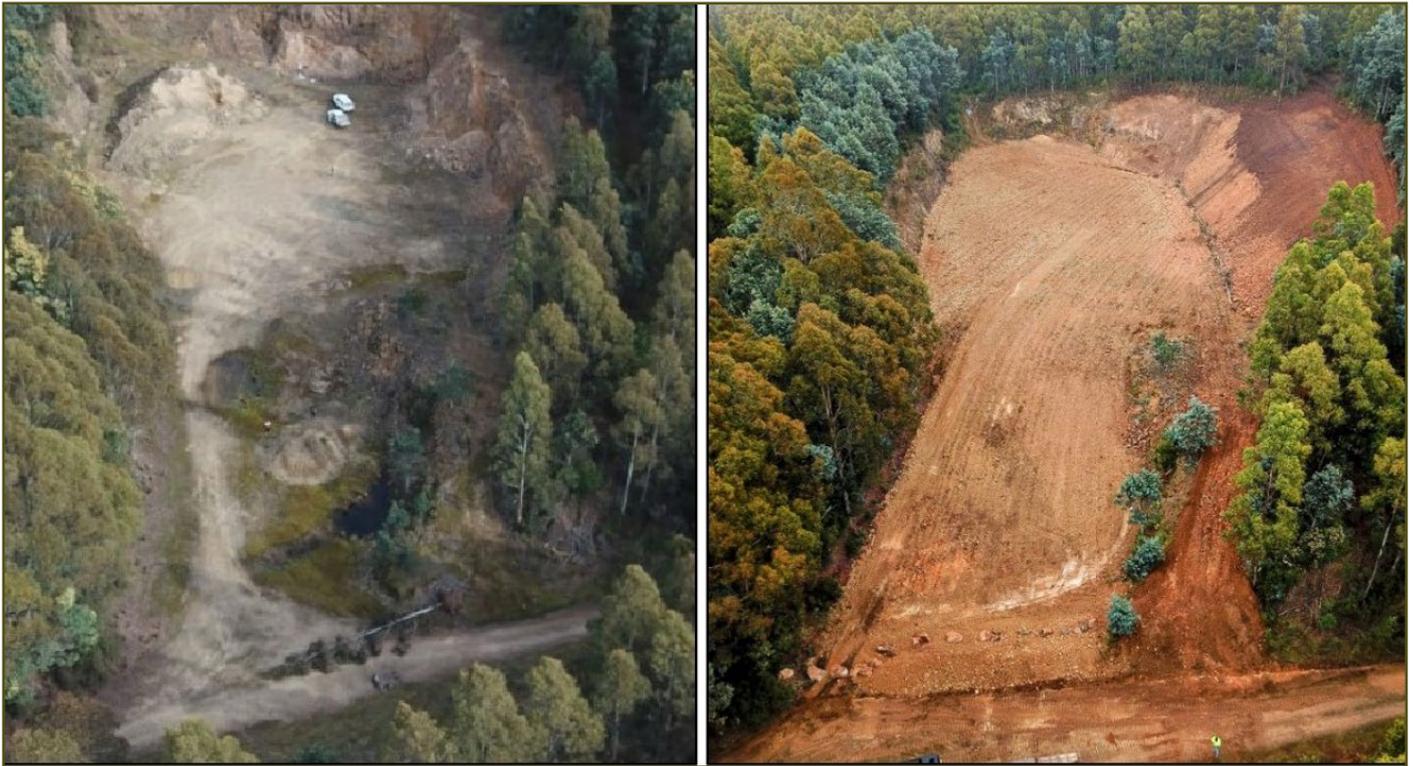
Rehabilitation of a former quarry at Rothalls Road was completed in April 2025. Rehabilitation actions were delivered according to the Rothalls Road Rehabilitation Plan and the EPA quarry code of practice. Comparative As of the quarry site pre and post rehabilitation earthworks are provided in Figure 11. MRT will continue to monitor the site biannually to assess the stability of earthworks and vegetation establishment with the intent to return the site to the regional management authority once safe, stable, and non-polluting.

Figure 11. Comparison of Rothalls Road Quarry pre (left), and post (right), rehabilitation.

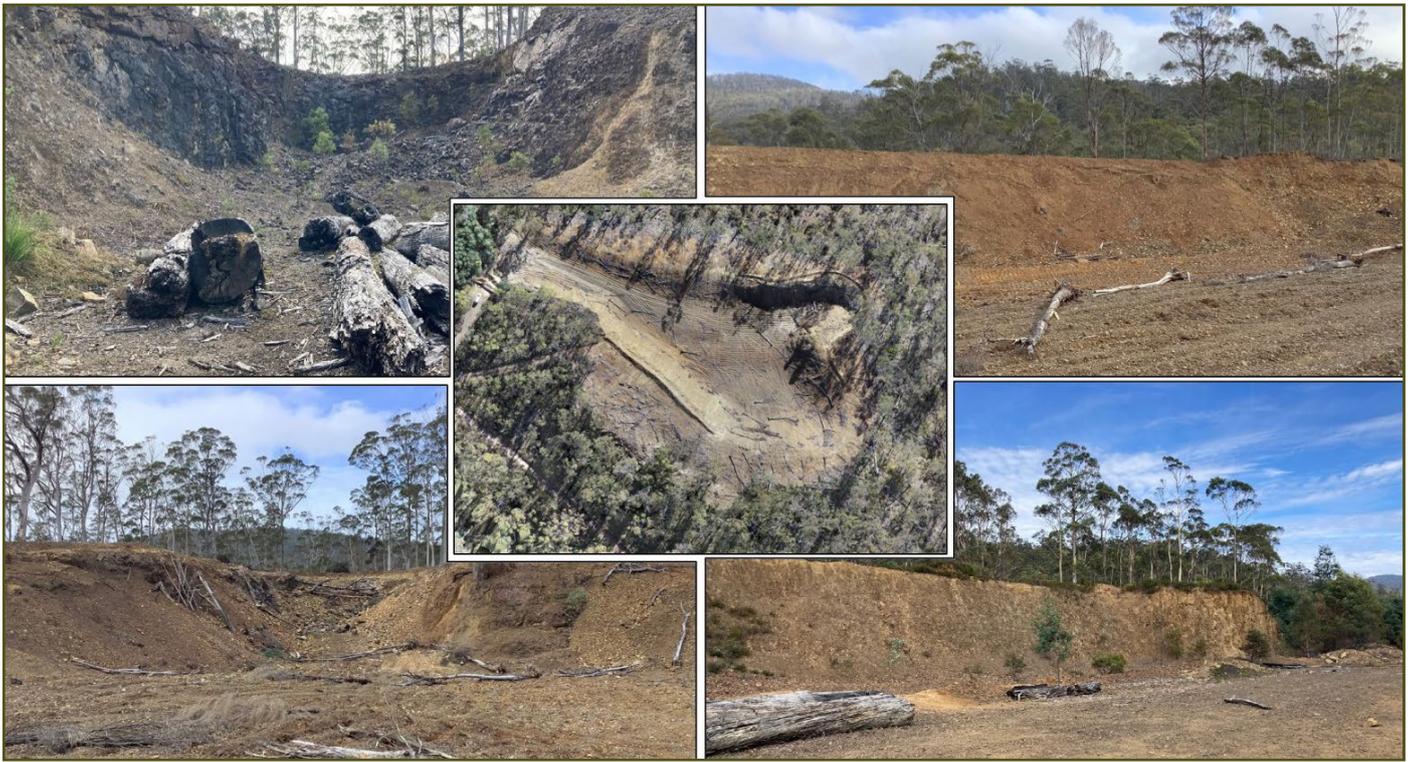
Figure 12. Comparison of Chestermans Sugarloaf quarry pre and post rehabilitation.

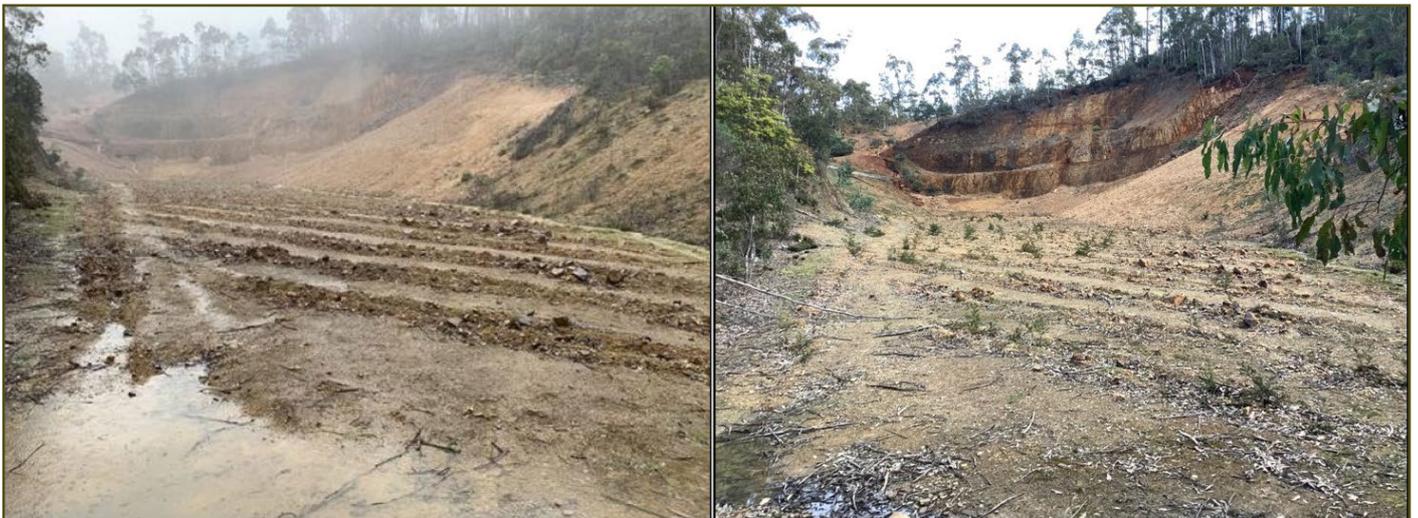
Figure 13. Comparison of Lake River Rd. Quarry indicating establishment of vegetation in rip lines.

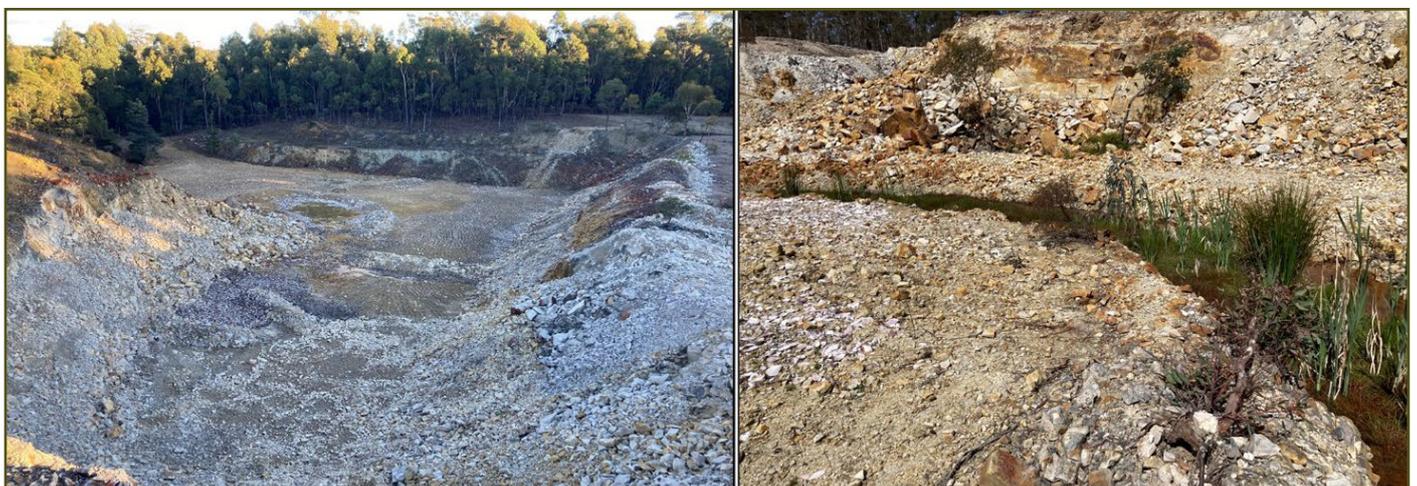
Water quality monitoring commenced at Hogans Rd. in 2017 due to identification of AMD leaving the site. Sampling conducted in 2024 indicated significant improvement in key indicators such as pH, conductivity and metal concentrations with vegetation now establishing in the outflow channel (Figure 14). At the catchment level, 2024 water monitoring indicates that parameters for pH and metals fall within the freshwater ANZECC trigger values for 95% aquatic species protection.

Figure 14. Shell grit established during rehabilitation (left) and aquatic vegetation in quarry outflow (right), October 2025.

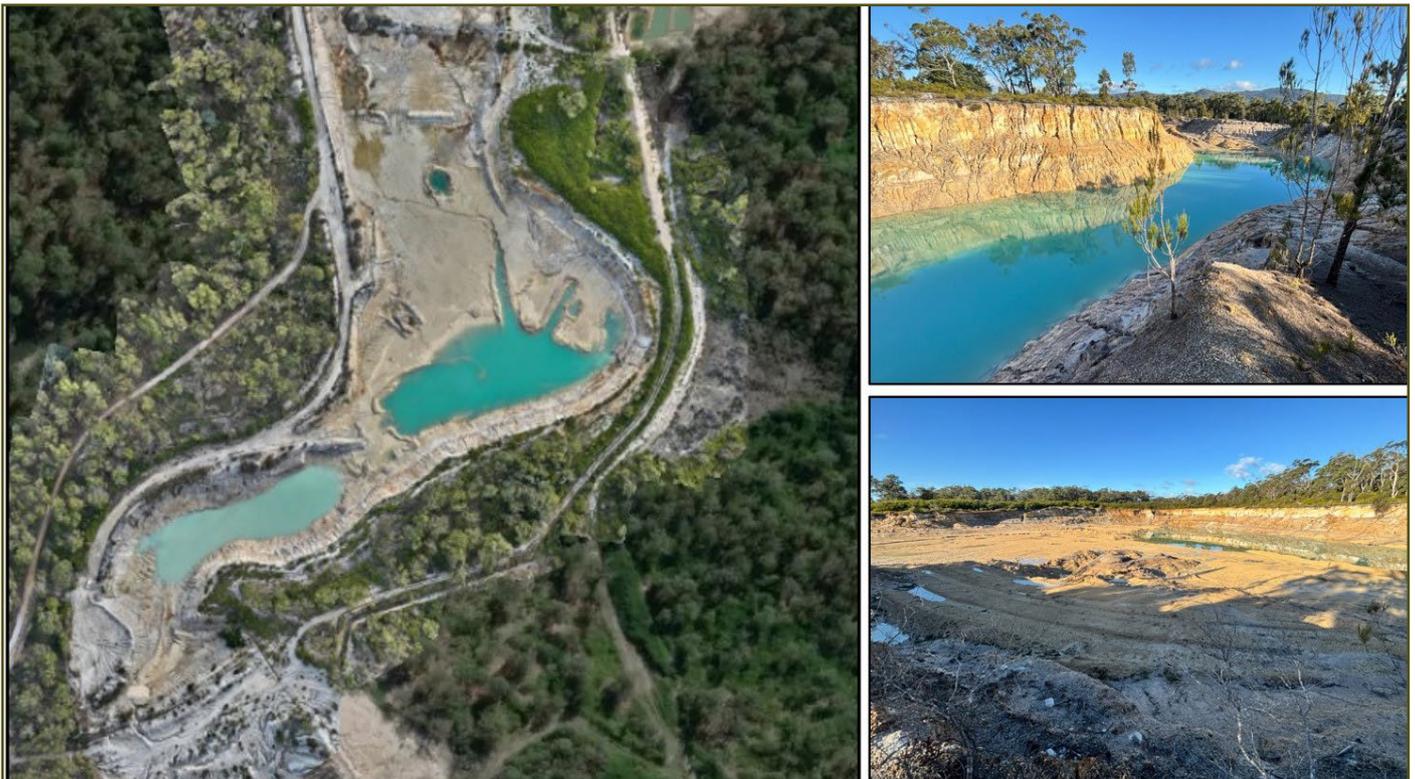
MRT carried out a dewatering campaign in May 2025 (Figure 15) funded through contributions from the RTF, facilitating water quality analysis, as well as pump mobilisation, hire, and maintenance. Operations were conducted in full compliance with permit conditions, and water sampling indicated that the receiving Ringarooma River was not adversely impacted, with physiochemical properties and metals remaining within acceptable concentrations.

Figure 15. Outcome of dewatering activities on Scotia Main Pit, May 2025.
