TR12.89-93

23. EXE RIVULET DAM SITE

by W. R. Moore

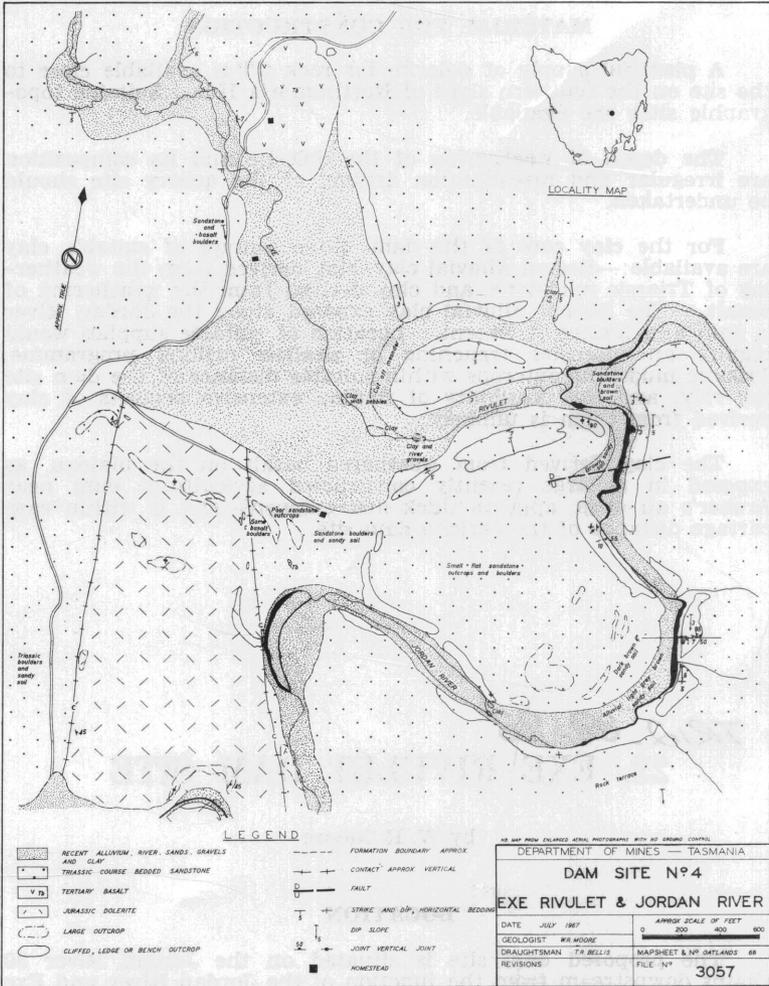
FIGURE 24

The Exe Rivulet dam site is situated on one of these meanders with the slip-off slope forming the western abutment and the undercut slope of sandstone cliffs forming the eastern abutment of the proposed dam. The water will flood back up the narrow Jordan valley into the Exe valley, above the now cut-off meander of the Jordan River, and into the large erosional basin present above the old junction of the Jordan and the Exe. This basin will provide the major storage area for this dam.

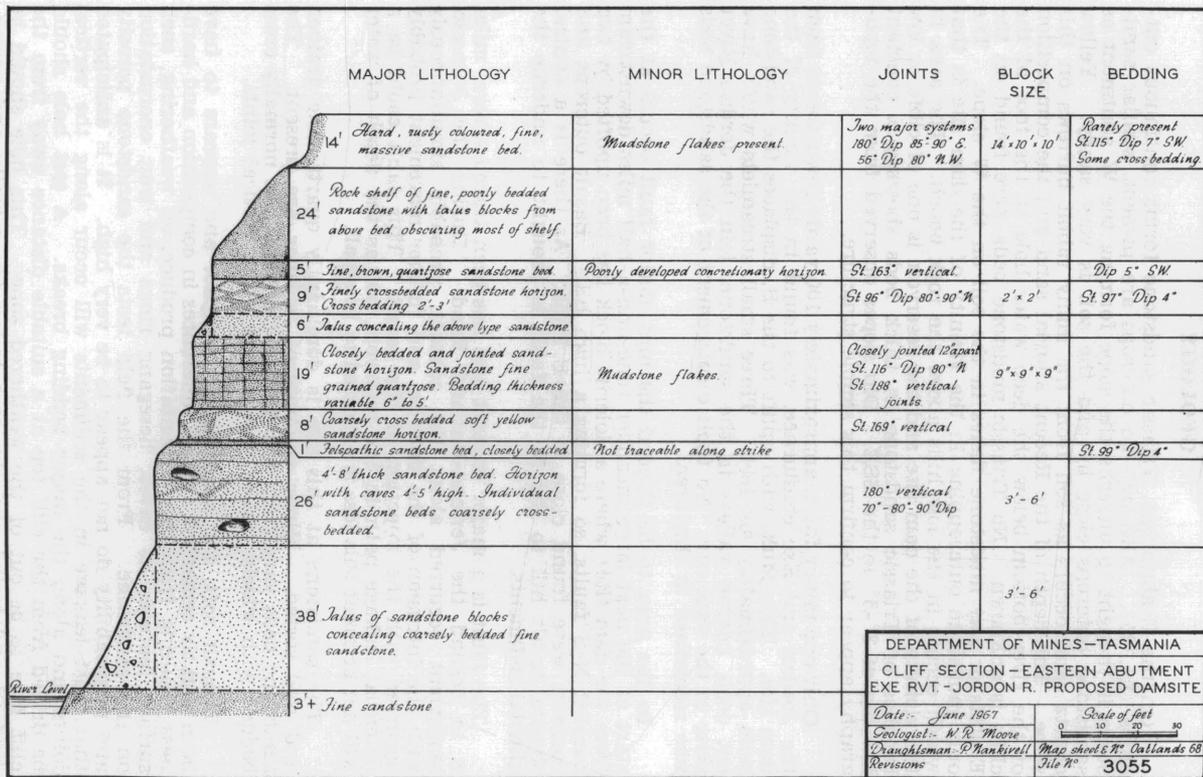
FIGURE 25

On the E abutment, Triassic sandstone forms continuous outcrops (fig. 25). Although no outcrops are present, similar sandstone is thought to underlie the slope forming the W abutment as sandstone outcrops close by and the soil is very sandy. Yellow quartz sand occurs as soil from the many rabbit burrows on this slope. The depth of the Recent alluvial sand and the composition of the river bottom below the deep water hole at the foot of the cliffs is unknown. No Triassic mudstone beds were found on the E cliffs or any mudstone flakes in the soil on the W slope. The only mudstone outcropping in the vicinity of the dam site is that which occurs in the low hills above the rock bench. The area in the vicinity of the dam site and the reservoir is one of cliffs or low benches of Triassic sandstone in thick beds showing a constant low dip of 3° - 5° to the SSE. Dip slopes observed from the topography appear to confirm this simple structure.

In addition, since much of the area on which the dam is to be built has no outcrop, a trench should be cut to expose the bedrock at the western abutment and along the centre line. The trench should be wide enough to show the type of foundation rocks and the number of joints on which the dam will be founded. The pool at the base of the cliffs should be drained and the talus removed.
