## Section 2: Engineering Geology

TR 14-57-64

### 11. Geology of a dam site on Deep Creek

W. L. MATTHEWS

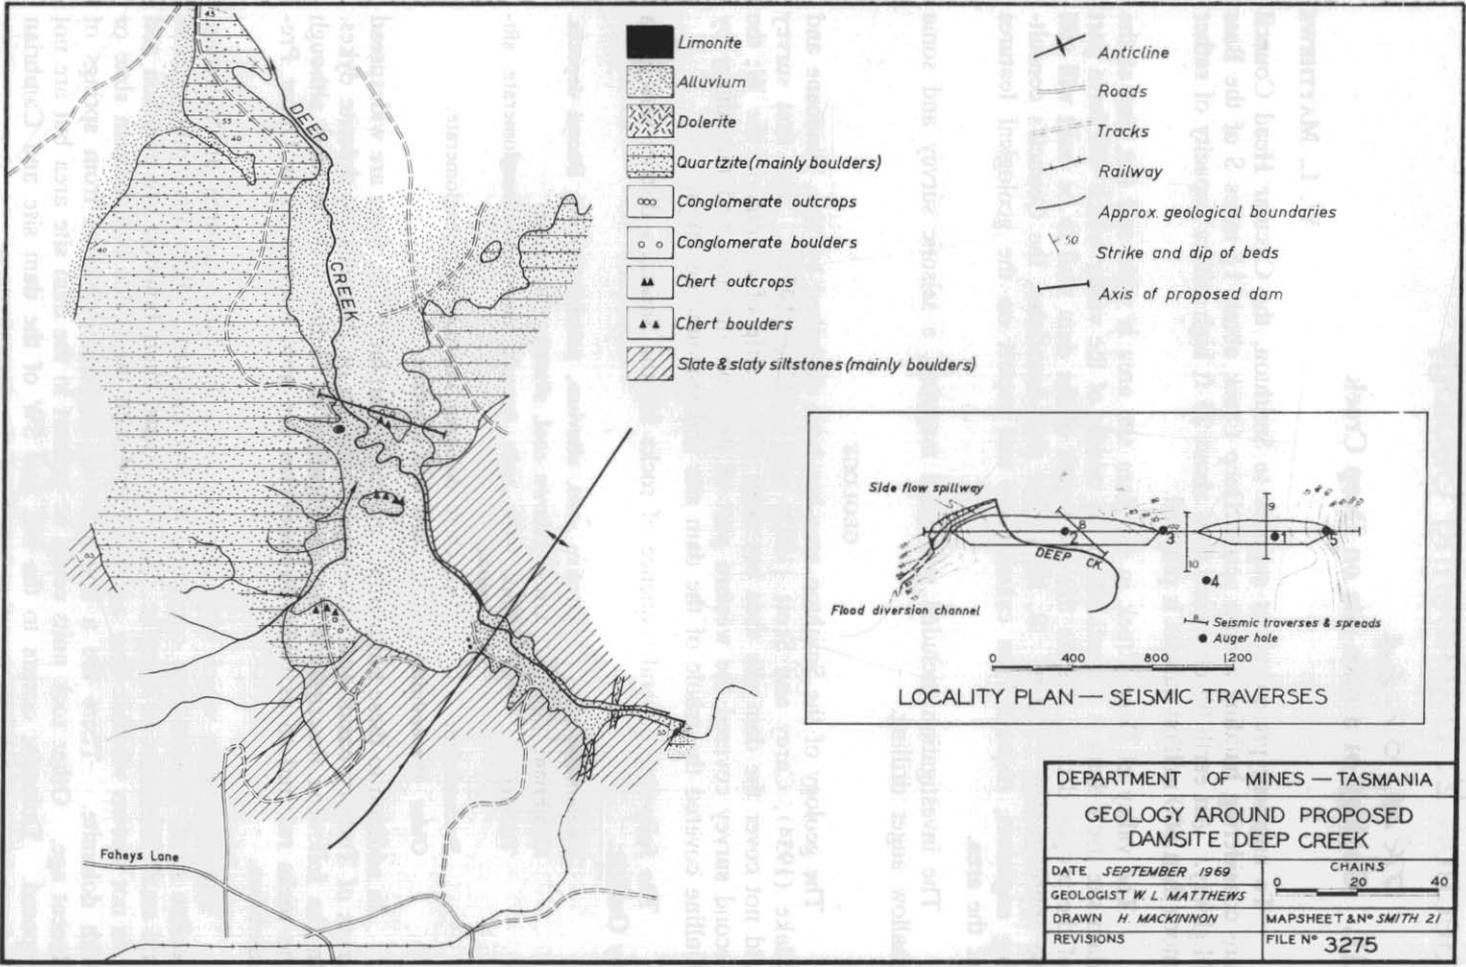
FIGURE 15

The rock units which obviously occur in the dam site area are alluvium, aeolian sand, Precambrian conglomerate and quartzite, Older Precambrian slate and small intrusions of dolerite. In some areas, chert boulders are common and it is not known whether they are associated with the Older Precambrian slate or with dolomite. There are a few areas of limonite deposited from springs of Recent age. Other rock units could be present in the dam site area but are not exposed. Dolomite occurs to the NE and SW of the dam site and Cambrian rocks occur in a NE-SW trending belt E of the dam site area.

Outcrops at and around the dam site are very rare and where they do occur (e.g., at about one mile N and at about one mile S of the dam site) the rocks are strongly folded. It is impossible to determine detailed rock structure at the dam site and only the regional structure determined from the few outcrops and from boulder distribution can be given. The boundaries of the hard rock units on the accompanying plan (fig. 15) were determined almost entirely from boulder distribution.

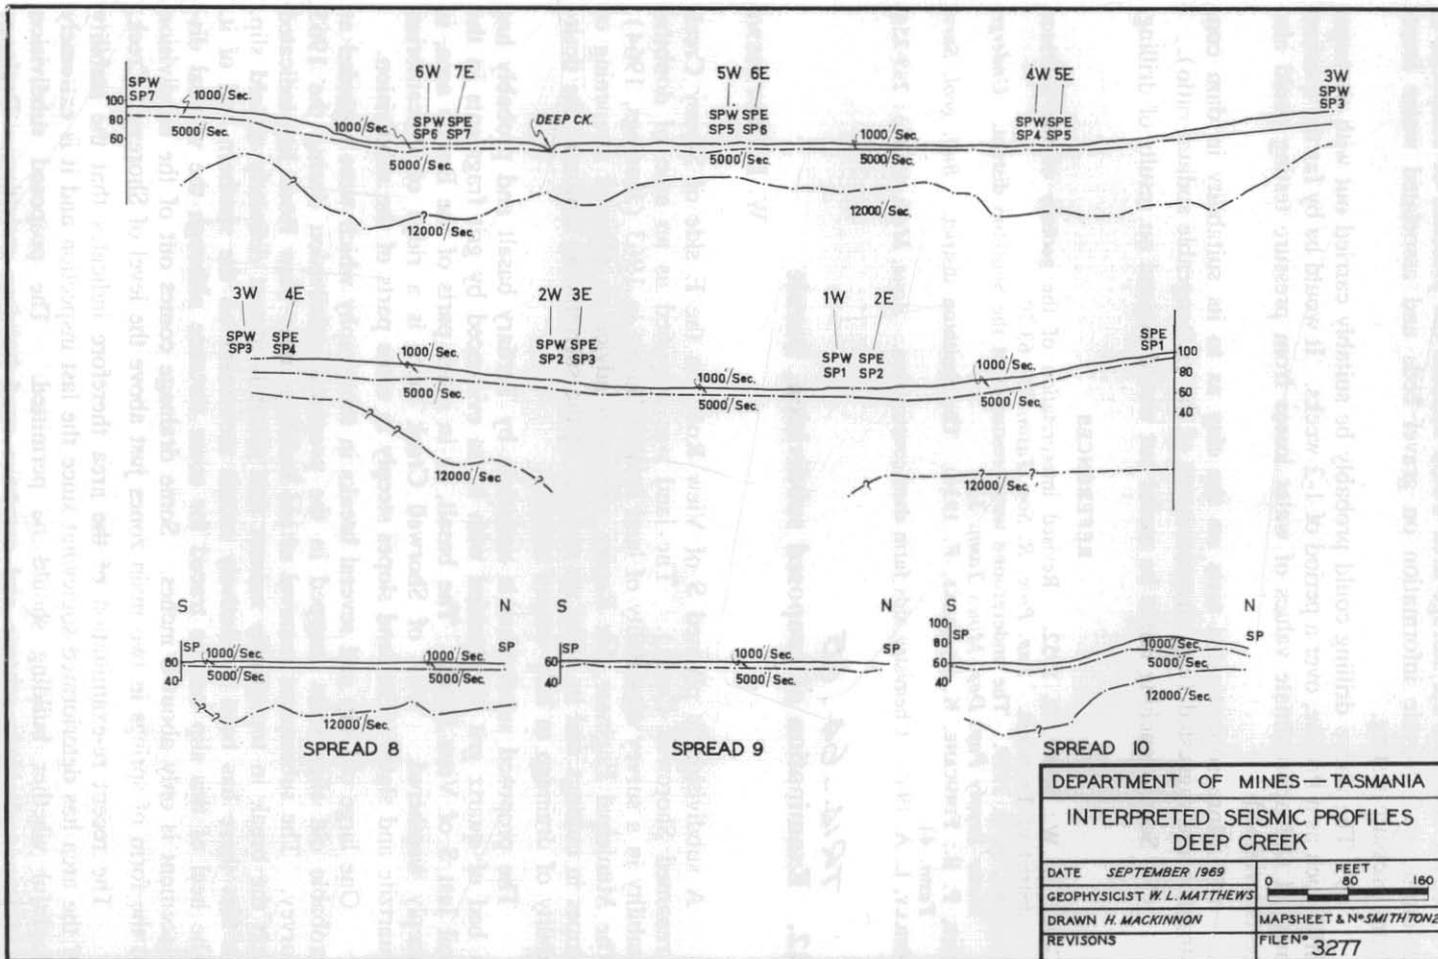
Figure 16

The results of the seismic work at the dam site are shown in the sections (fig. 16). The velocities shown are only average velocities and there could be sharp variations over short horizontal distances. It can be seen that there is a surface layer of material with a seismic velocity of about 1000 ft/sec with a thickness of up to 15 ft and probably averaging about 7 ft. With such a low velocity, this material could be expected to be loose and unconsolidated. Underlying this surface material is a layer with an average seismic velocity of 5000 ft/sec. This has a variable thickness from about 20 ft to greater than 100 ft. It is expected that open-jointed quartzite or weather siltstone could have a velocity of 5000 ft/sec. Below this layer is material with an average velocity of about 12,000 ft/sec. It is probable that both quartzite with closed joints and unweathered siltstone could have seismic velocities of this order.

(1) Because of the possibility of leakage through gravel beds and open jointed quartzite, drilling at points along the axis of the dam should be carried out to test the extent of these beds and water losses associated with them by pressure testing.
