TR14-67-70

14. Preliminary report of the geology of the Meander River
No. 1 dam site

P. C. STEVENSON

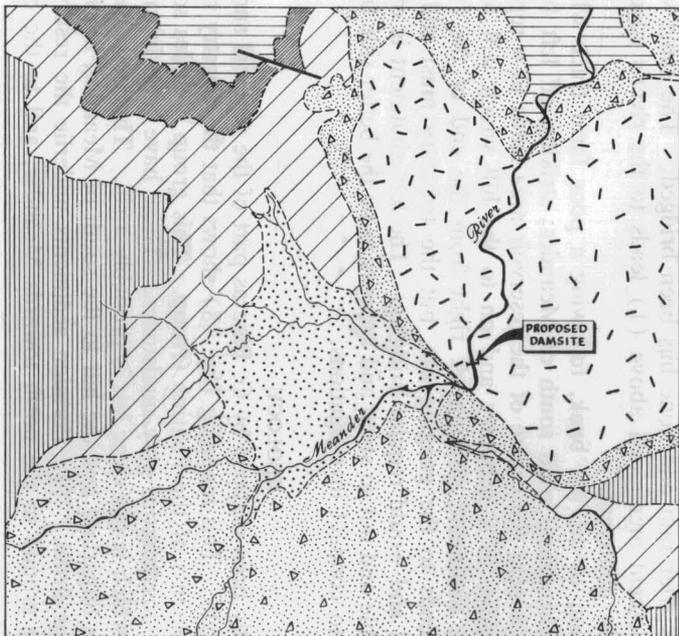
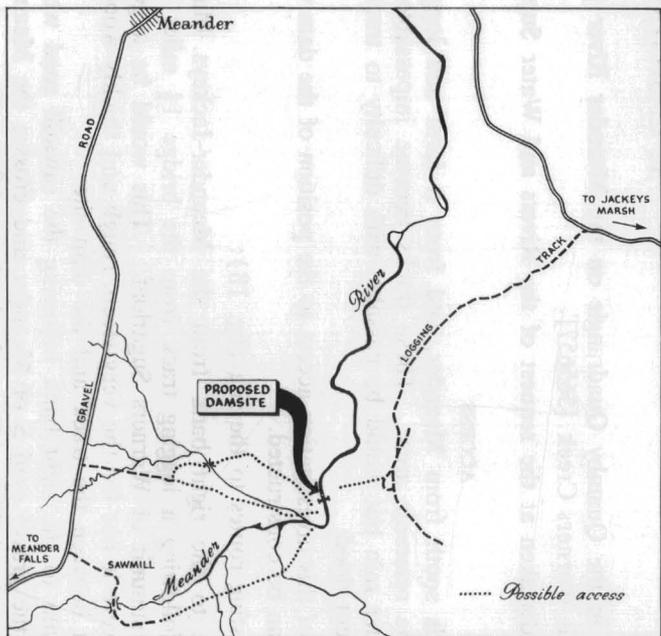
| GEOLOGICAL & ACCESS MAPS MEANDER RIVER NO 1 DAMSITE | |

The area has recently been mapped by G. Pike as part of the regional survey of the Quamby Quadrangle. This mapping (fig. 18) shows that the country rock consists of Permian sediments of the Poatina Group. This group includes some sandstones but is mainly fossiliferous grey mudstones. These have been intruded by dolerite, the form of which is not clear but is probably a sill. This mass forms the twin hills of Warners Sugarloaf and the hill to the south of Meander, between which the Meander River flows. The Permian sediments underlie the reservoir area and form the rising ground to the north towards Meander, and to the east.

As a dam site the location has much to recommend it. The dolerite abutments appear to be in sound material though the joint planes steeply dipping across the river may require minor local precautions.

The Permian-dolerite contact which runs N-S through the reservoir might in other circumstances be expected to cause leakage, but this cannot be regarded as likely here due to the high freeboard on all sides of the reservoir, and the very long leakage paths involved. The tight nature of the mudstones too, make leakage a minor hazard. The dolerite talus is often a leaky formation, but here the topography ensures that no leakage path exists.
