TR14-79-82
18. A mud spring and a landslide at Deviot

P. C. STEVENSON

An investigation was made of the occurrence of a mud spring at the request of J. Miller, and of a landslide at the request of R. Murdoch.

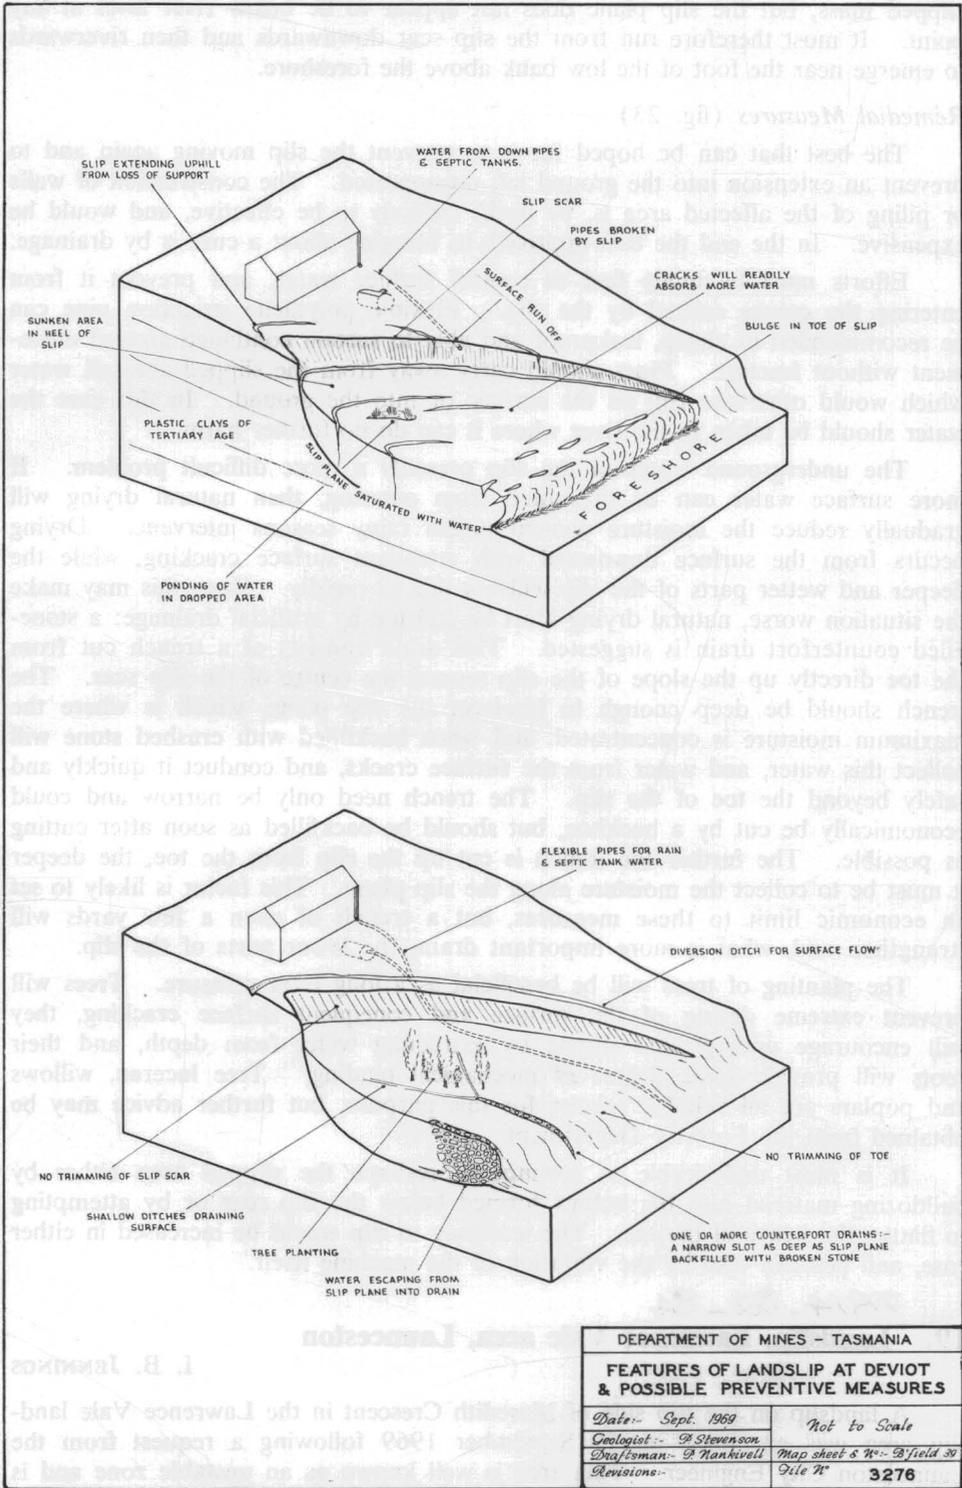
FIGURE 23

The slip has occurred on five waterside blocks occupied by Messrs Richmond, Brown, Reid, Howe and Murdoch (fig. 23). Apparently a slip occurred last year but the resulting ground disturbance was levelled off with a bulldozer.

At the Deviot slip many of these factors have been active, but particularly a previous slip episode and two unusually wet winters. The slip surface could not be located by drilling, as too many loose boulders were contained within the

slipped mass, but the slip plane does not appear to lie below river level at any point. It must therefore run from the slip scar downwards and then riverwards to emerge near the foot of the low bank above the foreshore.

Remedial Measures (fig. 23)

The best that can be hoped for is to prevent the slip moving again and to prevent an extension into the ground left unsupported. The construction of walls or piling of the affected area is, by itself, unlikely to be effective, and would be expensive. In the end the best approach to bringing about a cure is by drainage.

Efforts must be made first to control surface water, and prevent it from entering the cracks caused by the slip. Flexible polythene irrigation pipe can be recommended as cheap, leakproof and able to sustain continued ground movement without fracture. Pipes should carry away from the slipped area all water which would otherwise run on the surface or into the ground. In this case the water should be taken to the river where it can do no further harm.

The underground water in the slip presents a more difficult problem. If more surface water can be prevented from entering, then natural drying will gradually reduce the moisture content unless rainy seasons intervene. Drying occurs from the surface downward with attendant surface cracking, while the deeper and wetter parts of the slip will not dry so rapidly. Since this may make the situation worse, natural drying must be assisted by artificial drainage: a stone-filled counterfort drain is suggested. This drain consists of a trench cut from the toe directly up the slope of the slip toward the centre of the slip scar. The trench should be deep enough to intersect the slip plane, which is where the maximum moisture is concentrated, and when backfilled with crushed stone will collect this water, and water from the surface cracks, and conduct it quickly and safely beyond the toe of the slip. The trench need only be narrow and could economically be cut by a backhoe, but should be backfilled as soon after cutting as possible. The further the trench is cut up the slip from the toe, the deeper it must be to collect the moisture along the slip plane. This factor is likely to set an economic limit to these measures, but a trench of even a few yards will strengthen and, what is more important drain, the lower parts of the slip.

The planting of trees will be beneficial as a long term measure. Trees will prevent extreme drying of the surface and consequent surface cracking, they will encourage underground drying by extracting water from depth, and their roots will provide some degree of mechanical binding. Tree lucerne, willows and poplars are all suitable species for this purpose, but further advice may be obtained from the Forestry Department.

It is most undesirable to attempt to reshape the slipped area either by bulldozing material into the hollow formed below the slip scar or by attempting to flatten the heave at the toe. The tendency to slip would be increased in either case, and possibly also by the vibration of the machine itself.
