## 20. Further report on a landslip in the Lawrence Vale area

P. C. STEVENSON

I. B. JENNINGS

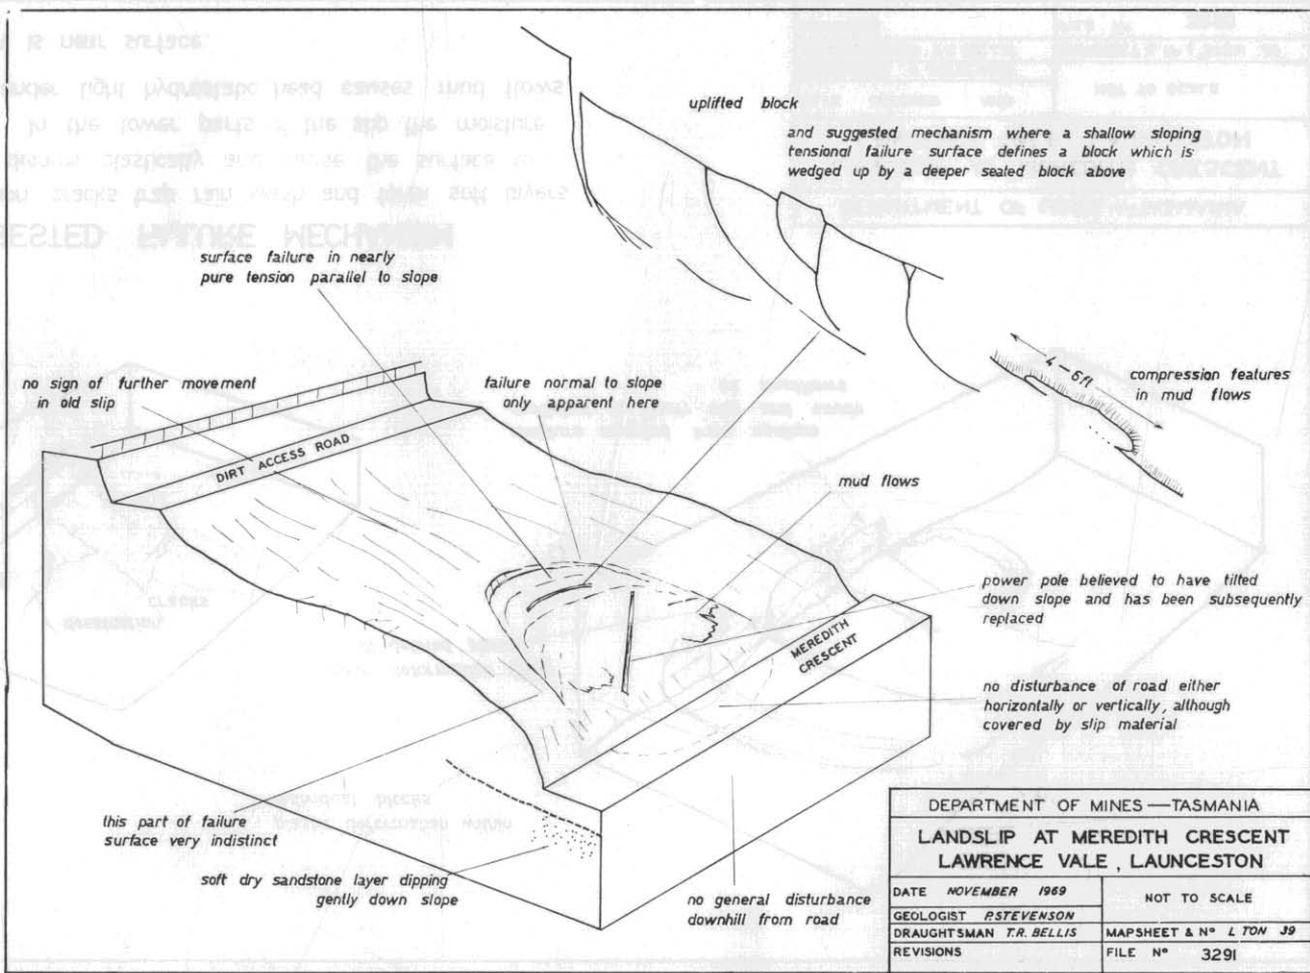
FIGURE 24

The following observations made during a detailed examination of the site are summarised in a block diagram (fig. 24).

Surface cracks had been opened by the differential movement of the ground surface. In almost all cases, the movement had been mainly parallel to the ground surface and there was little evidence of a component of movement normal to the ground surface, as is usual in the classic rotational slip.

There was evidence of flows of plastic mud in the toe region of the slip: the surface of the ground had been rendered sufficiently moist to flow slowly downslope and to produce pressure ridges and overfolds in the toe region. It was probably the invasion of the roadway by these mudflows that first called attention to the slip following the recent wet winters. Remnants of the flows remain where they did not advance as far as the road.

An unusual feature though one which appear characteristic of landslips in the clays of the Launceston area, is the uplifting of blocks of ground between adjacent tension cracks in the centre to upper part of the slip. This has been noted (Eckel, E. B., 1958) as characteristic of shallow slips and appears from the writers' observations to be due to a mechanism as outlined in Figure 25.

The present slip shows few of the normal features of a rotational slip.

There has been no heave of the toe which would have disrupted the road. The toe is drained by the sandstone layer.

Deformation has been largely plastic as evidenced by the failure in the lateral trench, by the mudflows and indirectly by the tensional nature of the surface: this has resulted in downhill slope movement rather than backward tilting.

No cylindrical slip planes were seen in any excavation.

Very moist but shallow (<12 ft) zones which are connected with surface cracks are abundant in the excavations, though not visually obvious.

The mechanism shown in Figures 24 and 25 is suggested as the cause of the slip.

If these conclusions are correct, then the measures being taken are designed to provide both surface and subsurface drainage and are the best practicable measures to achieve this.

The sewer pipes which are known to pass through the area adjacent to the slip, and within the slip itself, constitute a serious hazard as they are subject to deformation by the slightest ground movement. As they are inflexible they may crack and leak, and will introduce water into the area at the worst possible position. They should therefore be re-routed to avoid potential slip areas and if possible laid with joints capable of absorbing several inches of movement without leakage.

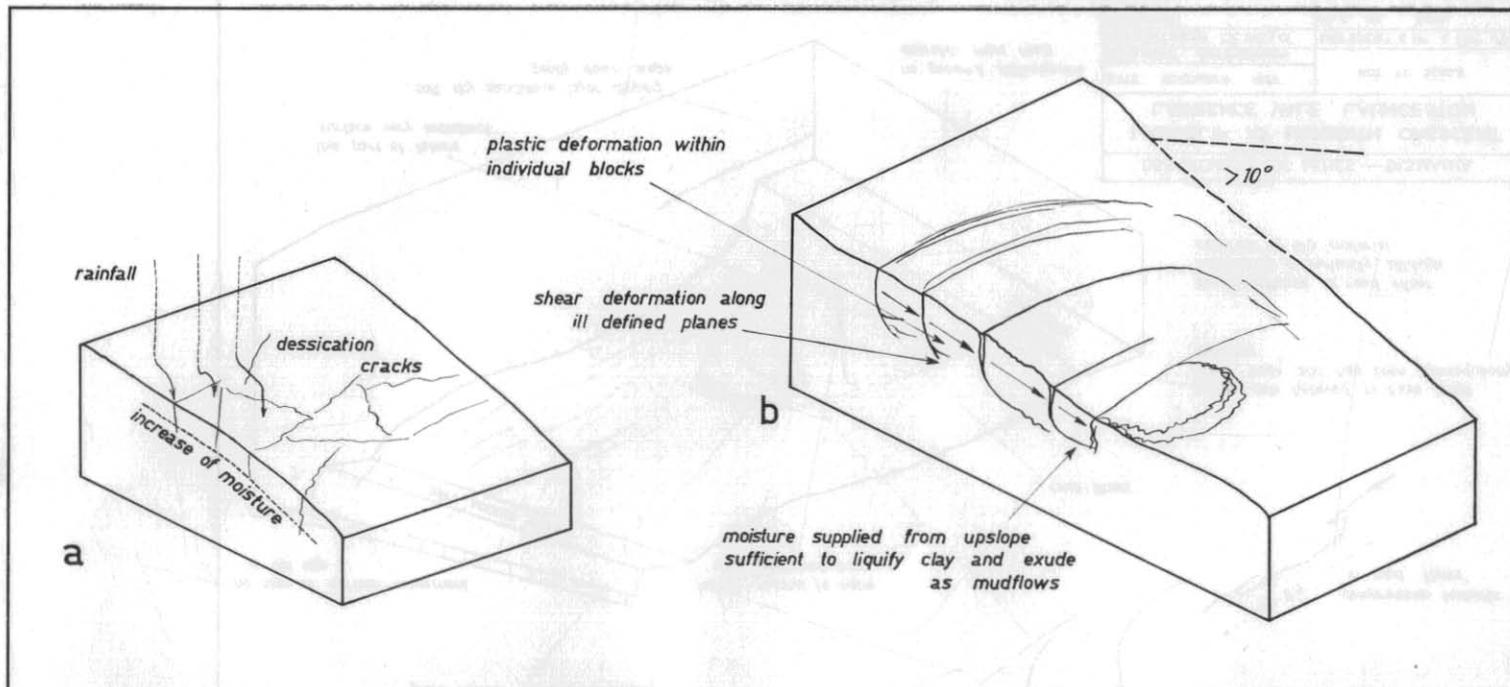
**SUGGESTED FAILURE MECHANISM**

Where desiccation cracks trap rain wash and form soft layers in clay. These deform plastically and cause the surface to fail in tension. In the lower parts of the slip the moisture increases and under light hydrostatic head causes mud flows. All deformation is near surface.
