36. Geological and seismic survey of a dam site on the Kermandie River

P.C. Stevenson

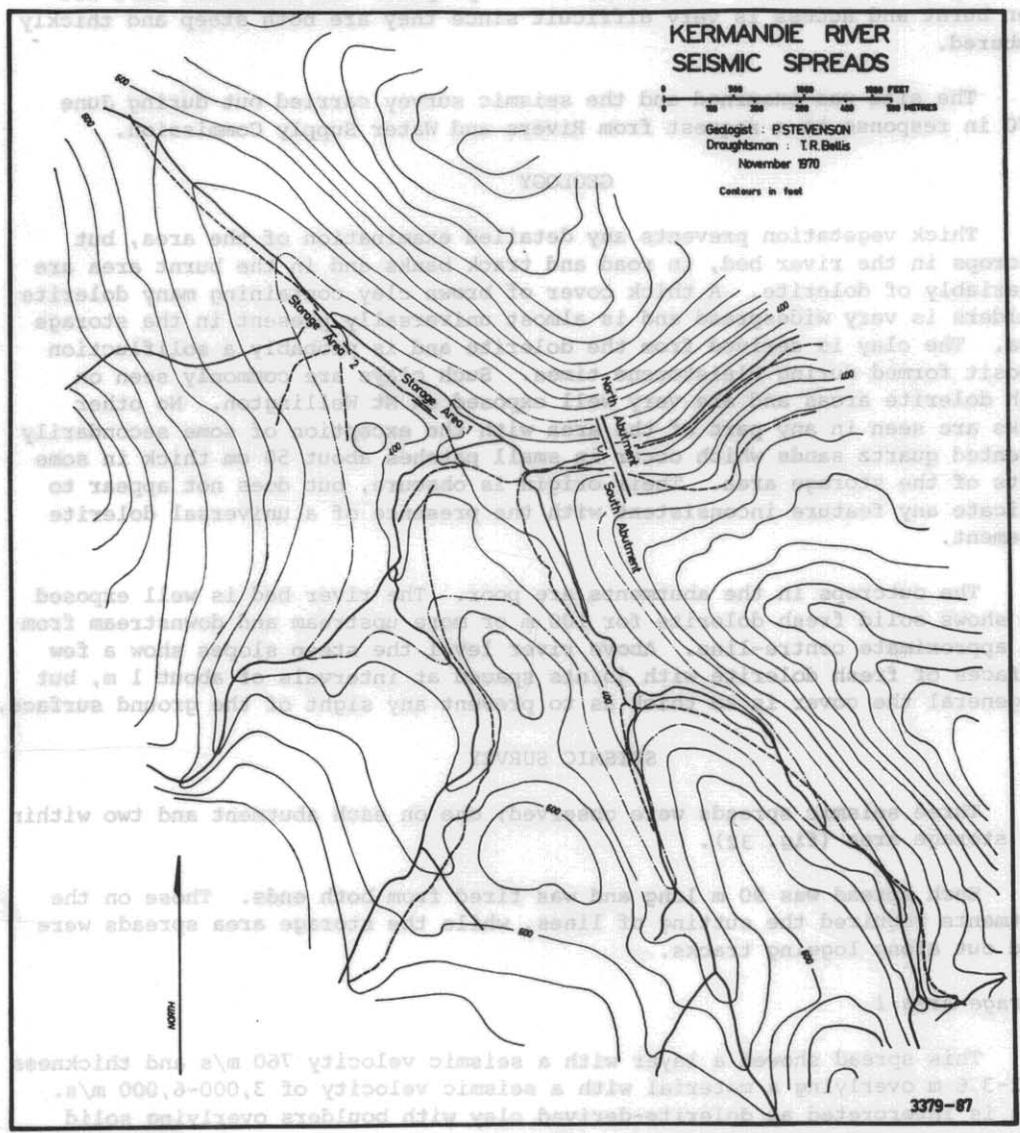
Figure 32.

Three seismic spreads were observed; one on each abutment and two within the storage area (fig. 32).

This spread showed a layer with a seismic velocity 760 m/s and thickness of 2-3.6 m overlying a material with a seismic velocity of 3,000-6,000 m/s. This is interpreted as dolerite-derived clay with boulders overlying solid dolerite some of which is jointed and weathered.

This spread showed a layer with a seismic velocity 1,100 m/s varying from 3.6-5 m thick overlying material with a seismic velocity of 4,300 m/s. This is interpreted as stiff dolerite-derived clay overlying moderately jointed fresh dolerite.

This spread was laid out uphill from the access road on a slope of 12° and does not include the steep cliff below it. It showed that the dolerite profile below the surface is very irregular from 60 cm - 4.5 m in steps probably corresponding to major joints and that the seismic velocity of the dolerite varied from 2,700-4,500 m/s and possibly higher. This variation would correspond to irregularity of jointing and probably weathering.

An irregular profile of dolerite below a surface slope of 24° is again thought to represent steps due to major joints. The overlying material is of low velocity and is soil and clay resting on the joint steps, while the seismic velocity in the dolerite is of the order of 4,500-6,000 m/s.
