## 13. Examination of Proposed Subdivision, East Devonport

W.L. Matthews

# AMBLESIDE SUBDIVISION DEVONPORT TEST PITS

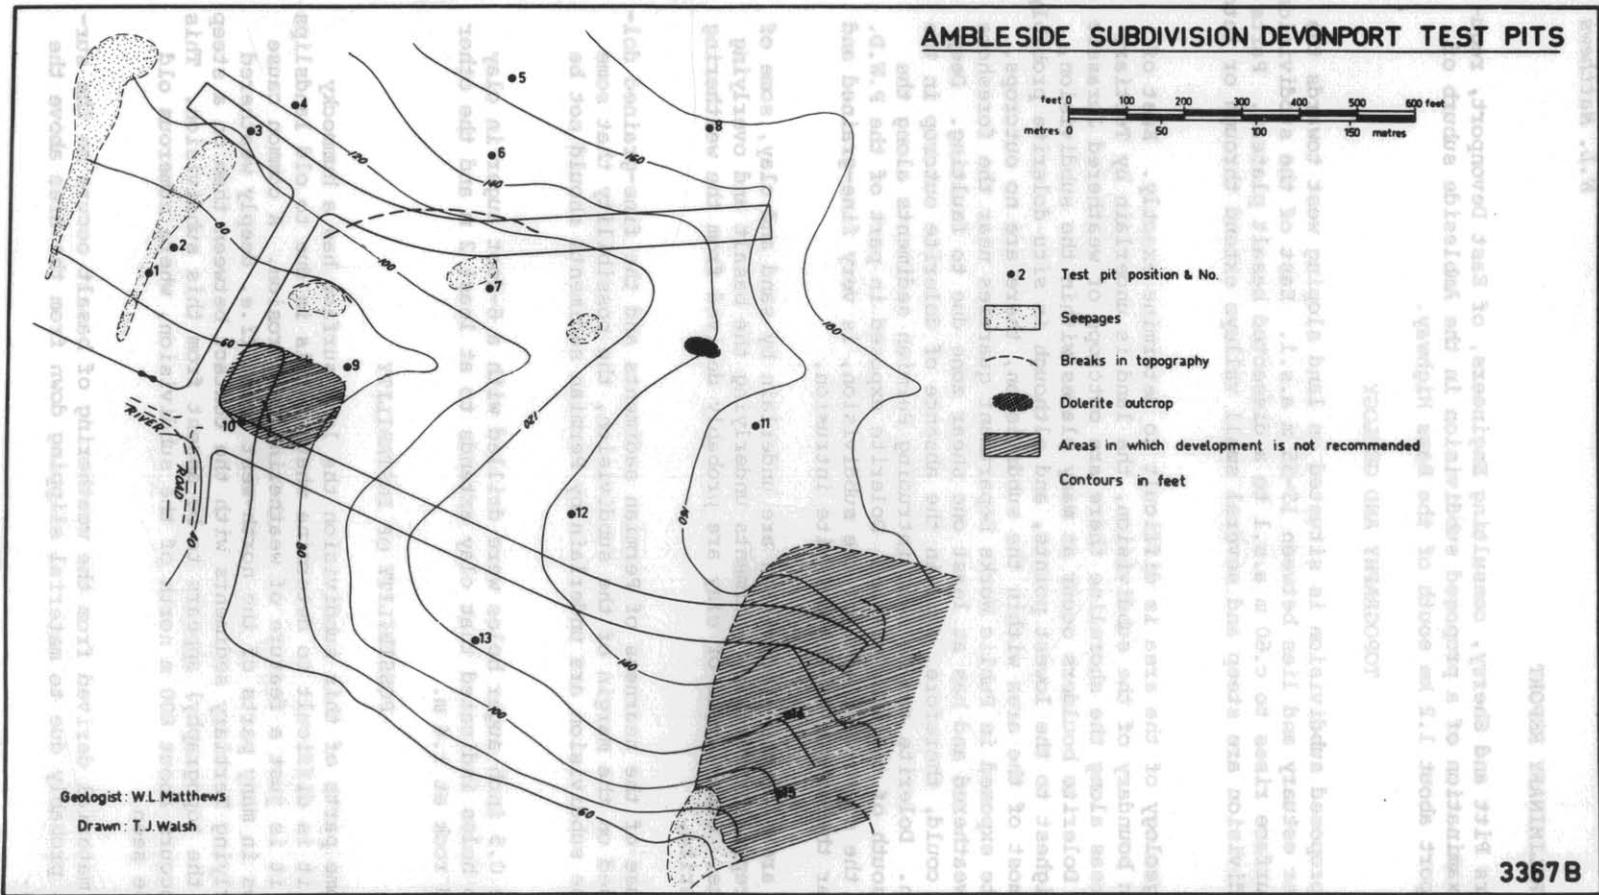
Fifteen pits have been dug with a back hoe in the approximate positions shown in Figure 13. The pits indicate that deeply weathered dolerite underlies the whole area. Further surface investigation resulted in the discovery of a small dolerite outcrop (fig. 13). The fact that several holes were dug to 4-5 m gives an indication the degree of weathering in the dolerite. Pits 10, 14, 15 show that varying thicknesses of sandy clay and clay overlie the dolerite in these areas. These beds are probably an accumulation of Tertiary sediments, and areas where they occur on fairly steep slopes (10-15°) are potentially unstable. The soil in some of the higher areas is derived from the weathering of basalt which occurs further up the slopes.

A number of areas have been marked where there is a change in slope or break in relief (fig. 13). They could represent the heels of very old slips or could be the result of differential weathering in the dolerite. A number of seepages have been noted in the proposed subdivision and these are also shown (fig. 13).

of the thickness of sandy clay and clay and the steepness of areas around Pits 10, 14, 15, it is suggested that these areas are not developed as there is some chance of unstable conditions developing if disturbed.

The steepness of some of the land surface, the seepages, and the possible very old slips suggests that development should proceed only after suitable precautions have been taken. The seepage and streams throughout the area should be drained to prevent accumulations of water in the soil. These drains should have some built-in flexibility so that they would be unaffected by small movements. cuttings around steep portions of the land surface should be avoided or the batter should be low so as not to promote instability, particularly to the crescent-shaped road on the east side of the subdivision but also to portions of other roads and to excavations for houses. Because
