14. Examination of land at East Devonport

The Devonport Council requested an inspection of a proposed subdivision of c.8 ha (20 acres) of land and a report on any possible unstable areas. The land, owned by M.F. Savage, is on the outskirts of East Devonport and is bounded by Port Sorell Main Road on the north, Bovill Street on the west and Drew Street on the south.

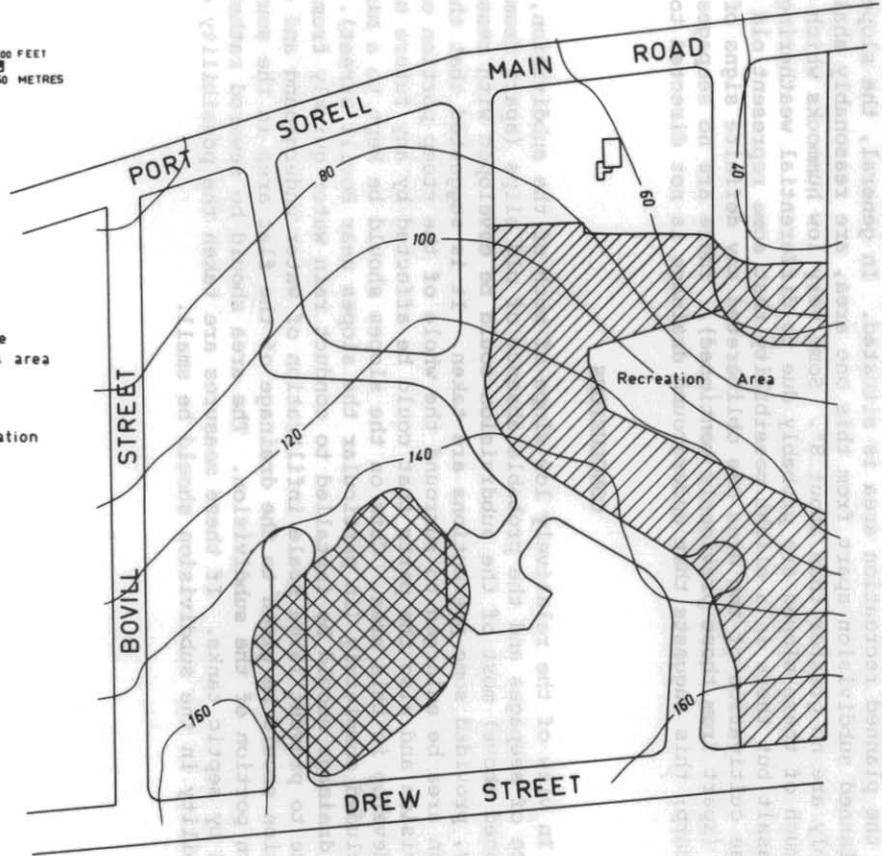
Figure 14.

Particular attention should be given to the drainage of this area

Along the scarp between the marine terrace and the plateau, where the slope is steep, a few old slips can be seen. Two occur west of the subdivision and within 180 m of Bovill Street and one extends on to the subdivision where the planned recreation area is situated. In general, the slopes on the planned subdivision apart from this one area, are reasonably shallow and probably are no greater than about 8°. Some very low hummocks which occur over much of these slopes are probably due to differential weathering of the basalt but there is a slight possibility that some represent old slips. Intense cultivation of the area has obliterated any definite signs of old slips (apart from those previously mentioned). There are no seepages along the scarp; this suggests that underground drainage is not directed to this area.

Suggested extension to recreation space

In view of the relatively low slope of much of the subdivision, the absence of seepages and the probable absence of old slips (apart from that mentioned above) most of the subdivision could be developed with reasonable safety, provided some precautions are taken. It is suggested that the recreation area be enlarged to surround the whole of the steep portion of this subdivision and also the parts that could be affected by any future slips that develop in this area. Cuts on the slopes should be kept to a minimum or excluded completely (in particular the slopes near Bovill Street). Adequate drainage should be installed to conduct rain water quickly from the surface to prevent large scale infiltration of water underground and special attention should be given to the drainage of the flat area in the south-western portion of the subdivision. The area should be sewered rather than served by septic tanks. If these measures are taken the possibility of instability in the subdivision should be small.
