## 16. Foundation conditions at Tamar Avenue, George Town

P.C. Stevenson

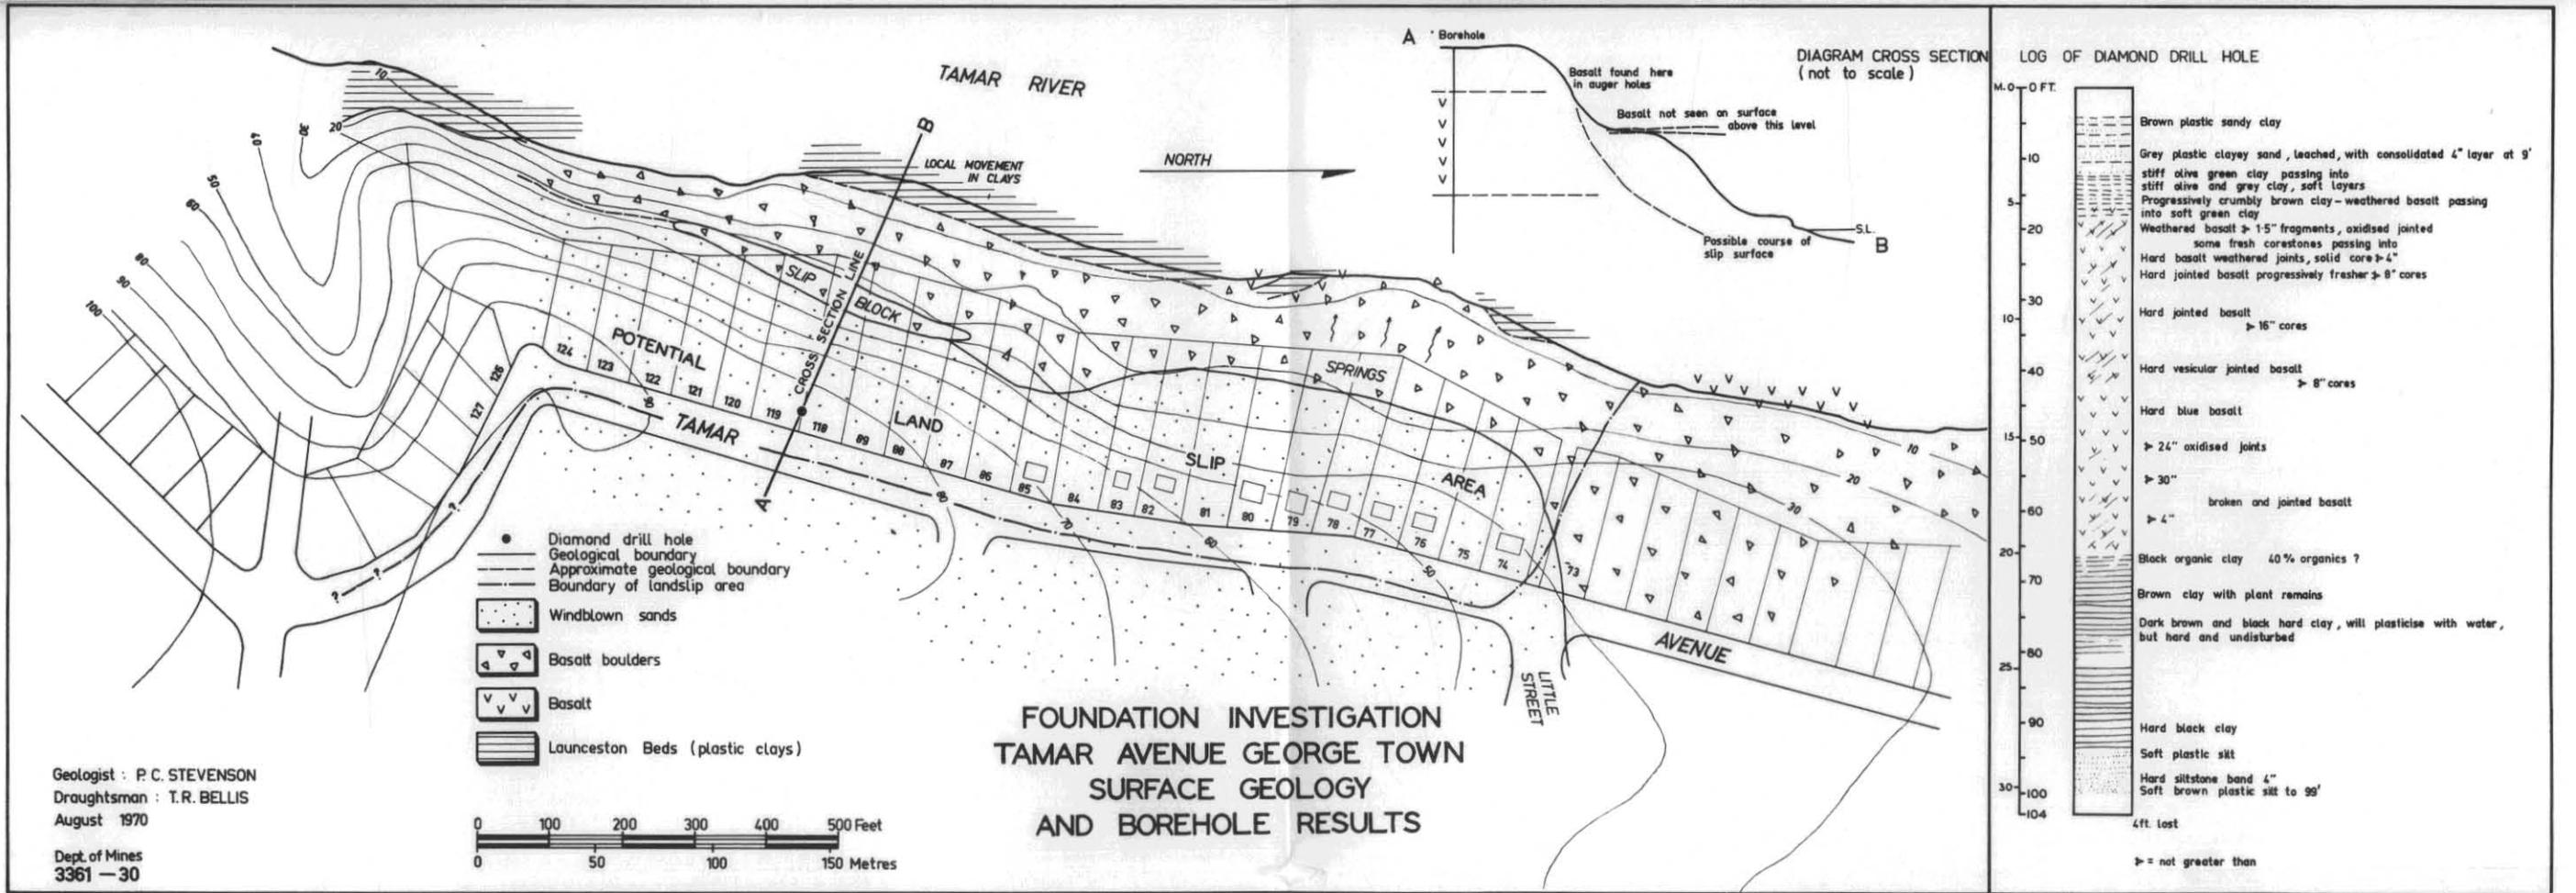
Figure 15.

An inspection of the Tamar Avenue area (fig.15) showed that the surface of the plateau consisted of a thin soil formed on windblown sands and that brown clays were present at about 1 m from surface. The slope of the river bank also showed blown sand with a spread of basalt boulders in a matrix of weathered basalt clay forming the lower slope. Along the shore and for about 3 m above it, the grey clay of the Launceston Beds was seen, locally these beds were seen to be or to have recently been, in mass movement. The plastic clay when liberally soaked in water, becomes sufficiently fluid to move downhill under its own weight. The clay is then capable of flowing slowly round trees and other obstructions and this has occurred to a small extent along the shore.

An area about halfway down the slope and including the seaward ends of Blocks 122, 121, 120, 119, 118, 89, 88, 87 does not conform to the rest of the slope but is flattened into a shelf. This feature is characteristic of old slips and represents part of the old top-of-slope level which has been dropped by slipping. The age of this slip is unknown but judging from the size of the trees now growing on it, it could be 40-60 years old. The clay displaced from below the block has long since been removed by the river.

The borehole has shown that the shelf on the slope below Blocks 122-87 is an old slip, for it has displaced the basalt downward. In confirmation, auger holes drilled in the sand of the slope above the slip showed the presence of basalt, the significance of which is indicated on the cross section.
