## 22. Examination of Cascade Dam, Derby

W.L. Matthews

The Rivers and Water Supply Commission are studying the possibility of raising the level of the Cascade (Briseis) Dam by 15 m so that more water will be available for irrigation and mining purposes. A geological examination has been made in response to their request.

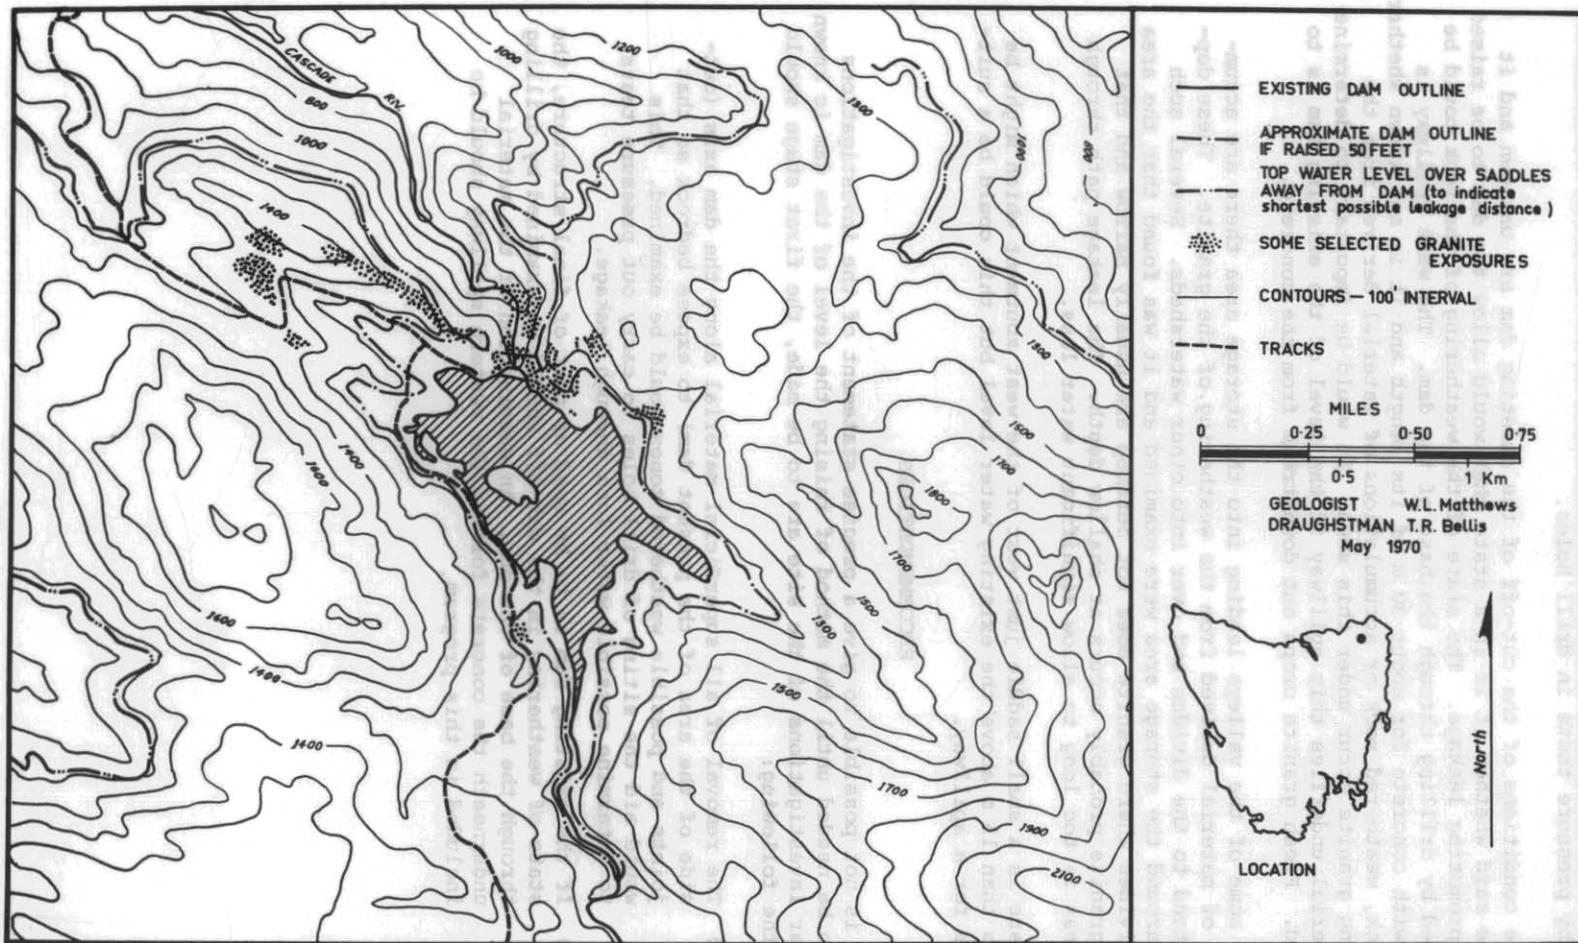
Figure 20. Sketch map of Cascade (Briseis) dam area.

Granite crops out over much of the area. Only areas where outcrops are particularly significant have been marked on Figure 20.
