## 27. Landslips, Upper Plenty Road, August 1970

D.E. Leaman

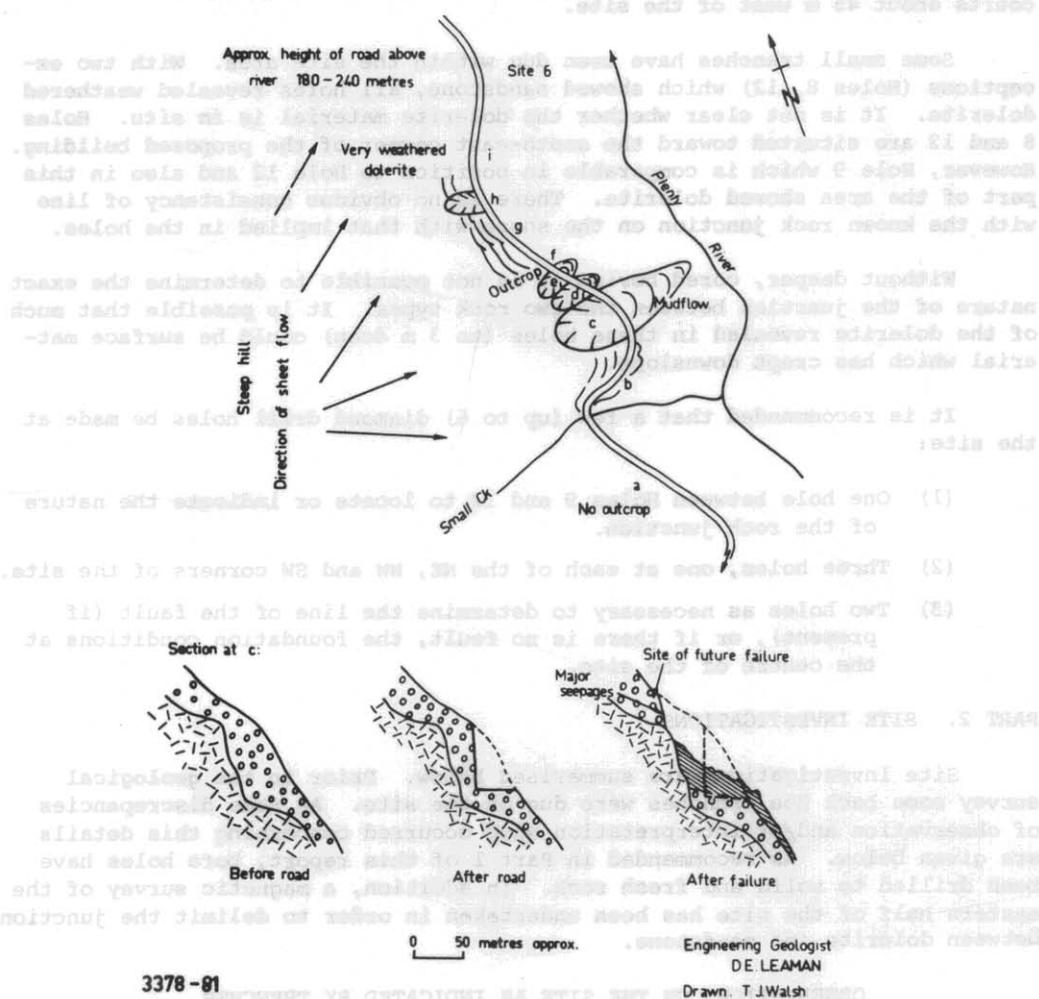
(6) Major slippage zones (fig. 24):  $k = 4.3-4.5$ .

(a) Cuttings up to 2.5 m high in soil and boulders. No significant slippage occurred as the top of the spur is approached and there was probably little runoff over this region to add to direct rainfall, whereas north of the creek the hill slopes steeper and the catchment area becomes significant.

(b) Cuttings up to 9 m high in soil and boulders (proportion 1:1)  $bf = 1.2-1.5$ . The material has failed and then moved as a muddy mass. Small portions of the slip which have not fragmented have dropped vertically. Any vegetation merges into the flow once failure takes place.

(c) The main slip ( $h = 21$ ,  $d = 18$ ,  $bf = 6$ ) has occurred in loose fragmental material and bare outcrops have now been exposed. Future failures will be limited to the overburden at the back and top of the face. The section shows in pictorial form the history of this part of the cutting. The seepages above massive rock, now exposed, were responsible for the failure.

(d-e) Smaller slips now exposing massive dolerite. Their effect was limited due to the thin cover of loose material as compared to (c).

(f) No slippage due to dolerite outcrop.

(g) Zone of terraced slips, each with  $bf = 0.6-0.9$  and no obvious rotation. They are generally small because of rock at shallow depth (partially exposed near road level) which prevents large scale movement.

(h) Large slip of two steps,  $bf = 0.6, 3$  which moved later than the terraced slips (g), and which shows very little rotation. No outcrops of solid rock is visible at road level.

(i) Much weathered dolerite, no failures. Loose cover very thin.

Figure 24. Landslips on the Upper Plenty Road, August 1970.

Remedies could include cutting back to bedrock (weathered or fresh); stepping the cuttings, or trenching up hill. The latter is the only practical solution in most cases but such trenches would need to be dug to solid rock and gravel or rock filled to remain useful drains. Where weathered or fresh rock is exposed in a cutting the overlying soil should be scraped off the region adjacent to the face.
