TR16_164-167

28. Further investigations of drainage problems at the Westville Estate,
Prospect Vale, Launceston.

P.C. Stevenson

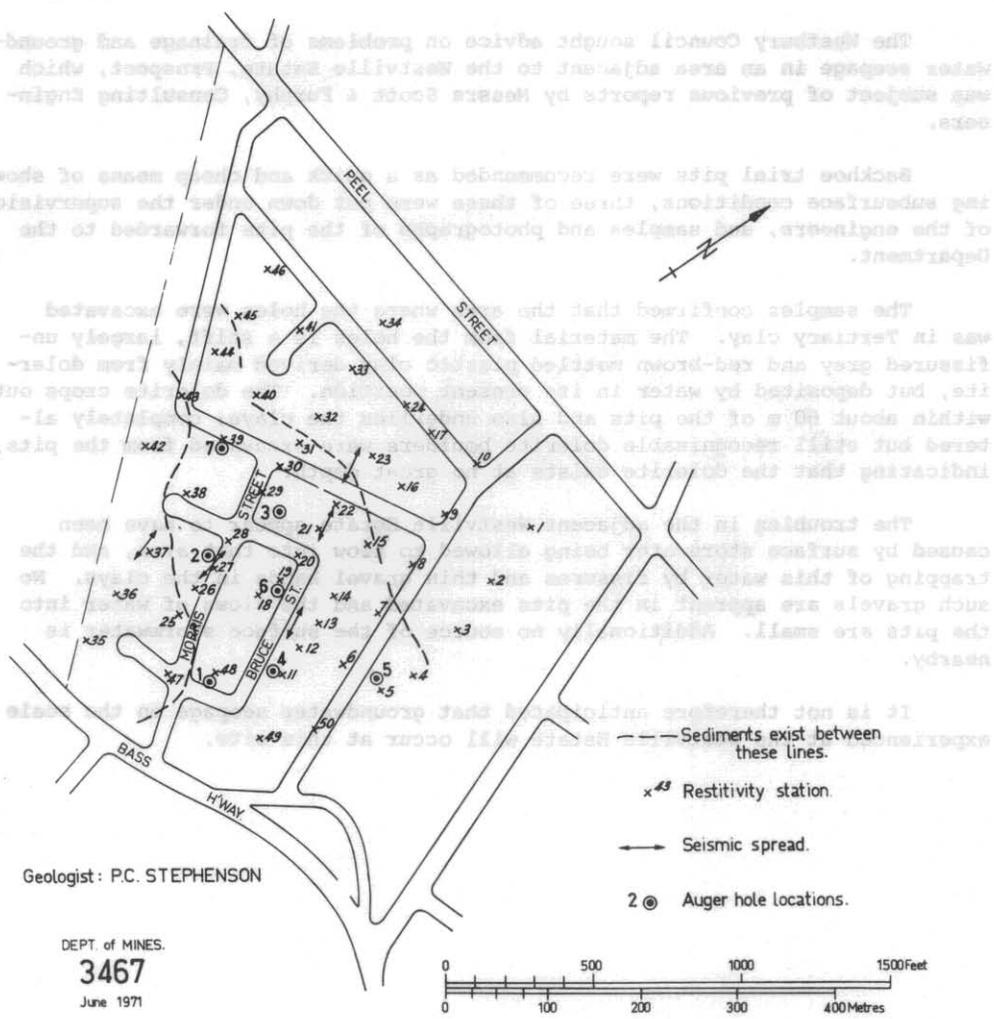
Figure 48. Locations of geophysical work and augering, Westville Estate, Prospect Vale.

The positions of fifty resistivity stations and six seismic spreads are indicated in Figure 48. The resistivity survey was conducted using Wenner configuration at 0.6, 1.5, 3 and 6 m spacings, and the seismic spreads of 12 geophones were fired from both ends, with spacings of 2.1 or 3 m.

No water table was detected from the resistivity measurements, a finding consistent with the predominantly clayey nature of both the sediments and dolerite. Gravels containing free water were rare or at least very thin and were only detected at Stn 11, 12 and 50 and possibly at 13 and 14.

About 7 holes should be drilled by power auger to a depth of 6 m to reveal at what depth the water is moving and in what material. A careful check of the level at which water first appears and any subsequent changes of water level in each hole should be made. Samples of all materials encountered should be taken paying particular attention to thin sand and gravel which may contain water.

Samples should be taken of the water in each hole for possible analysis. Suggested positions for the auger holes are indicated on Figure 58.
