33. Results of drilling, Pipers River dam site 12A.

D.E. Leaman

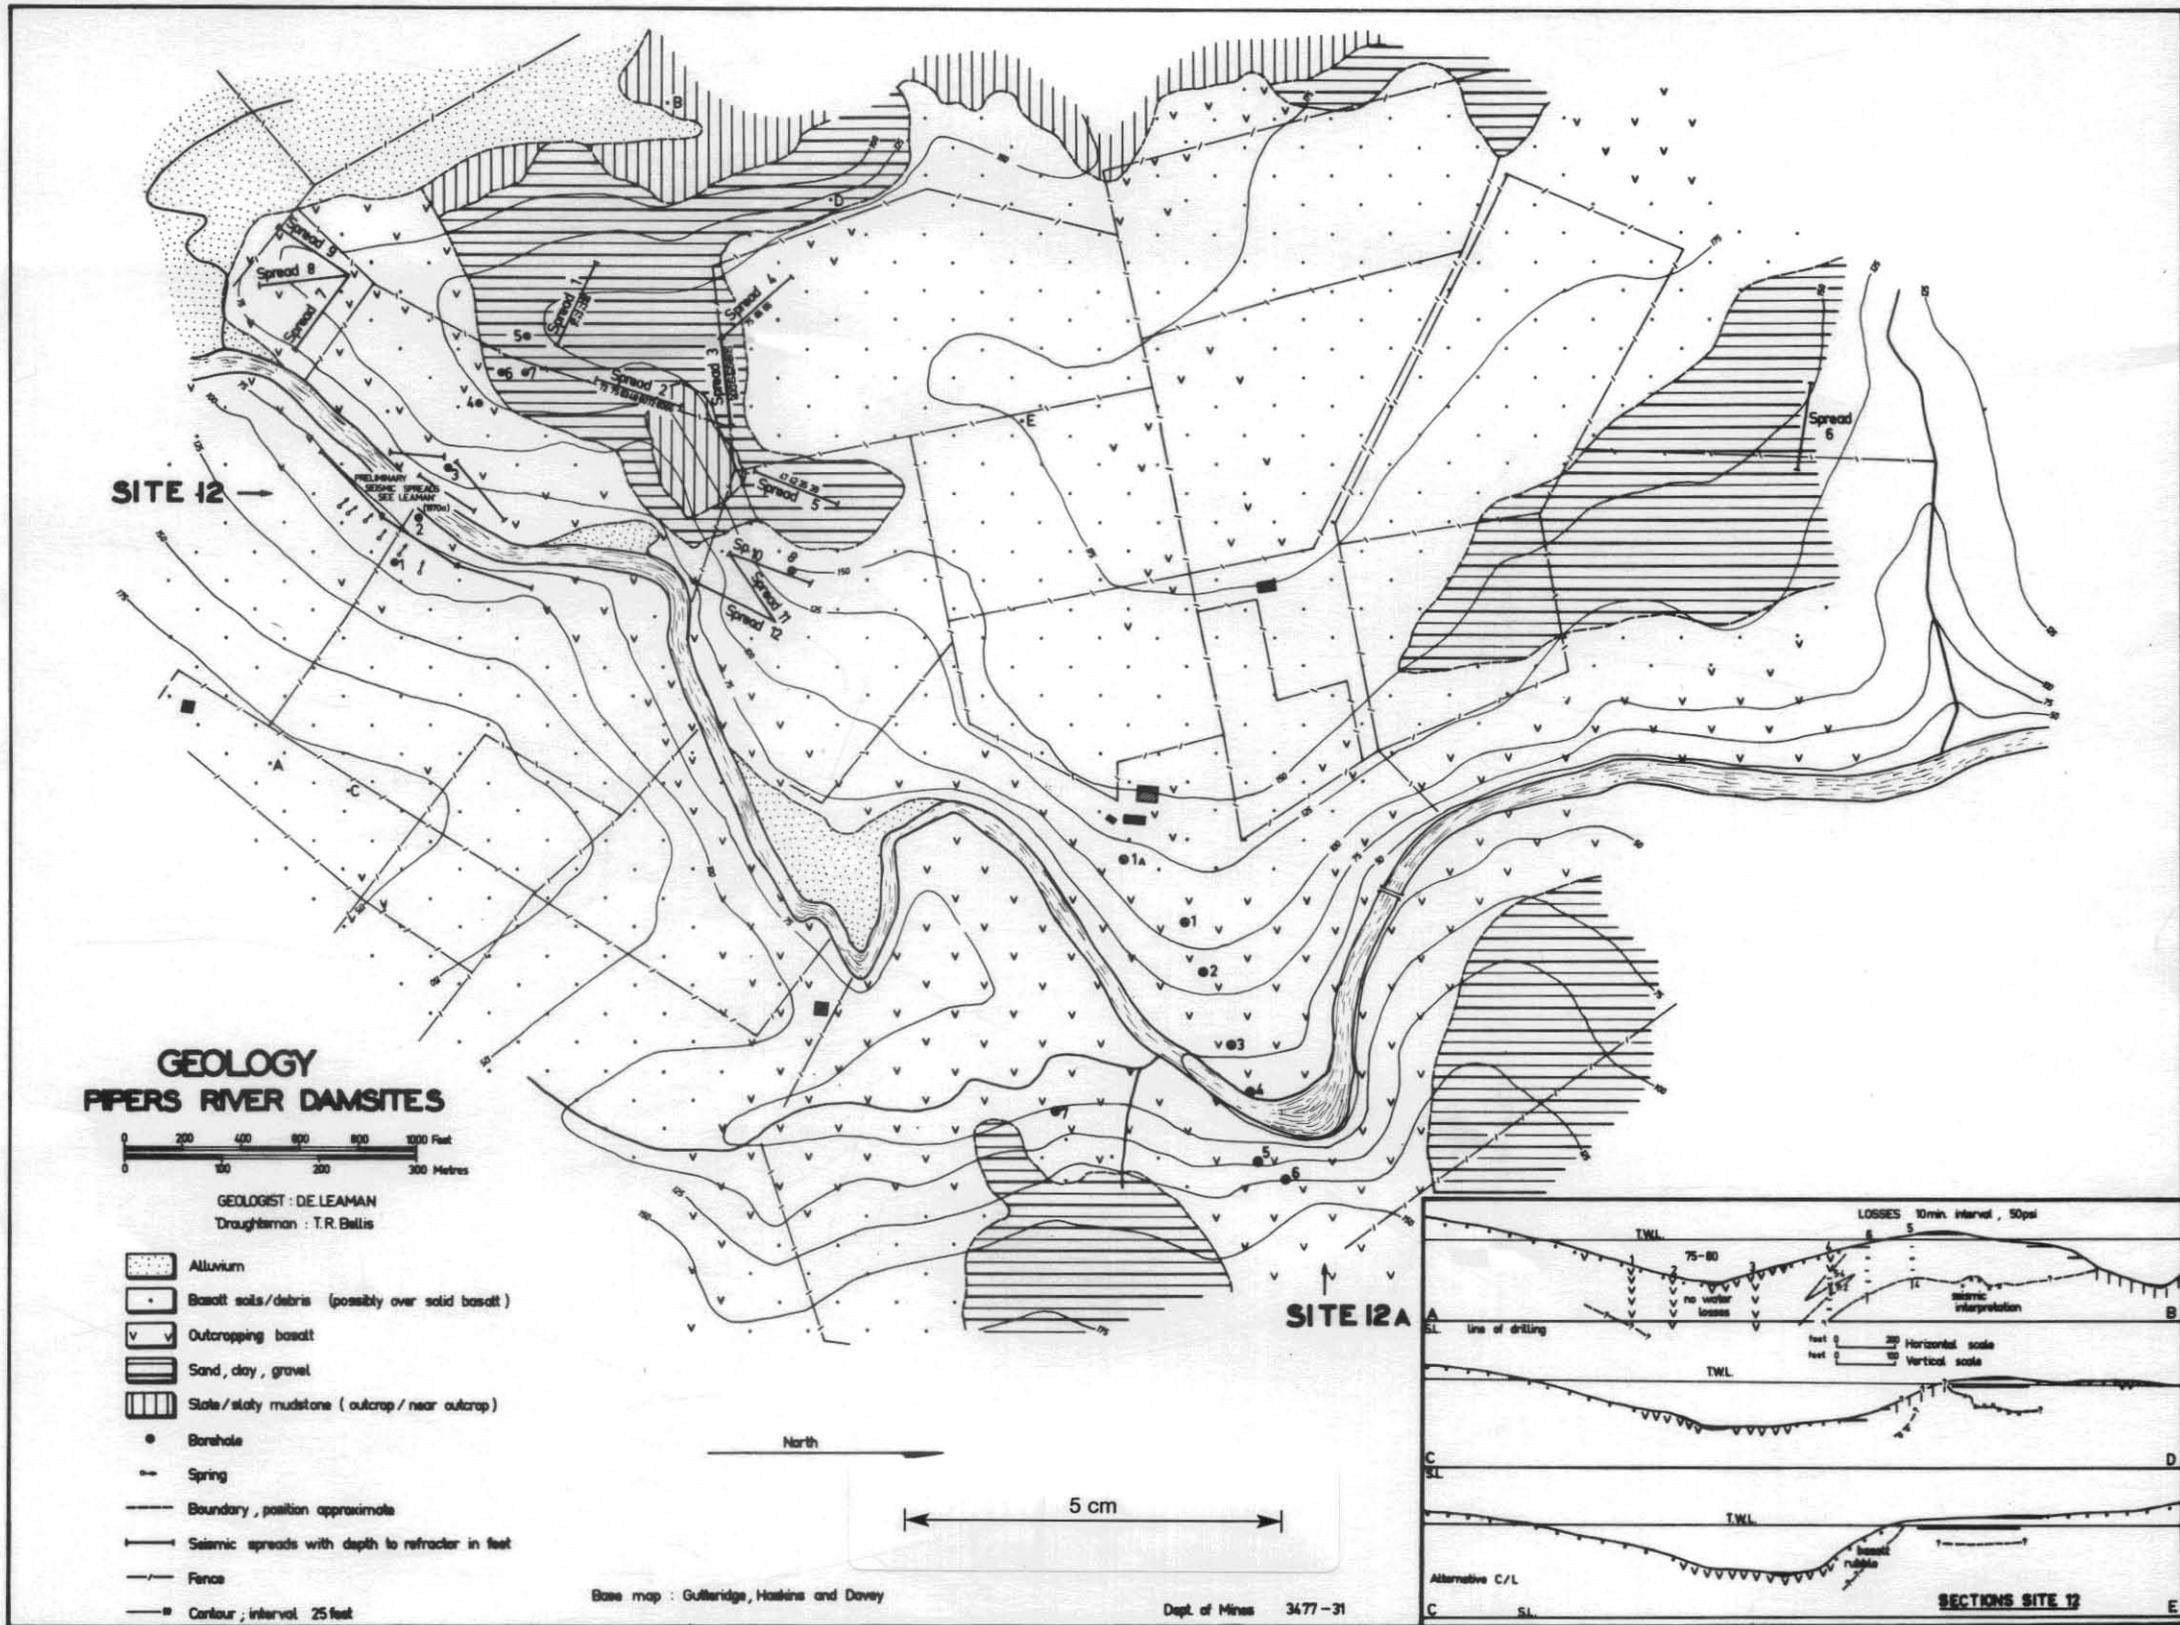
Figure 55.

Site 12A is located downstream of site 12 at an incised bend in Pipers River east of 'Leura' homestead (fig. 55). Eight bore holes were sited in an initial drilling programme to determine whether good foundation conditions existed at the site. Surface mapping revealed basalt soils, boulders and outcrop. However, experience elsewhere along the valley has shown that soil and boulder covered areas may conceal permeable sediments. Holes 1, 2 and 3 were drilled by the Department of Mines and holes 1A, 4, 5, 6 and 7 by James & Co. Holes 1 and 6 are located at TWL and hole 4 at river level.

Site 12A has been shown on foundation and water leakage considerations to be a feasible site for a large dam on Pipers River. No significant deficiencies have been noted and no further drilling is recommended on the dam foundation. However some additional shallow drilling is suggested north of hole 1A on the spillway to confirm the material and its suitability for rock-fill in the dam.
