## 33. Proposed lawn cemetery, Kingston

D.E. Leaman

A private lawn cemetery has been proposed for a property north of Browns River, which is owned by W.C. Hodgman of Kingston. Peacock, Darcey and Anderson, surveyors, acting on behalf of the development company, requested a study of the area in order to determine its suitability for the purpose. Information was required on the depth of soil general bedrock conditions, the depth of the water table and the nature of drainage.

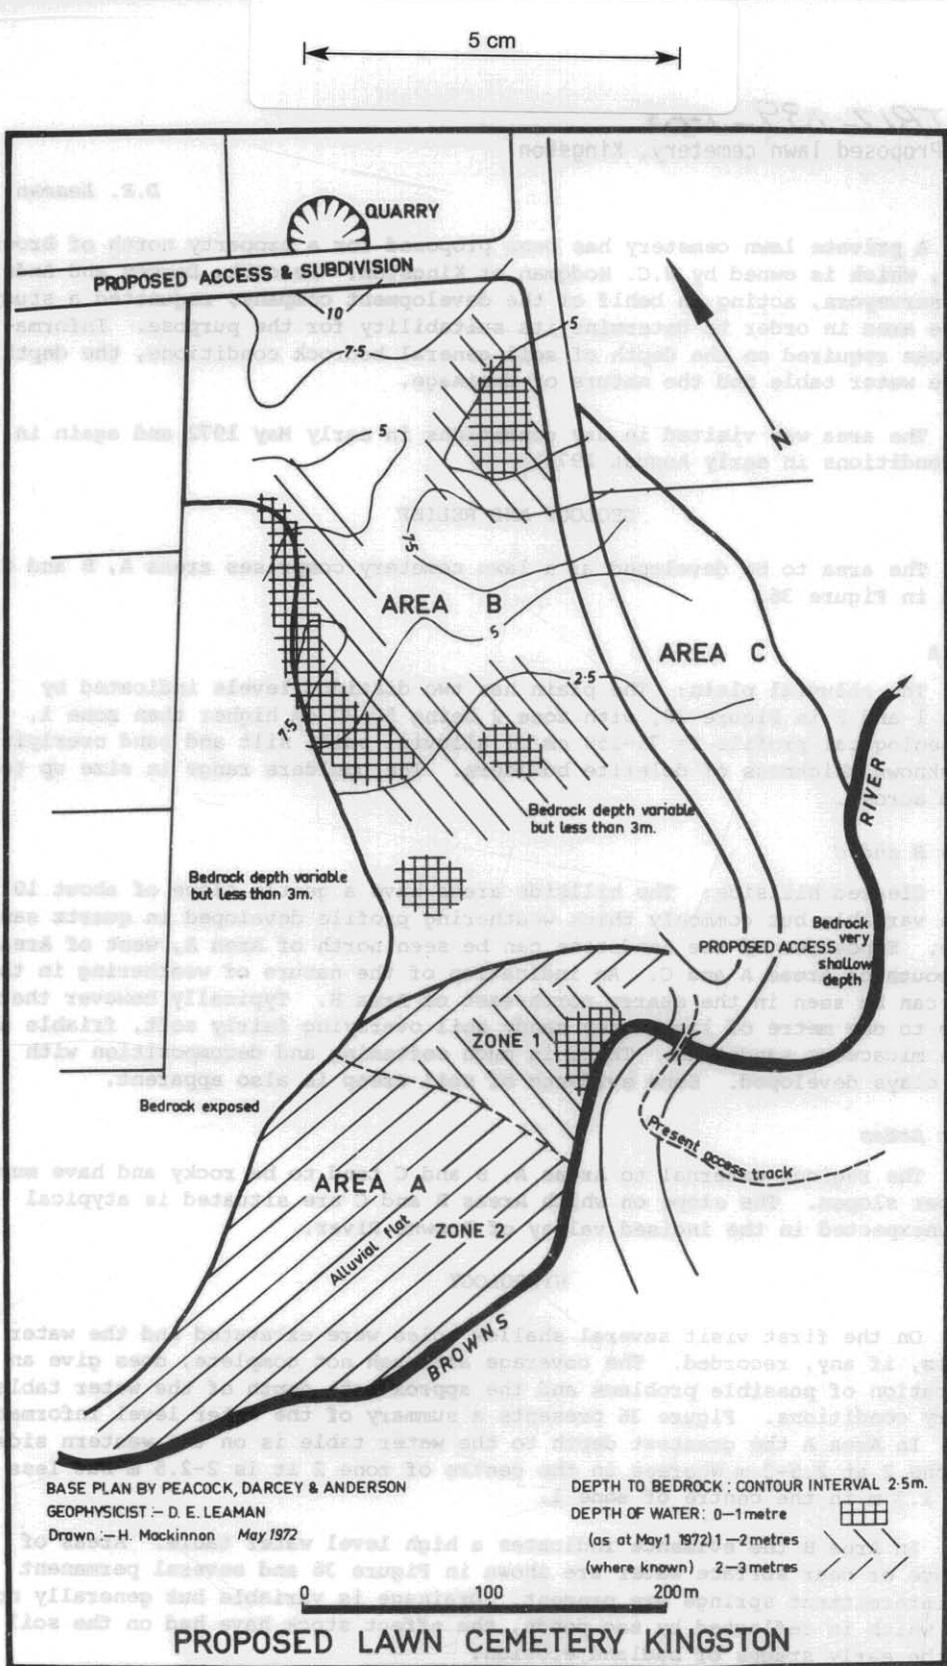
The area to be developed as a lawn cemetery comprises areas A, B and C shown in Figure 36.

The alluvial plain: The plain has two distinct levels indicated by zones 1 and 2 in Figure 36, with zone 2 being 50-70 cm higher than zone 1. The geological profile is 75-150 cm of alluvial soil, silt and sand overlying an unknown thickness of dolerite boulders. The boulders range in size up to 40 cm across.

On the first visit several shallow holes were excavated and the water levels, if any, recorded. The coverage although not complete, does give an indication of possible problems and the approximate depth of the water table in dry conditions. Figure 36 presents a summary of the water level information. In Area A the greatest depth to the water table is on the western side of zone 2 at 2.5-3 m whereas in the centre of zone 2 it is 2-2.5 m but less than 1.3 m in the centre of zone 1.

In Area B the evidence indicates a high level water table. Areas of surface or near surface water are shown in Figure 36 and several permanent and intermittent springs are present. Drainage is variable but generally not good which is reflected by sag ponds, the effect stock have had on the soil and the early stages of badland erosion.

Contours on the depth to the bedrock (solid sandstone) interface are shown in Figure 36. The quality of the rock improves downslope and solid sandstone occurs at shallow depth in the western section of Area B.
