TR18-100-102

14. Treatment of cuttings at Tolmans Hill, Hobart

D.E. Leaman

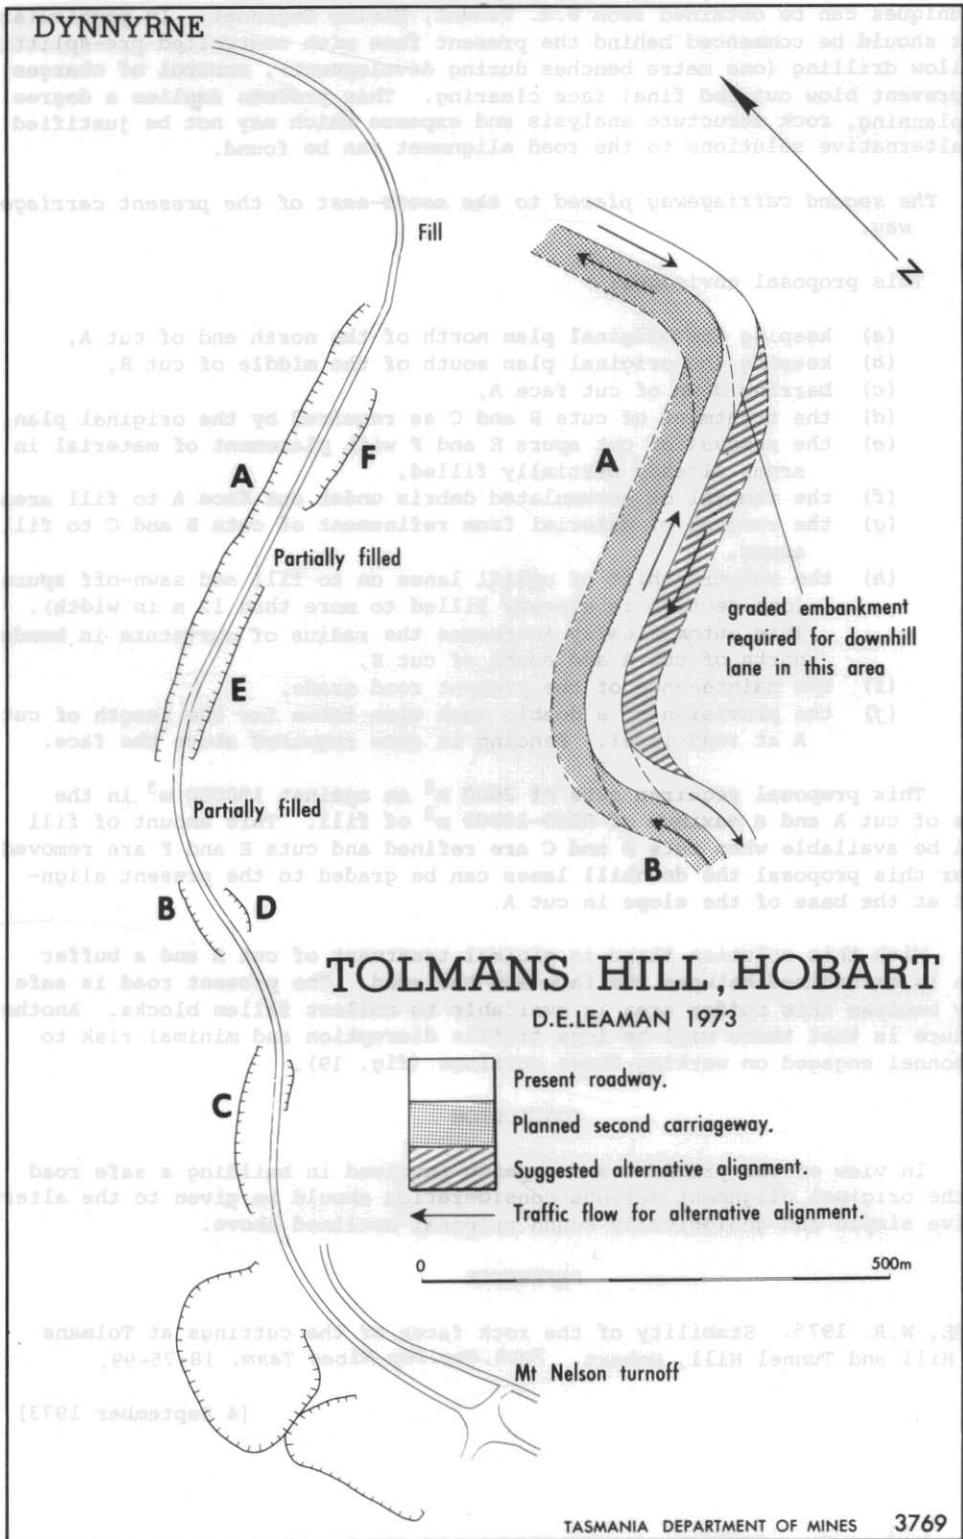
Figure 19.

The extensive cuttings along the Southern Outlet Road in the region of Tolmans Hill have been described in detail by Moore (1975) who clearly demonstrates that they are at present quite unsafe. If these cuttings are to be made safe, any remedial treatment must take account of the properties of the dolerite.

With this solution there is minimal treatment of cut A and a buffer zone is maintained between the face and the road. The present road is safe only because this buffer area is available to collect fallen blocks. Another feature is that there will be less traffic disruption and minimal risk to personnel engaged on working these cuttings (fig. 19).

- (a) keeping the original plan north of the north end of cut A,
- (b) keeping the original plan south of the middle of cut B,
- (c) barring down of cut face A,
- (d) the treatment of cuts B and C as required by the original plan,
- (e) the removal of cut spurs E and F with placement of material in areas already partially filled,
- (f) the removal of accumulated debris under cut face A to fill area,
- (g) the removal of material from refinement of cuts B and C to fill areas,
- (h) the outward shift of uphill lanes on to fill and sawn-off spurs (one section is already filled to more than 12 m in width). This automatically increases the radius of curvature in bends north of cut A and south of cut E,
- (i) the maintenance of the present road grade,
- (j) the provision of a double mesh wire fence for the length of cut A at road level. Fencing is also required above the face.

This proposal requires cuts of 2600 m<sup>3</sup> as against 150000 m<sup>3</sup> in the area of cut A and a maximum of 8000-10000 m<sup>3</sup> of fill. This amount of fill will be available when cuts B and C are refined and cuts E and F are removed. Under this proposal the downhill lanes can be graded to the present alignment at the base of the slope in cut A.

In view of the problems and expense involved in building a safe road on the original alignment serious consideration should be given to the alternative simple and geologically sound proposal outlined above.
