TR18-75-99

13. Stability of the rock faces of the cuttings at Tolmans Hill and Tunnel Hill, Hobart.

W.R. Moore

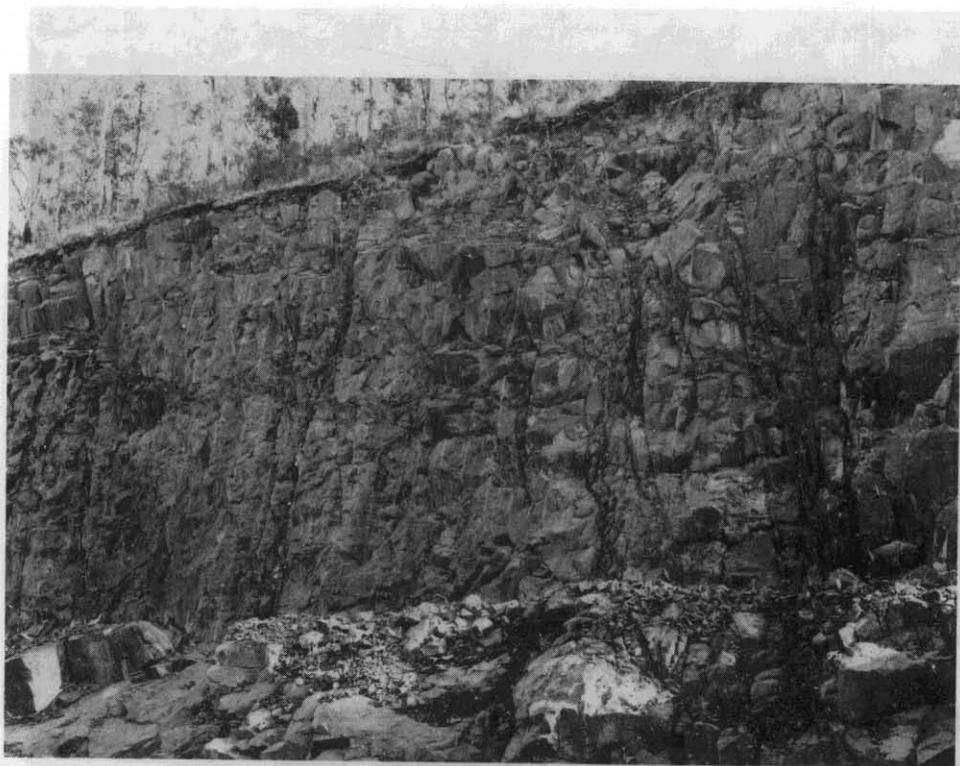
The cutting is in dolerite. In its natural state dolerite forms steep sided, often vertical outcrops. Well developed, closely spaced vertical joints, due to the cooling of this rock give rise to the columnar structure so frequently seen in Tasmania, for example the 'organ pipes' of Mount Wellington. These closely spaced, vertical to sub-vertical joints are the most conspicuous feature of the large cutting at Tolmans Hill (plate 1).

The washing out of the clay and its expansion through wetting and drying is very actively proceeding in the weathered zone and has undoubtedly caused the rock fall at the western end of the cutting (plate 12). The striking feature of this rock fall is the large amount of rock deposited on the bench floor (plate 13) compared with the small area from which the rock fall originated (plate 1).

Plate 1. *Tolmans Hill cutting. Vertical jointing in dolerite.*

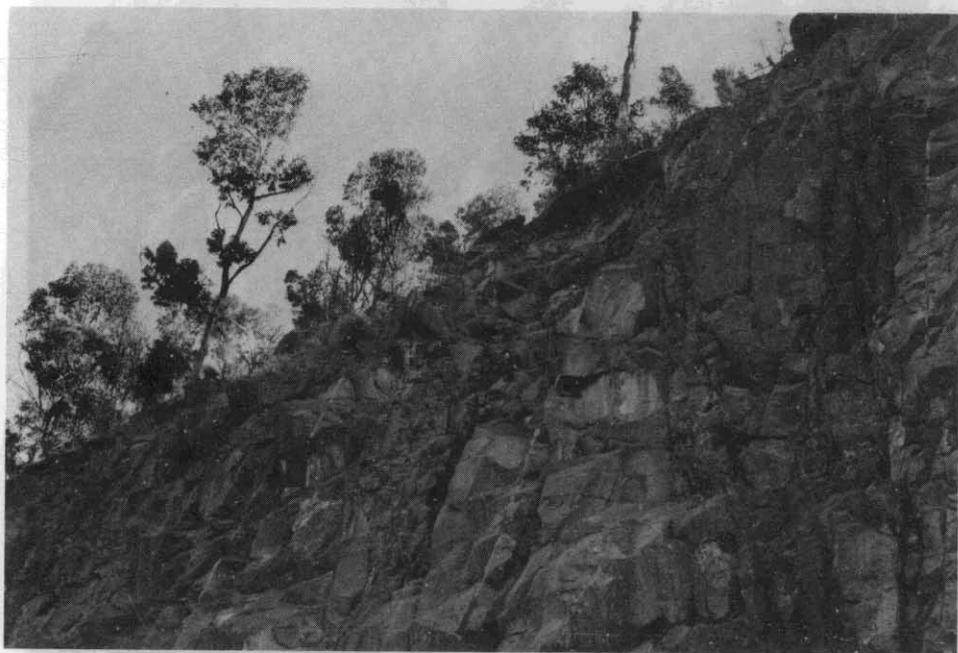
The vertical joints run in many directions but form two sets in approximately N-S and E-W directions giving rise to block-shaped outcrops (plate 3). The frequency of the occurrence of these vertical joints is variable. Along the face of cutting, areas of widely spaced joints are followed by zones of intense jointing where the joints occur very close together (plates 1, 2).

Plate 2. *Tolmans Hill cutting. Vertical joints in dolerite, with a zone of closely spaced joints. Note the slip-circle basin in the weathered zone from which a rock fall originated.*

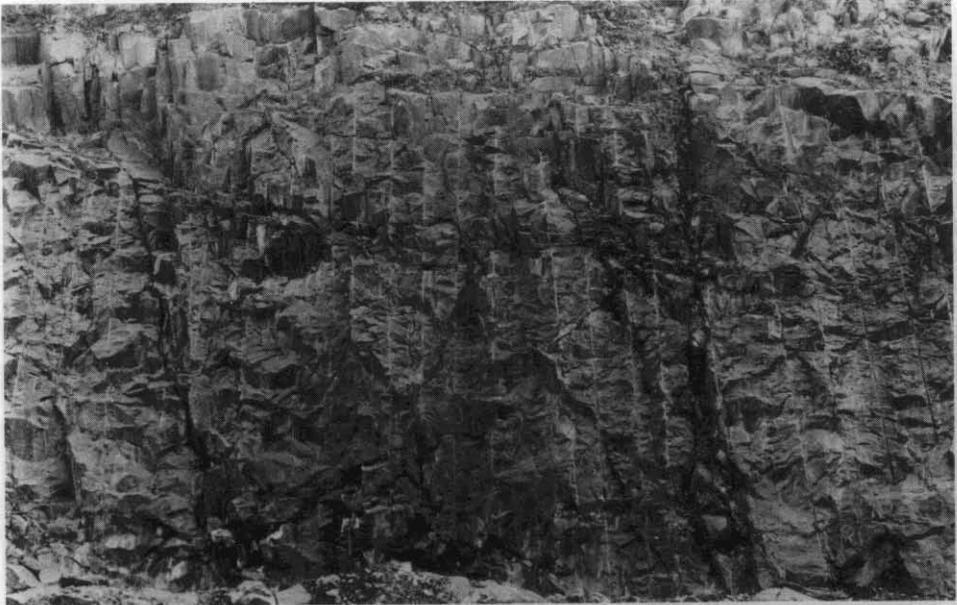
As well as these swarms of vertical joints, minor crush zones are also present along the face of the cutting. Here the rock has been pulverized. Travertine and zeolite veins and encrustations are present in these crush zones. No slickensides were found but some shear polish is evident indicating that some vertical movement had occurred in these zones (plate 3).

The opening of the joints due to load relaxation appears to be more active in the case of horizontal joints (plates 5, 6, 10), although some vertical joints are also opening because of this process (plate 3).

Plate 3. *Tolmans Hill cutting. Vertical joints in dolerite with a crush zone at right centre.*

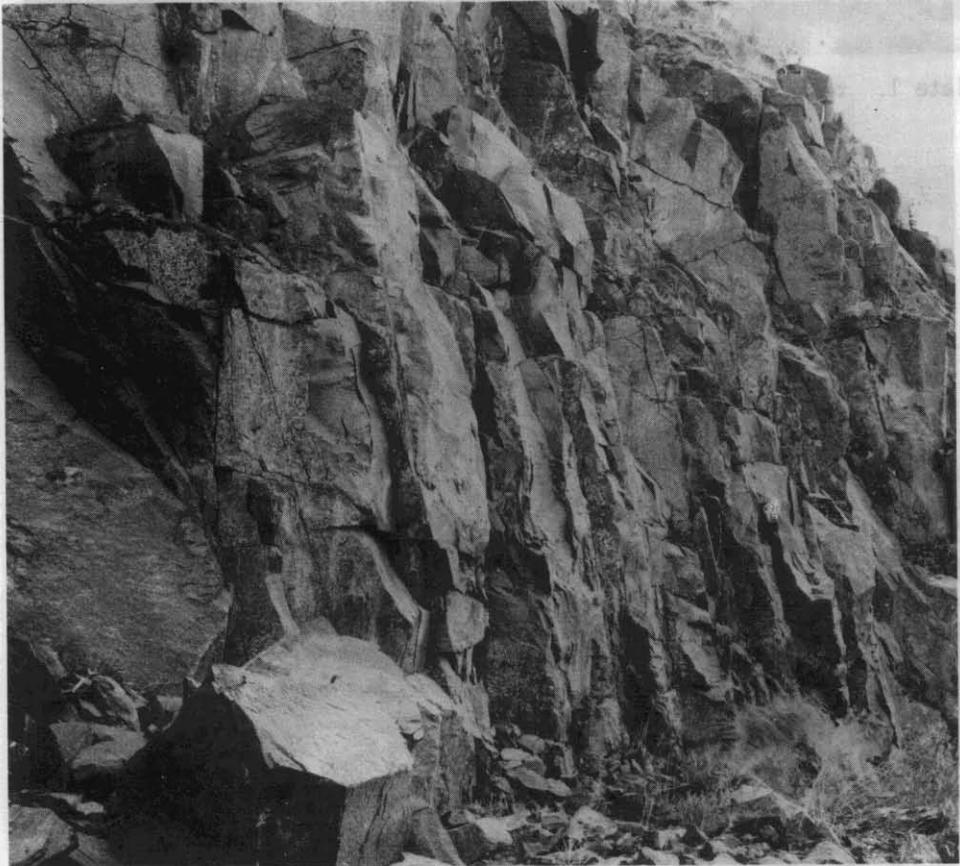
A set of horizontal to sub-horizontal joints is not as conspicuous as the vertical joints but is equally important. These joints are spaced wider apart than the vertical joints but are present on all the dolerite cuttings of Tolmans Hill and can be seen in all the photographs. These horizontal or plate joints are frequently parallel to the slope of the original hill. Particularly in the weathered zone forming the 3-4 m of the dolerite, these joints are clay filled (plates 4, 5).

Plate 4. *Tolmans Hill cutting. Sub-horizontal joints in dolerite.*

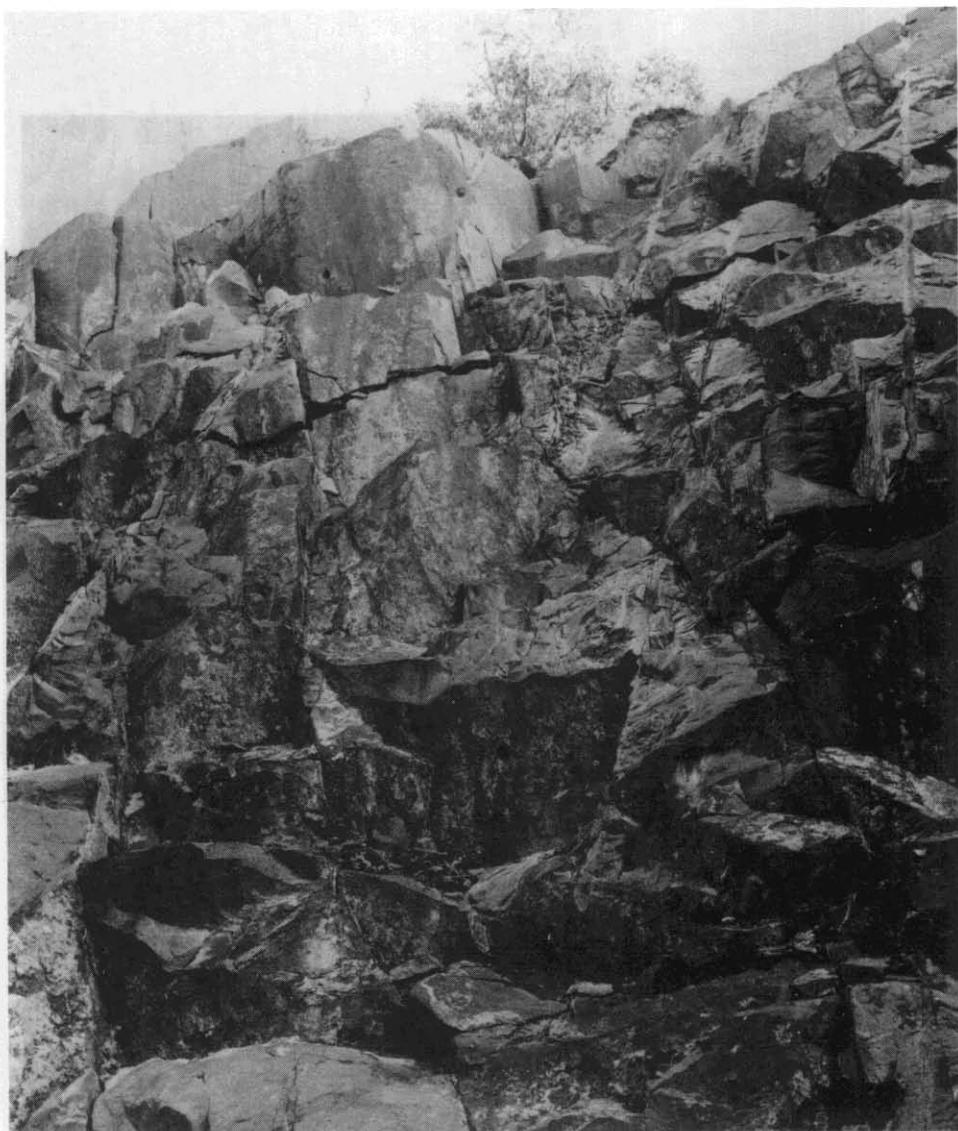
Plate 5. *Tolmans Hill cutting. Sub-horizontal joints and a clay-filled joint in the weathered zone near the top of the cutting.*

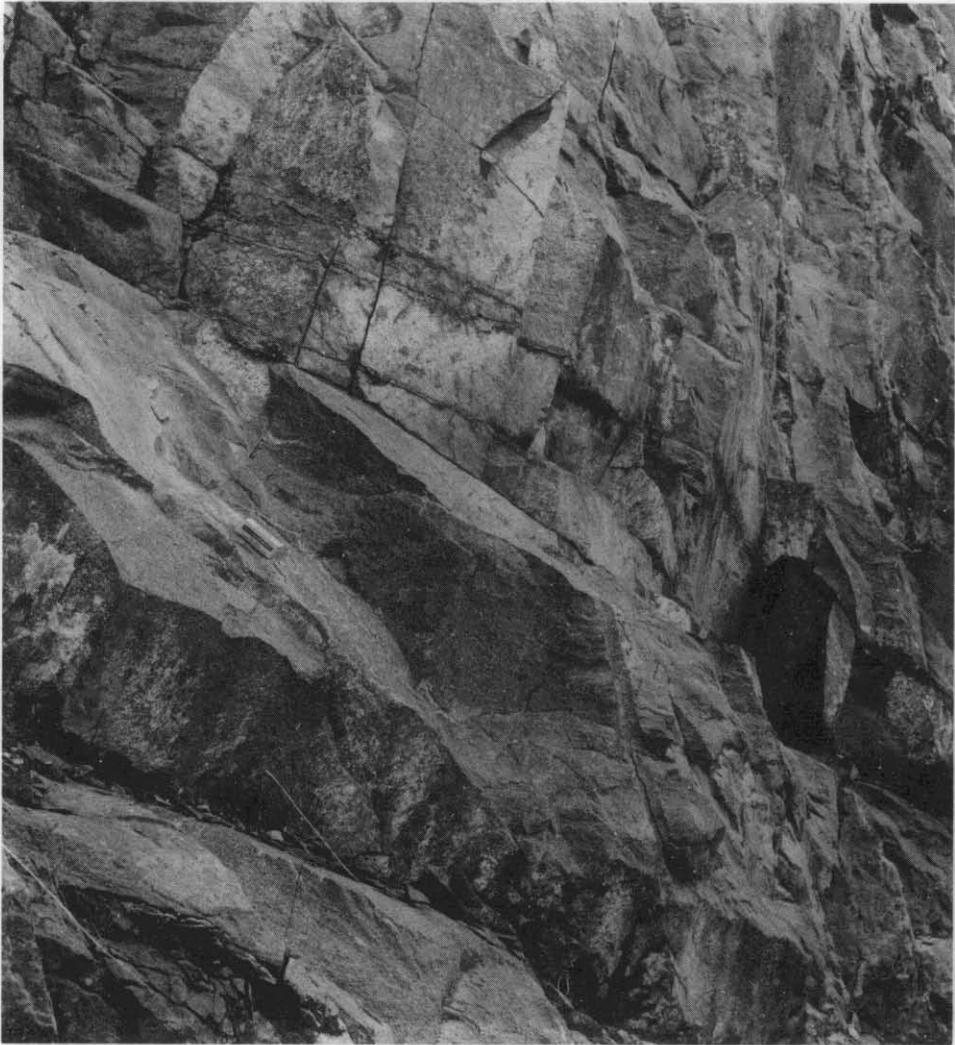
Throughout much of the cutting many of these plate joints have a component of dip away from the existing wall of the cutting towards the road (plates 6, 7).

Plate 6. *Tolmans Hill cutting. Sub-horizontal joints with dip towards the road.*

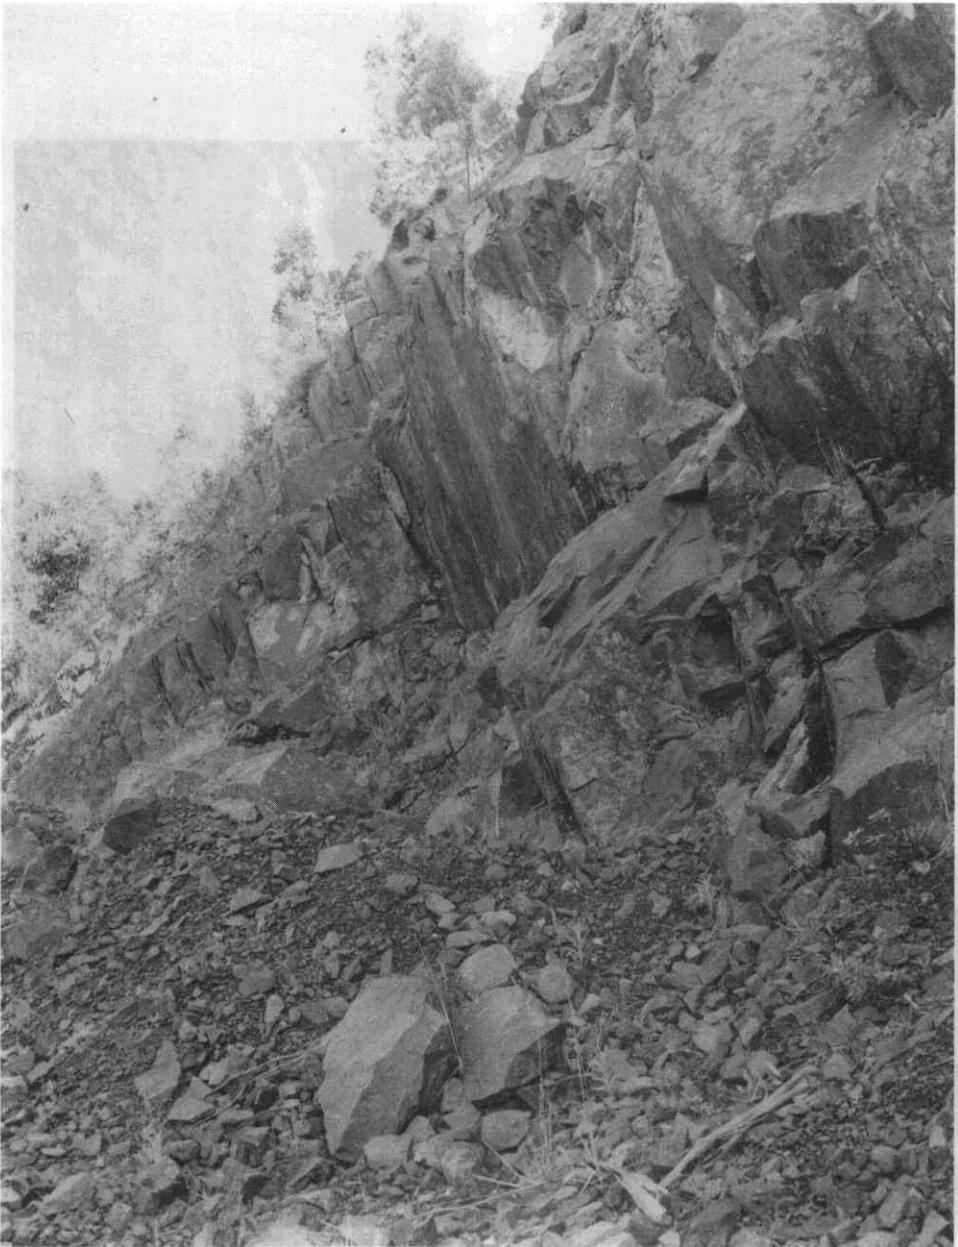
Plate 7. Tolmans Hill cutting. Sub-horizontal joints with dip towards the road.

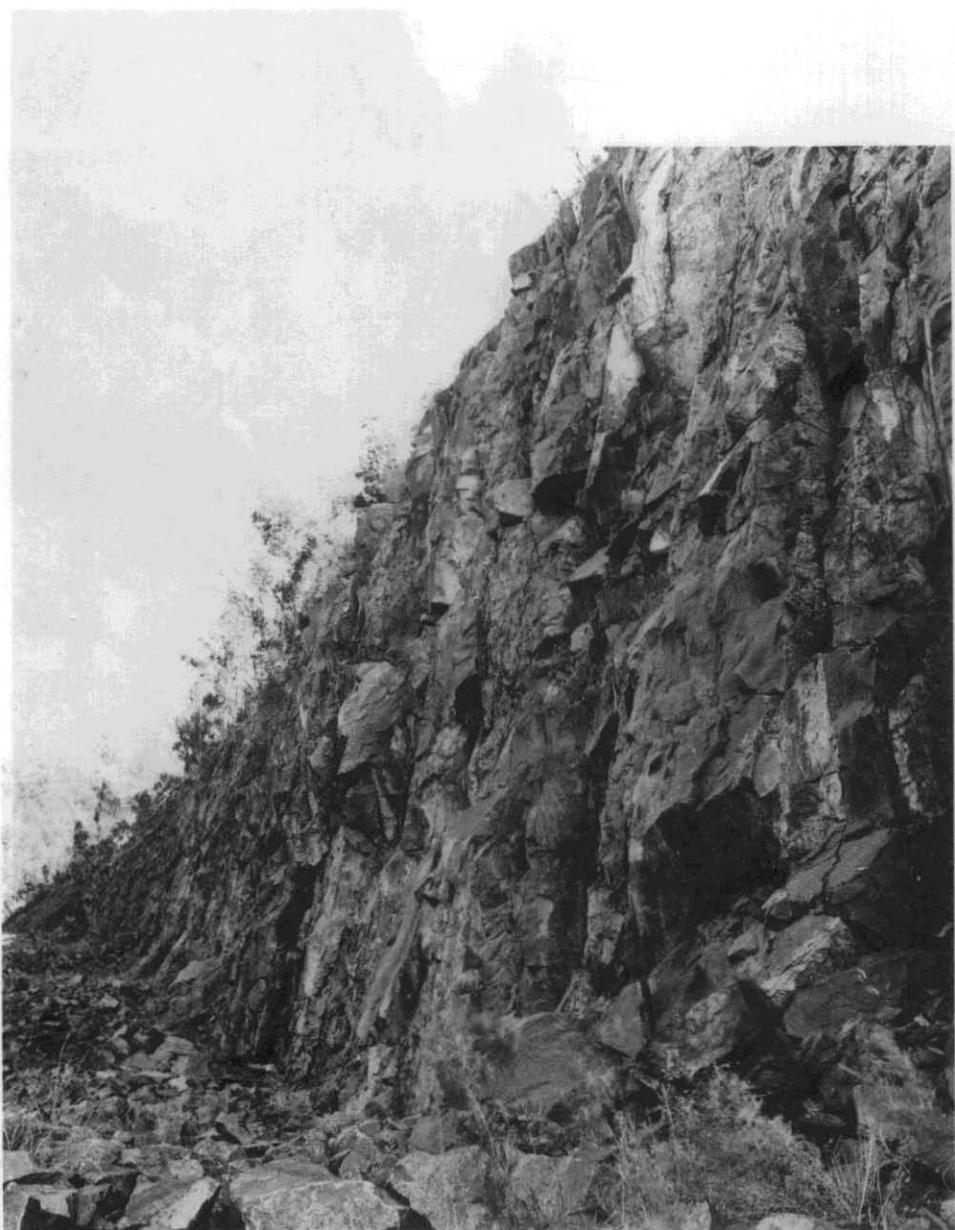
A period of severe frost has occurred since the photographs were taken and several large perched blocks marked on Plates 8-11 have already fallen. The area behind the protective wall left at the foot of the eastern end of this cutting appears to be rapidly filling due to the continuous spalling of blocks from the face.

Plate 8. *Tolmans Hill cutting. Perched blocks on the cutting face.*

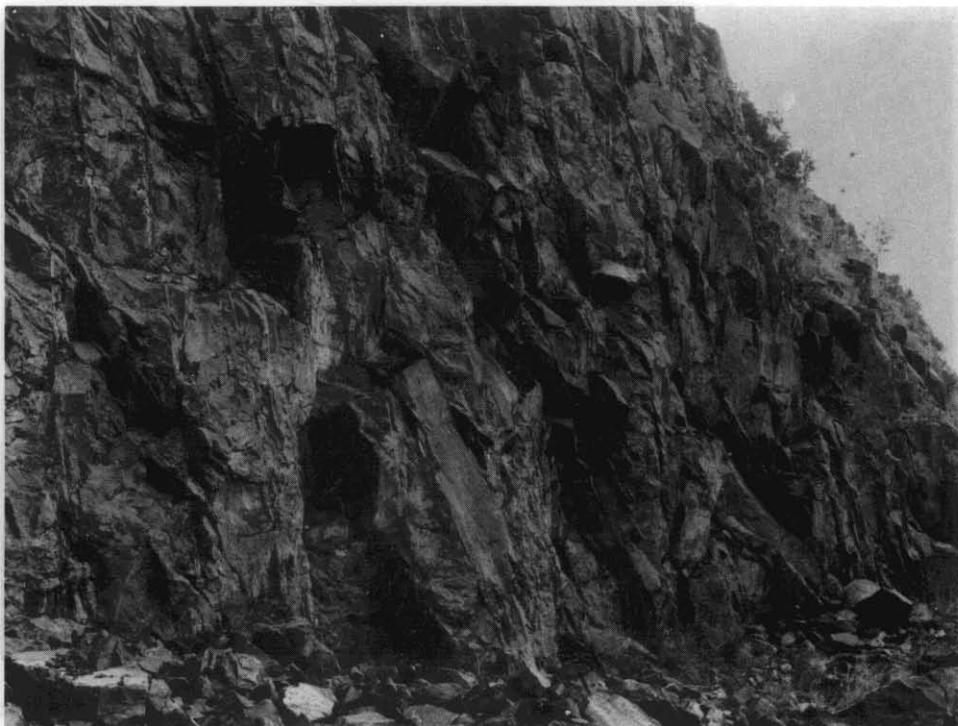
Plate 9. *Tolmans Hill cutting. Perched blocks on the cutting face.*

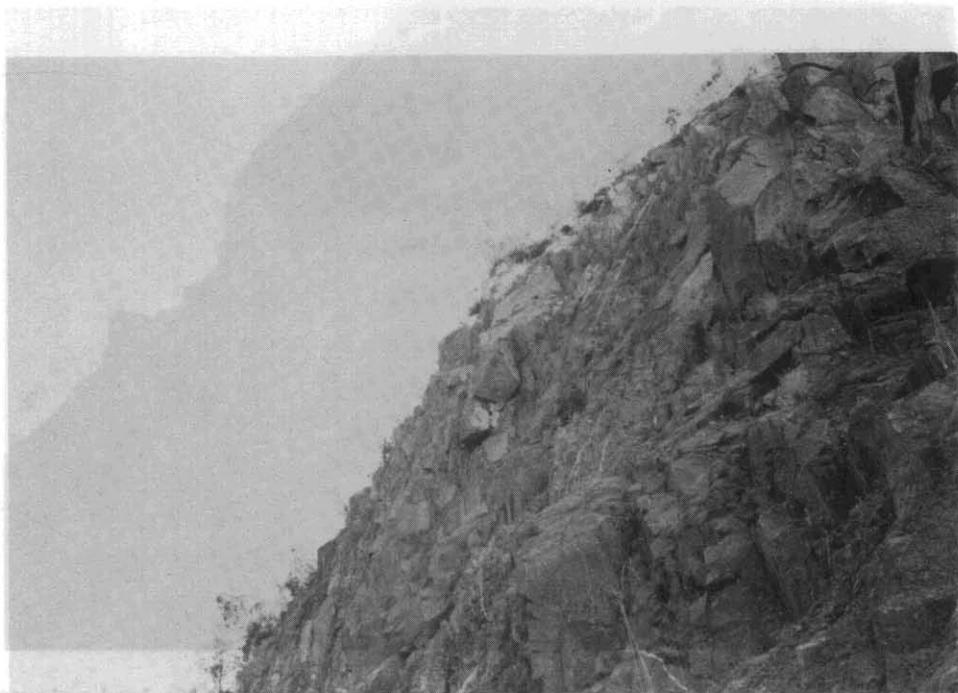
Plate 10. *Tolmans Hill cutting. Unstable perched block.*

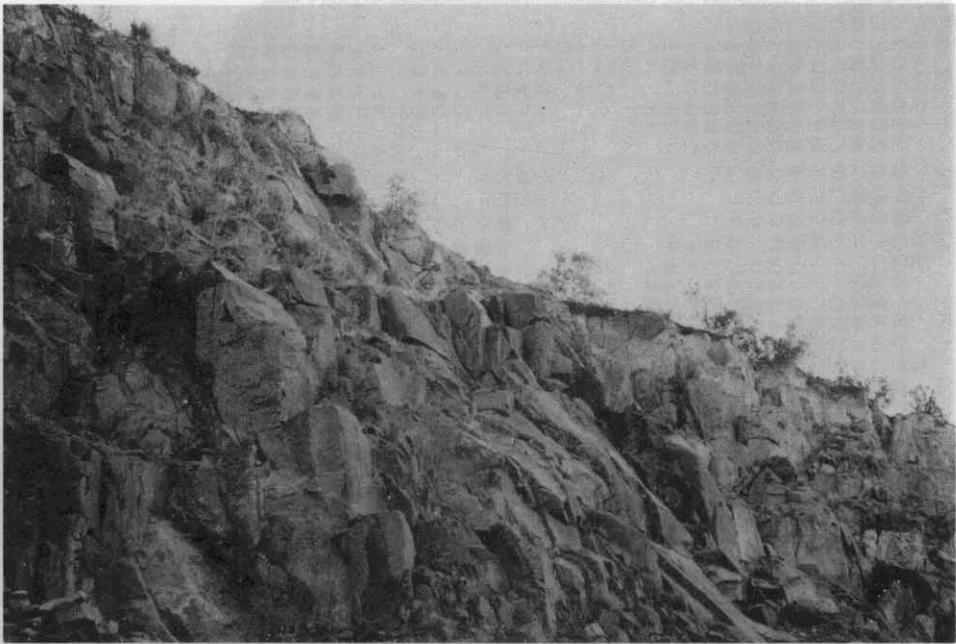
Plate 11. *Tolmans Hill cutting. Perched blocks and horizontal relaxation joints.*

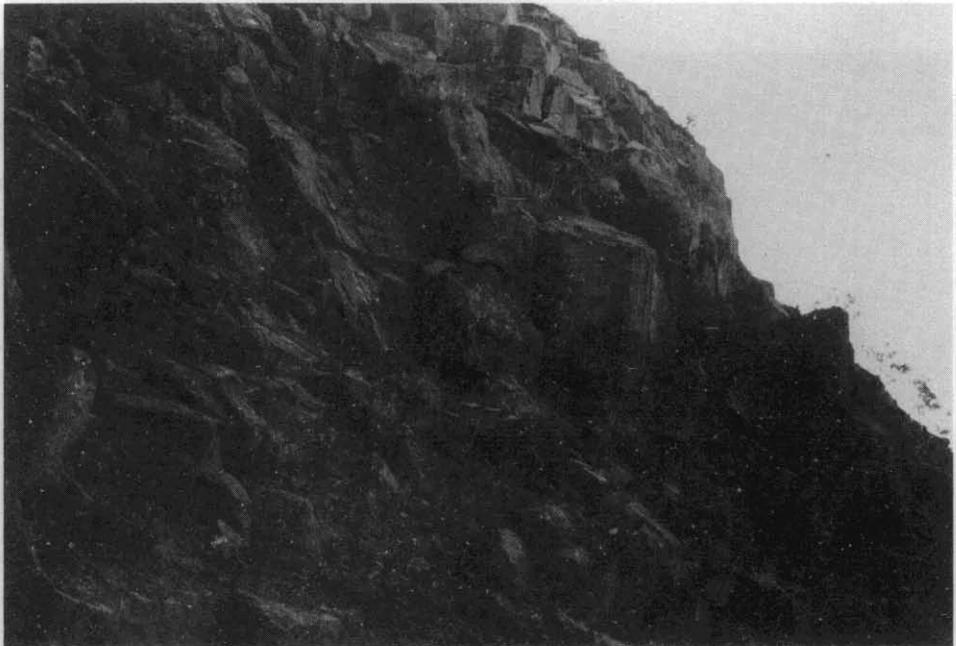
Plate 12. *Tolmans Hill cutting. Vertical joints opening by load relaxation.*

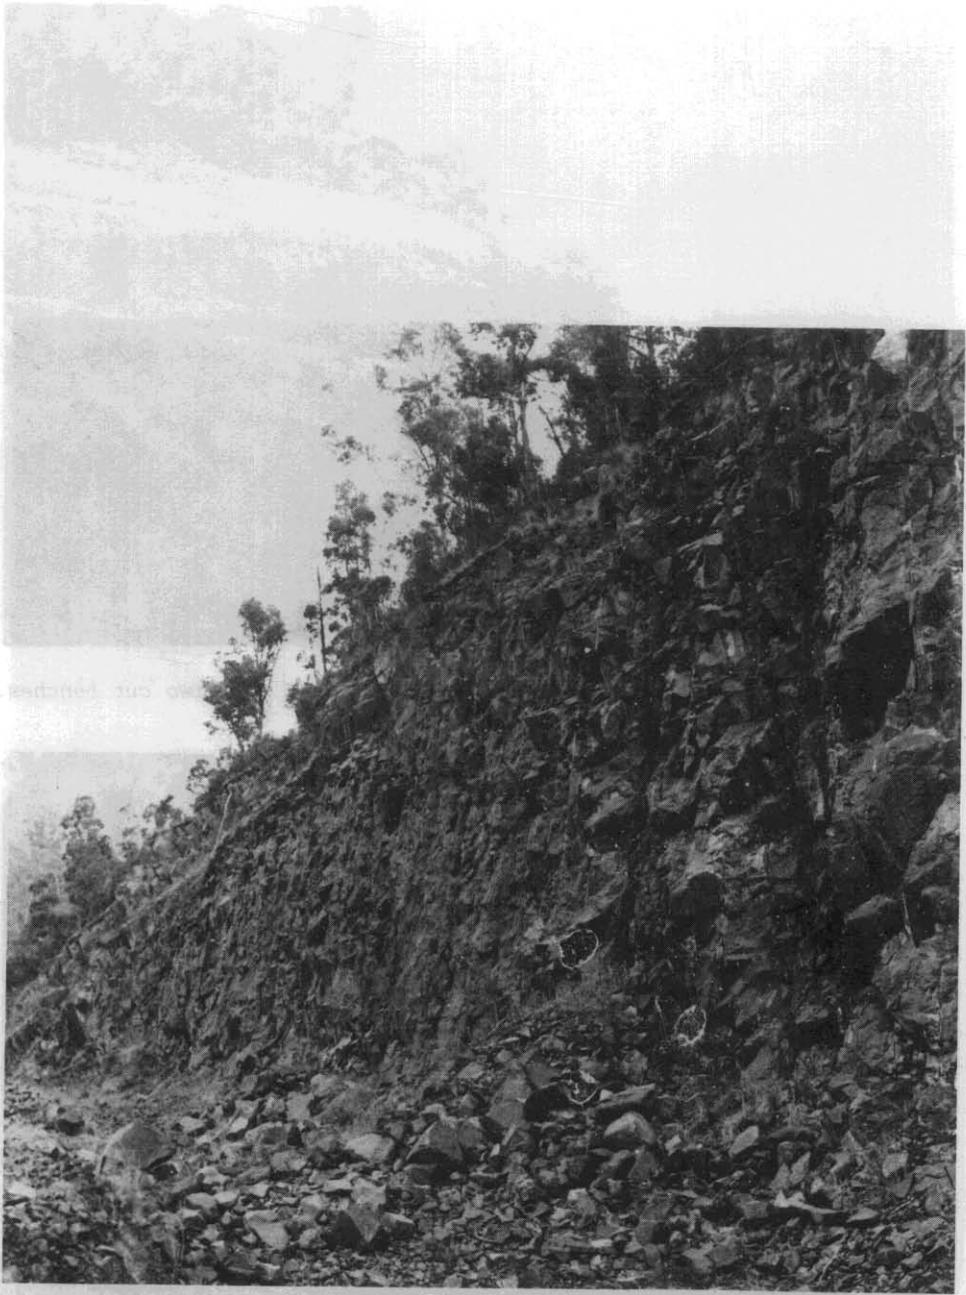
Plate 13. Tolmans Hill cutting. Debris from the rock fall on the bench.

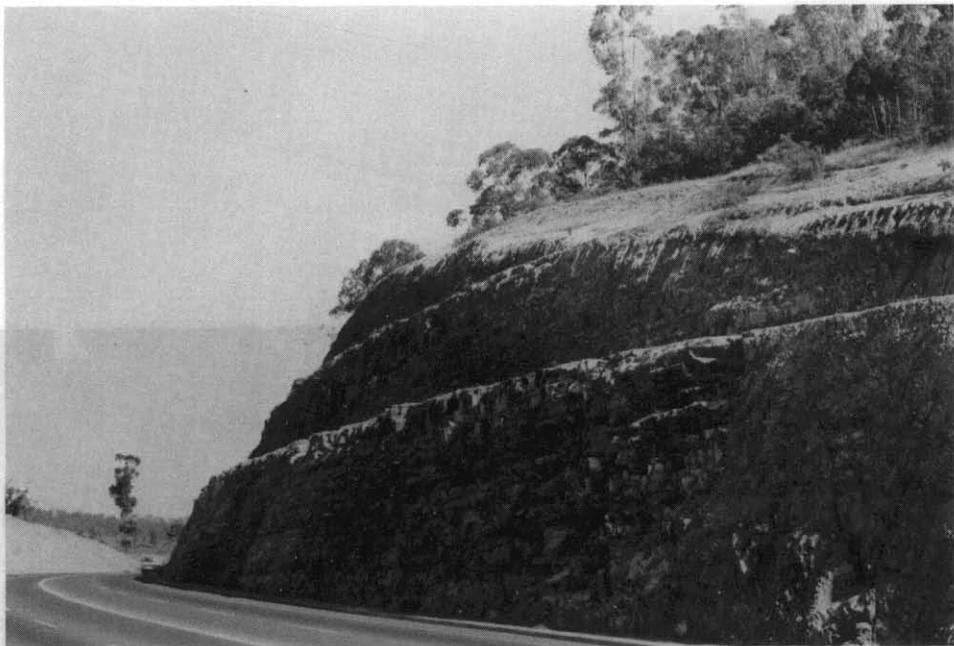
The cutting through Tunnel Hill on the Eastern Outlet Road consists of two long, high rock batters. The northern batter is wholly cut into bedded Permian siltstone, sandy siltstone and mudstone. The slope of the face ranges between 65-85°. There are two narrow benches (plate 14).

Plate 14. *Tunnel Hill cutting. North cutting wall with two cut benches. Well-bedded Permian sediments.*

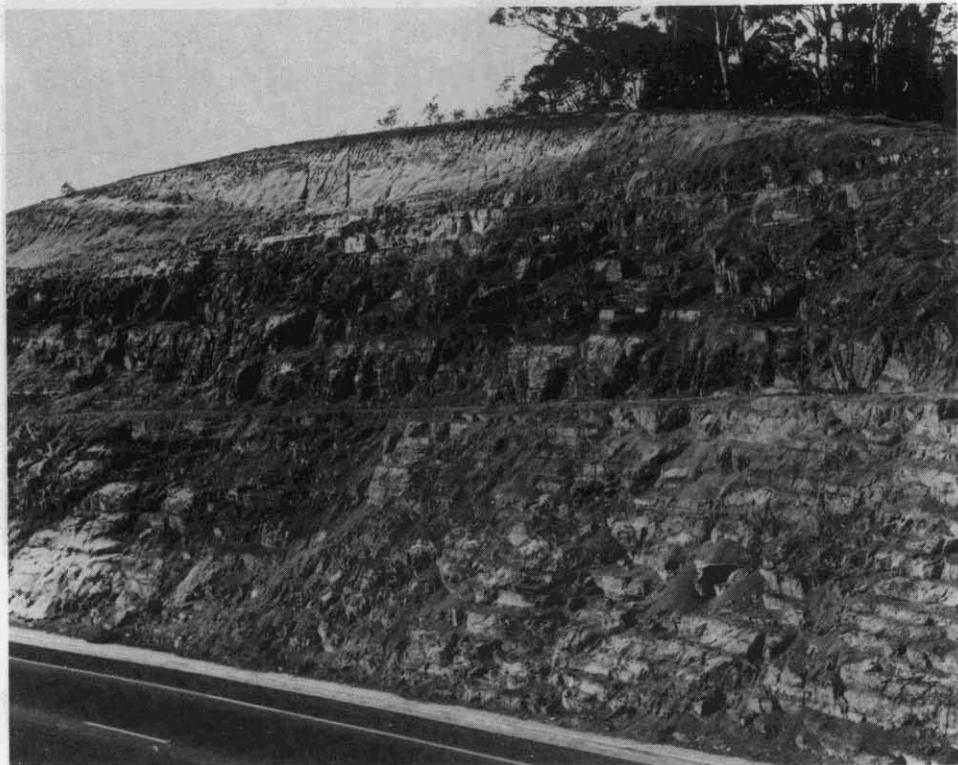
The southern batter is mainly cut in Permian mudstone and silty sandstone and siltstone; Tertiary sand caps the crest of the cutting revealing the profile of a buried Tertiary valley (plate 15). This batter contains one bench. Its overall slope is less steep than that of the northern face: for this reason and because it is facing north, this batter does not exhibit as great a deterioration as the northern batter.

Plate 15. *Tunnel Hill cutting. South cutting wall. Well-bedded Permian sediments, and a Tertiary valley near the top of the cutting.*

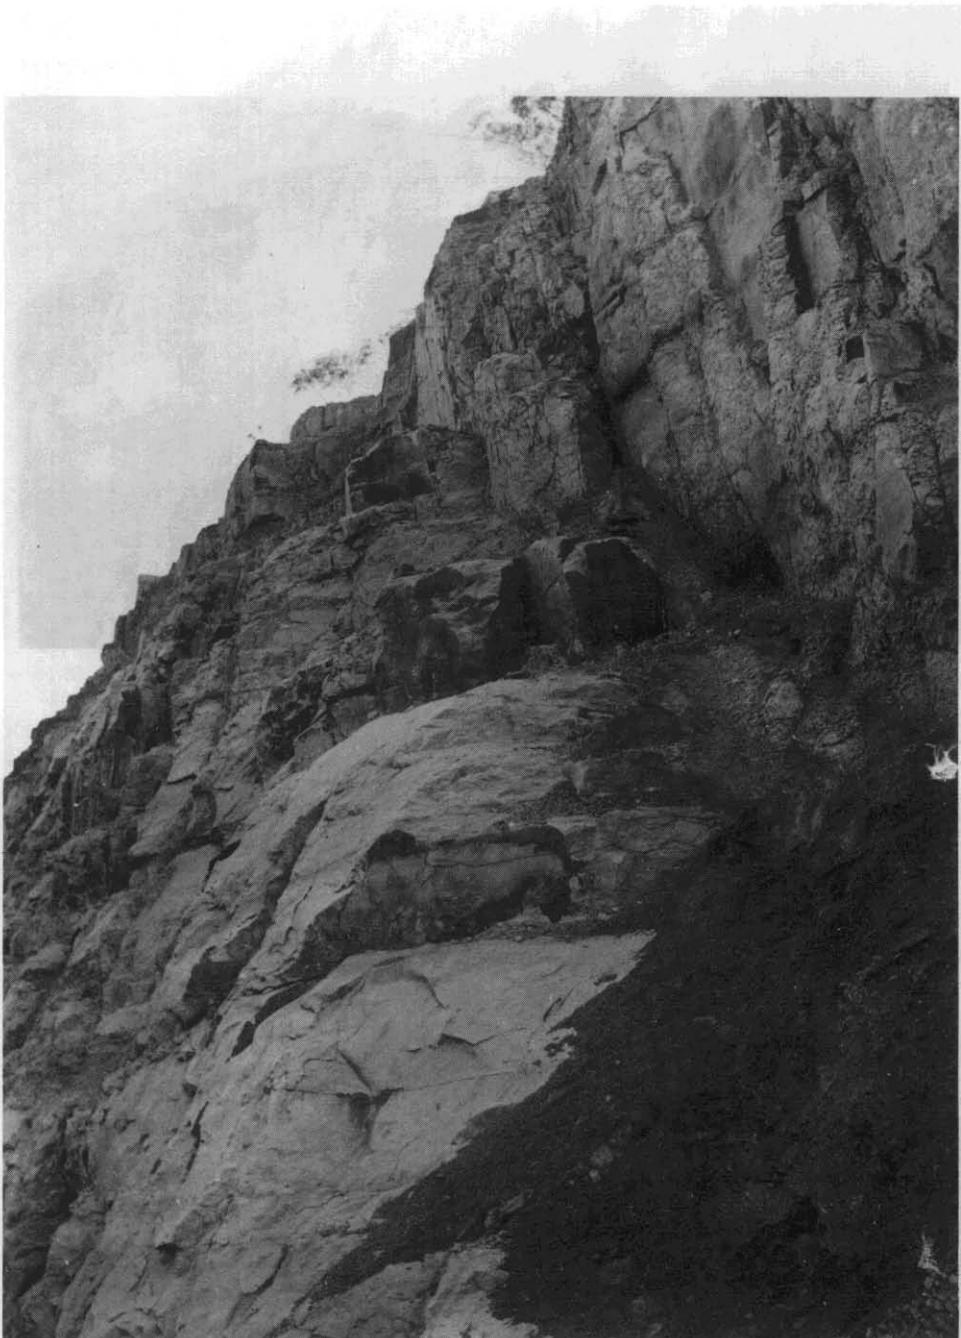
The amount of clay that can be removed from the bedding and joints within these Permian sediments is illustrated in Plate 21. The opening of the vertical joints through removal of the load is shown in Plates 22-24. The effect of freeze and thaw in the spalling of large blocks is illustrated in Plates 25-27. The speed with which this block spalling is eroding away the existing rock benches is seen in Plate 28 and 29. The perched block shown in Plate 31 has fallen since the photograph was taken and debris is present on the lower rock bench in Plate 32.

Plate 21. *Tunnel Hill cutting. Clay removed from bedding planes and joints.*

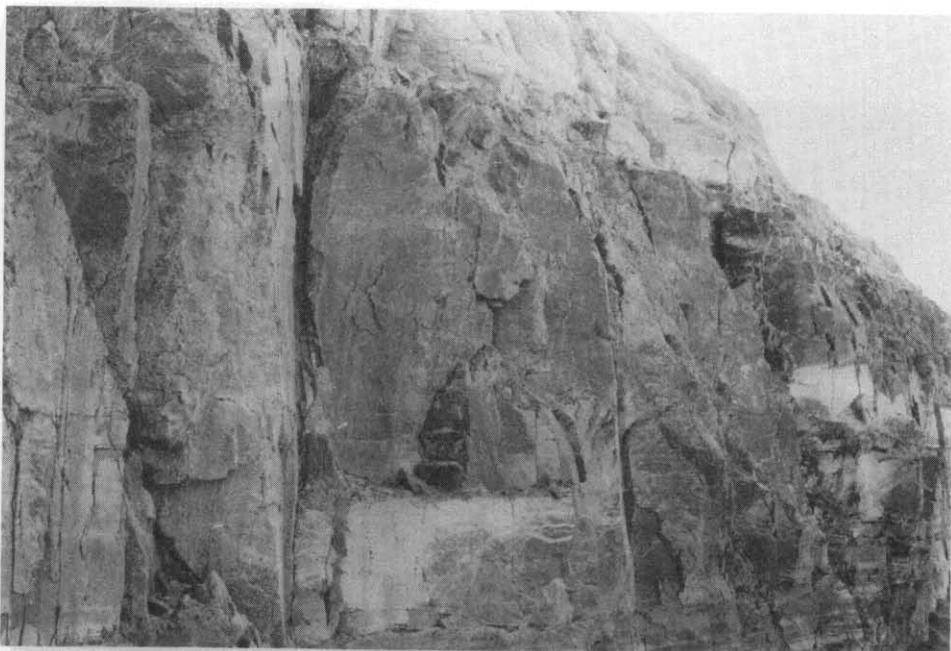
Plate 22. *Tunnel Hill cutting. Opening of vertical joints.*

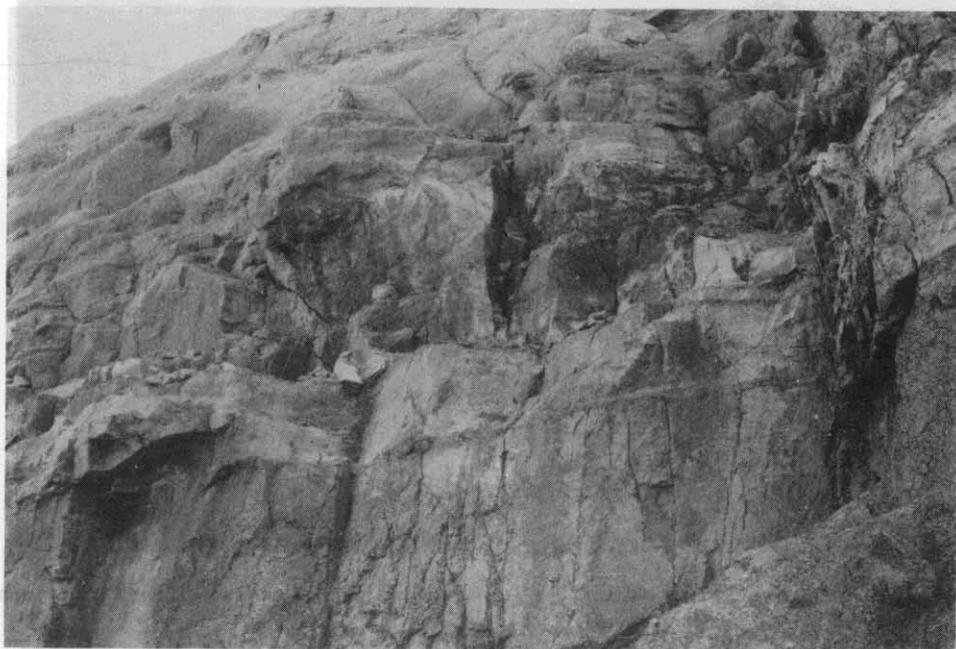
Plate 23. *Tunnel Hill cutting. Opening of vertical joints.*

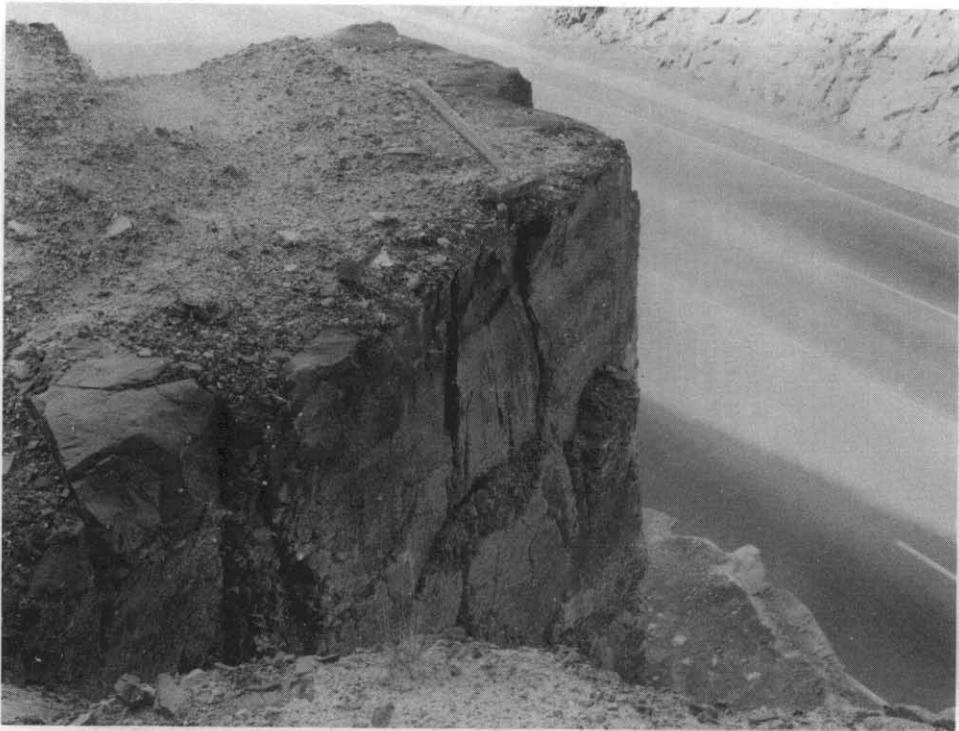
The greatest danger at Tunnel Hill cutting does not appear to be from single blocks falling as illustrated, but from a rock fall from a higher level triggering the collapse of the lower benches. The existing benches, because of the bedding, have a tilt towards the cutting face. Water and water-saturated clay collect in this area and remain for long periods (plates 24, 28).

Some of this water must seep down the joints (plate 24) below the bench. Through the wetting and drying of the clay in these joints and the freezing and thawing of the water, the rocks forming the bench become potentially

Plate 24. *Tunnel Hill cutting. Vertical joints opening due to load relaxation.*

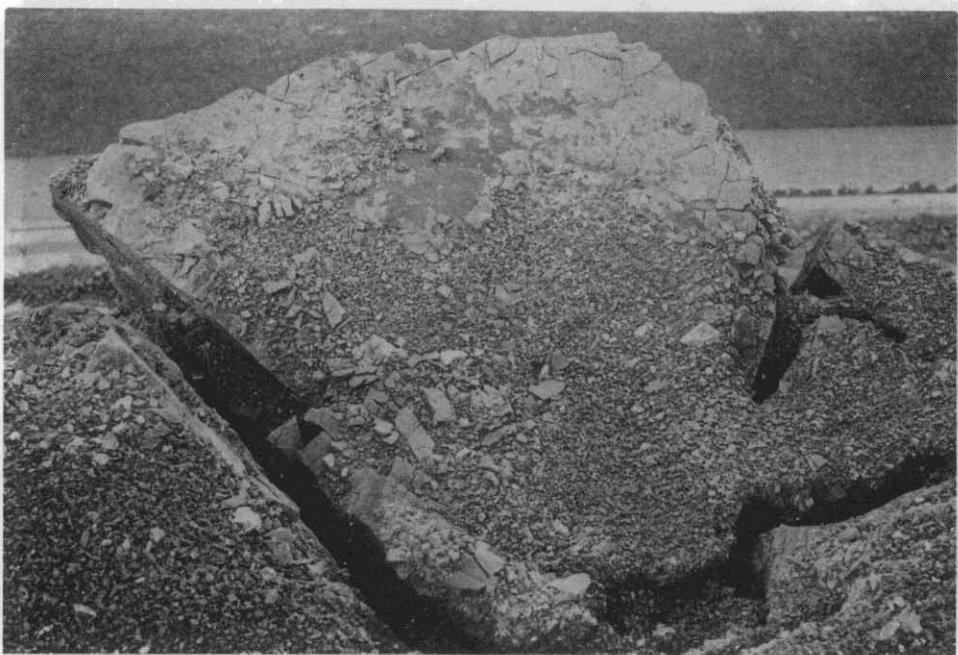
Plate 25. *Tunnel Hill cutting. Movement of blocks due to freeze and thaw.*

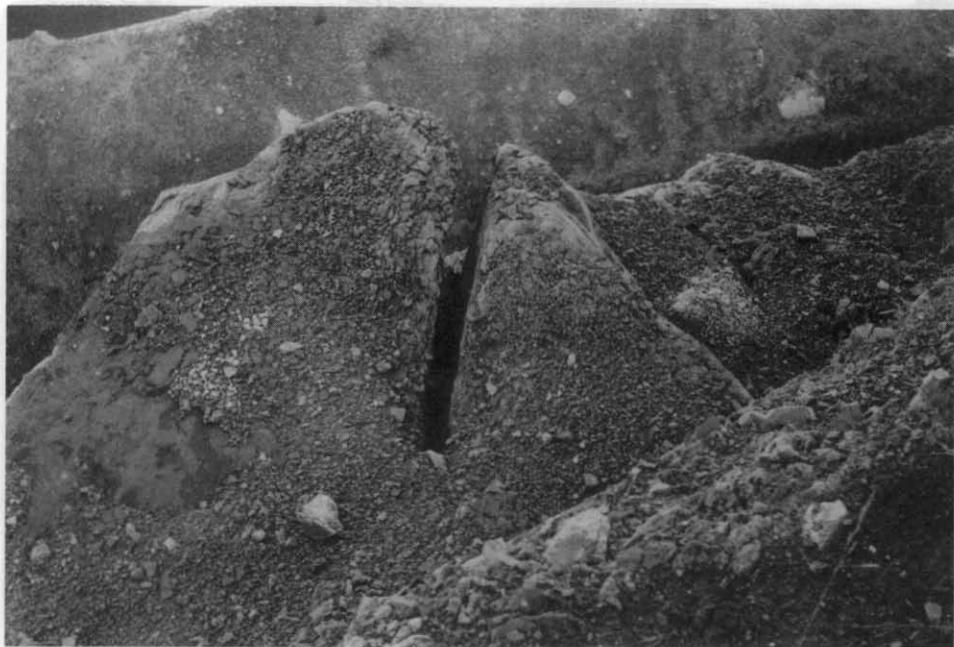
Plate 26. Tunnel Hill cutting. Cracks opening along vertical joints.

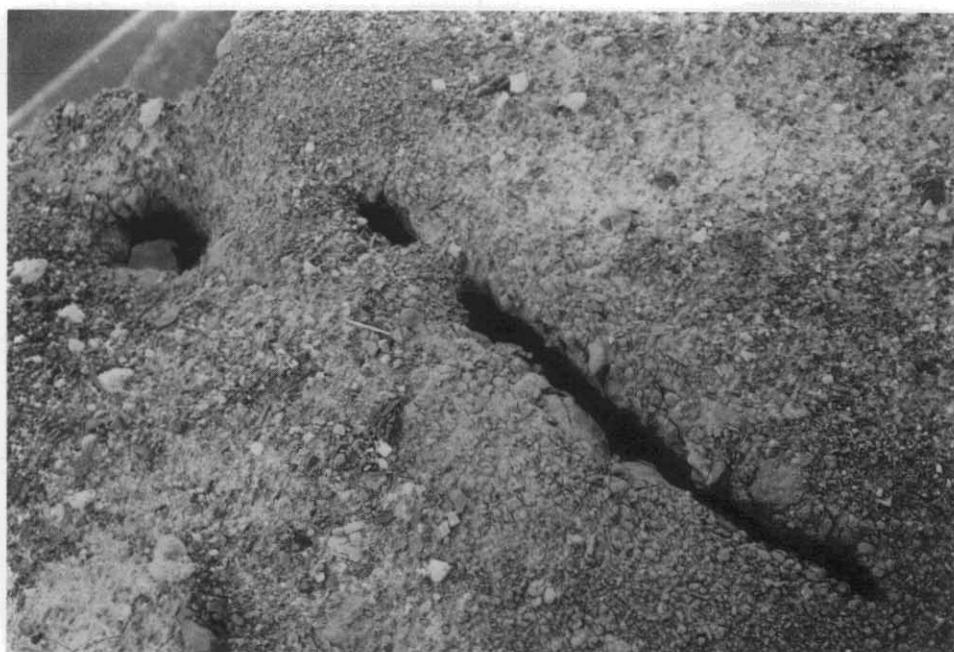
Plate 27. Tunnel Hill cutting. Freeze and thaw and washing out of clay
along vertical joints. Note old drill hole.

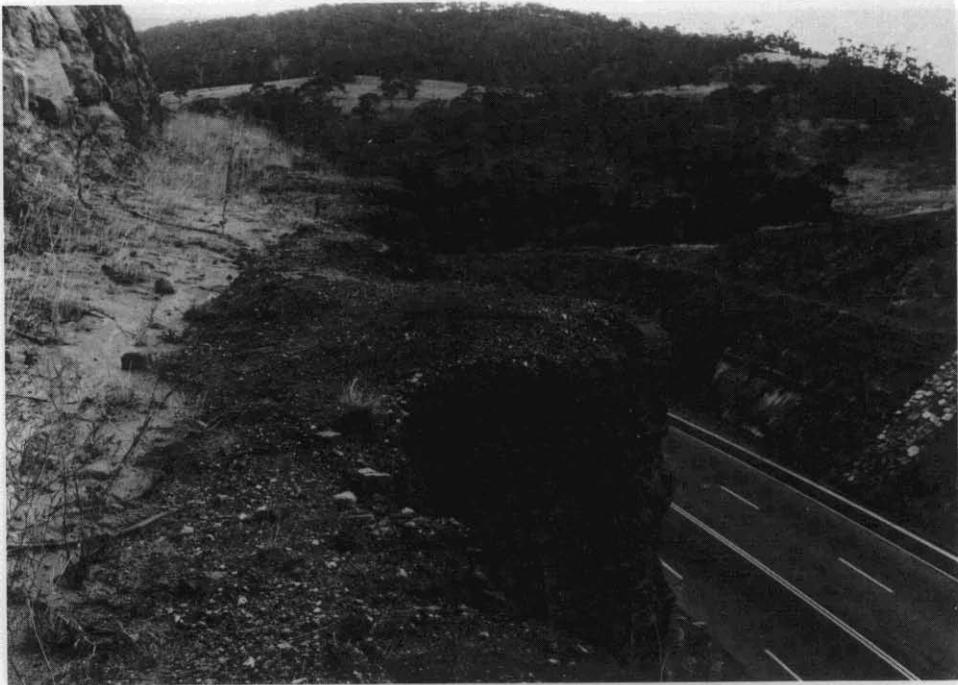
Plate 28. *Tunnel Hill cutting. Eroding away of existing rock bench. Water and clay lying at the foot of the bench face.*

- (1) The existing loose blocks should be barred down.
- (2) The cutting should be patrolled regularly at roadway level, and on the benches.
- (3) The existing benches should be drained so that water will not collect on their surfaces, these drains should run parallel to the face and be capable of transporting much of the fine clay as well as the water.
- (4) To make this southern batter absolutely safe further terracing will be required. The existing benches are too few and too narrow.

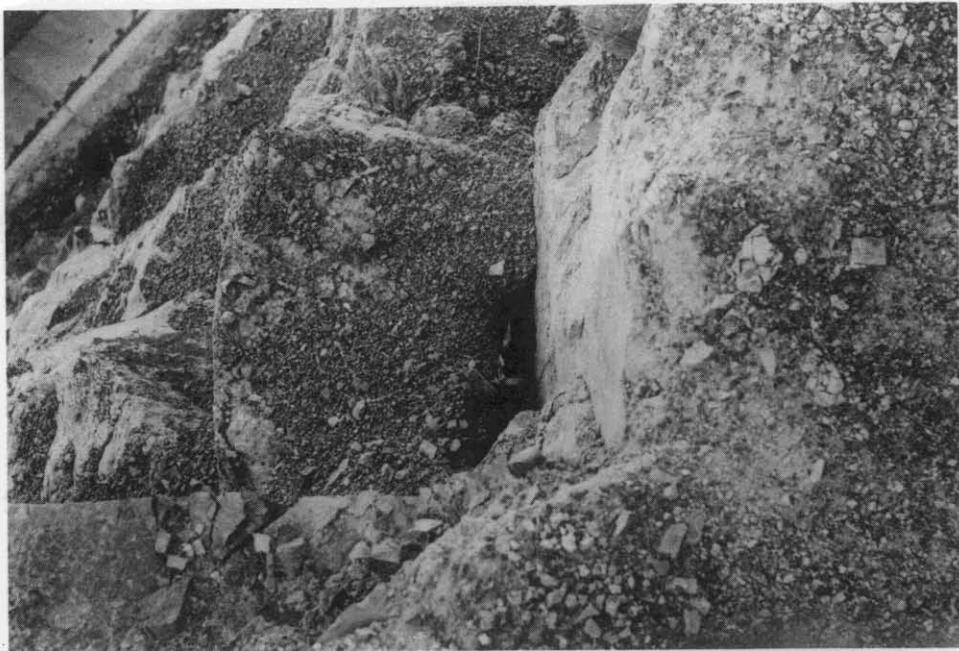
unstable (plates 29, 30). Rocks falling from a higher level on to this bench may trigger off larger falls from the lower benches.

Plate 29. *Tunnel Hill cutting. Part of bench which has dropped along vertical joints.*

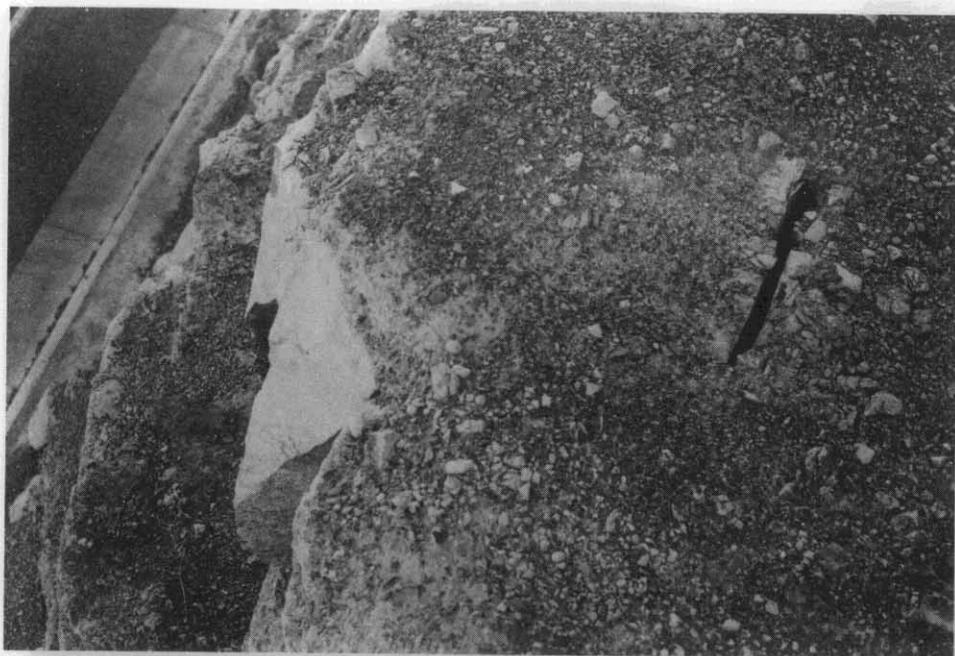
Plate 30. *Tunnel Hill cutting. Crack opening along vertical joints on the bench.*

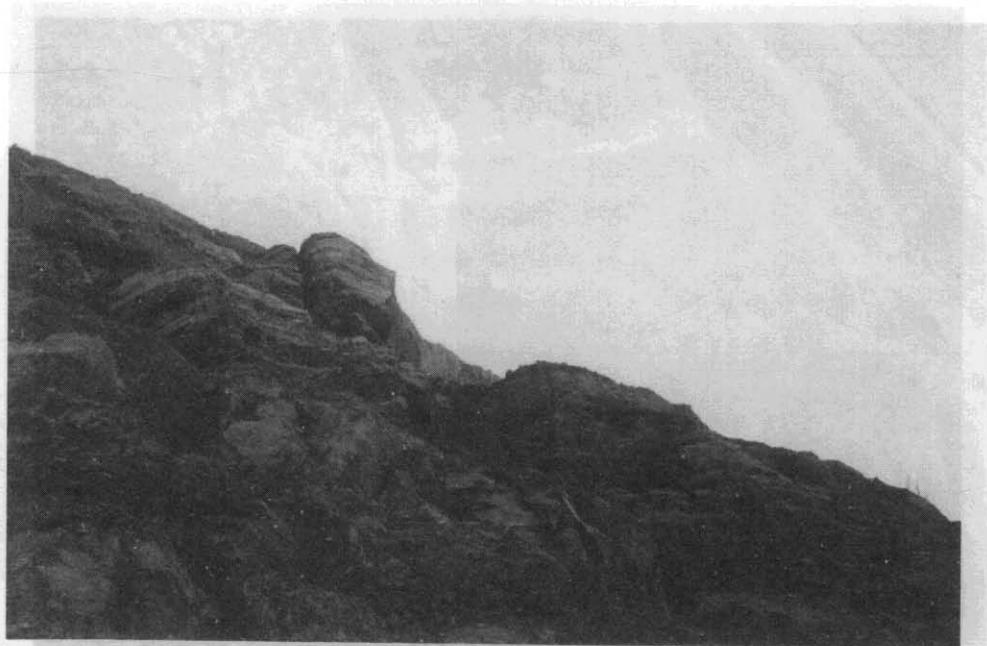
Plate 31. *Tunnel Hill cutting. Perched block on the upper bench face.*
