TR18-75-99

13. Stability of the rock faces of the cuttings at Tolmans Hill and Tunnel Hill, Hobart.

W.R. Moore

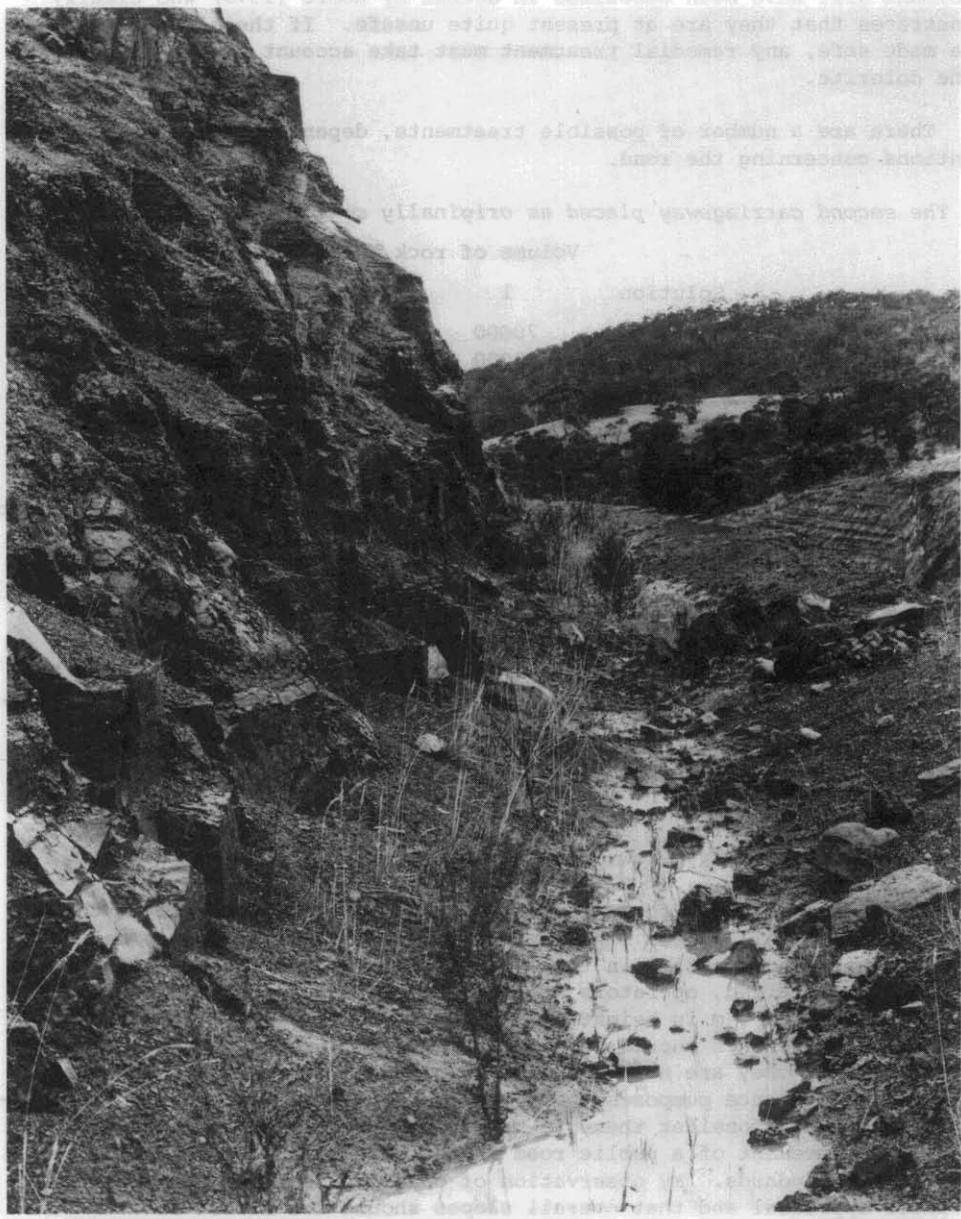
The amount of clay that can be removed from the bedding and joints within these Permian sediments is illustrated in Plate 21. The opening of the vertical joints through removal of the load is shown in Plates 22-24. The effect of freeze and thaw in the spalling of large blocks is illustrated in Plates 25-27. The speed with which this block spalling is eroding away the existing rock benches is seen in Plate 28 and 29. The perched block shown in Plate 31 has fallen since the photograph was taken and debris is present on the lower rock bench in Plate 32.

Plate 32. Tunnel Hill cutting. Perched block now fallen onto the lower bench: note water lying on bench.
