### LANDSLIDES IN THE PALOONA DISTRICT

By KERRY BURNS

During June, 1956, in a period of heavy rain, the pipe-line carrying the Devonport water supply was broken by a landslide which carried the pipe some distance down the hill.

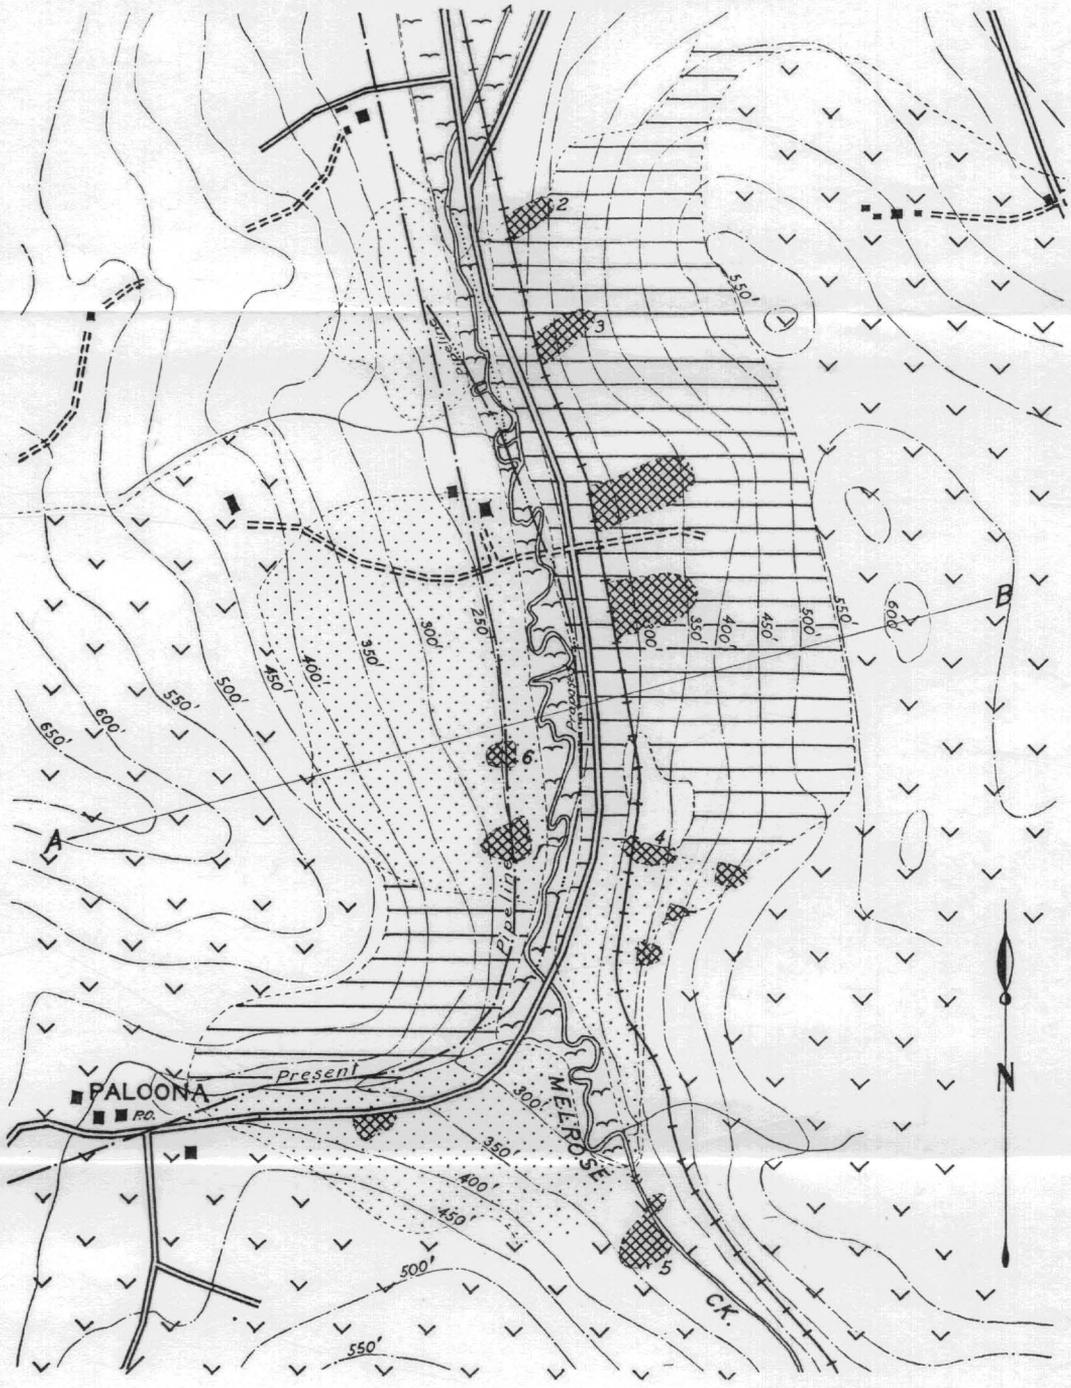
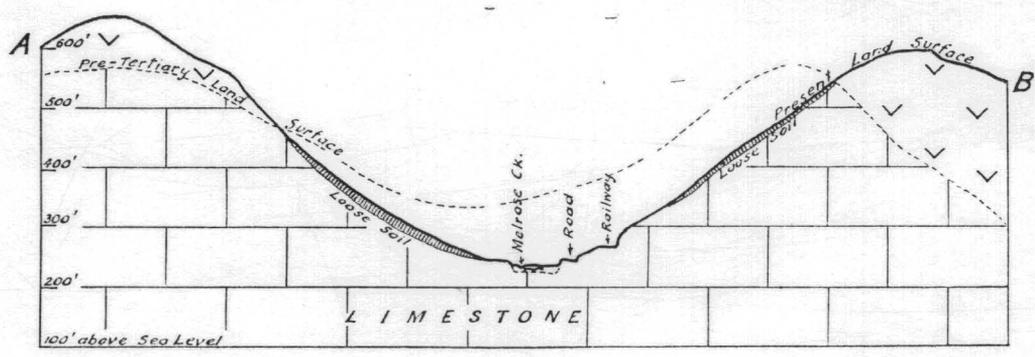
# LANDSLIDES IN THE PALOONA DISTRICT

On the accompanying map, all recent landslides in the valley are shown. Except for No. 5, all have occurred over a limestone bedrock.

Slip No. 2 was initiated when the railway line was cut, as elbow bends at the base of the trees indicate movement at that time. The renewed movement this year was a combination of the types known as earthflow and debris avalanche, with a slumped arcuate head, and a bulging over-folded toe which has spilled out across the old railway track. The sides of the flow show evidence of marked transcurrent shearing, with slickensides well developed in the clays.

Slip No. 3 was also initiated by the railway cutting, and a stone embankment was built in order to stabilise the slope. However, pronounced bowing outwards of this wall indicates that movement has occurred since. The old pipe-line crosses one edge of this slip, and a resident told me that trouble was experienced with breaks in the old pipe-line due to this slip.

Slip No. 4 is a small one that moved this year, carrying the wire fence several feet downslope.

Slip No. 5 is a large earthflow moving on a very shallow slope. Examination shows that previous movement has occurred (at least several years previously) and the movement this year was renewed movement of the frontal portion of the old flow. A very large, soggy, water-laden, swelled toe has developed near the creek, resembling a solifluction lobe.

Slip No. 6 is a small earthflow that moved some years ago, breaking the pipe-line.

This slip had been extensively cut up at the time of the field work, so it was not possible to determine what type of movement had occurred, nor even its boundaries. However, I was informed that the toe developed overhanging the creek, which puts the pipe-line position at the middle or heel of the slip. Presumably it was the same type as the others investigated, namely an earth-flow, moving on a shallow slip surface.

The sole of the slip was in brown, laminated clays, and in the bottom trench white bands dipping down-hill were clearly visible. All of those bands carried slickensides indicating the top-side moved down-hill over the bottom, so almost certainly these are the slip surfaces upon which the surface material moved.

The pipe-line will only be safe from slippage when it is relocated outside the area altogether.

Since considerations of hydraulic grade make it necessary to pass through the valley, it is desirable that the new route pass down the middle of Melrose Creek (on the belt marked as alluvium on the map), i.e., avoiding the sides of the valley.

In cross-section the river flat has steep banks overhanging it, and in all cases this is material that has migrated down-slope for distances up to 450 yards. All this material has moved to reach its present position, and as events this year have proved, needs little encouragement to move again. It is advised, therefore, that the steep banks overhanging the river flats be avoided. This particularly applies to a steep bank overhanging the western side of the creek at the northern end where the proposed new pipe-line joins the present 18-inch main.

Further south, the proposed new line is to be cut into the eastern bank of the creek, next to the road. This location (while not ideal) should be satisfactory provided the pipe-line is deeply buried, to about creek level. This should carry it beneath any potential slips.
