TRI-41-49

RESERVOIR SITES NEAR KELCIE'S TIER

By KERRY BURNS

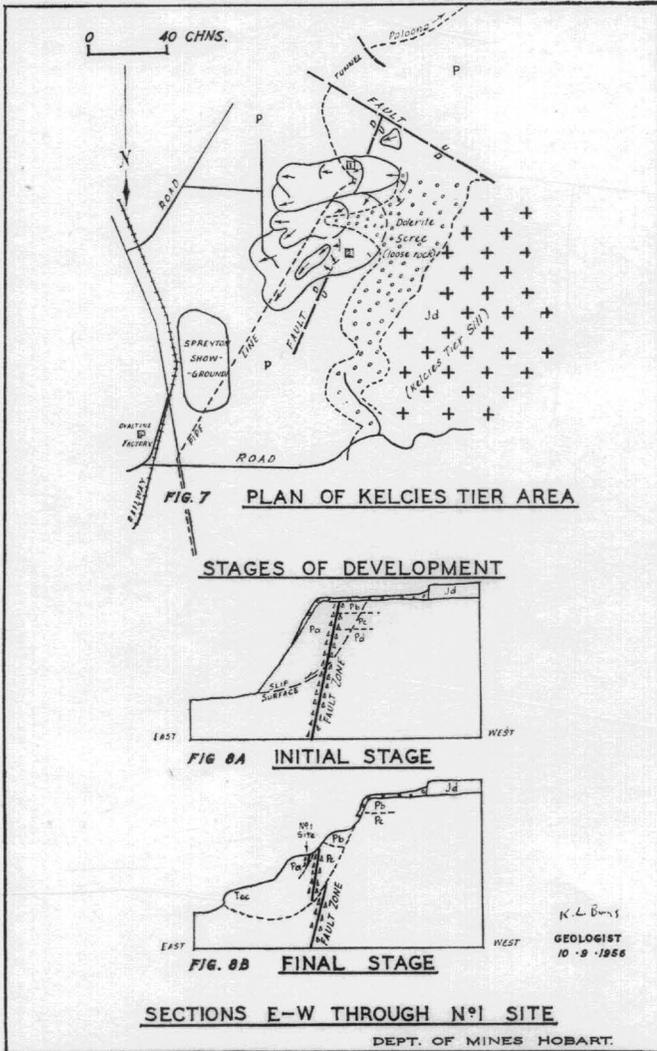
PLATE 12

Combining observations from the two reservoir sites, the slips have developed as outlined in Fig 7 (section).

The initial slope was a fairly steep one, and from the occurrence of fault breccia, the fault lay some distance back from the edge. The dolerite scarplet lay west of the edge of the slope (Fig. 8a), just as it does today. The claystone or shale underlying the dolerite has very low strength, so that extensive scree overlay the top bench, migrating on a slope of only a few degrees, as it still does today.

As the hill-slope retreated west, the amount of lateral support on the column of rock bounded by the hill-slope on the east, and fault zone on the west, was progressively reduced, so that the slope became unstable. It failed initially by deep deformational shear (Schulz and Cleaves, p. 291).

The initial failure was as a pair of slides, the northern one probably first. Both slides were probably slope failures (Terzaghi and Peck, p. 182), but in the northern one the surface of sliding may have intercepted the slope some distance above the foot of the slope.

This initial failure created the No. 2 site. The second stage (Fig. 8b) concerned the fault zone. Renewed movement occurred, with the heads of the new set of slips coincident with the fault plane, which would be weak in tension. The shear surface thus developed can be differentiated at No. 2 site from tectonic slickensides by the fact that the slide shears are developed in very weathered material (after weathering), whereas tectonic slickensides are destroyed when that stage of weathering is reached.

The alignment of the heads of this second set is responsible for the topographic linear interpreted by Hughes as a fault. The interpretation is correct, but the linear is a secondary feature, as described. When the second movements took place, breccia in the fault plane was unsupported, and tumbled down on to the surface of the slips. This is the situation at No. 1 site.

The surface material at No. 2 site is a mixture of dolerite and Permian boulders. The original scree (dolerite) is overlain by new dolerite which has travelled down the slope from above, admixed with Permian from the exposed back slope. This is illustrated in Figs. 5 and 6. Since the original slide, the dolerite scree originating from the top bench has established a talus slope onto the second bench (containing No. 2 site), has migrated across the bench and over the edge, to some extent obscuring the fault linear. This scree development is shown as a tongue on Fig. 8a, but the shape was not mapped in detail.

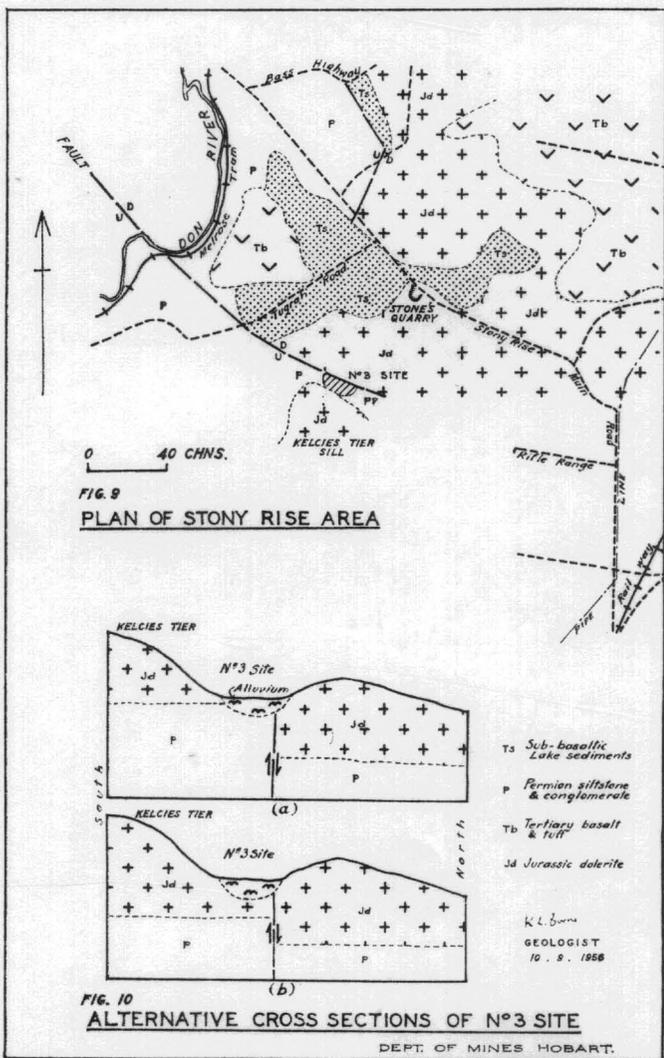
PLATE 13

As shown in the map (Fig. 9), the area is overlain by tertiary sediments and basalt. The northern-most patch of sediments has been faulted since deposition, or contemporaneous with deposition. The bedrock is the Permian and dolerite. The dolerite everywhere overlies the Permian, and jointing patterns suggest it is merely the dawn-faulted northern extension of the Kelcie's Tier sill.

The fault through No. 3 site was projected west, and when this area was examined, a fault down-throwing north in the required sense was located, so it is certain that a fault passes through the site. It is, however, uncertain whether the fault was of such throw as to expose the Permian at No. 3 site, so the two alternatives are presented (Figs. 10 a, b). Fig 10a is the favoured alternative.

With either structure, the site is sufficiently stable for a large reservoir, being capable of taking very high loads. The significance of the depth of alluvium, type of bedrock, and position of the fault is dependent on the amount of excavation envisaged, and type of structure. The evaluation of these factors depends upon the engineering proposals.

The No. 3 site, then, is eminently suitable from a geological standpoint.
