19. A probable landslip at Stanley.

W.L. Matthews

Tech.Rep.Dep.Mines Tasm, 20.

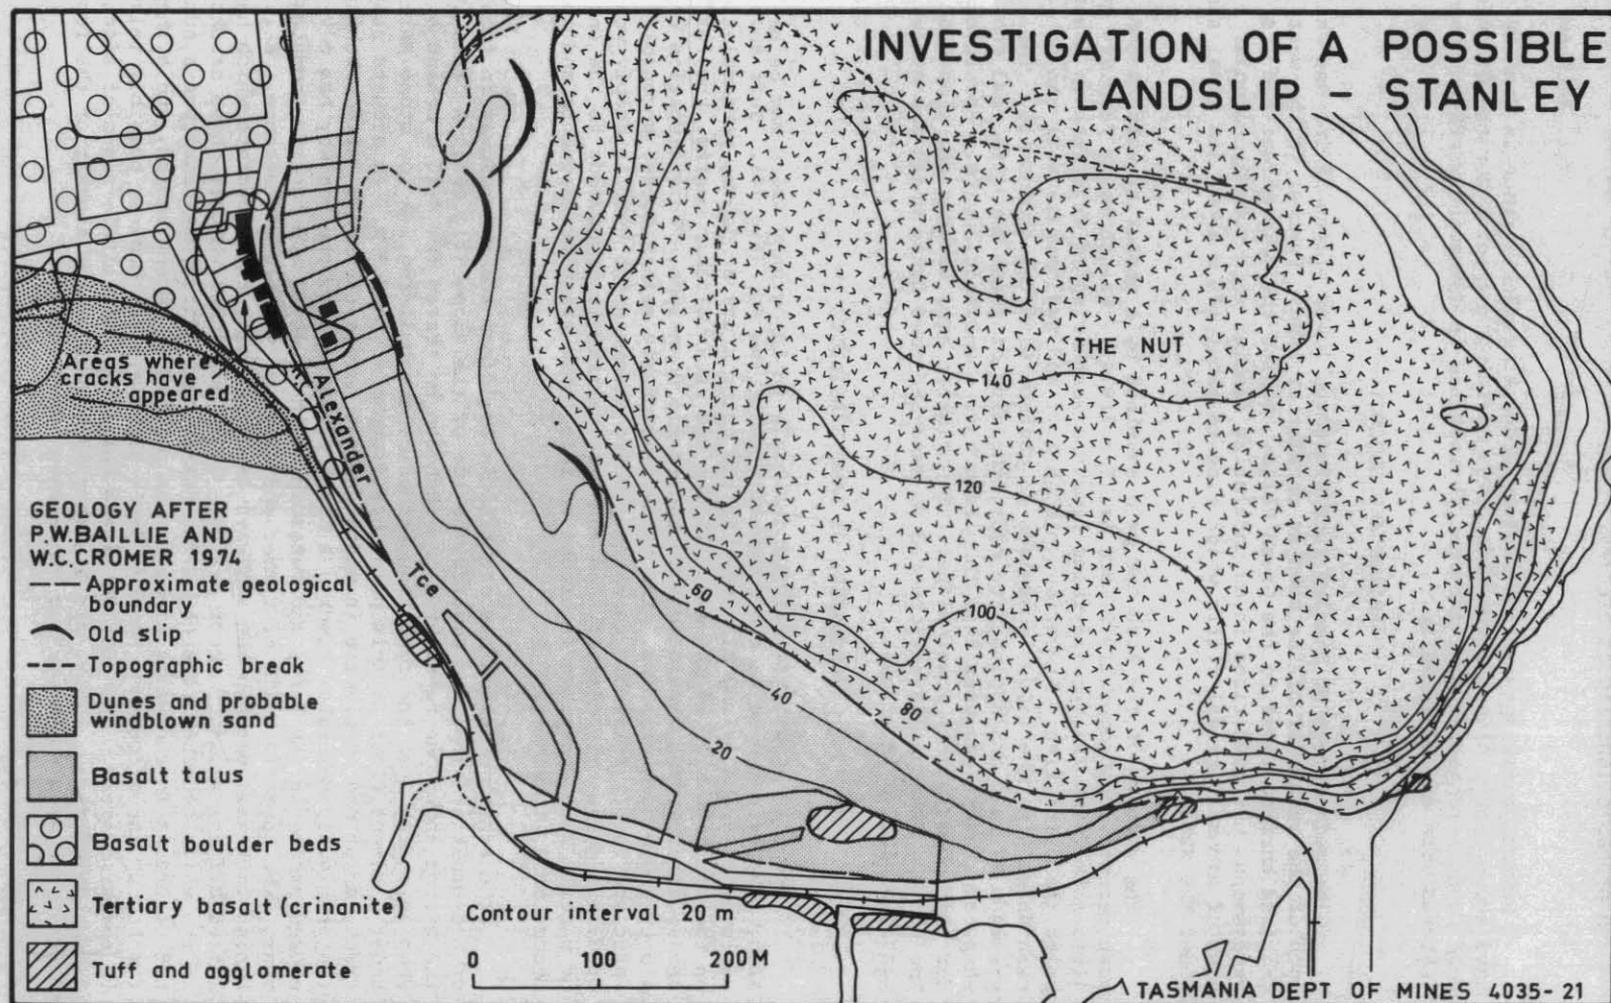
Figure 44.

Three old rotational slips and a break in topography which may be an old slip, have been mapped on the southern side of The Nut (fig.44). Tuff and agglomerate probably underlie most of the talus areas at depth, particularly on the southern side of The Nut. If The Nut is a volcanic centre, the tuff and agglomerate beds would be expected to dip downslope. This situation would aid the formation of slips. The talus is probably mainly loose, unconsolidated and fairly permeable to water. Where examined the tuff is deeply weathered, but moderately compact, and would be relatively impervious to the entry of water. When disturbed it breaks up into loose granular fragments and would become more permeable.

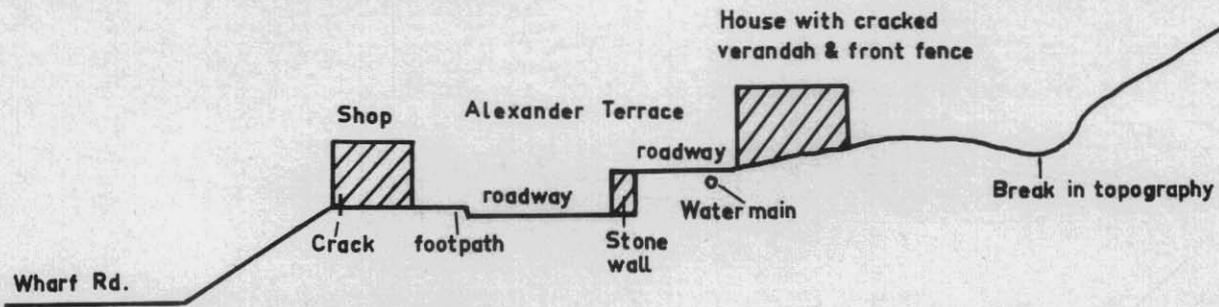
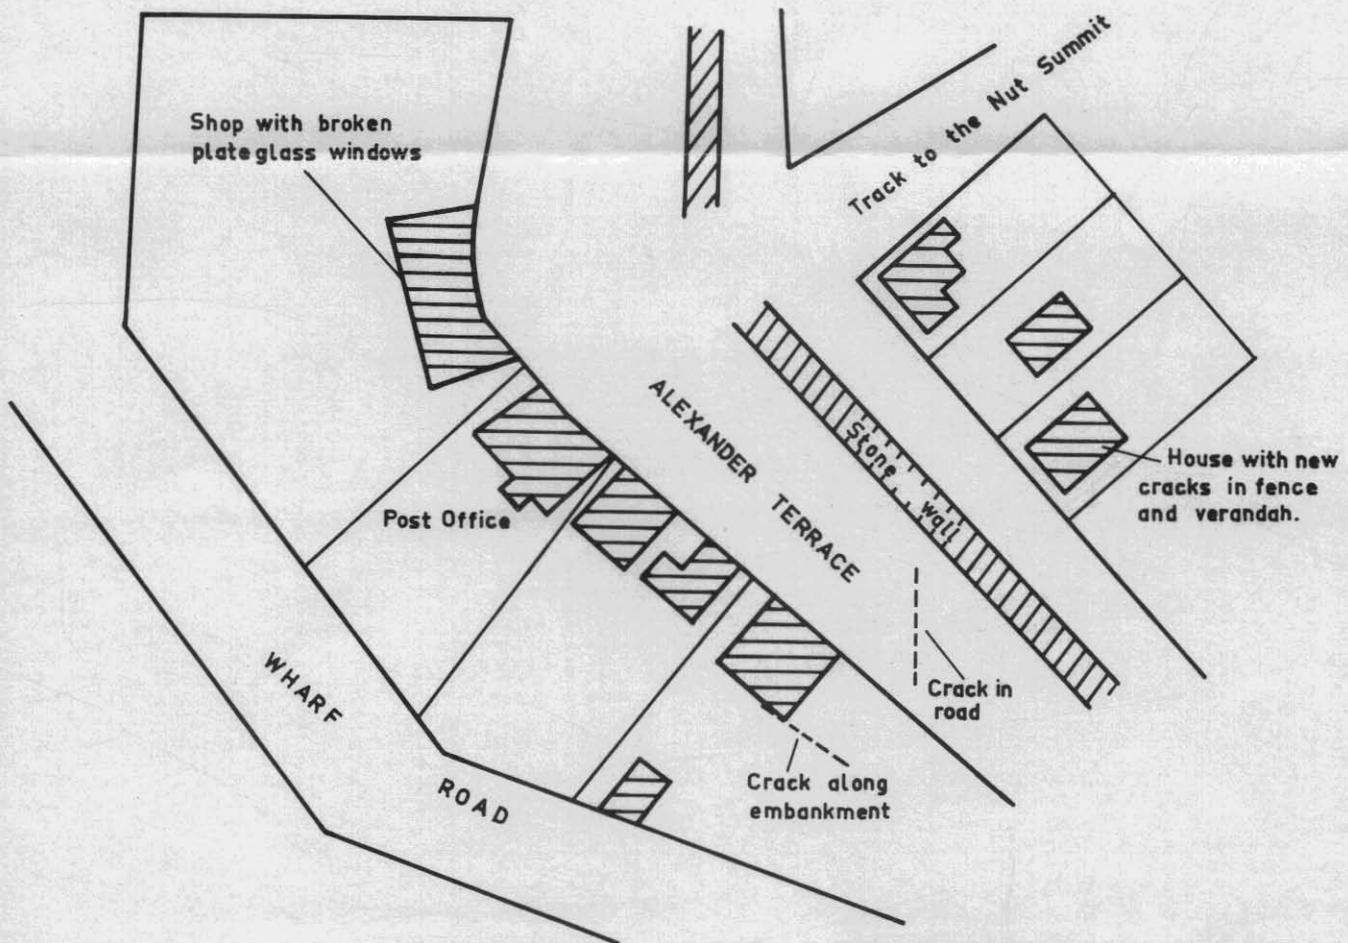
FIGURE 45

The recent cracking has occurred in buildings and the roadway in front of the break of slope and towards the toe of the slope (fig.45). A crack in the ground about one centimetre in width can be traced for 8-10 m behind a shop extending into the rear foundations of the building. A low stone wall under a cement floor at this point has dropped about 0.3 m. An arcuate shaped crack, about one centimetre in width extends across Alexander Terrace behind the previously described crack. A house fronting onto the roadway has developed cracks in the fence and verandah, both of which are concrete constructions. The house is built of timber and shows no visible disturbance. A 1.5 m high rock wall between the roadways is capped with thin concrete which has lifted off the rocks by about 2-3 cm. It is not known whether these cracks in the walls occurred recently. The nearby post office has developed a number of cracks in the walls since it was painted in recent months, and a shop further up the street has had two plate glass windows broken, possibly related to earth movement. The outside of the buildings show little signs of significant deformation. There are a number of cracks in the asphalt of the footpath in the area but it is not known when these formed.

A number of seepages occur in the bank behind the shop where the ground cracking has occurred. One seepage flows at about 10-15 litres per minute, the property owner stating that it has flowed at this rate for approximately six months, but had not occurred before then. If this is correct, it would appear that some alteration in the groundwater flow direction has taken place, a drain has become blocked, a water supply pipe may have corroded and is leaking, or a poor connection may have been installed. The council replaced the water main along the edge of the upper roadway between January and March 1975.

If this seepage has only occurred this year and not before, it is likely that any movement is connected with it. Changes in drainage or a leaking pipe would be the most likely causes of such a seepage.

It is apparent that at least part of the area in which cracks have developed, is affected by a slip which has developed at the toe of an older slip in common with slips in many other areas. The amount of movement is currently relatively small. Other sections for example the Post Office and the shop where plate glass windows have broken, could be affected by a slip but the cracks could have been caused by softening of clay in the talus due to moisture increase and subsequent settlement.

If the seepages in the bank behind the shop are only a recent development, as the owner states, it is apparent that some change in the groundwater flow has taken place, or drainage has been re-directed. It is possible that a domestic water pipe has corroded and is leaking or a poor connection has been made in the water main and these possibilities should be examined.

Heavy traffic should be prevented from travelling along this part of Alexander Terrace and a speed limit of about 30 km/h placed on other traffic along Wharf Road and Alexander Terrace near the area affected.

A possible means of stabilising the area would be to place rock against the foot of the slope, but some hundreds of tonnes would probably be necessary

just to stabilise the small area behind the shop. If the slip covers a wider area, this solution would probably be impractical.

Drainage from the seepages should be maintained and conducted away from the slope.
