TR20\_381\_384

R.710. Magnet mine residues after fifty years of weathering.

H.K. Wellington

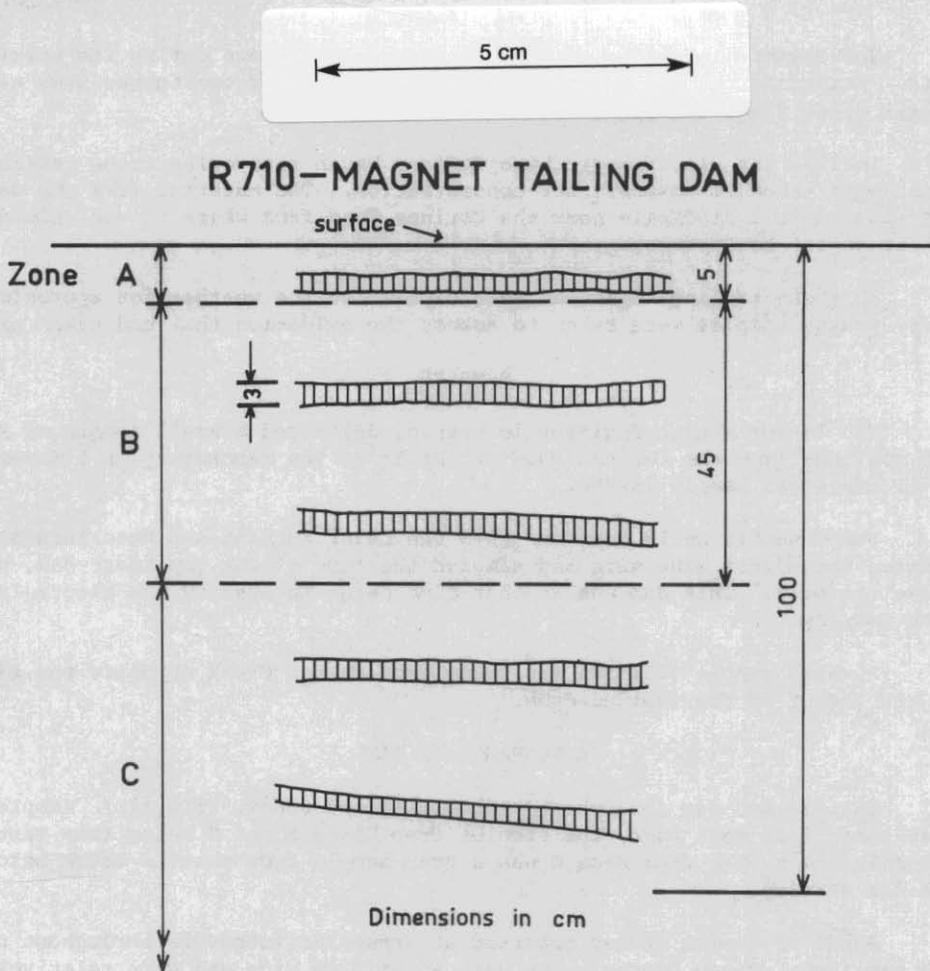
Figure 110.

The exposed dam face showed three distinct zones, (fig.110). Samples were taken from each zone, the samples from Zones A and B being from vertical channels while that from Zone C was a grab sample from about a metre below the dam surface.

Cross-section through Magnet Tailing Dam showing:

Zone A—very dark weathered top (5 cm)

Zone B—brownish stained, not as weathered as 'A' down to 50 cm

Zone C—below 50 cm no brown staining which indicates weathering

▣▣▣▣ - bands of coarse stones relatively free of fine material.

These bands were spaced through the normal tailings which were much finer in size.

From the assays, the surface zone (A) appears enriched in metals which may have been due to oxidation, although the sulphide sulphur is also high, possibly indicating that a richer material was placed in this top layer. However the sulphate content indicates considerable oxidation compared with the other zones.

Although a brownish stain penetrates into the dump to about 50 cm from the surface, no oxidation was detected chemically, except in the top 5 cm.

This dam has been oxidised over only the top 5 cm after the long exposure of a relatively coarse permeable material containing 3% sulphide sulphur. The presence of carbonate minerals may explain this, as the acidic products formed by the oxidation of the sulphide have decomposed the carbonates at hand thus preventing the penetration through the dam of low pH solutions.

Oxidation has for practical purposes been confined to the top 5 cm of a dam containing a coarse, permeable material containing 3% sulphur. An explanation for this could be the carbonate content of the material.
