TR3-122-135

Unstable Slopes and the Forth Pipeline

by K. L. Burns

SUPPLEMENTARY REPORT

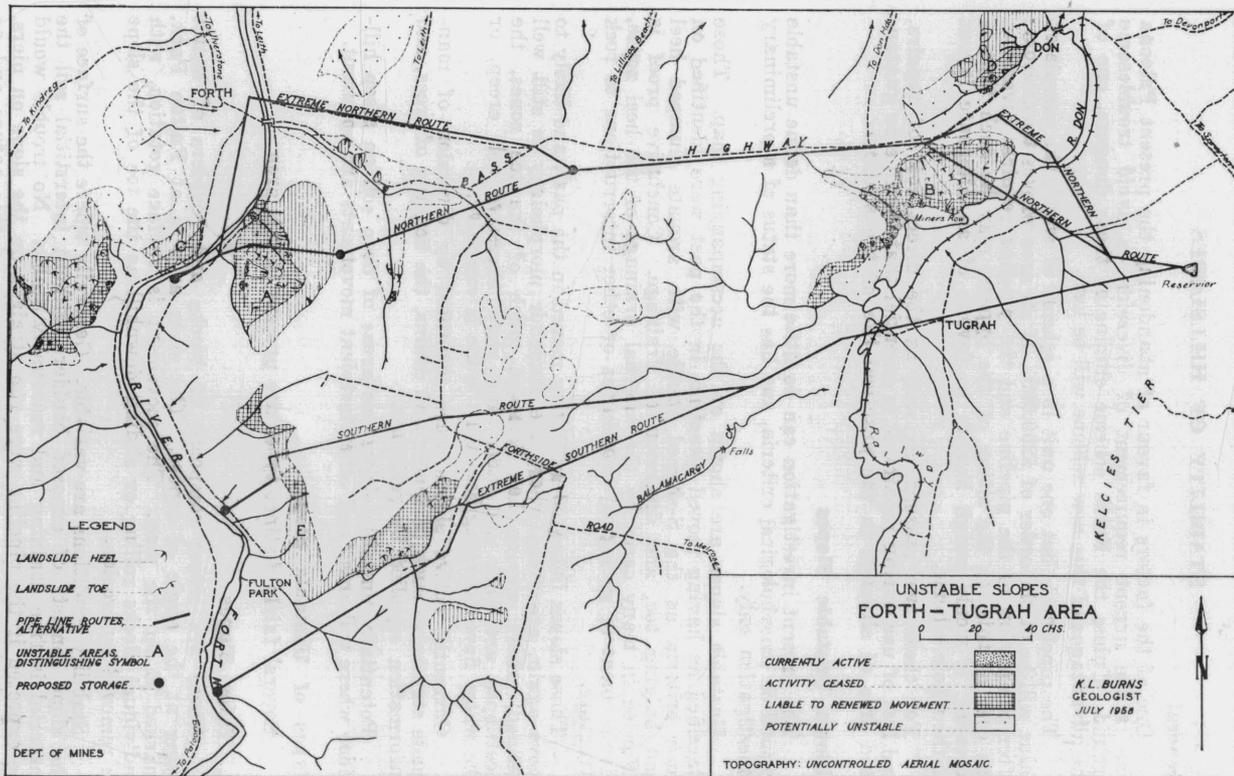
Figure 26

These are slopes composed of blocks and boulders of basalt lying at the angle of repose. The main area is at Fulton Park, marked E on the map. The movement is surface rotation, with individual blocks rolling or sliding downhill as the toe of the slope is removed by erosion.

Stability conditions are variable. Generally where the surface of the slope consists of exposed boulders without interstitial soil the material is free draining and reasonably stable. No trouble would be expected if the pipeline were run straight up the slope on piers. The first steep bank on the Paloona line is of this nature and no trouble has occurred.

However, in many cases these slopes are covered by deep soil, imperfectly drained, and they are therefore distinctly hazardous. If the crossing of area "E" on the southern route is kept as short and direct as possible there will be no difficulty. This route as surveyed is unfortunately sited in this respect and the amount of correction required is shown on the plan as a dog-leg at the top of the hill.

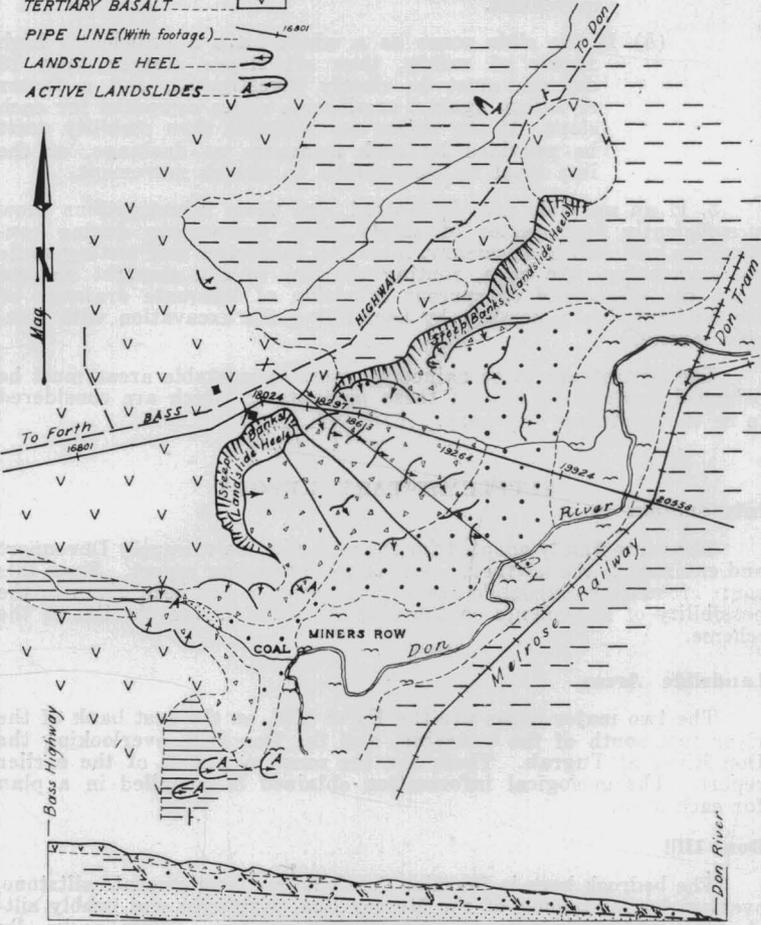
Figure 27

The bedrock here is Permian fossiliferous conglomerate siltstone, overlain by sandstones of the Mersey Coal Measures and pebbly siltstones corresponding to the Woodbridge Group. These rocks dip steeply east, due largely to drag-dip on a major Tertiary fault a short distance west, so that they outcrop as narrow belts with a N.N.W. strike. The belt of Mersey Coal Measure passes through the western side of the slide zone, and it is probable that the slides moved on a bedding surface, possibly a coal measures clay or shale, which dips east into the Don River.

The landslide toes appear truncated by the river terrace, which means the movement predates the present meander pattern of the Don River; i.e., it occurred some thousands of years ago. The landslide morphology has been somewhat modified by subsequent erosion.

The direct cause of slippage is undercutting by the Don River and since this process has now largely ceased, the slides are considered stable. The only activity noted consists of small slides where undercutting is still effective, but this is away from the pipeline route, and will not affect it.

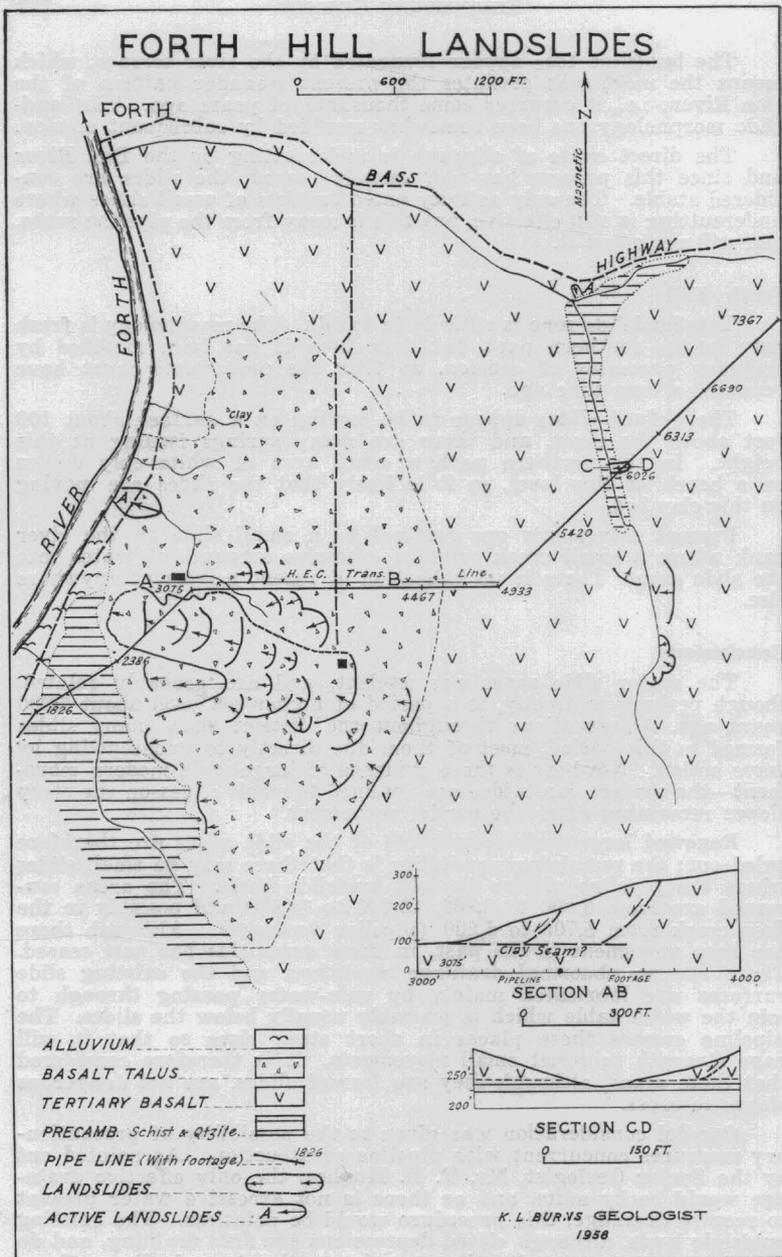
Figure 28

This landslide zone is entirely in basalt. The morphology is fresh only in the southern part, but even here it has been modified by ordinary processes of erosion, so that the movements must have occurred a long time ago.

The defined slides appear to be moving on a surface about 100 feet above the river, and there are many springs issuing at this height. In the northern part, a small area of white clay occurs on a bench at this level, so it is likely that the slides are moving on this clay bed.

Present movements are confined to a small slide on the river bank where a small creek supplies excessive amounts of water into the slide area. There is no indication of recent movement anywhere else.

The route adopted, although crossing formed slips, is reasonably safe for pipeline construction. A check should be made during construction to ensure no new slips are caused by the excavation. Care should be taken to prevent leakages in the portions 3,000 to 3,800, 5,700 to 6,200, 18,200 to 18,400 (pipeline footages). Permeable backfilling in these areas is unnecessary and even harmful as it will increase the amount of rain-water delivered into the formed slides.
