TR7-98-101

## 26. INDUSTRIAL WATER SUPPLY, TRIABUNNA

by I. Jennings.

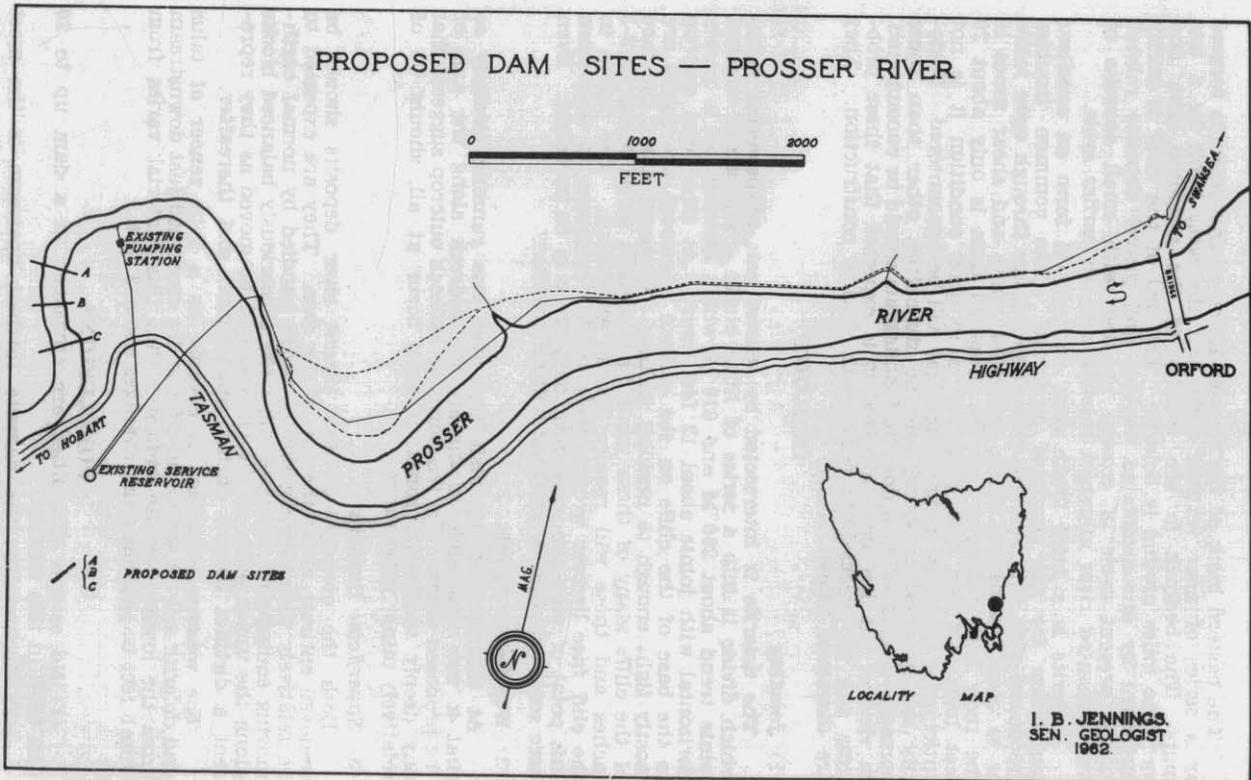
FIGURE 28.

The eastern bank of the Prosser River at this point is formed by a series of near vertical cliffs and the west bank by a low spur. The bedrock in the vicinity of the proposed dam and for some miles around is dolerite. The bed of the river is partly concealed by unconsolidated boulder and gravel deposits related to the present cycle of erosion together with small deposits of well cemented river alluvium belonging to an earlier cycle.
