18. FURTHER EXPLORATIONS AT FLAGSTAFF GULLY DAM

by I. Jennings

SKETCH PLAN & SECTIONS
EXPLORATORY WORKINGS IN FLAGSTAFF
GULLY DAM

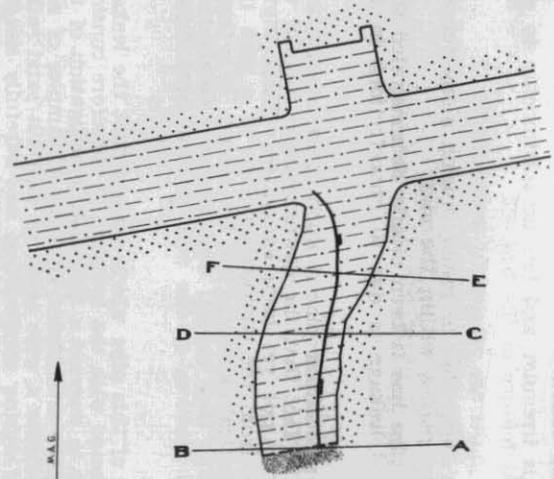
FIGURE 34.

The new path occurs about 10 feet west of the original pipe and, unlike it, is irregular in plan. Where intersected, the path trends roughly at right angles to the axis of the dam but just north of the axis it turns abruptly and trends toward the intake area of the first leakage path. The downstream portion of the second leakage path has not yet been excavated.

This path, like the first one, is located along the interface of the clay core and the bedrock and extends upwards 2 to 3 feet into the core. This does not necessarily imply that the piping

DOWNSTREAM PORTION OF NO 2
LEAKAGE PATH

The bedrock along the line of the new leakage zone has been carefully examined. It consists of rather hackly jointed mudstone but lacks the well developed master jointing exposed in the first leakage pipe. There is no special feature of this rock which would suggest leakage within the bedrock. Indeed completely similar rock occurs underlying the undisturbed clay core wall along both sides of the present excavation. Thus there is no geological evidence to suggest that the leakage originated within the bedrock.

A careful examination of the boundaries of the filter material and clay along the pipe revealed places where the piping had locally spread out laterally within the clay. This indicates that at some time branches or portions of the leakage path occurred within the clay. Also, if the leakage occurred from a point in the foundation rocks and developed by piping from the downstream face, then it seems doubtful if such a path would ever cut back up to the upstream face.

It is therefore recommended that a series of samples be taken each representing only a few inches of the clay core and mechanical analyses be made of these. If they disclose any significant variations in the clay-silt/sand ratios then further detailed sampling should be undertaken. Ideally such samples should be taken from a series of large diameter cores drilled, or driven, vertically through the core wall.
