TR9-112-120

# 11 GEOLOGICAL REPORT ON THE RISDON BROOK DAMSITE

by I. B. Jennings

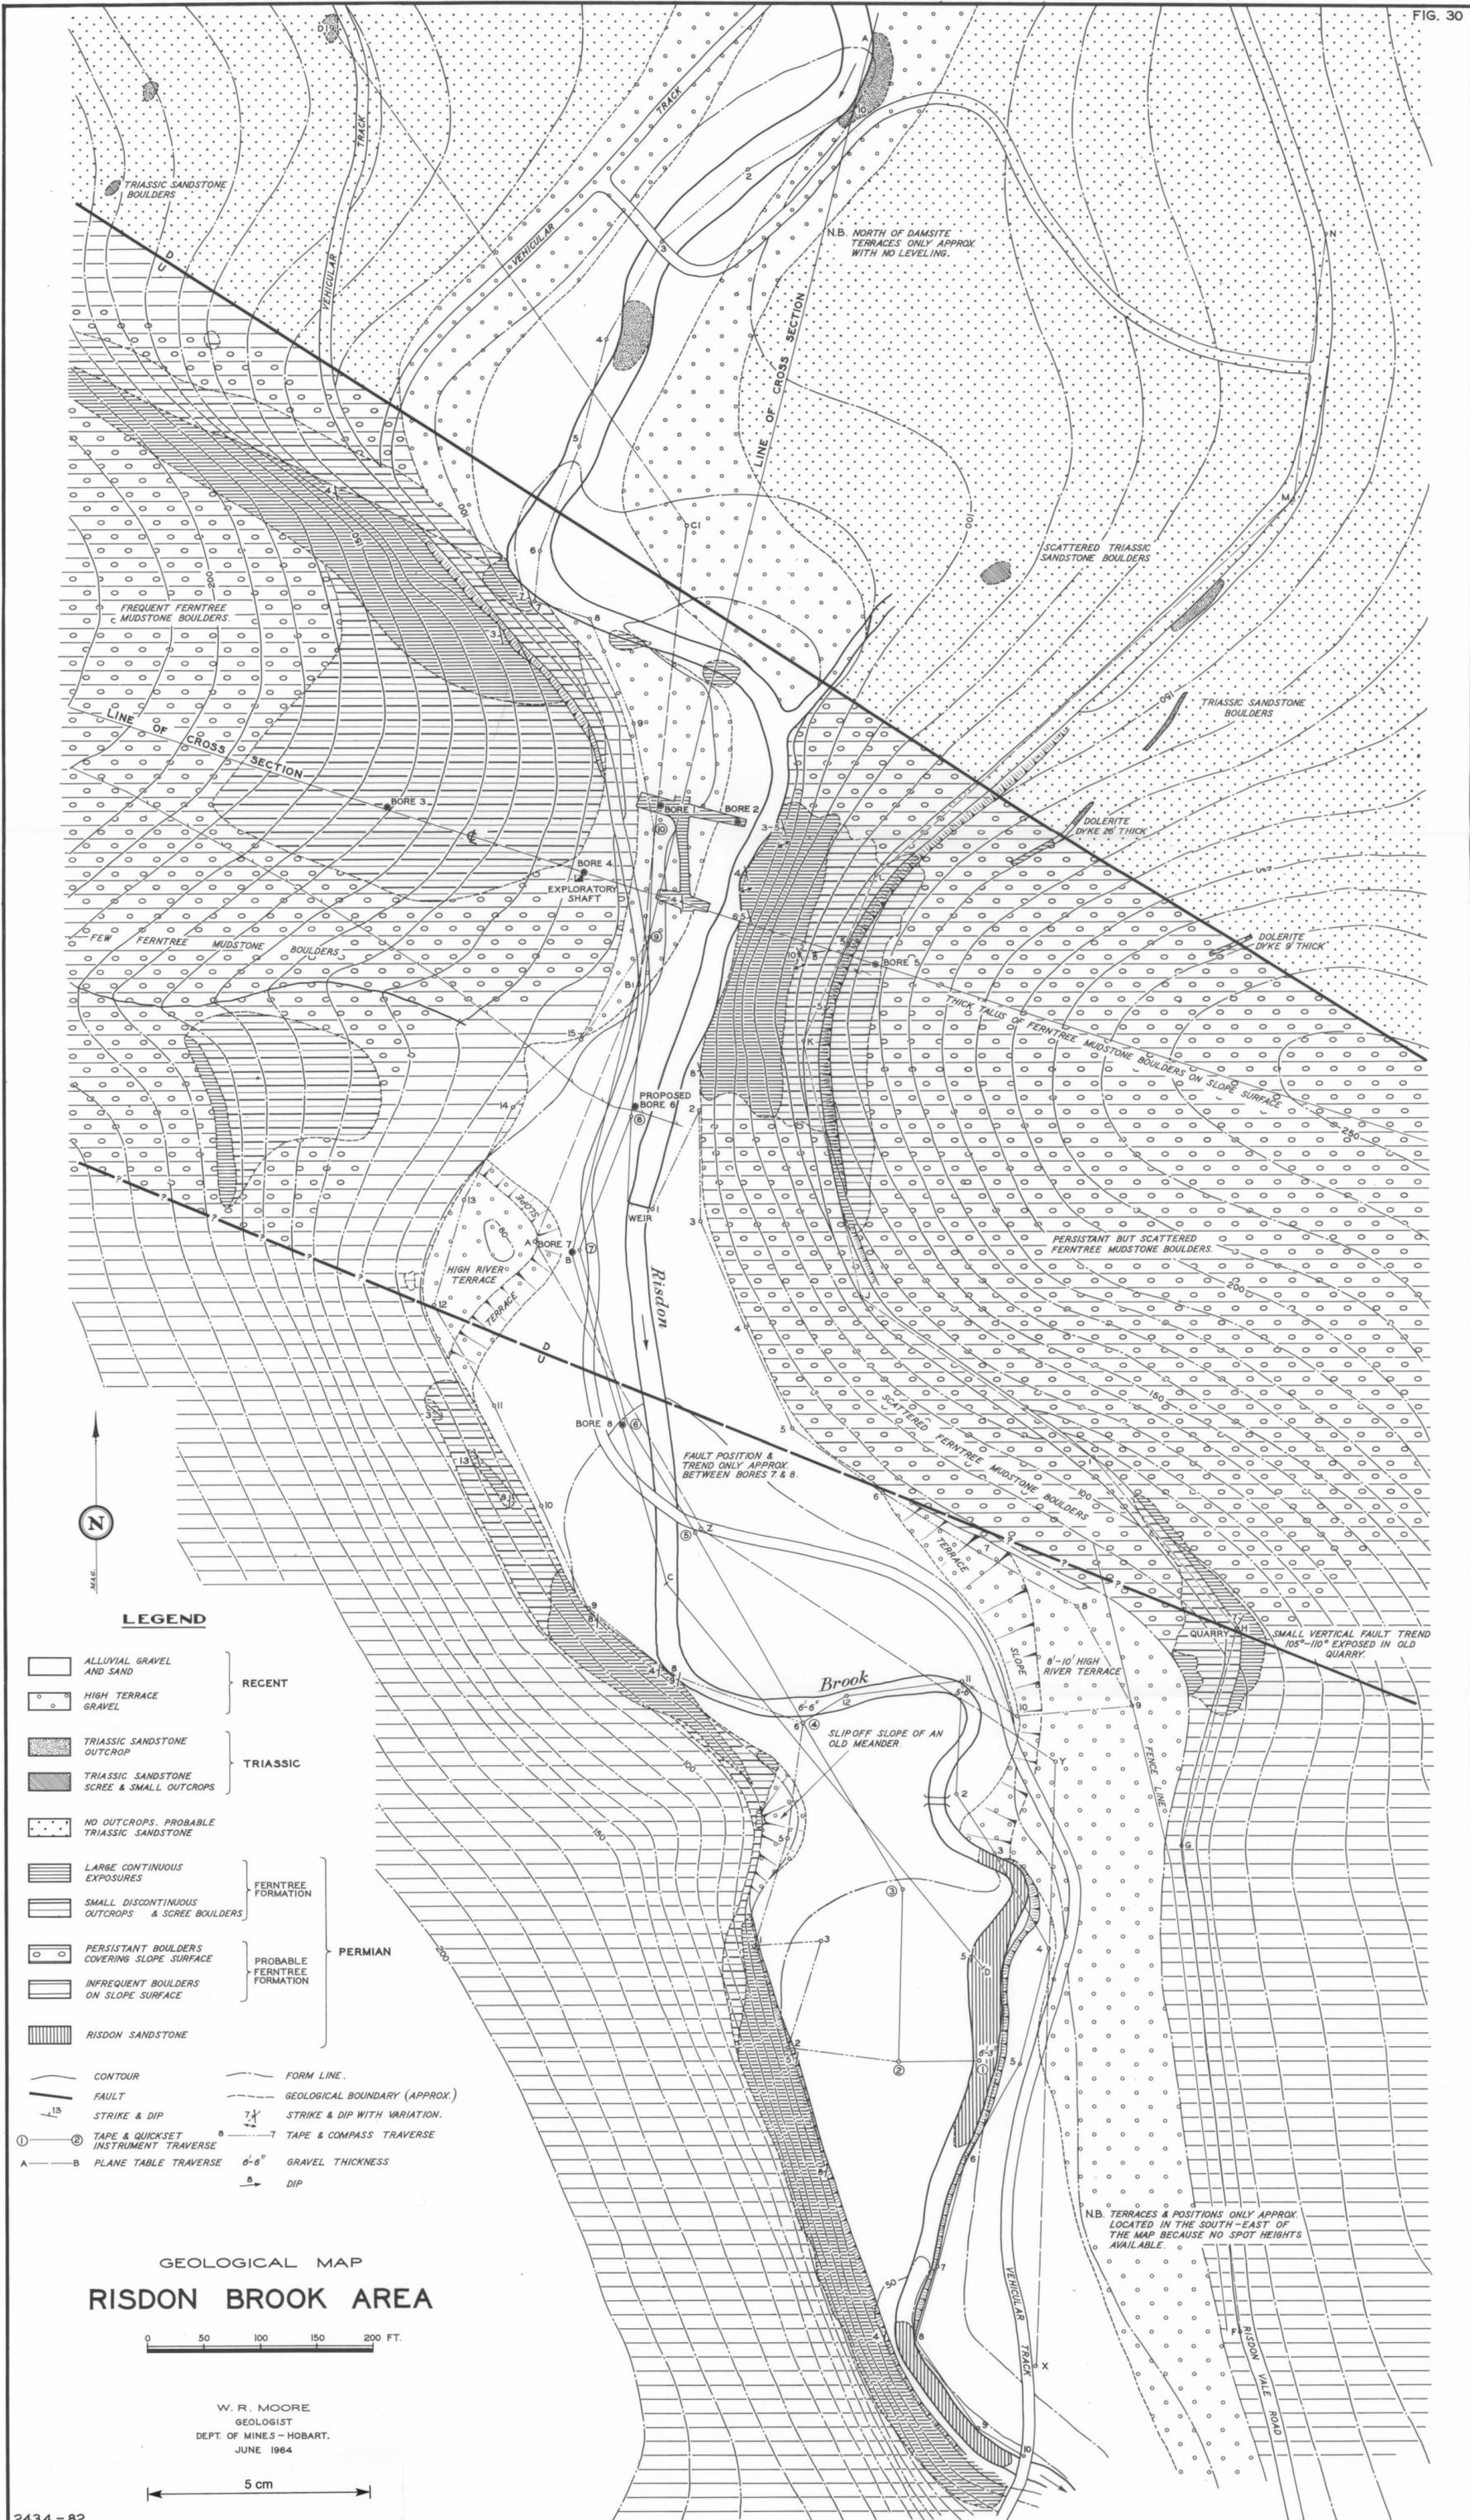
GEOLOGICAL MAP  
RISDON BROOK AREA

Previous workers have shown that this fault has a displacement (downthrow to the north) of at least 250 feet and possibly more than 600 feet. On Figure 30 the position of the fault has been fixed by the distribution of outcrops, by exposures in two trenches on the east abutment and by the contact reported in a trench excavated at creek level just upstream from the dam. From this information the trace of the fault in plan is remarkably straight indicating that the fault plane is nearly vertical.

Diamond drilling has demonstrated the existence of a small fault, indicated on Figure 30, crossing Risdon Brook 440 feet downstream from the dam. Surface mapping together with a study of the drill cores show that the fault must have a minimum displacement, downthrow to the north, of 65 feet. The trend of the fault cannot be firmly established from the information available and the position indicated on Figure 30 is based on drilling results and a study of distribution of outcrops. It should not be regarded as proven. Where this fault crosses the road east of Risdon Brook there is a narrow (4-5 feet) zone of brecciation.
