## Second report on the Parklands landslide

*by K. L. Burns and R. D. Gee*

# THE PARKLANDS LANDSLIP

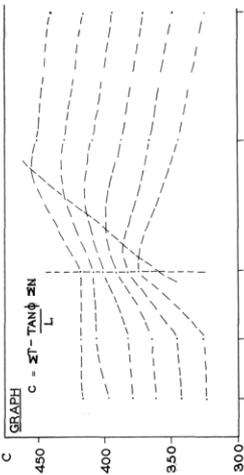
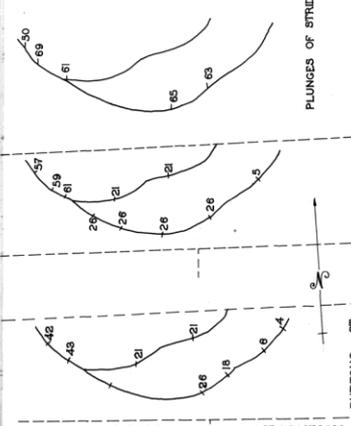
PROFILES OF ENBANKMENT  
BETWEEN BASS HWY AND BUTTON  
STREET

The slide is in soft brown clay derived from dolerite. The heavily striated heel dips around 65 degrees. Using this figure and survey data, a section of the slide has been constructed. This shows that the total weight is of the order of 1200 tons. The base of the slide is about five feet below highway level, close to the top of the bedrock. There is only a small moment opposing movement, so that the shearing strength of the clay is the only factor preventing collapse.

TOP : 20 FEET WEST OF LANDSLIDE  
BOTTOM : THROUGH PARKLANDS LANDSLIDE

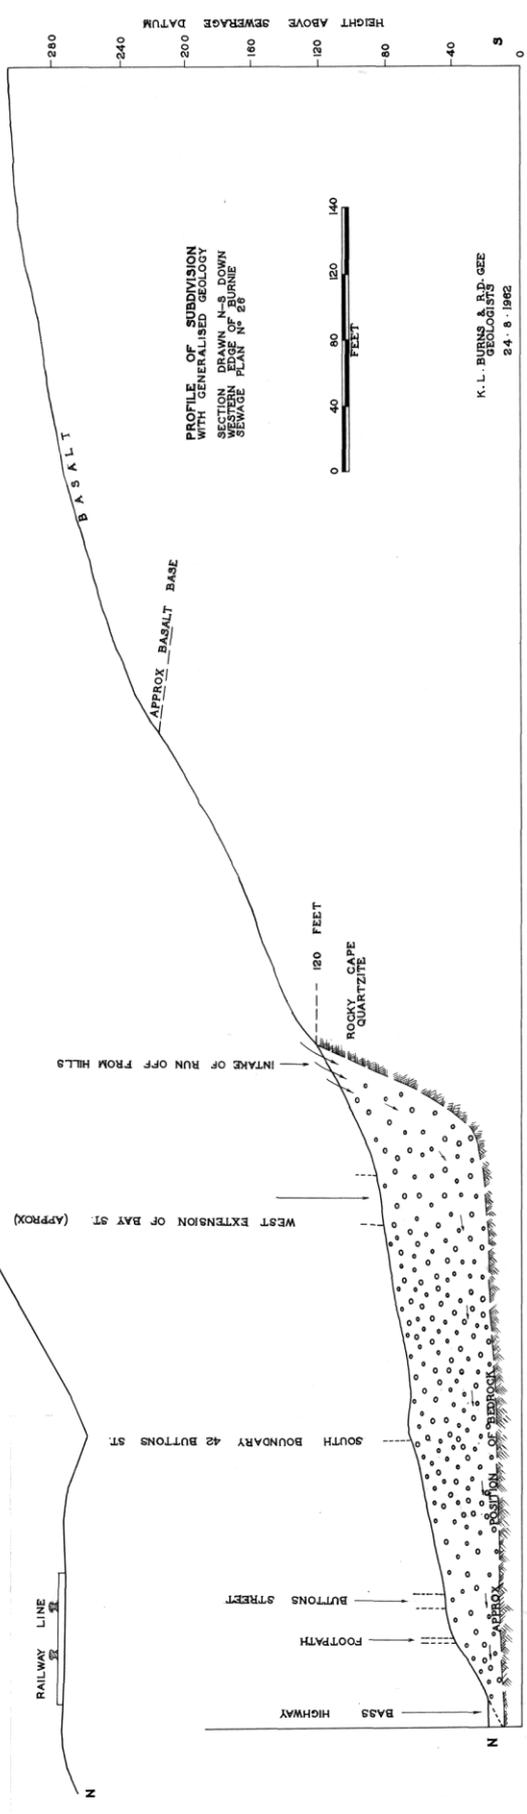
PROFILE OF SUBDIVISION  
WITH GENERALISED GEOLOGY  
SECTION DRAWN N-S DOWN  
WESTERN EDGE OF BURNIE  
SEWERAGE PLAN N° 28

The water table is very high in this general area. Water is entering the talus slope from the back hillside, partly as runoff over impervious rocks, and partly by conduction through low channels in the basalt. The highest inlet is about 120 foot above sewerage datum. The bank uphill of the Bay Street extension is saturated to ground level and weeping onto the road. Underground water is emerging in the back yard at No. 42 Buttons Street. Investigations show the source is not leaking drains. The ground immediately west of the westernmost house in Buttons Street is saturated,

The first stage of a hydrological investigation, geological mapping, has been initiated. The flow path of underground water is shown generally on the accompanying section, but the paths in plan are a matter for investigation. It is likely that a principal resurgence is located in the hollow at the western end of Buttons Street. A rise in water table due to abundant winter supplies, and restriction of outlets at highway level, would lead to high pressures under the embankment. This explains the long history of landsliding, and seasonal control.

If such groundwater conditions are present, which is highly probable, the only effective drainage is by means of an adit driven under the embankment at sea level, below highway level.

Groundwater conditions are an essential, and largely unknown, aspect of this problem. It is recommended that a hydrological investigation be made to determine general groundwater levels in the area, and the positions of intake and outlets. A number of drill holes, averaging 50 feet long, will probably be a necessary part of such an investigation.
