## UNPUBLISHED REPORT 1963/14

### Flagstaff Gully Dam

by I. B. Jennings

SKETCH PLAN & SECTIONS  
 EXPLORATORY WORKINGS IN FLAGSTAFF  
 GULLY DAM

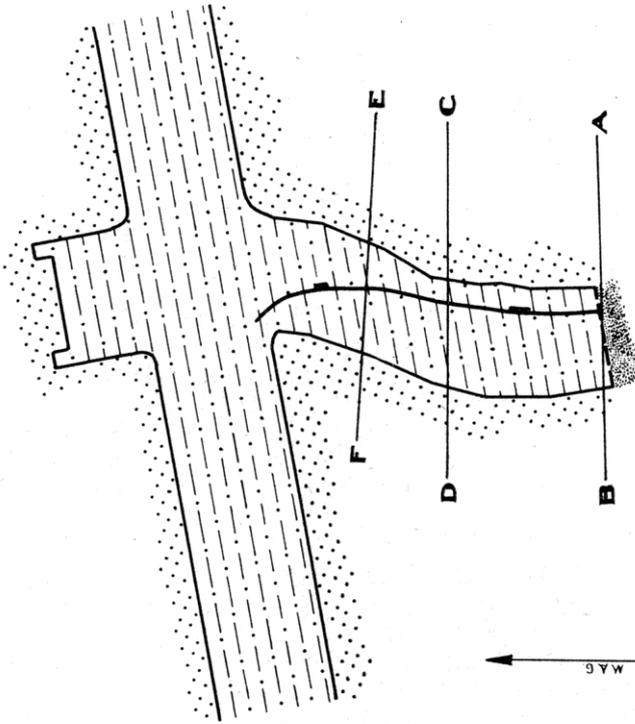
DOWNSTREAM PORTION OF NO 2  
 LEAKAGE PATH

The downstream portion of a second leakage path has been examined and a sketch plan and sections are attached. The floor and roof of this section of the pipe were well defined, but in places the clay along the walls was soft and wet and the precise boundaries were difficult to place.

The relevant feature of this portion of the pipe is that there is no evidence for erosion, apart from minor lateral spreading, entirely within the clay. The pipe apparently developed along the clay/rock interface and its course appears to have been determined originally by irregularities on the rock surface. A strong joint, or step, was noted roughly following the leakage path but no evidence could be found for leakage along the joint itself.

These findings confirm some of the points raised by the consultant engineers in their letter dated 18 November 1963. From a geological point of view the following is the position. The failure of this dam has been attributed to leakage along joints or structures in the bedrock which resulted in piping along the surface of the bedrock. However, despite careful examination no structure which could have caused sufficient leakage to initiate piping of this kind in a normal clay has been found, although it is accepted that the bedrock would have been saturated with pore water. In view of these findings I considered that there was sufficient justification for re-examining the physical and mineralogical properties of the clay. The presence of silty bands within the clay is only one of several aspects which should be examined in this connection. Preliminary tests have also been made on the mineralogical composition of the clay and other tests may be desirable. A complete investigation of the properties of the clay would probably lead into fields beyond the scope of normal geological investigations.
