## Foundation conditions of proposed extension to Bellerive Yacht Club

by I. B. Jennings

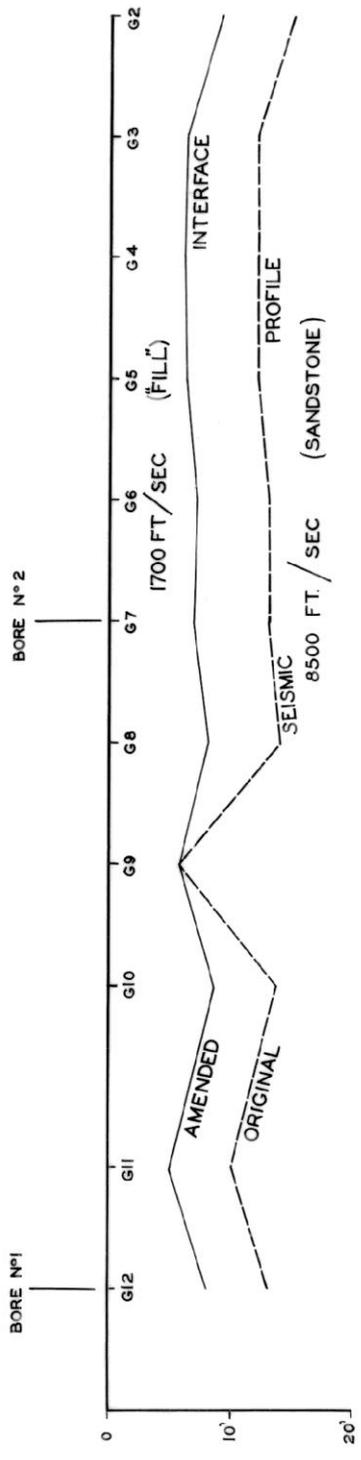
**TRAVERSE A**

Original and adjusted seismic profiles are shown on the accompanying plan, these indicate the depths to bedrock along the seismic traverses.

The investigations have revealed that the rock, Triassic sandstone, is overlain by a thin layer of filling. The disagreement between the two seismic traverses has been adjusted by means of the drilling results and indicates that generally the rock is less than 10 ft. from the surface. As was expected the fill is a heterogeneous collection of sandstone rubble, gravel, clay, bricks and logs. In Bore No. 2 the fill was reported to be poorly consolidated possibly due to the removal of fines by fluctuating ground water.
