## Further report on the Ambleside subdivision, East Devonport

by W. L. Matthews

# AMBLESIDE SUBDIVISION DEVONPORT TEST PITS

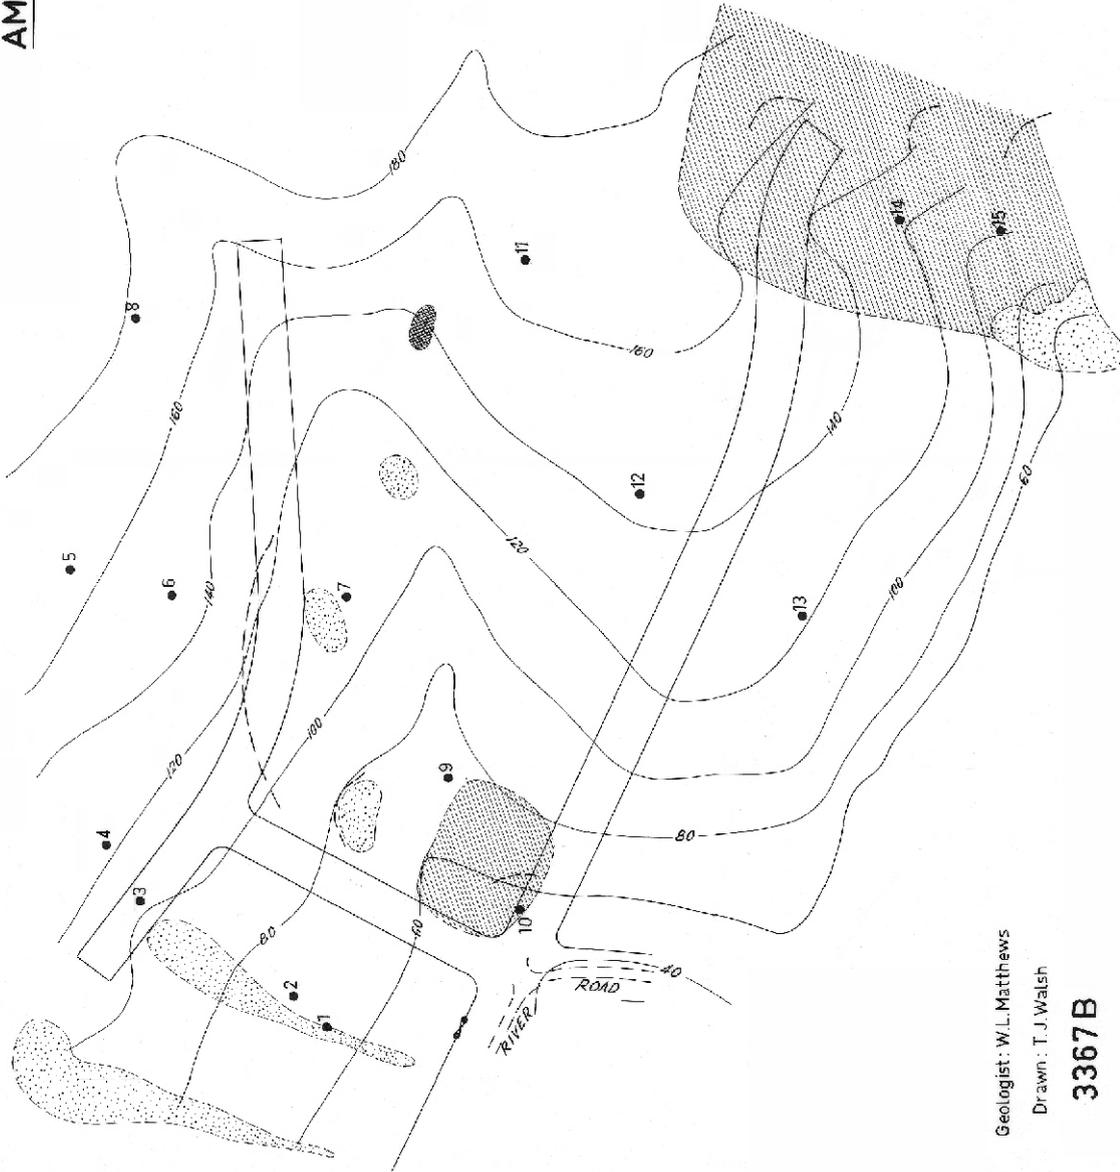
**Figure 1**

Following the first report dealing with the stability of this area (Matthews, 1972), fifteen pits were dug with a backhoe in the approximate positions shown on Figure 1. The materials struck in each hole are listed at the end of this report. The pits indicate that deeply weathered dolerite underlies the whole area. Further investigation of the surface resulted in the finding of one small dolerite outcrop and this is shown on Figure 1. The fact that several holes were dug to 3.6 to 4.6 m indicates the degree of weathering in the dolerite. Holes 10, 14 and 15 show that sandy clay and clay overlie the dolerite in these areas with a varying thickness of cover. These beds are probably accumulations of Tertiary sediments, and areas where they occur on fairly steep slopes (10 to 15°) should be treated with some caution. The soil in some of the higher areas is derived from the weathering of basalt which occurs further up the slopes.

A number of areas have been marked where there is a change in slope or break in topography. These could represent the heels of very old slips or could be the result of differential weathering in the dolerite. A number of seepages have been noted in the proposed subdivision and these also have been shown on Figure 1.

The steepness of some of the land surface, the seepages, and the possible very old slips suggests that development should proceed only after precautions have been taken. The seepages and streams throughout the area should be drained to prevent accumulations of water in the soil. These drains should have some built-in flexibility so that they are unaffected by small movements. Cuttings around steep parts of the land surface should be avoided or the batter should be low so as to not promote instability, particularly in the crescent-shaped road on the eastern side of the subdivision but also parts of other roads and excavations for houses. Because of the thickness of the sandy clay and clay and the steepness of areas around pits 10, 14 and 15, it is suggested that these areas are not developed as there is some chance of unstable conditions developing if the ground is disturbed.

The blocks in this proposed subdivision are large and allow a wide choice of sites for the houses. It is suggested that the houses, where possible, are built away from steeper portions of the land surface. The P.W.D. is creating quite steep high cliffs in their quarry face. Although slips are not usually regarded as being associated with dolerite in most areas they are not unknown (Leaman, 1972). The depth of weathering in this locality suggests that some precautions should be taken, and houses should be built some distance back from the edge of these cliffs.
