Report on the failure of a clay bank near Comalco's dam, Bell Bay.

P.C. Stevenson

BANK FAILURE AT COMALCO'S DAM NEAR GEORGE TOWN

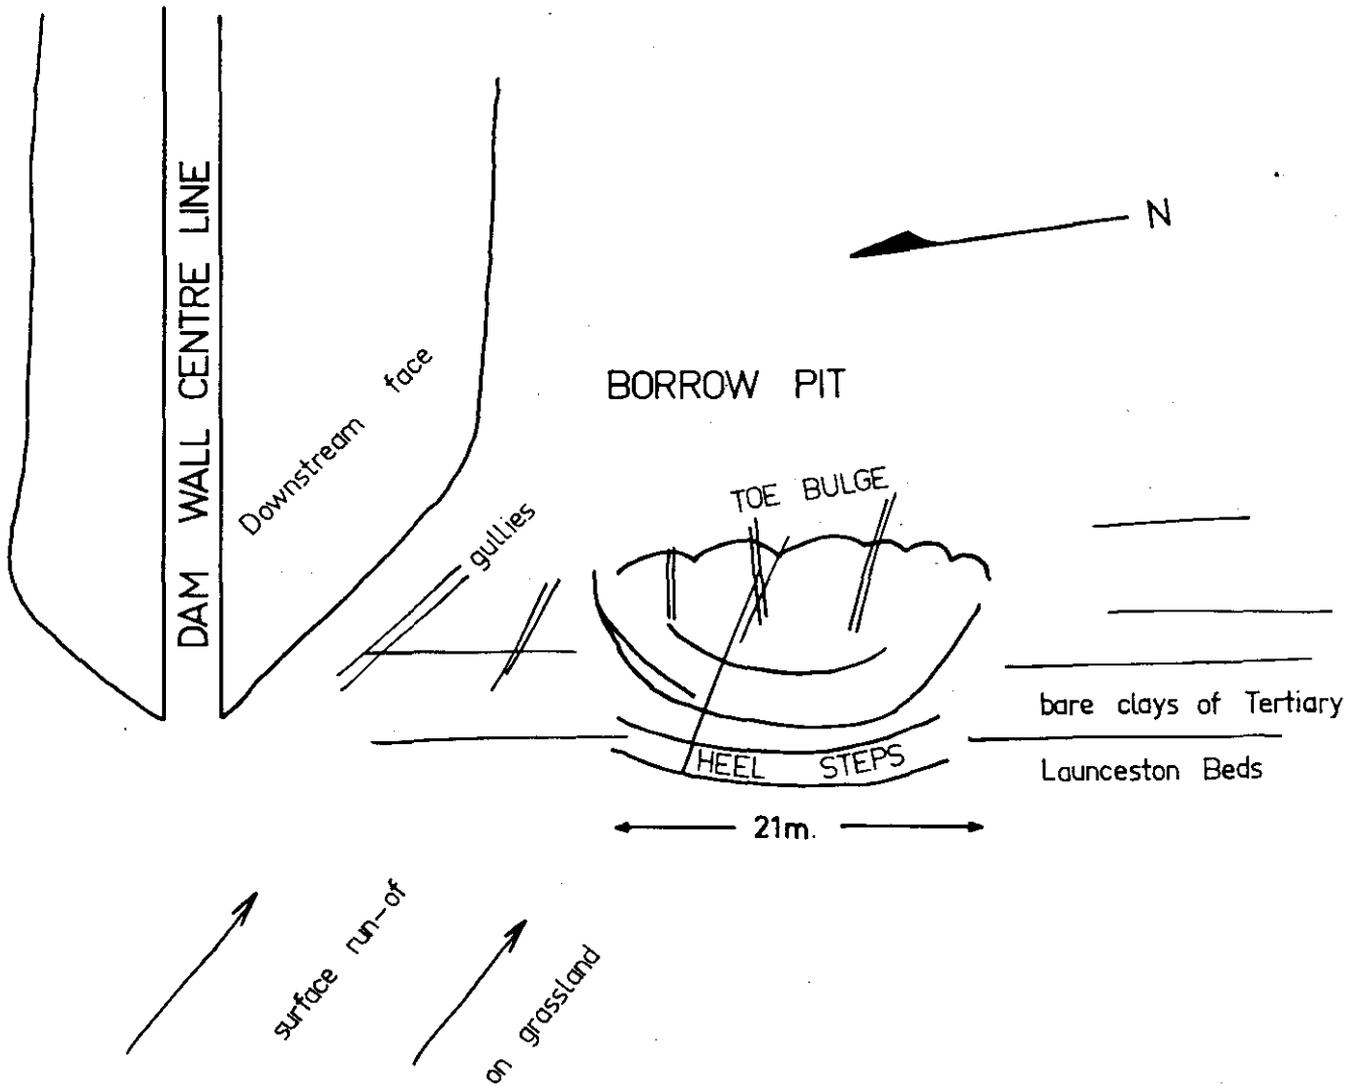
Figure 1

The bank that failed is approximately 20 ft in height and forms the steepest side of the borrow pit, sloping at an angle estimated at 16° . The bank lies parallel to the old valley side, is at right angles to the dam centre line and is situated downstream from it (fig. 1).

Part of the bank has failed and is slipping back into the borrow pit. The slip is at present approximately 75 ft in width, 50 ft from heel to toe, and at the nearest margin approximately 80 ft from the dam centre line.

The style of slip is similar to many in the Tamar area and is probably of the shallow blanket slide type (Stevenson, 1971). Steps at the heel and in the upper half are from 6-18 ins in height, and a well developed toe bulge is 1-2 ft high.

The heel has cut back up the slope and is now affecting previously undisturbed grass land, but most of the slip area is bare clay. No attempt has been made to grass over the bank, or to divert surface drainage which has cut gullies in both slipped and unslipped parts of the bank to a depth of 3 ft.

- (a) Stripping of surface cover, with consequent disturbance of moisture profile, shrinkage and cracking;
- (b) Failure to divert surface run-off thus enabling concentrated flow into shrinkage cracks;
- (c) Oversteepening of the bank. 11° is probably about the limit for stability in this material, provided the other factors are corrected.
