Slope stability at Rosevears, trial pits.

S. Elmer

Mr. R.J. Eastoe of Rosevears has requested a further examination of the stability of his land [Proposal Plan Bd-560] following the recommendations of an earlier report (Elmer, 1971). Two trial pits were dug with a back-hoe and examined on 2 September 1971. Their positions are shown on Figure 1.

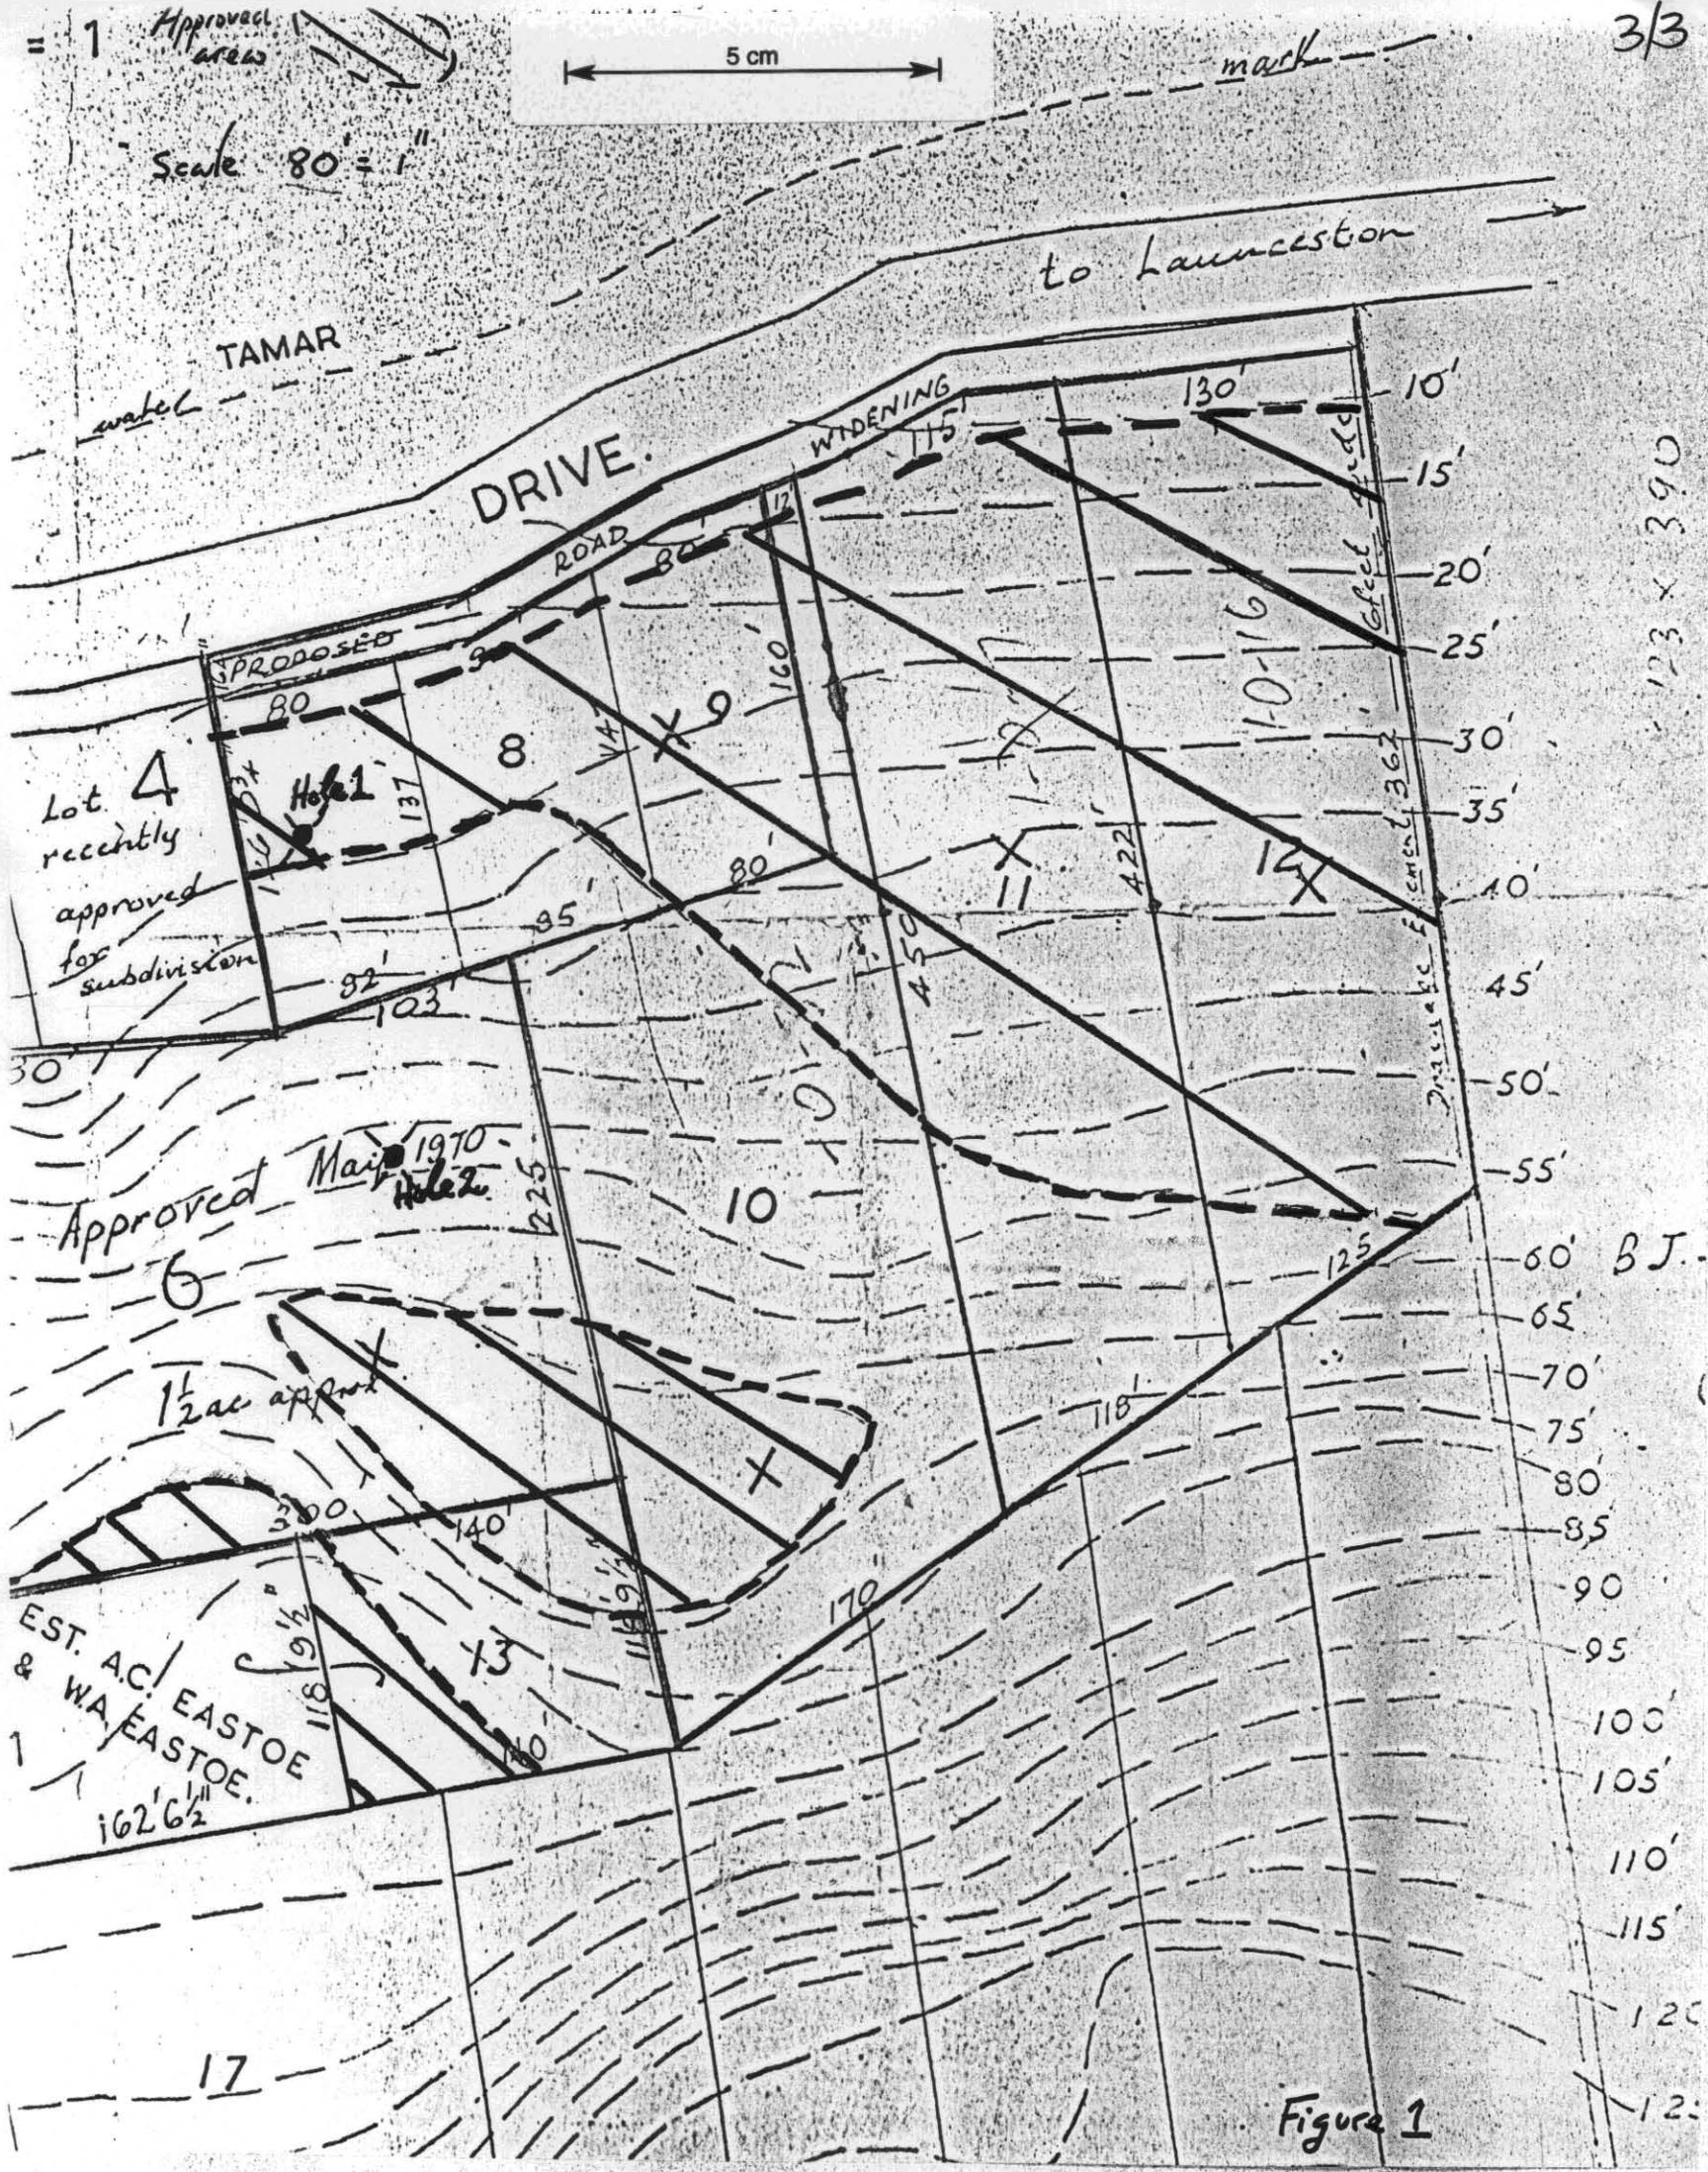
Figure 1

Approved areas

Building should be restricted to the bottom, flat part of the land and the upper gentle sloping areas that are well away from the crest of the slope (fig. 1). Effluents from stormwater and septic tanks should not be allowed to soak into the ground within the area of the subdivision or the adjoining road reserve.
