Slope stability of Danbury Park.

S. Elmer

Six back-hoe pits were examined on 28 September in order to determine the stability of the area of land referred to the Department of Mines by the Town and Country Planning Commission as Proposal Plan Bd-566.

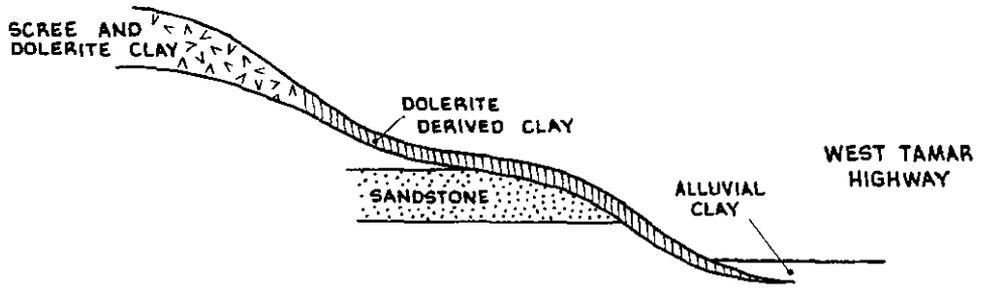
Schematic cross-section

The clay in Hole 1 may be considered as alluvial, the clay in Hole 2 and the grey clay occurring from 2-10 ft in Hole 3 is a Tertiary sedimentary clay, and the clay in Holes 4, 5 and 6 is derived from dolerite. The latter clay has moved downhill from the dolerite outcrop, and mantles the entire slope.

The sandstone observed in Holes 5 and 6 was estimated to be more than 50 ft in thickness. The upper steep part of the area consists of dolerite scree.

The upper dolerite scree area may be regarded as stable since weathered scree is known to be stable on a slope of up to 20°. The incline of the slope in this area is less than 15°. The doleritic clay is less slip prone than sedimentary clay and is known to slip only on very steep cuts. The lower part of the slope where this clay occurs is almost flat, and thus may be assumed stable. There were no obvious signs of old or new landslides in the area.
