Stability of land owned by the Roman Catholic Church, Preservation Bay, Penguin.

W.L. Matthews

PROPOSED SUBDIVISION PRESERVATION BAY

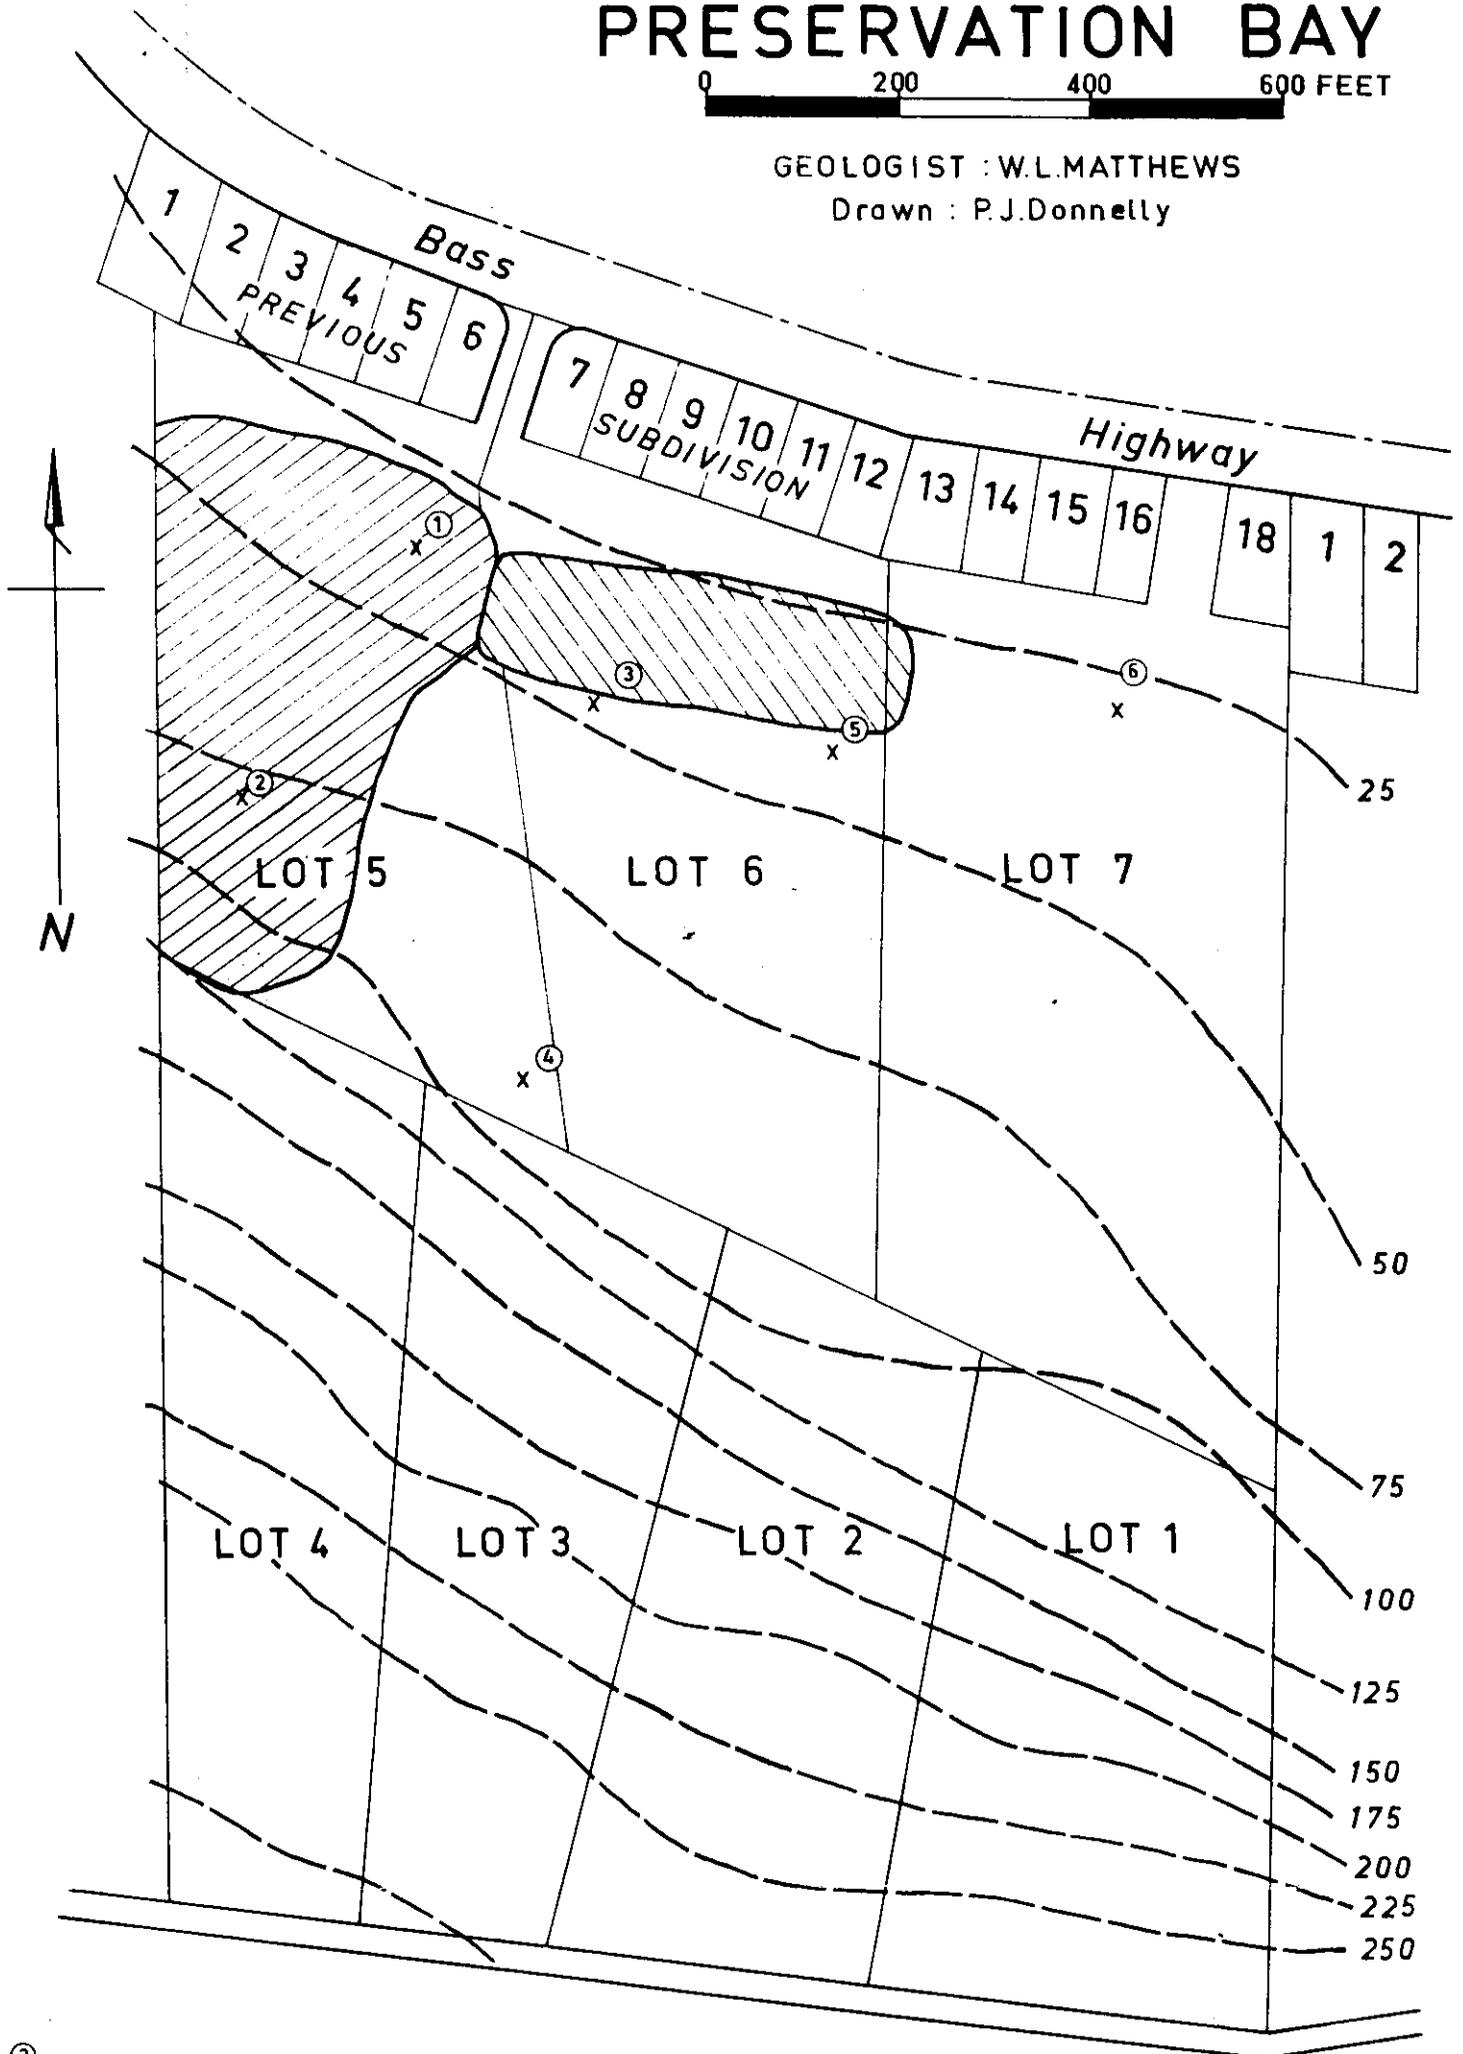
Figure 1.

The gentler sloping land in front of the steep slopes were regarded as being possibly suitable for subdivision and it was in this area that the test pits were sited to examine the underlying material. On the northern part of Lots 5 and 6 are slightly steeper sloping zones, the angle being some $7\frac{1}{2}$ - 10° and 10° - 15° respectively. These areas have been marked on the accompanying plan (fig. 1).

With poor drainage and excavation practices it is possible that slips could develop on the two relatively steep areas marked on the plan. These steeper areas are on Lots 5 and 6 and to be reasonably safe from the effects of any instability that could develop, it is suggested that development be restricted in these areas.

The numerous seepages that occur in the area should be drained so that the water is conducted away as quickly as possible and not allowed to percolate back into the soil. This in particular refers to the large seepage which has been dammed near the junction of Lots 6 and 7.
